Our Ref.: 12679377 – NMOCD – 1

December 4, 2025

Closure Report
Devon Energy Production Company, LP
Exmoor 15 CTB 2
Unit Letter A, Section 15, TS25, R31E
GPS: 32.134225, -103.757538
Eddy County, New Mexico

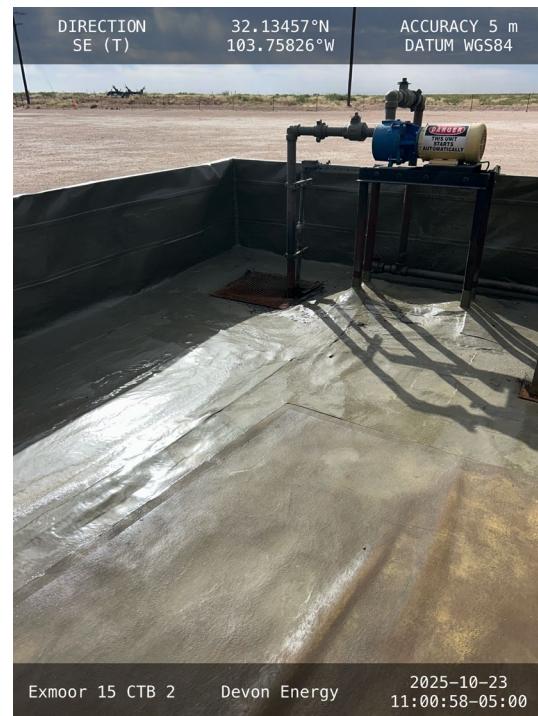
Photo 2 View of southeast corner of containment.

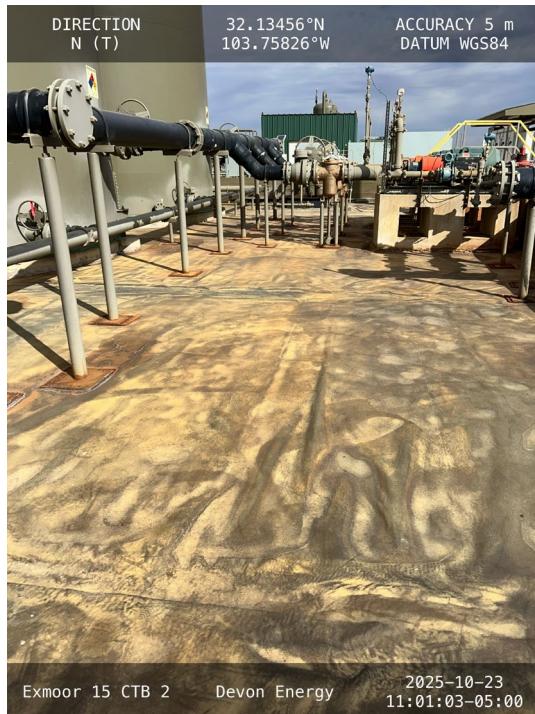
Photo 3 View of eastern portion of secondary containment facing north.

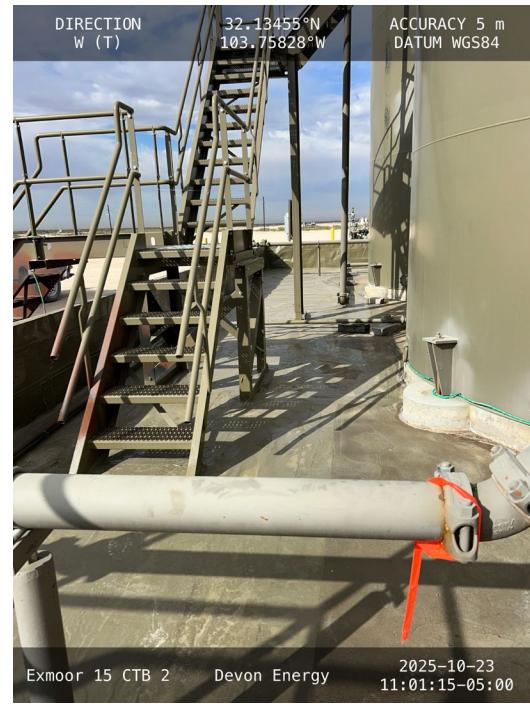
Photo 4 View of southern portion of secondary containment facing west.

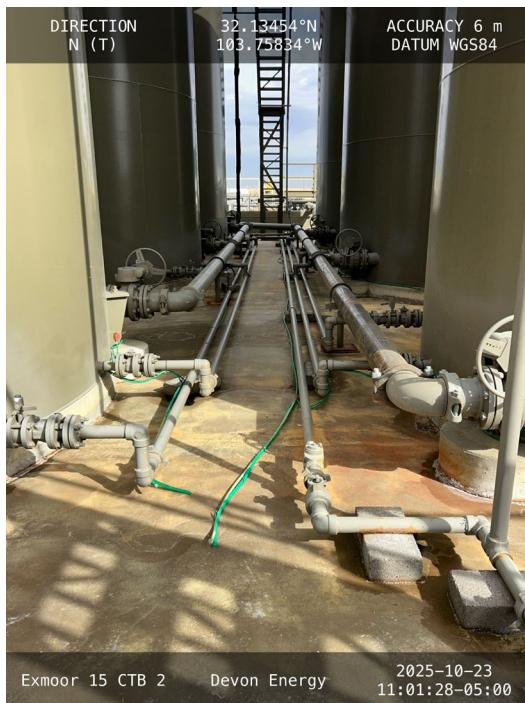
Photo 5 View of central portion of secondary containment facing north.

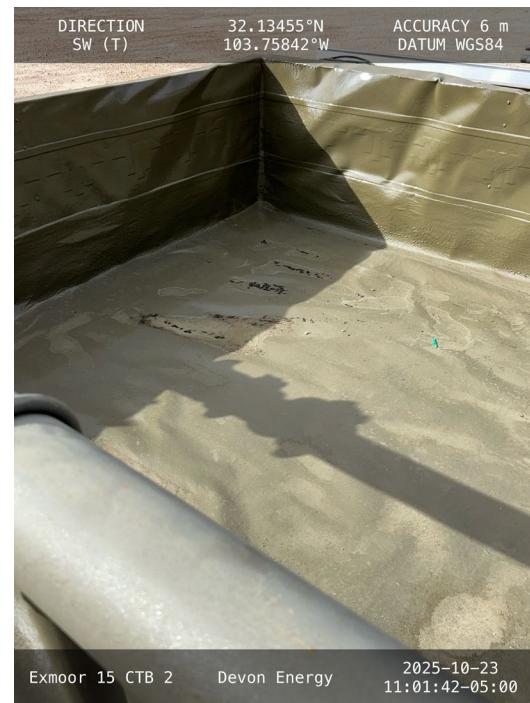
Photo 6 View of southwest corner of secondary containment.

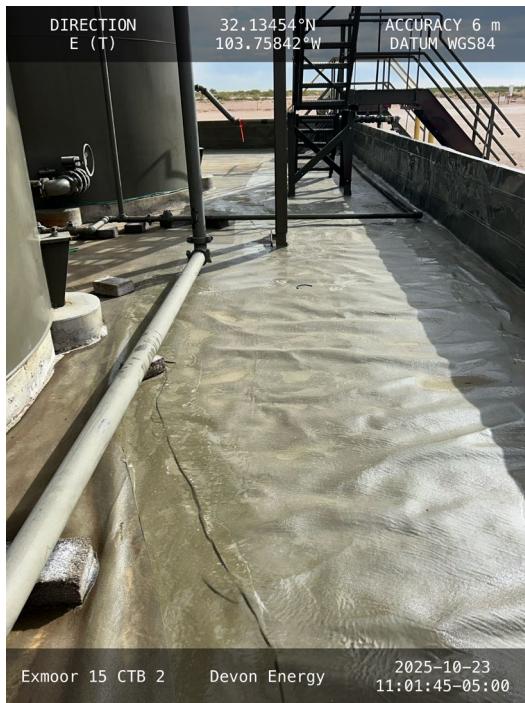
Photo 7 View of southern portion of secondary containment facing east.

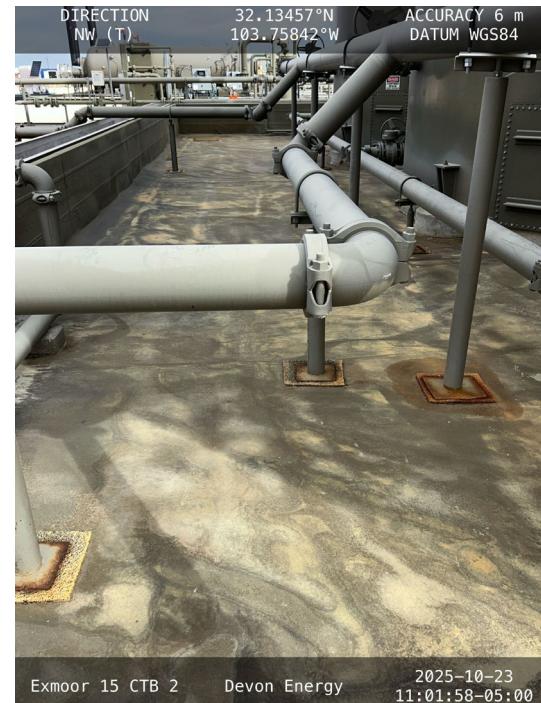
Photo 8 View of western portion of secondary containment facing north.

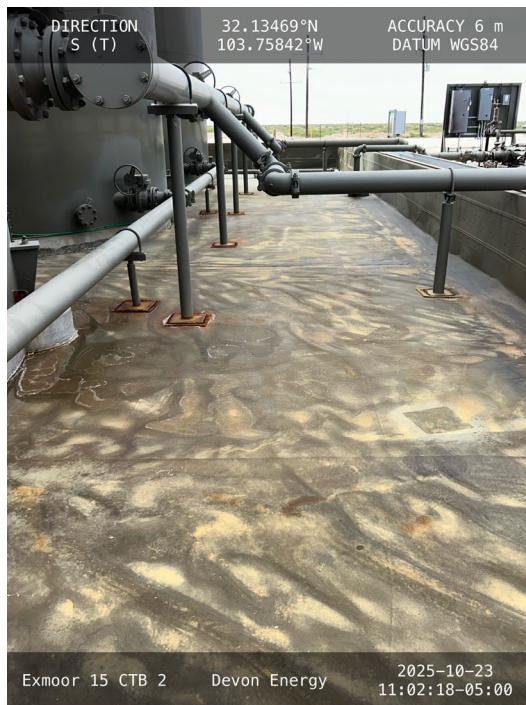
Photo 9 View of western portion of secondary containment facing south.

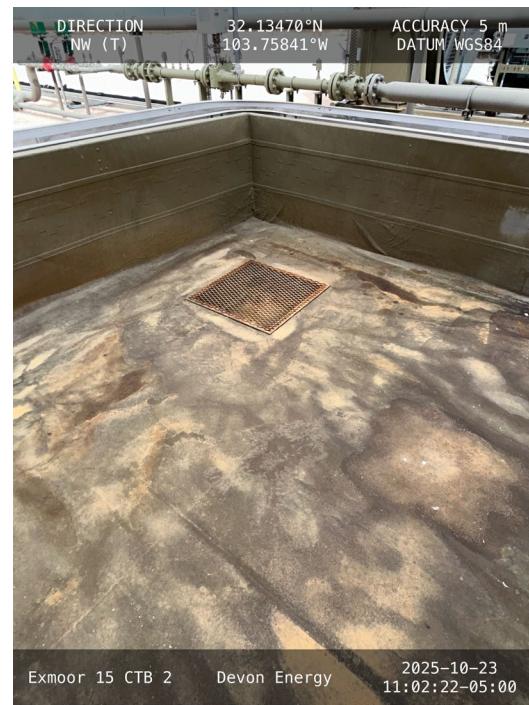
Photo 10 View of northwest corner of secondary containment.

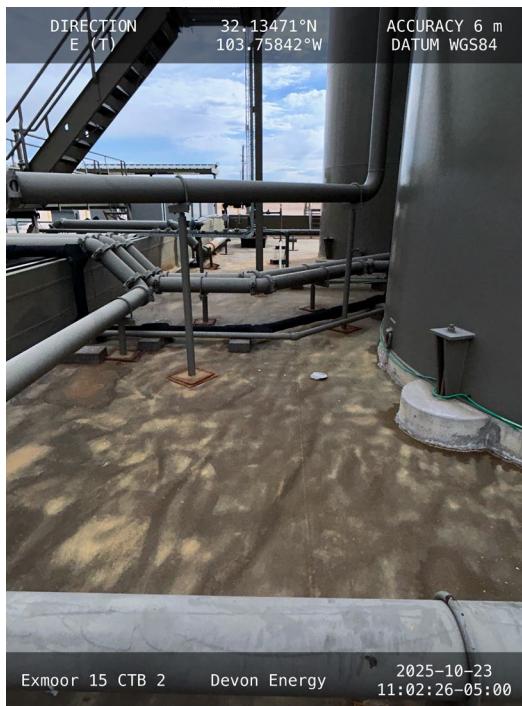
Photo 11 View of northern portion of secondary containment facing east.

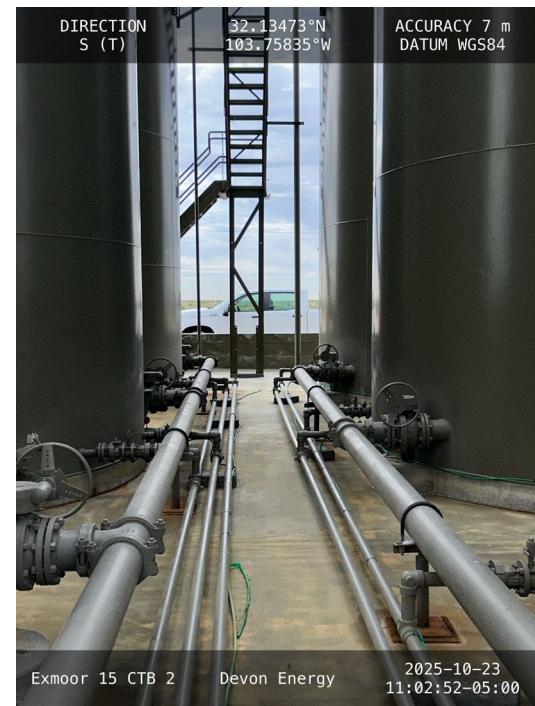
Photo 12 View of central portion of secondary containment facing south.

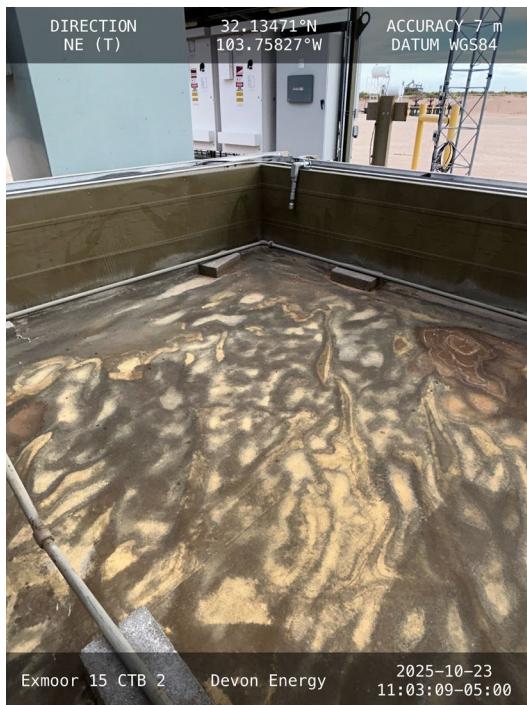
Photo 13 View of northeast corner of secondary containment.

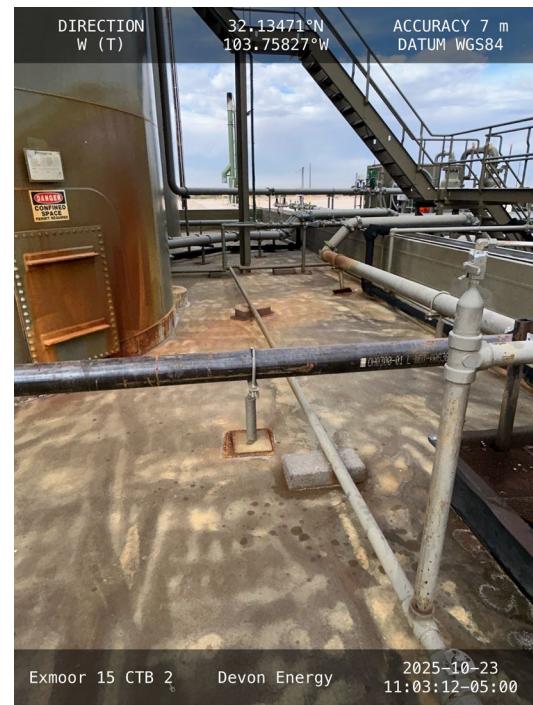
Photo 14 View of northern portion of secondary containment facing west.
