Remediation Report and Closure Request
El Cedro Tank Overflow
Section: 31 Township: 29N Range: 5W
Lat: 36.688047 Long: -107.402200
Rio Arriba County, New Mexico

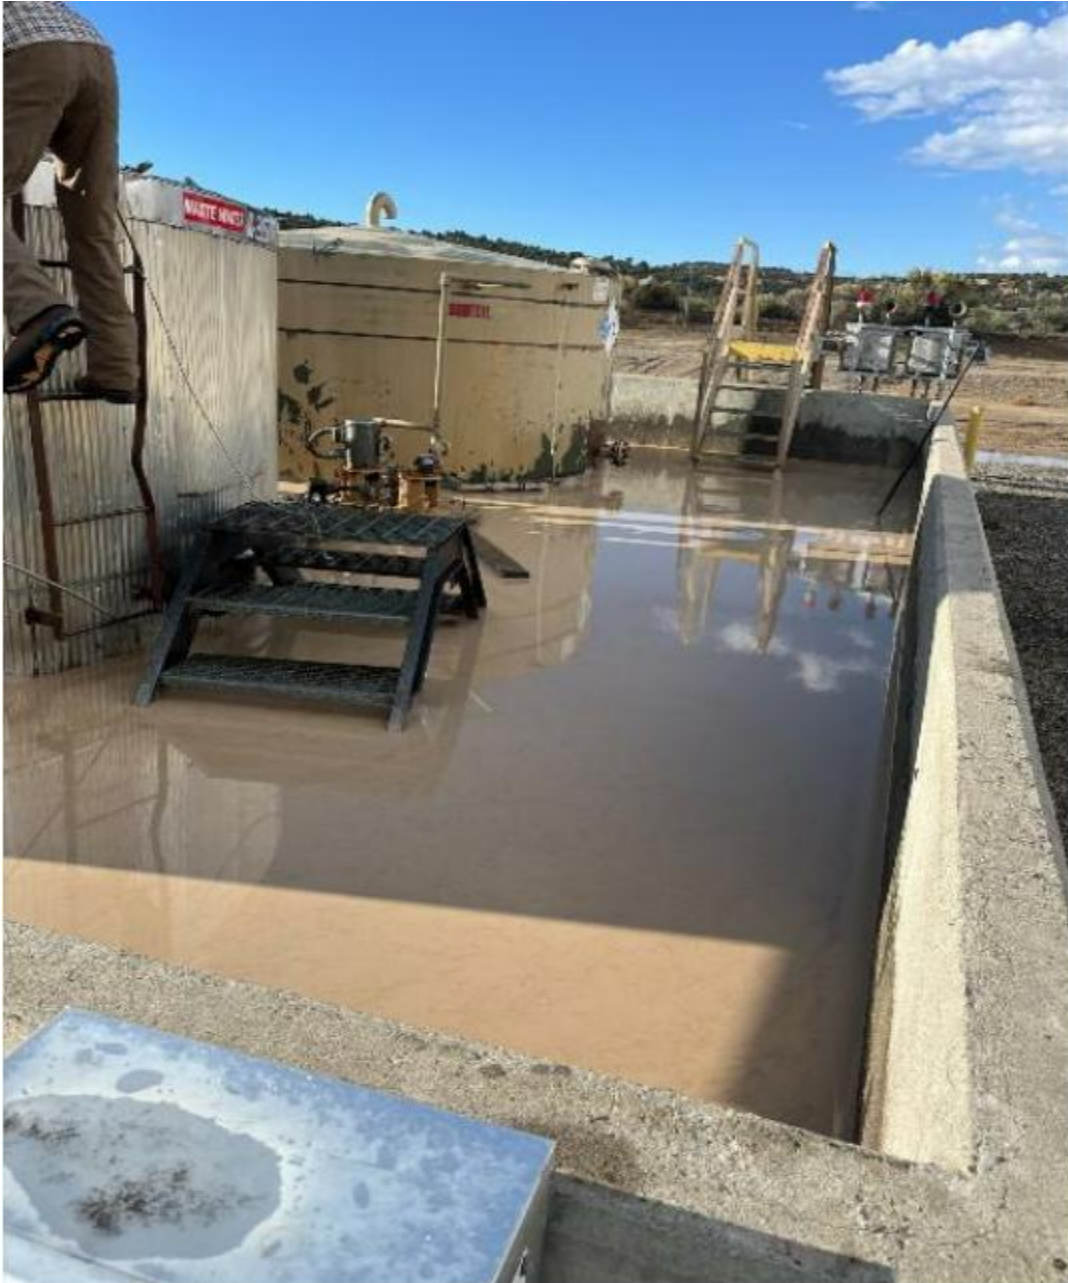
After Release

Harvest Personnel discovered a release at El Cedro CDP. The release was due to an excessive amount of rain collecting in the concrete containment and into the wastewater tank from the skid drains throughout the facility. This caused the wastewater tank to overflow into the concrete containment. Release volume was calculated to be 9.9 bbls. A truck was called to remove the fluids, for the next day.

All free-standing liquids were sucked up.

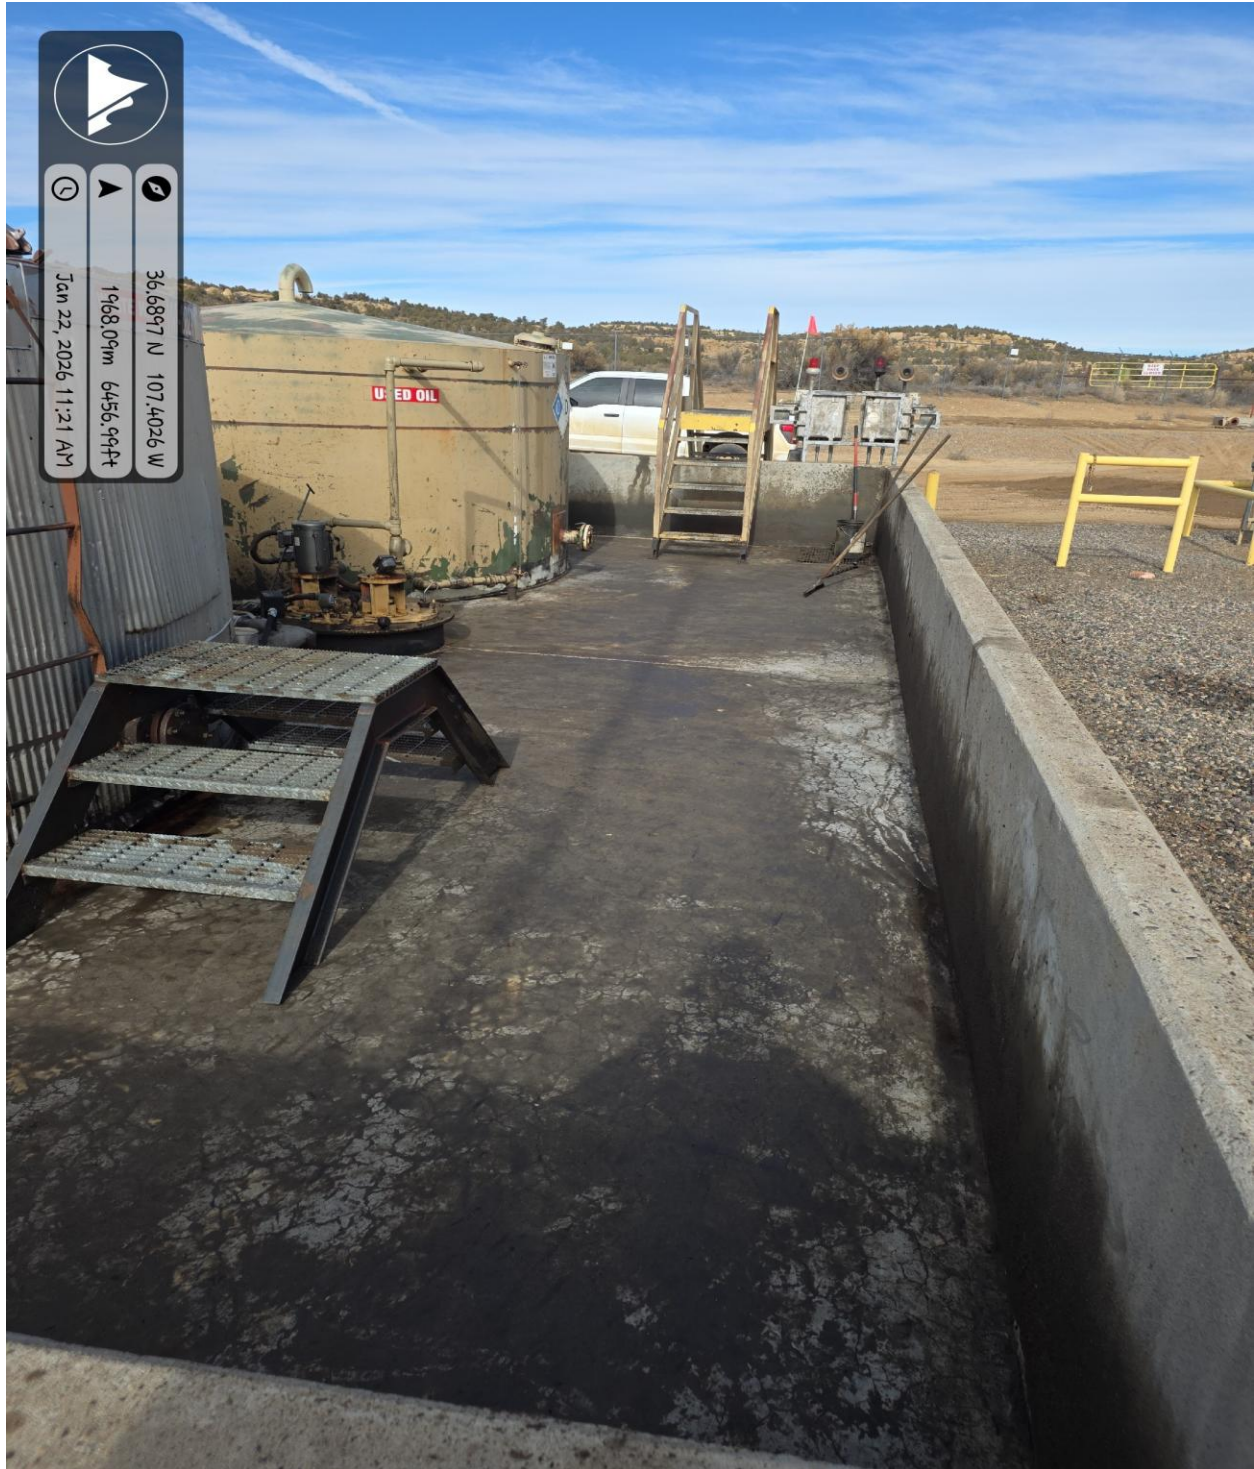
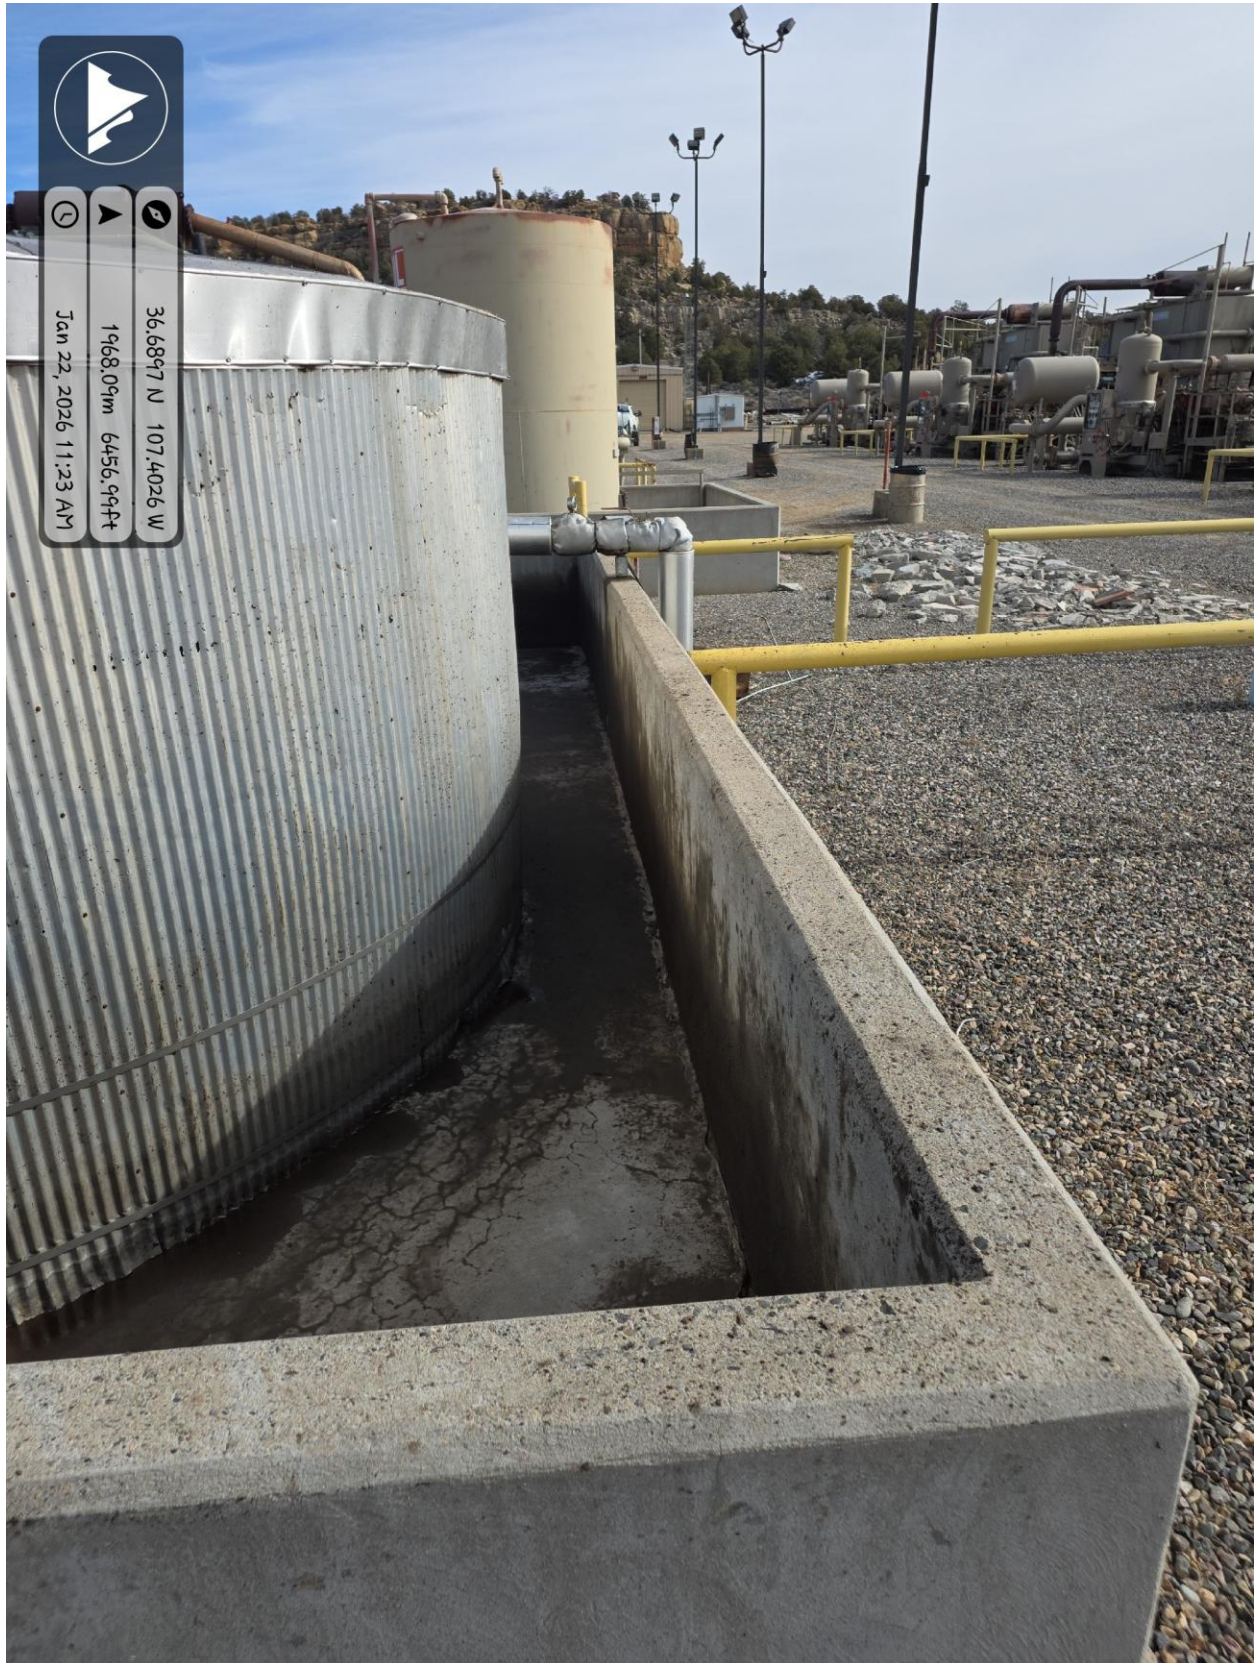
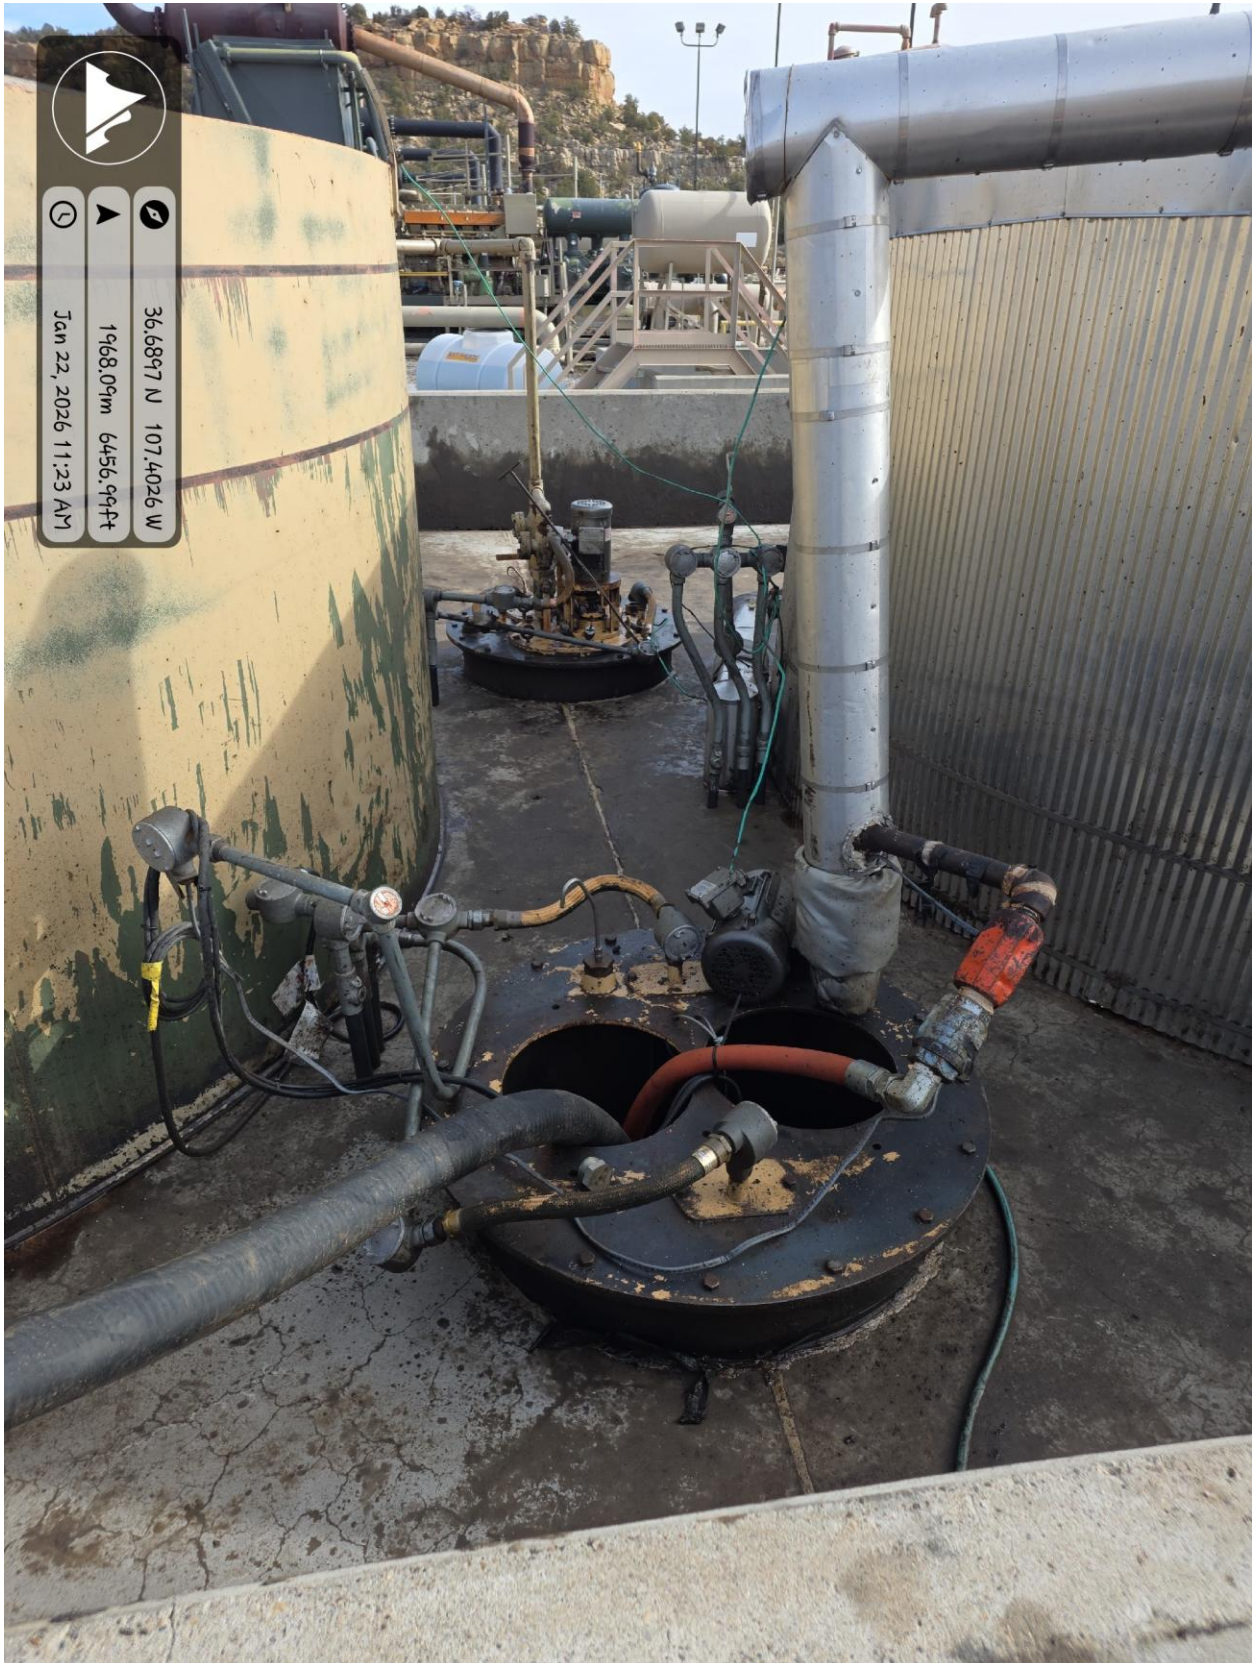
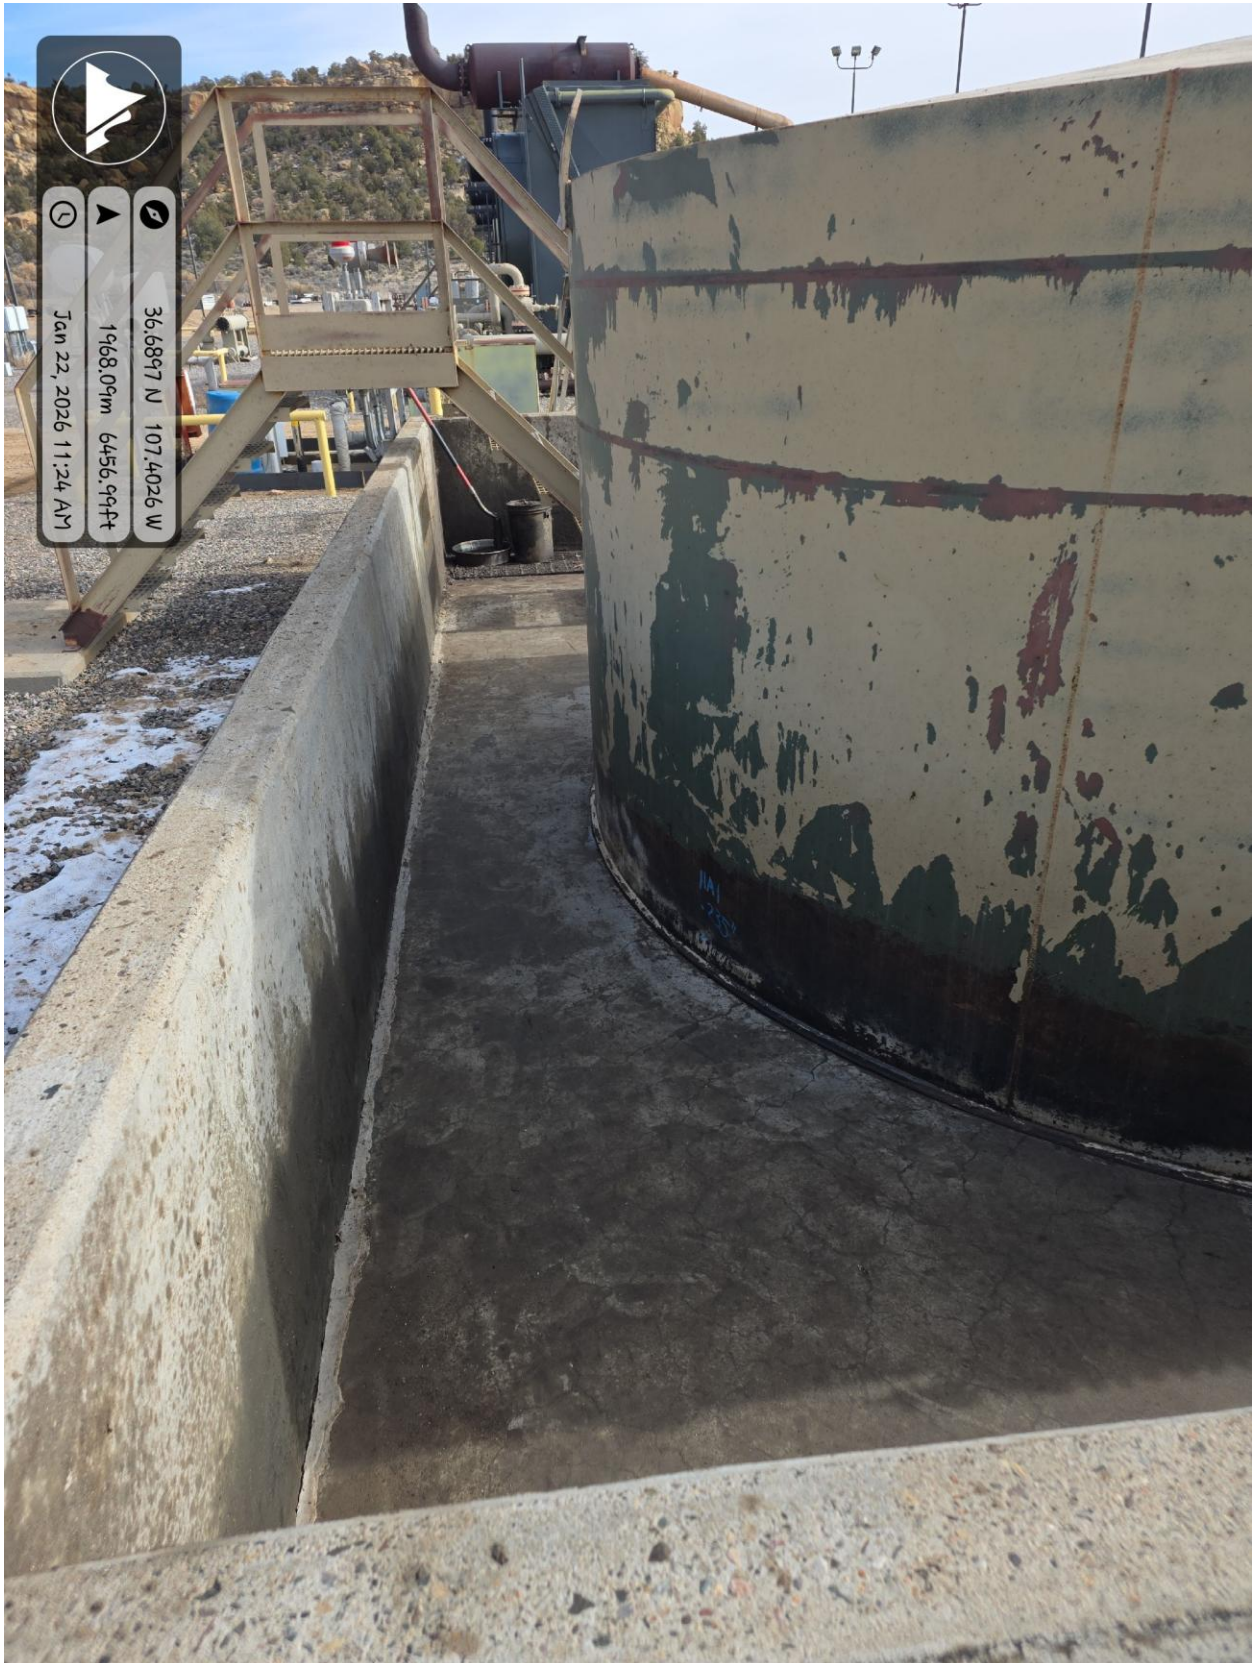
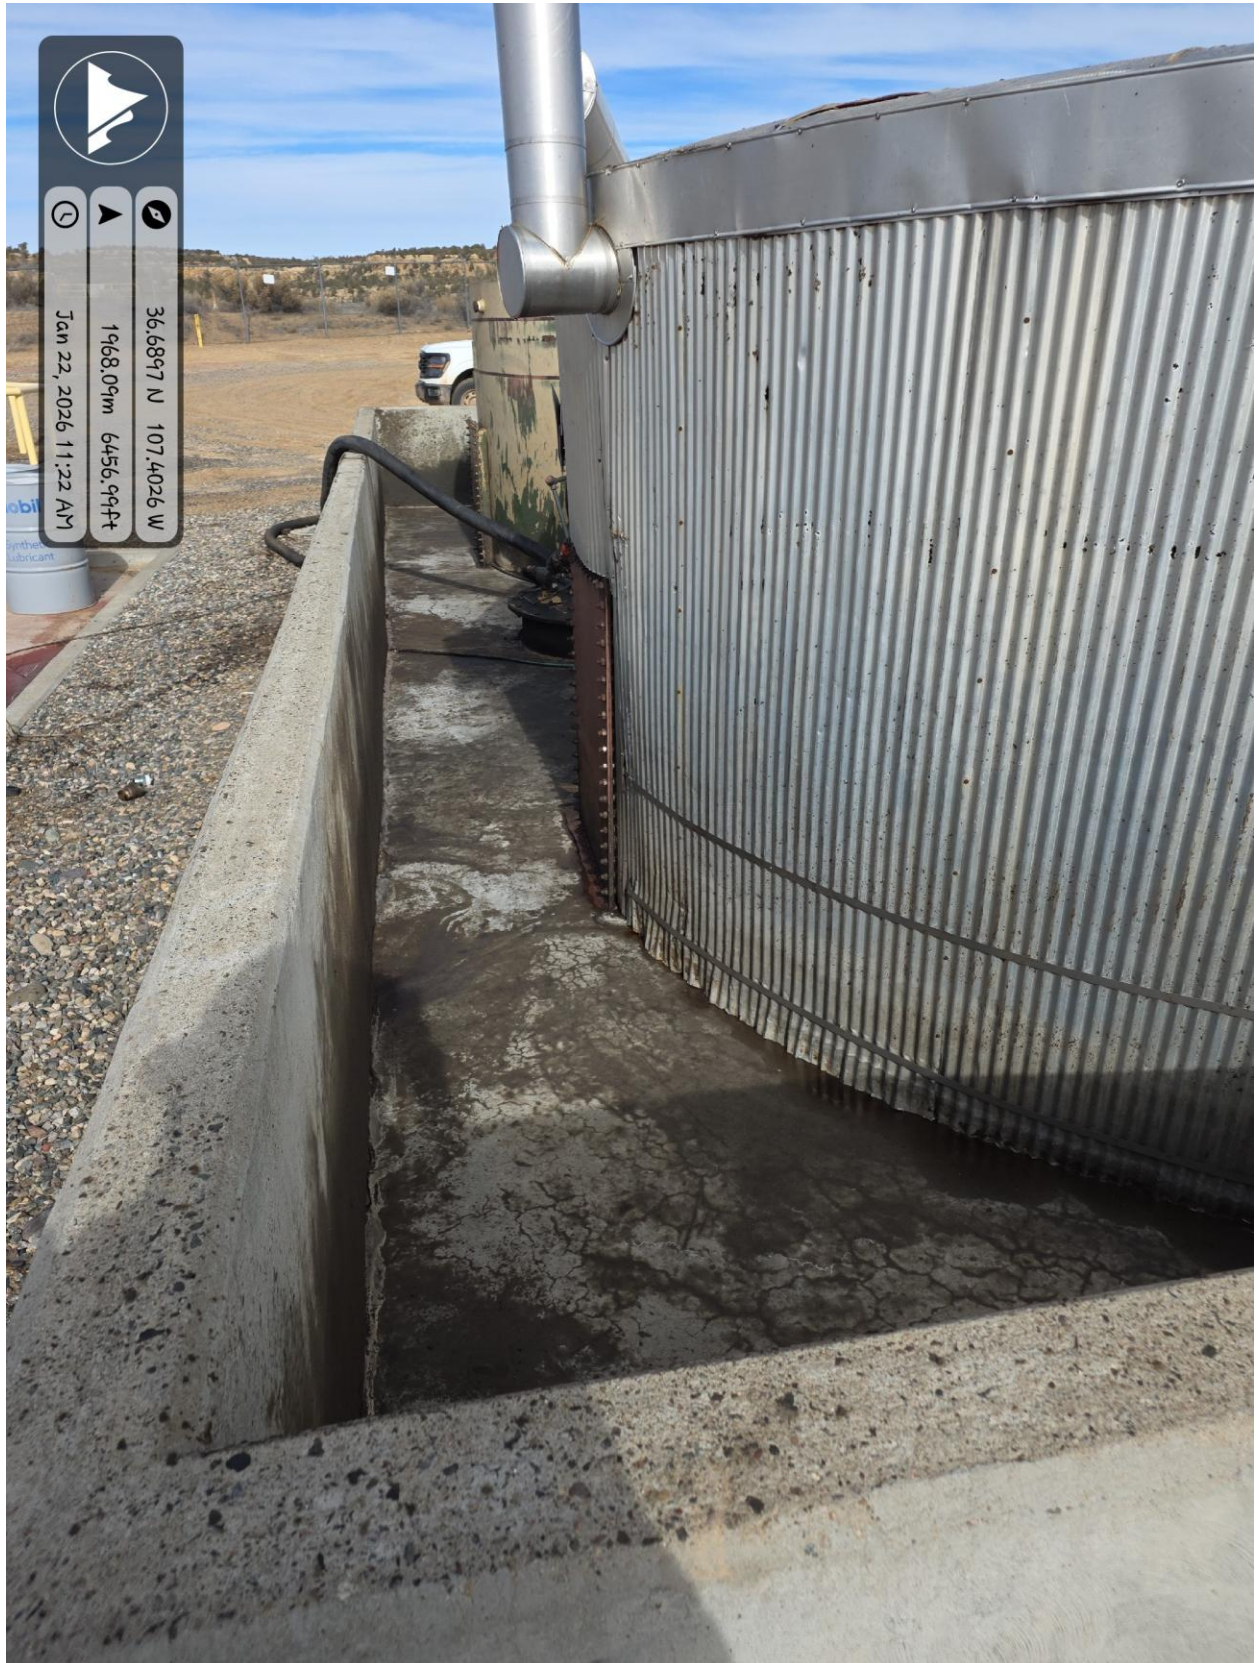
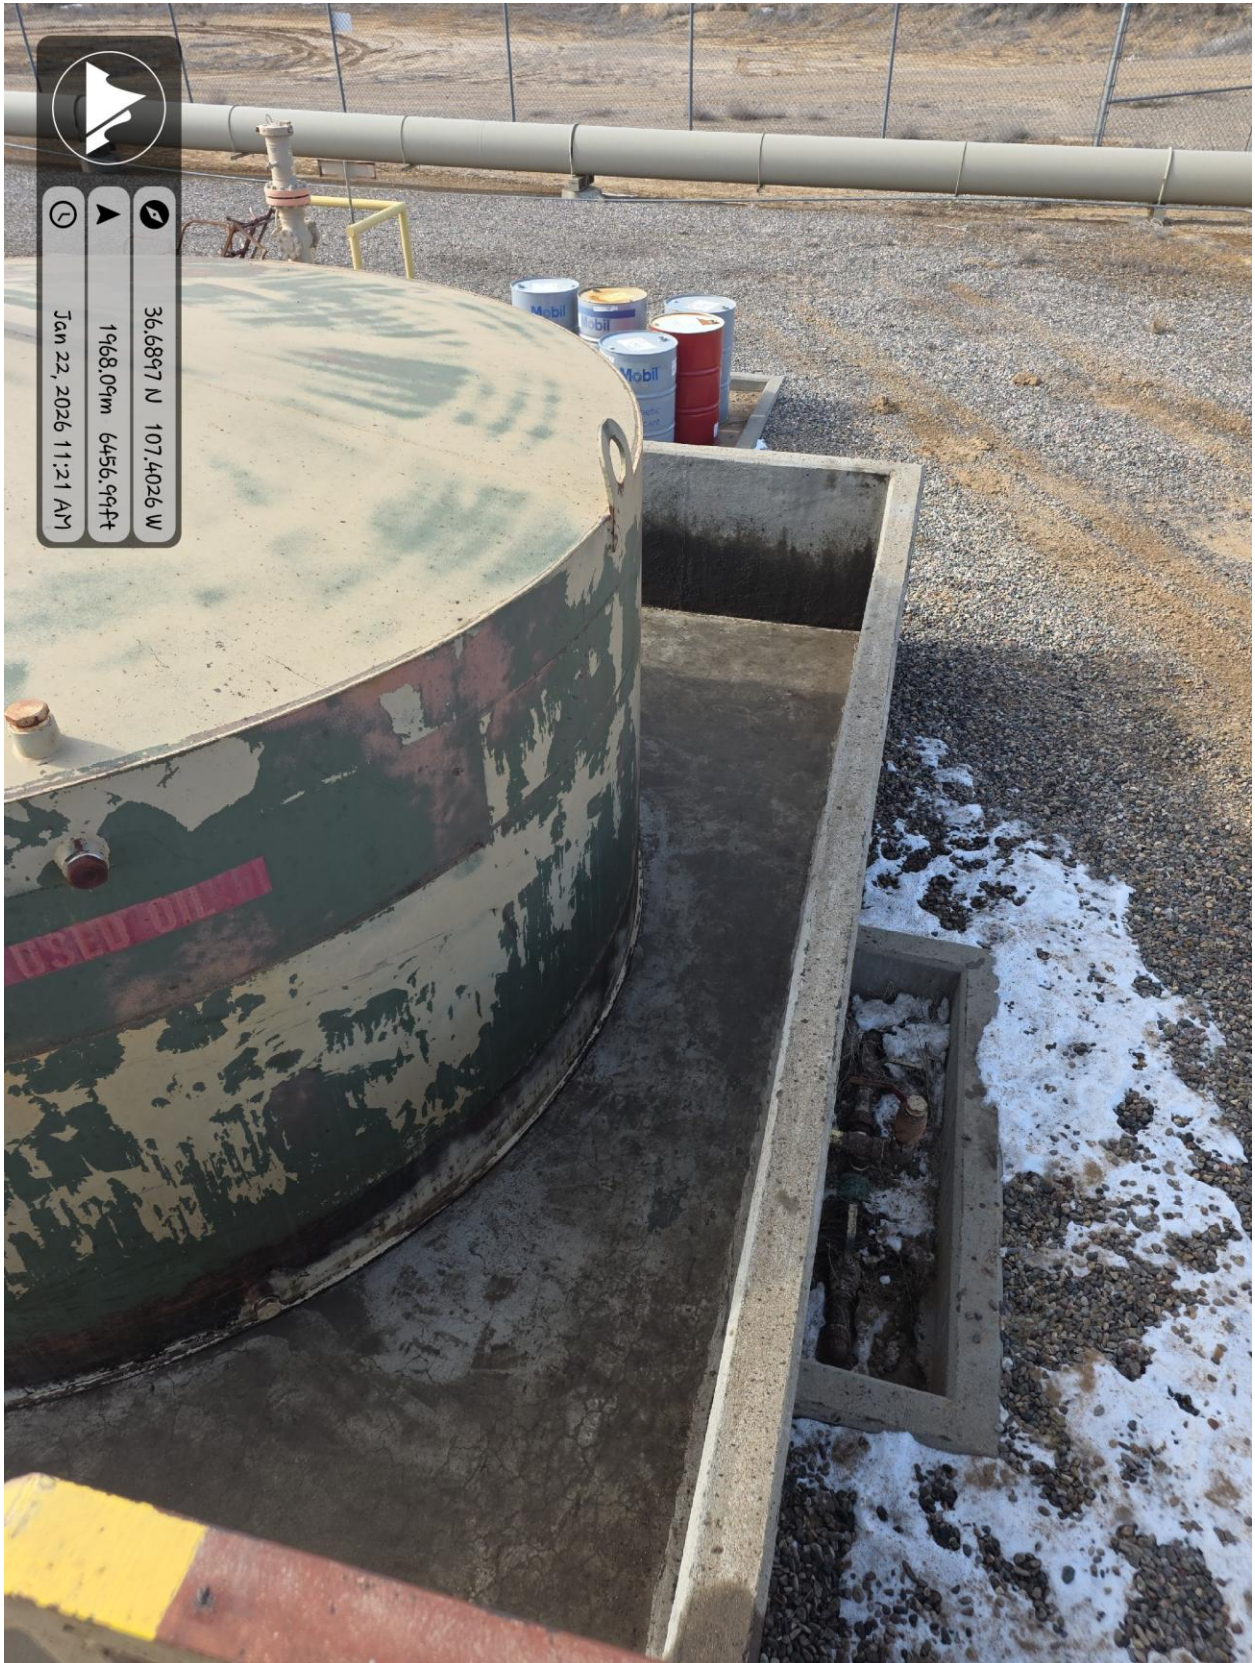
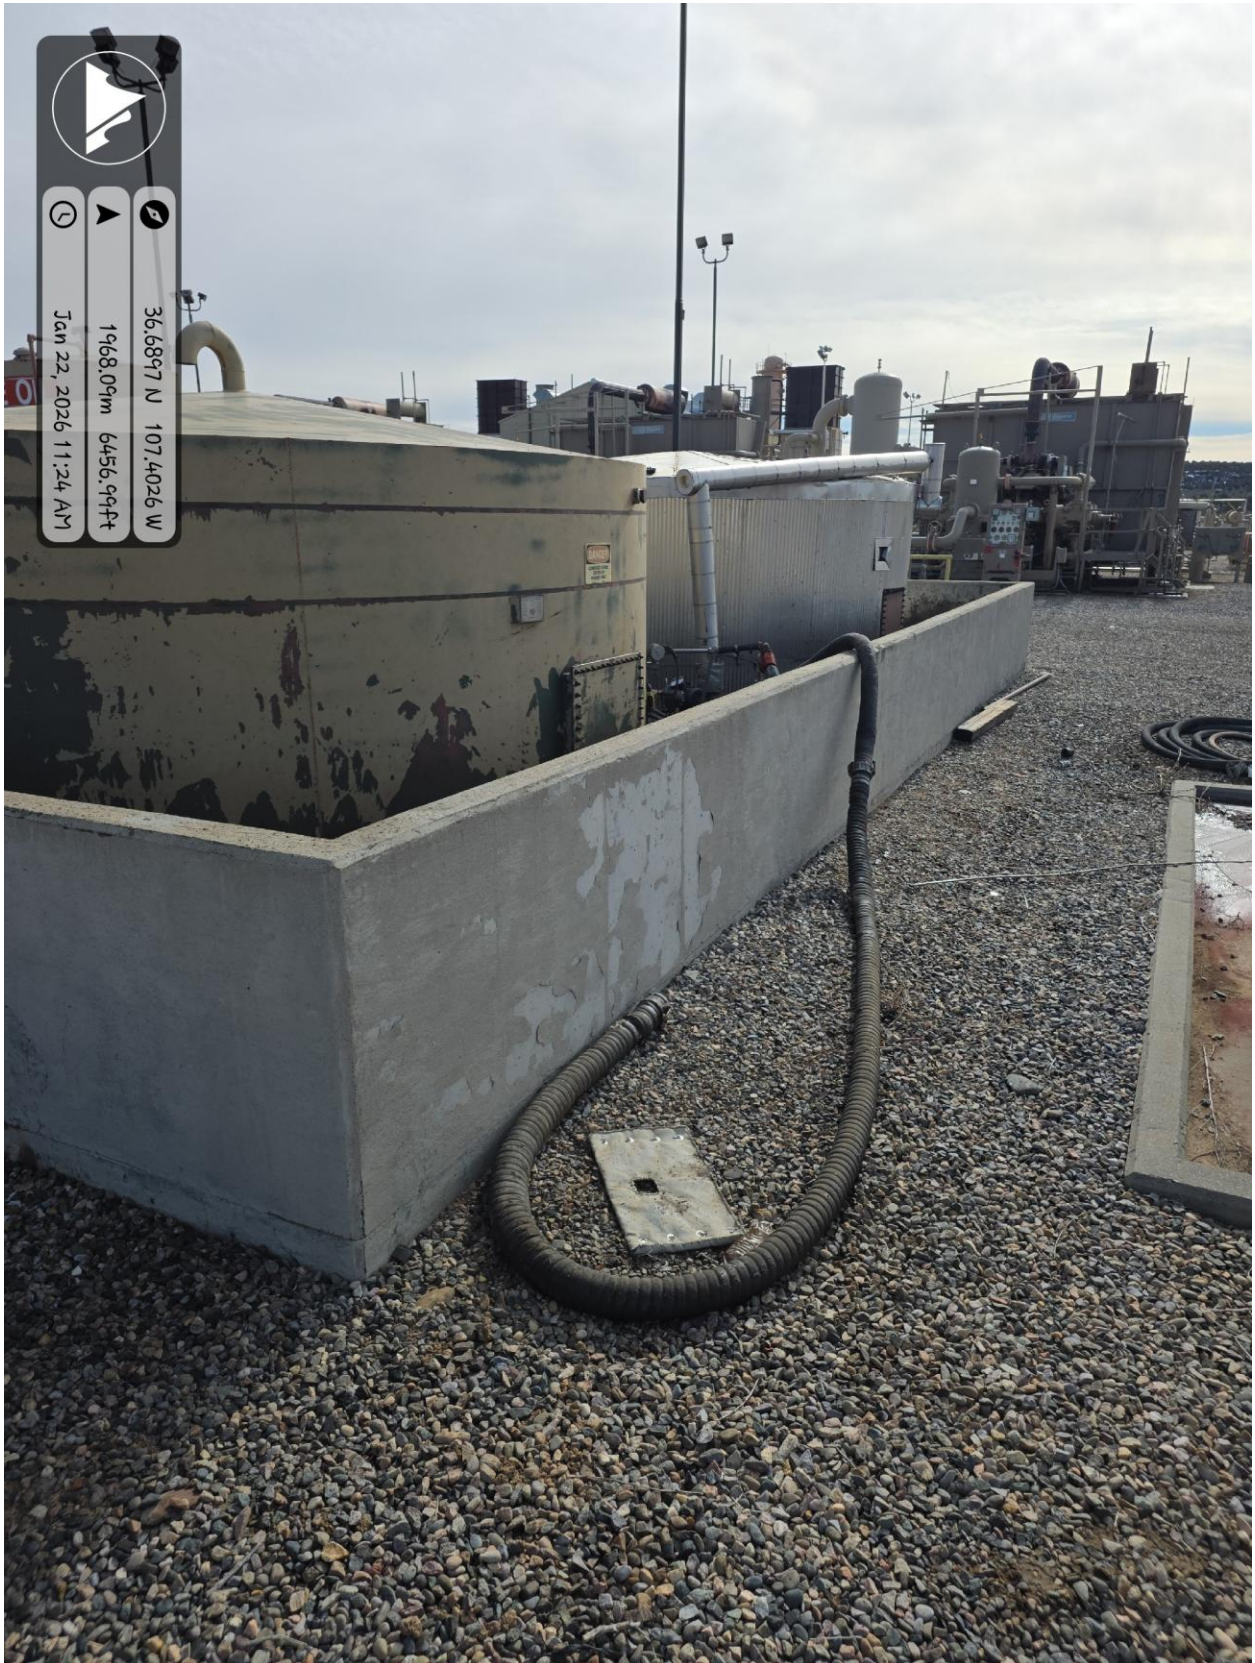
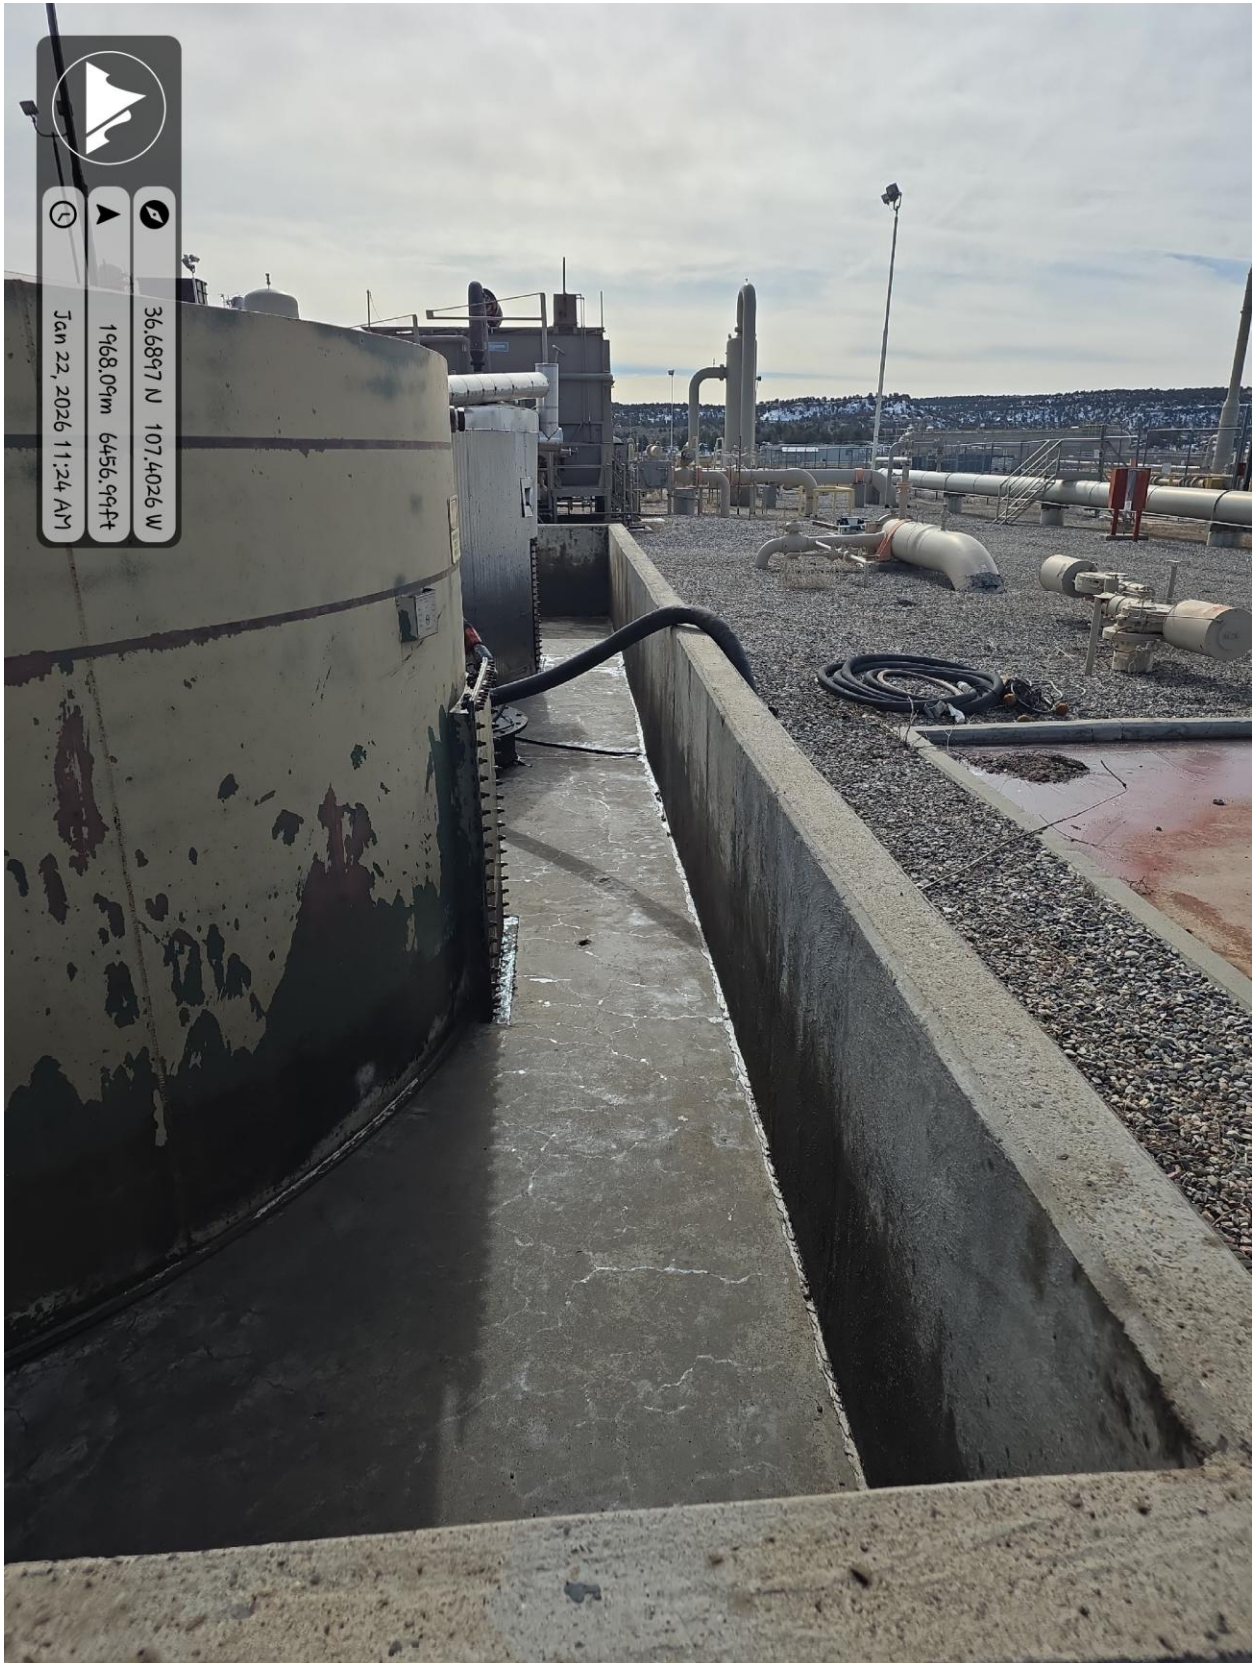
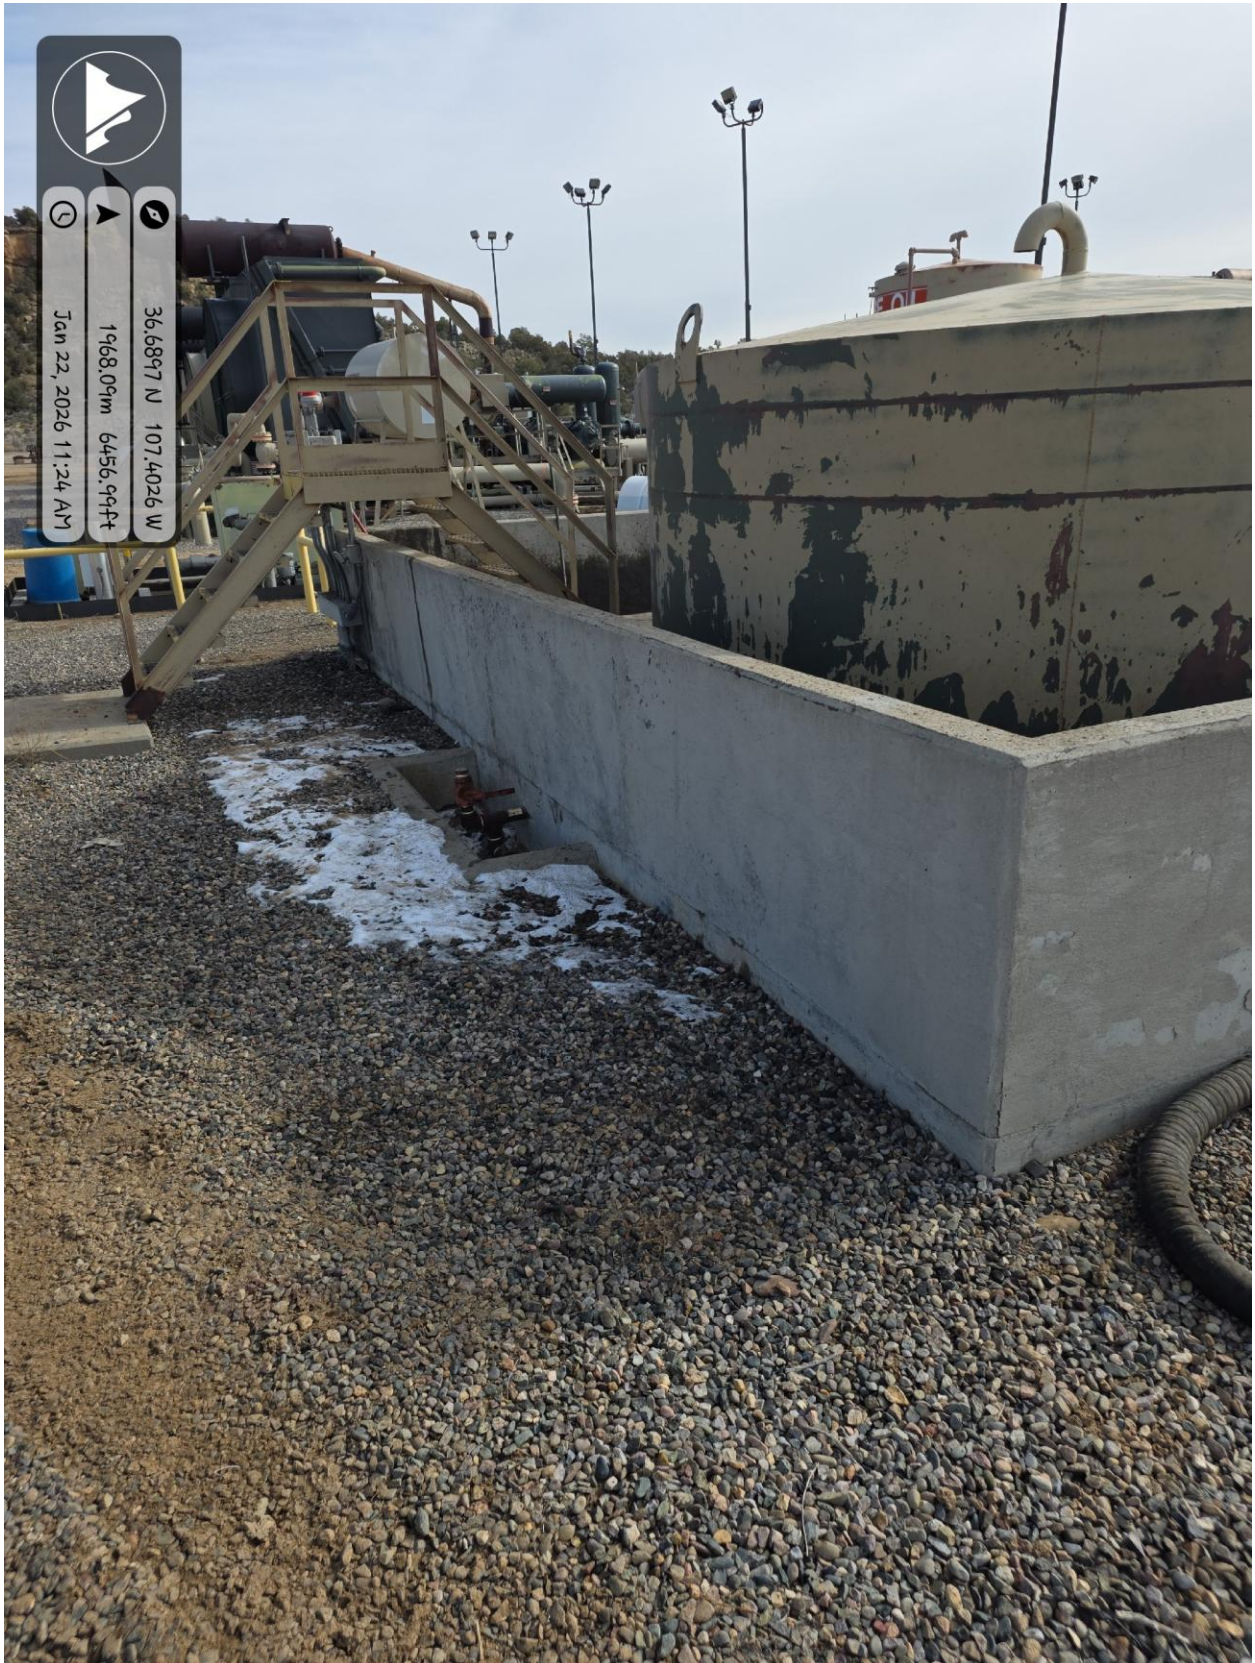
After Cleaning

Harvest personnel were on location to perform liner inspection. No liner integrity issues were found. No further action required.

Containment was de-greased, scrubbed and pressure washed.
