Remediation Report and Closure Request
El Cedro Tank Overflow
Section: 31 Township: 29N Range: 5W
Lat: 36.688047 Long: -107.402200
Rio Arriba County, New Mexico

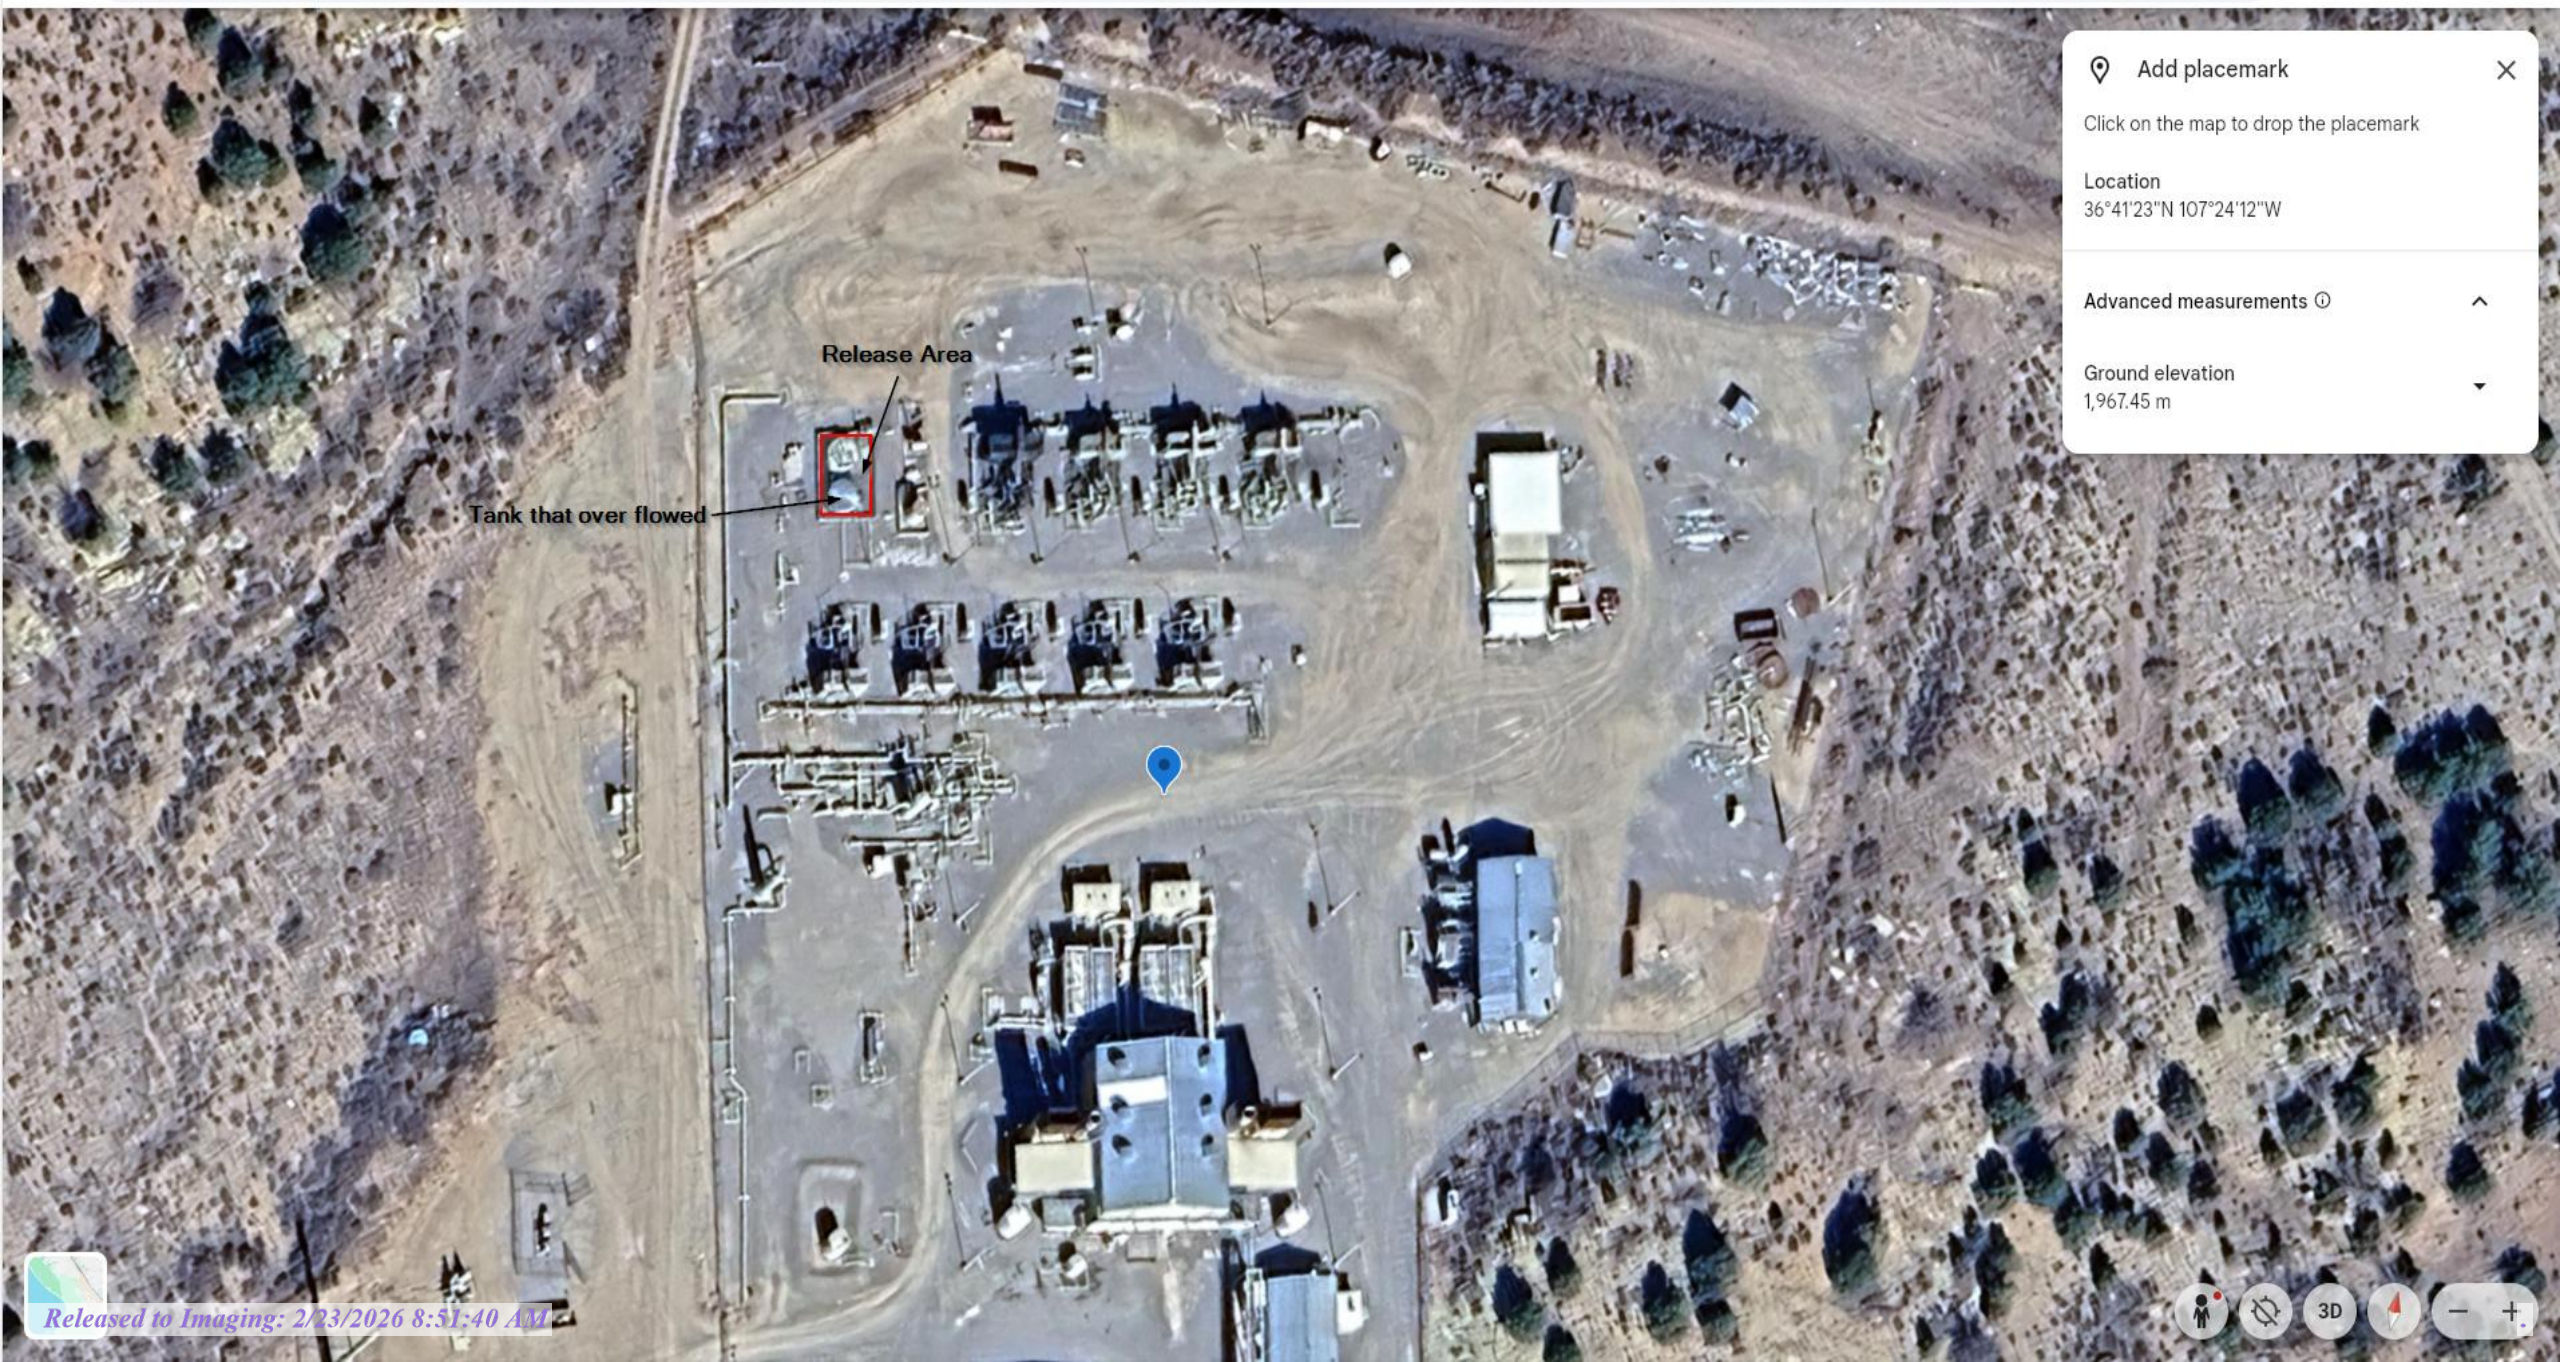
Release Area
Tank that over flowed
