MAPLE STATE TB

Incident ID nAPP2526527439

Liner Inspection and Closure Report

February 2, 2026

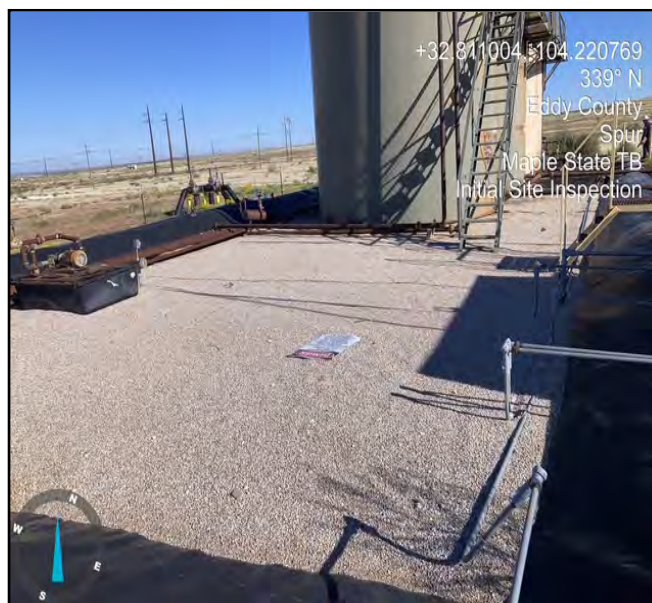
Photo of liner taken during initial liner inspection facing north.

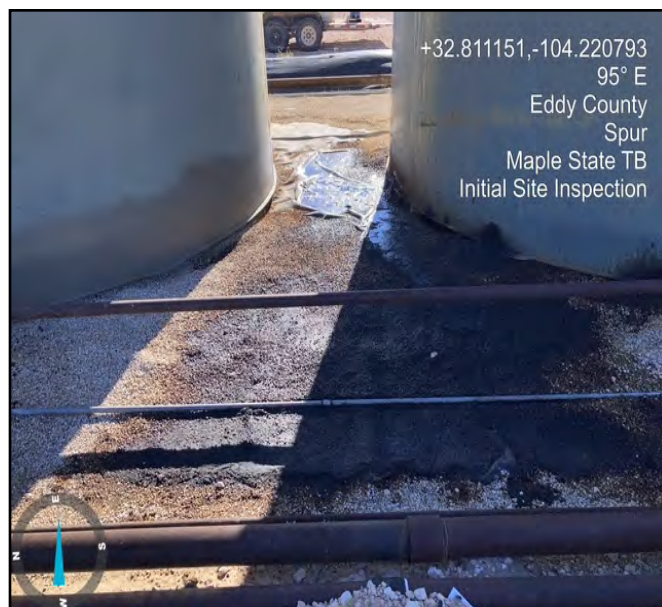
Photo of liner taken during initial liner inspection facing east.

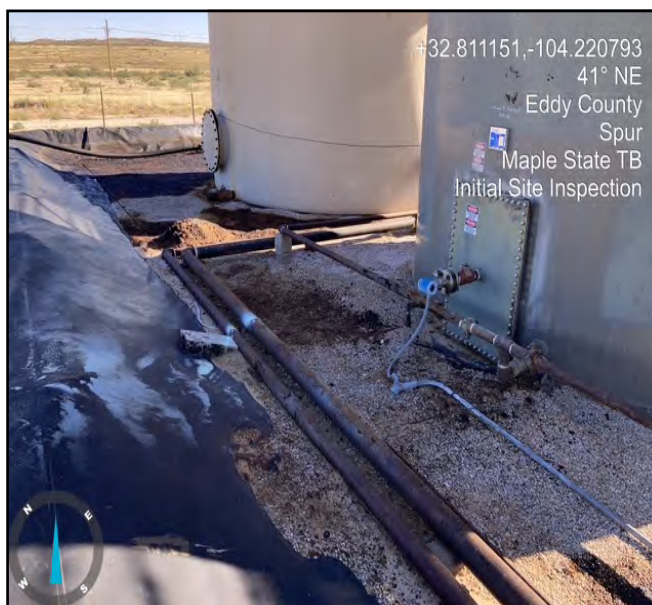
Photo of liner taken during initial liner inspection facing northeast.

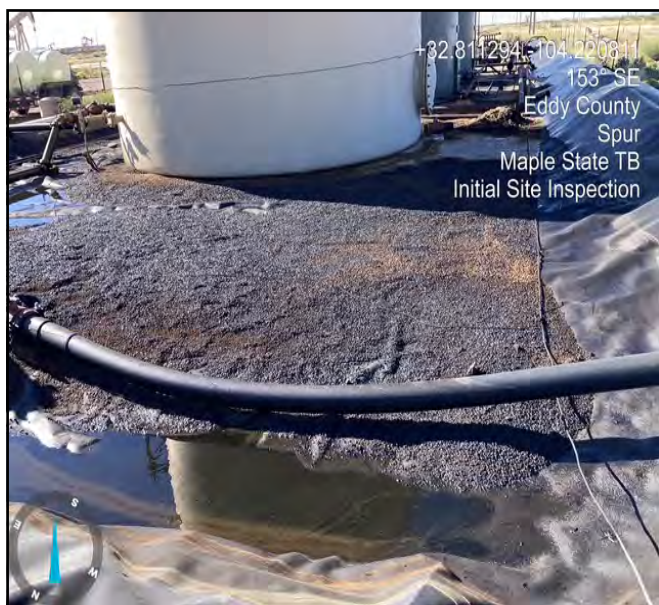
Photo of liner taken during initial liner inspection facing southeast.

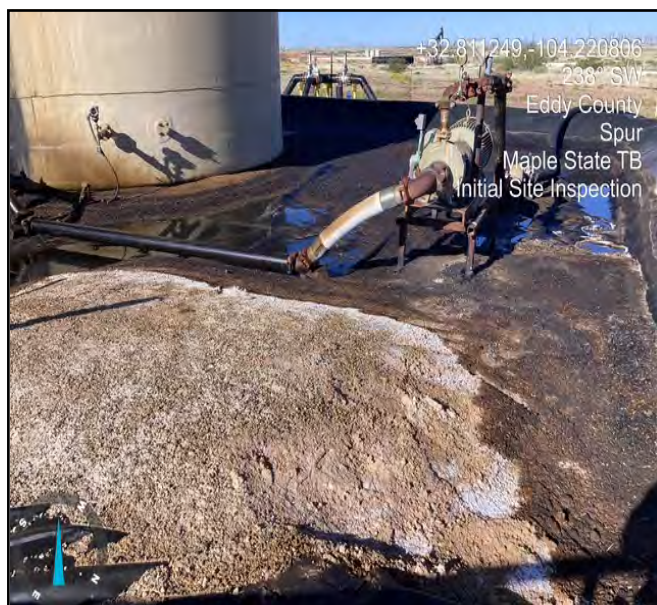
Photo of liner taken during initial liner inspection facing southwest.

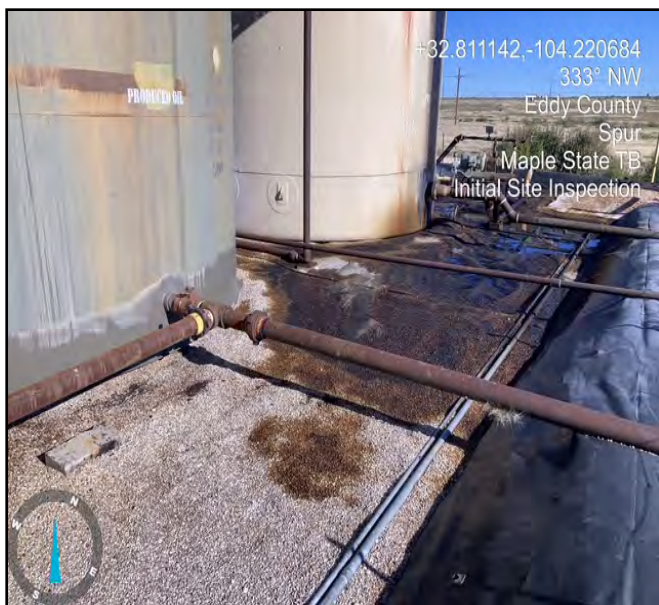
Photo of liner taken during initial liner inspection facing northwest.

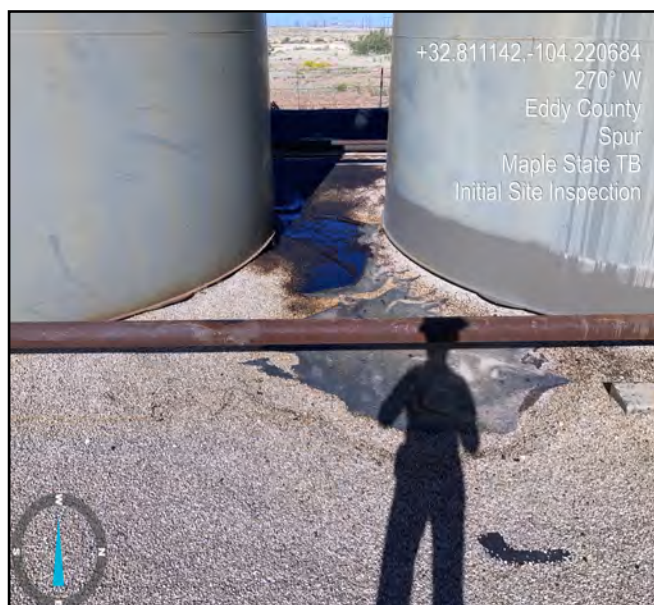
Photo of liner taken during initial liner inspection facing west.

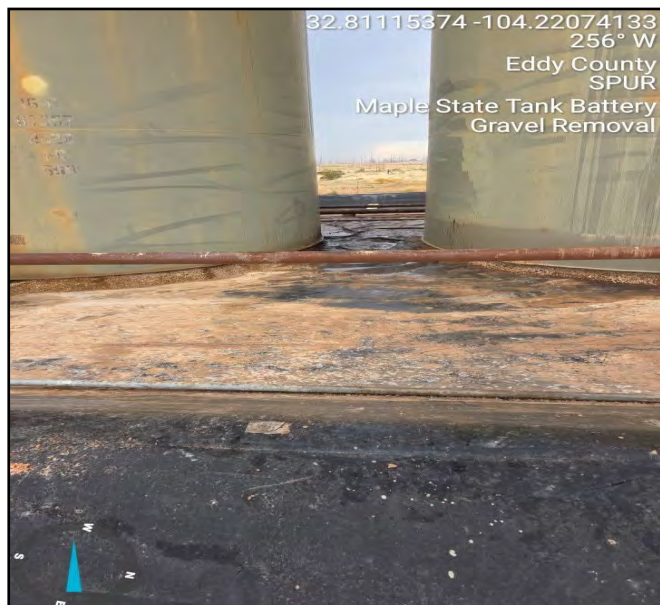
Photograph taken prior to gravel removal, facing west.

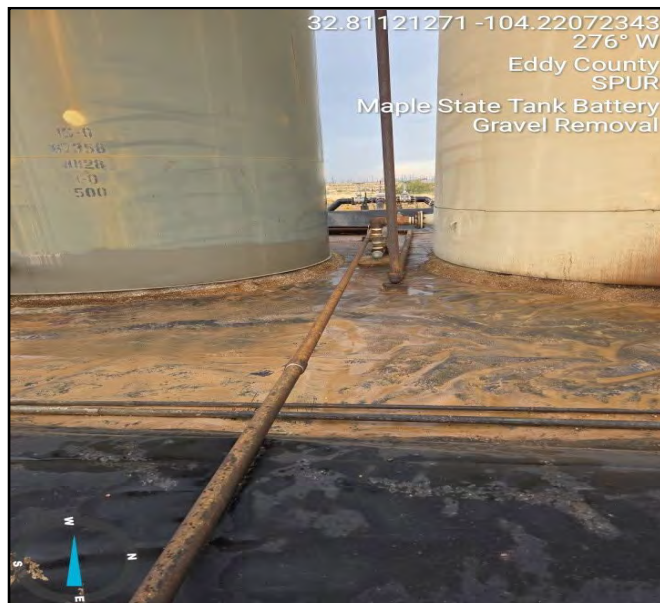
Photograph taken prior to gravel removal, facing west.

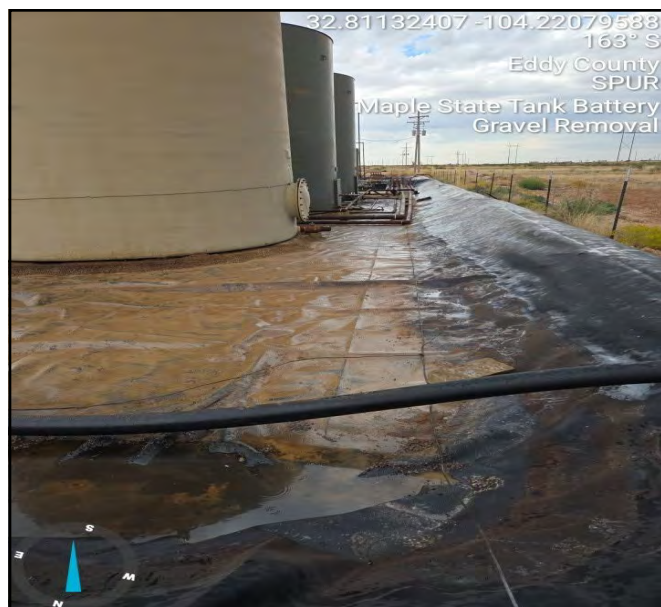
Photograph taken prior to gravel removal, facing south.

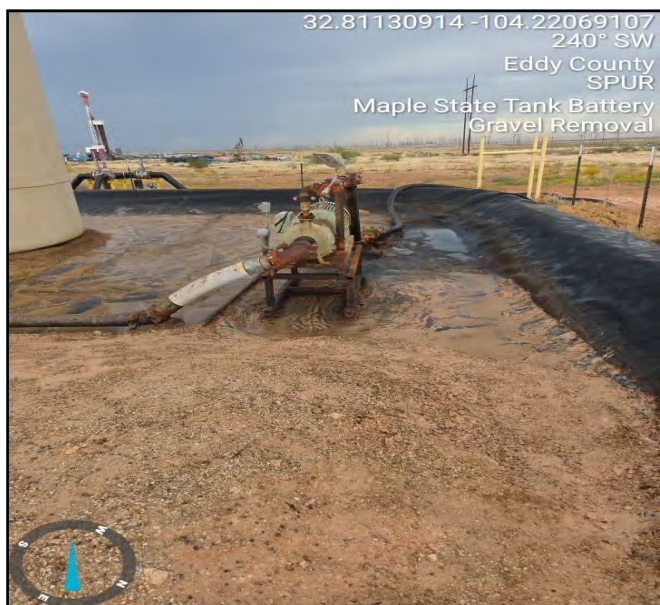
Photograph taken prior to gravel removal, facing southwest.

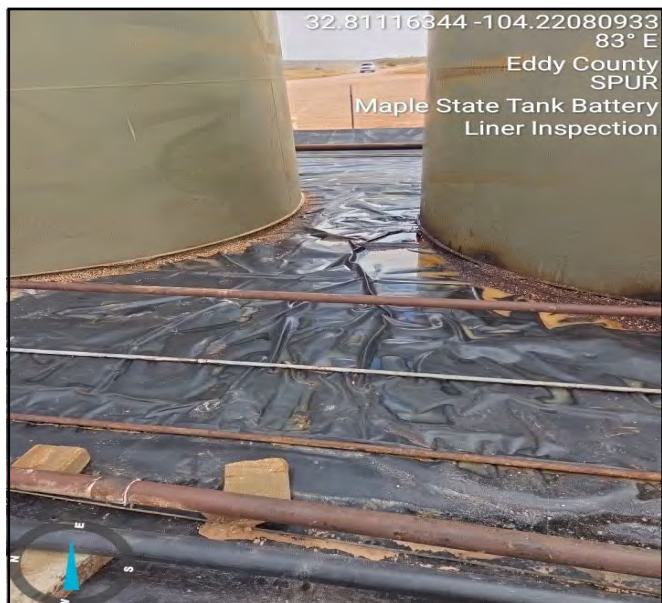
Photo taken pursuant to power washing. Facing east.

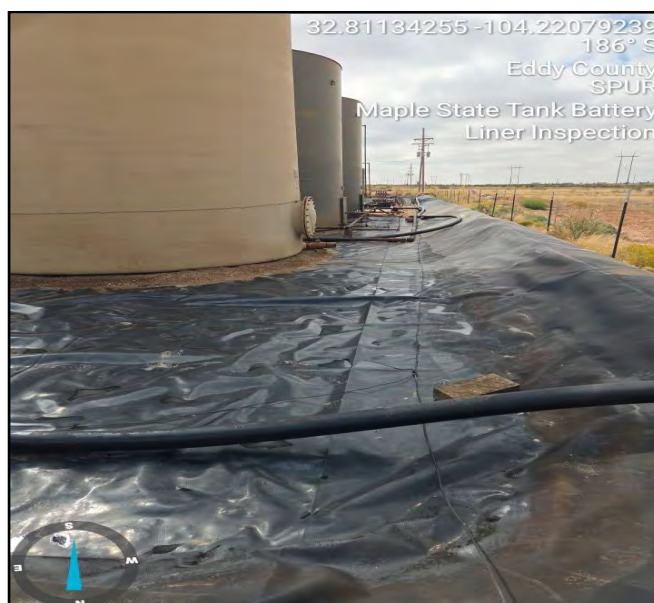
Photo taken pursuant to power washing. Facing south.

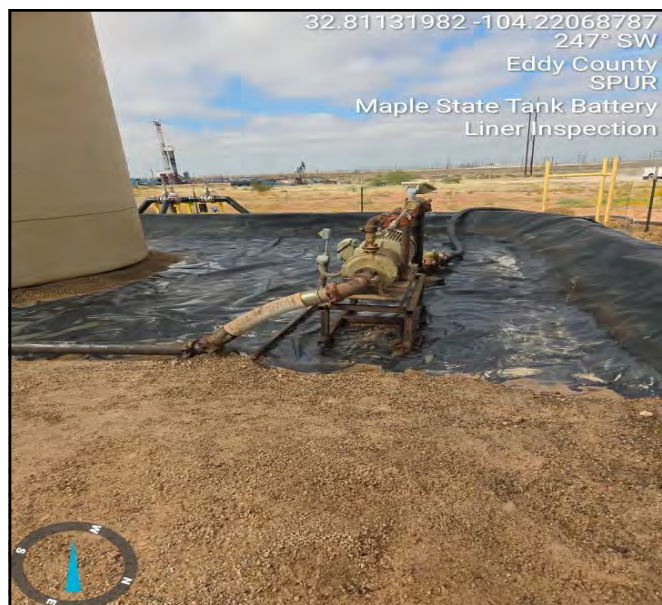
Photo taken pursuant to power washing. Facing southwest.

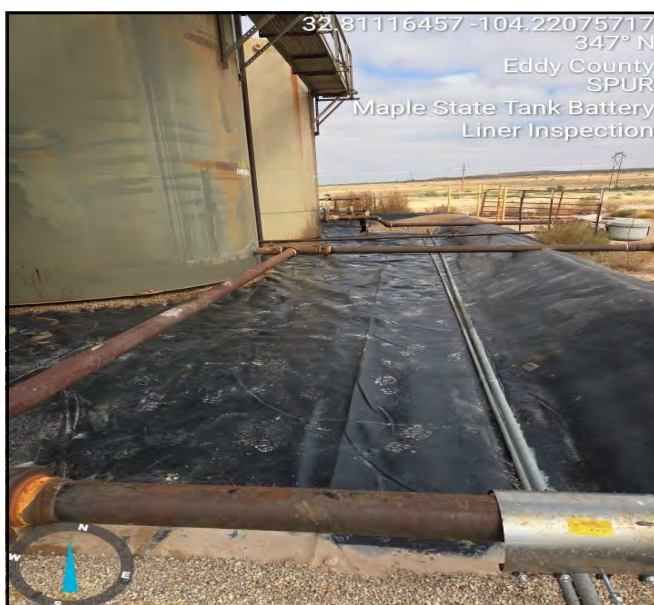
Photo taken pursuant to power washing. Facing north.
