Re: 2024 Annual Groundwater Monitoring Report

Florance M #047X
San Juan County, New Mexico
Harvest Four Corners, LLC
NMOCD Incident No: nAUTOfAB000185
Remediation Permit Number: 3RP-317-0

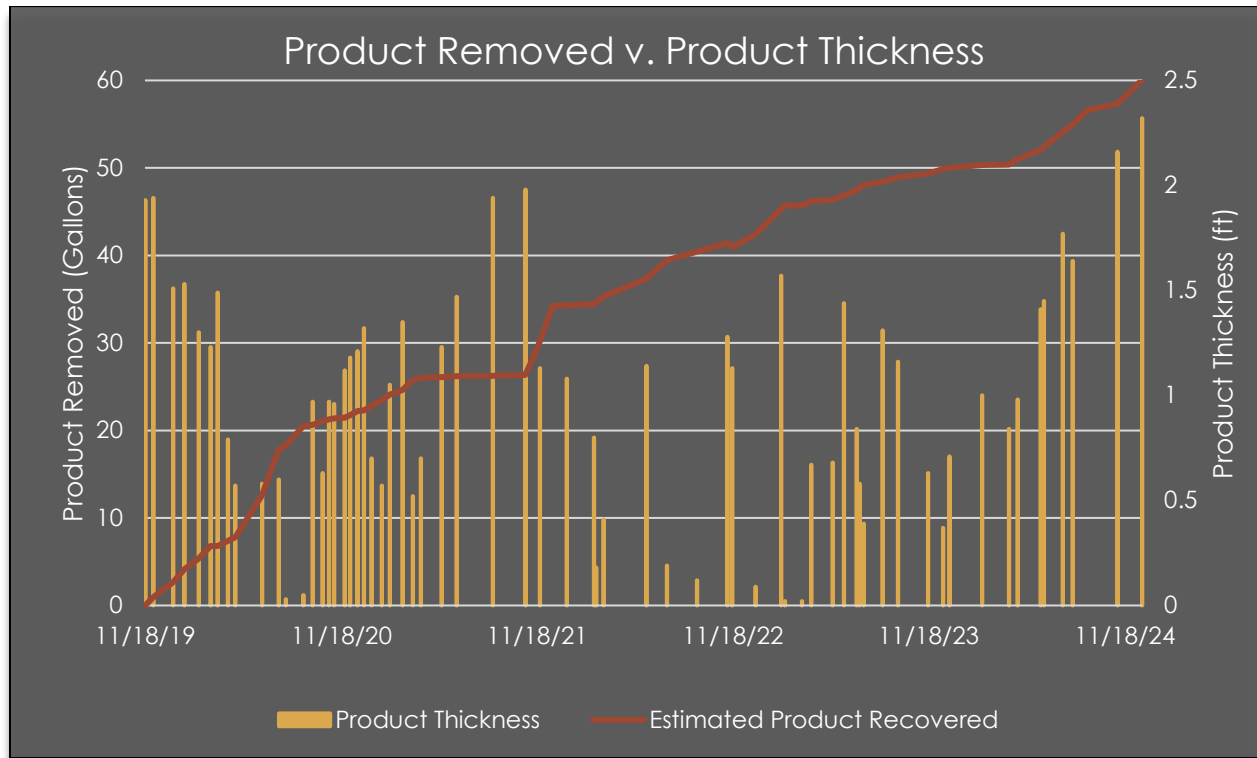
Approximately 60.0 gallons of PSH have been recovered from monitoring well MW-3 through pneumatic pumping, manual bailing, and product recovery socks between November 18, 2019, and December 20, 2024. A total of 10.0 gallons of PSH were recovered in 2024. PSH thickness was 1.93 feet at the time of the installation of the PSH recovery system in November 2019. In 2024, PSH ranged in thickness from 0.84 feet in April 2024 to 2.32 feet in December 2024. Operation data and system maintenance and manual product recovery are summarized in Table 3. Product thickness and estimated product recovery for monitoring well MW-3 is depicted on the chart below.

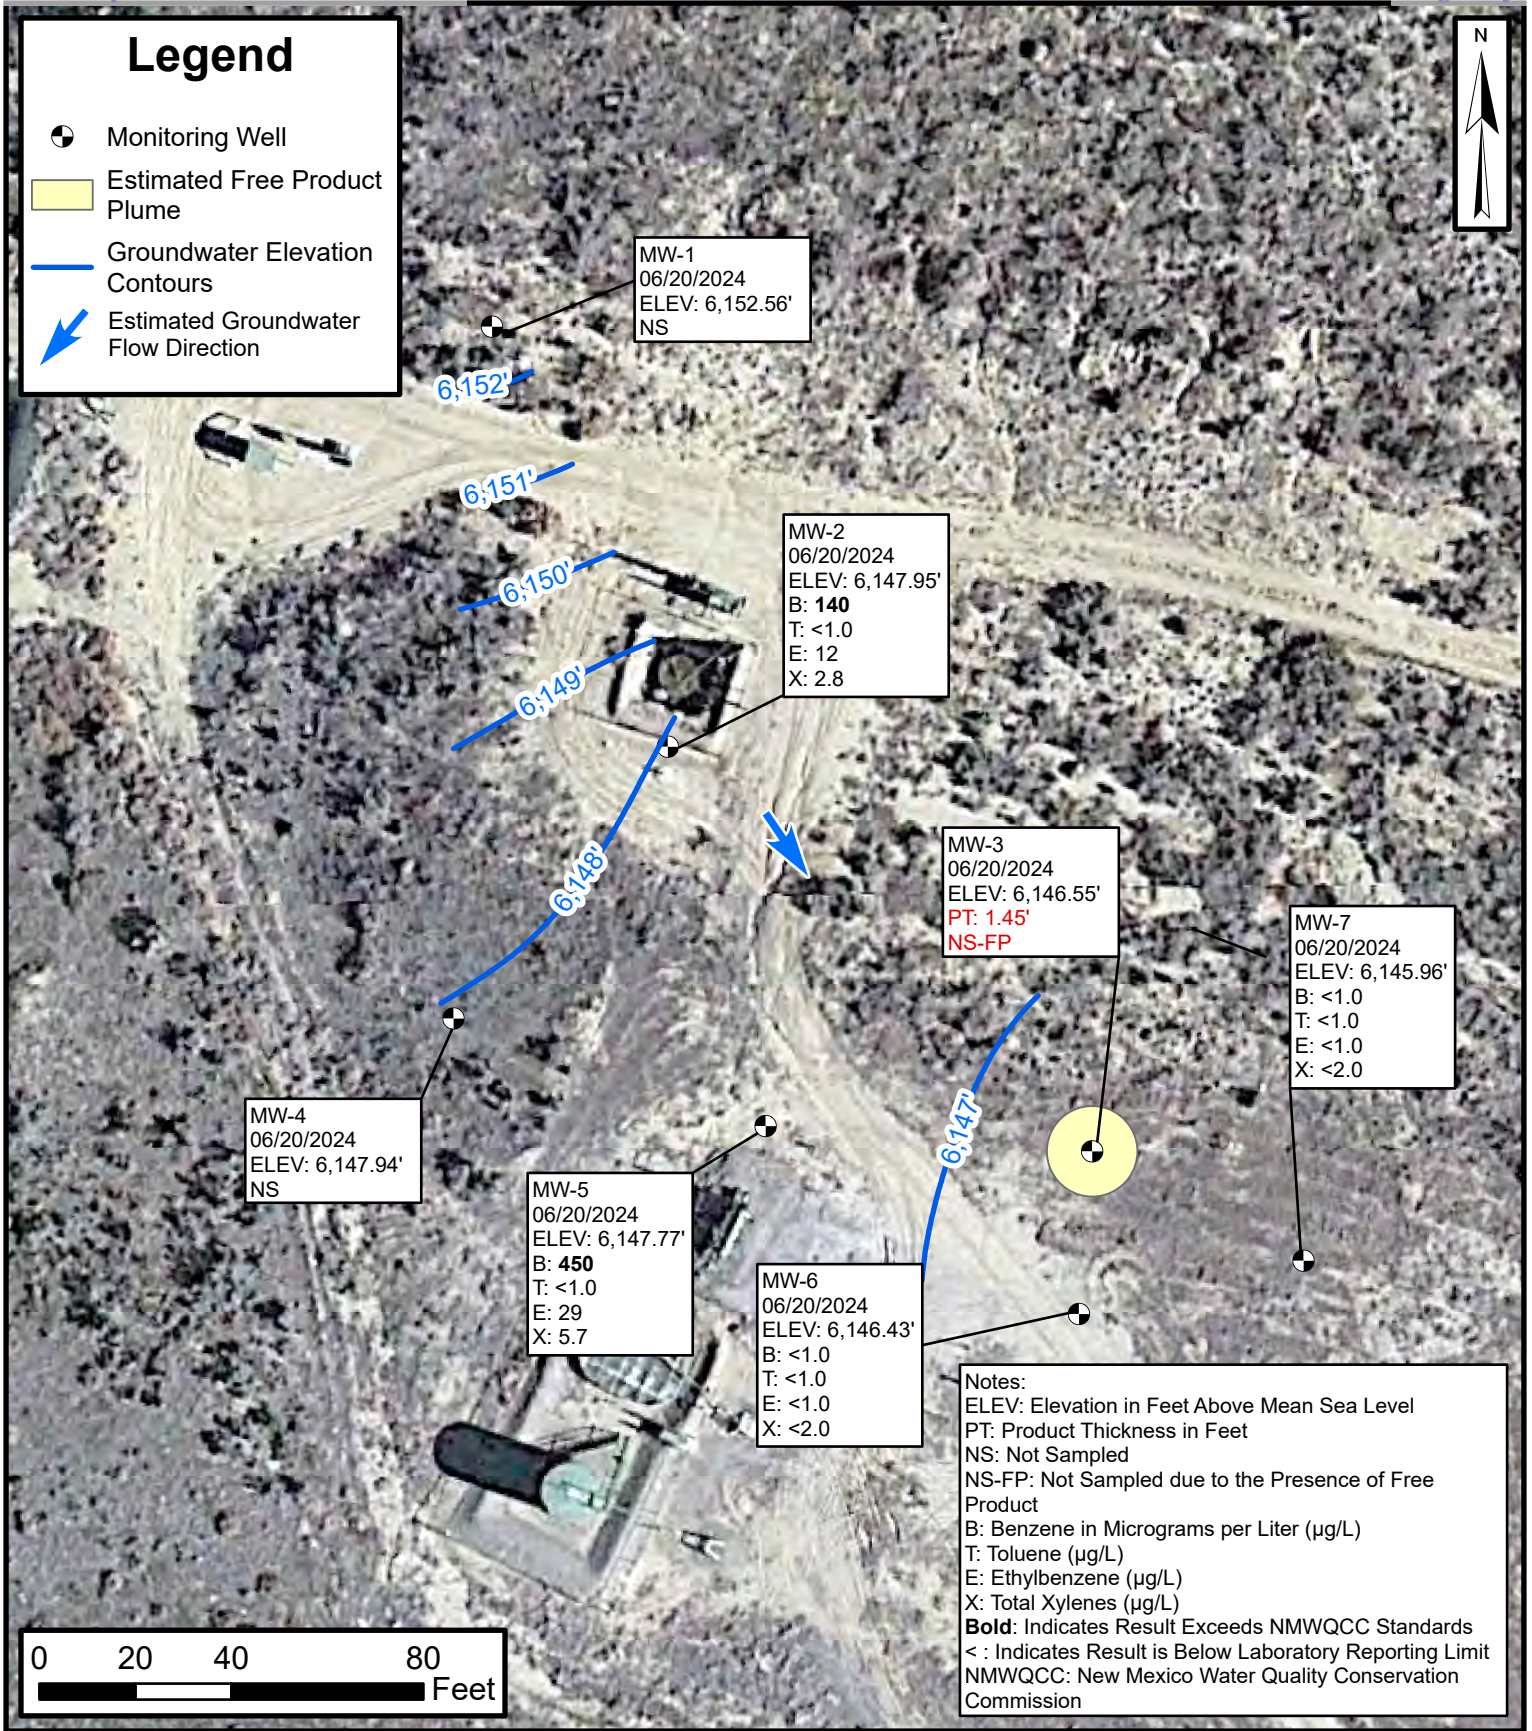
FIGURE
3

All wells on Site, except for MW-1, MW-3, and MW-4, were sampled on June 20, 2024. BTEX constituents in groundwater were detected in monitoring wells MW-2 and MW-5. Groundwater from wells MW-2 and MW-5 contained benzene concentrations of 140 µg/L and 450 µg/L, respectively, which exceeds the NMWQCC standards. Monitoring wells MW-6 and MW-7 did not contain detectable concentrations of BTEX compounds in groundwater and were compliant with the NMWQCC standards. BTEX results and approximate PSH plume extent are presented on Figure 3 and summarized in Table 2.

Groundwater Elevation (June 2024)
 Florance M #047X
 Harvest Four Corners, LLC
 36.8436, -107.8010
 SW/NE, Sec 5, T30N, R9W
 San Juan County, New Mexico
