## **Liner Inspection and Closure Request**

**Devon Energy Production Company, LP**

**Fully Loaded 12 CTB 2**

**NMOCD Incident # NAPP2535865109**

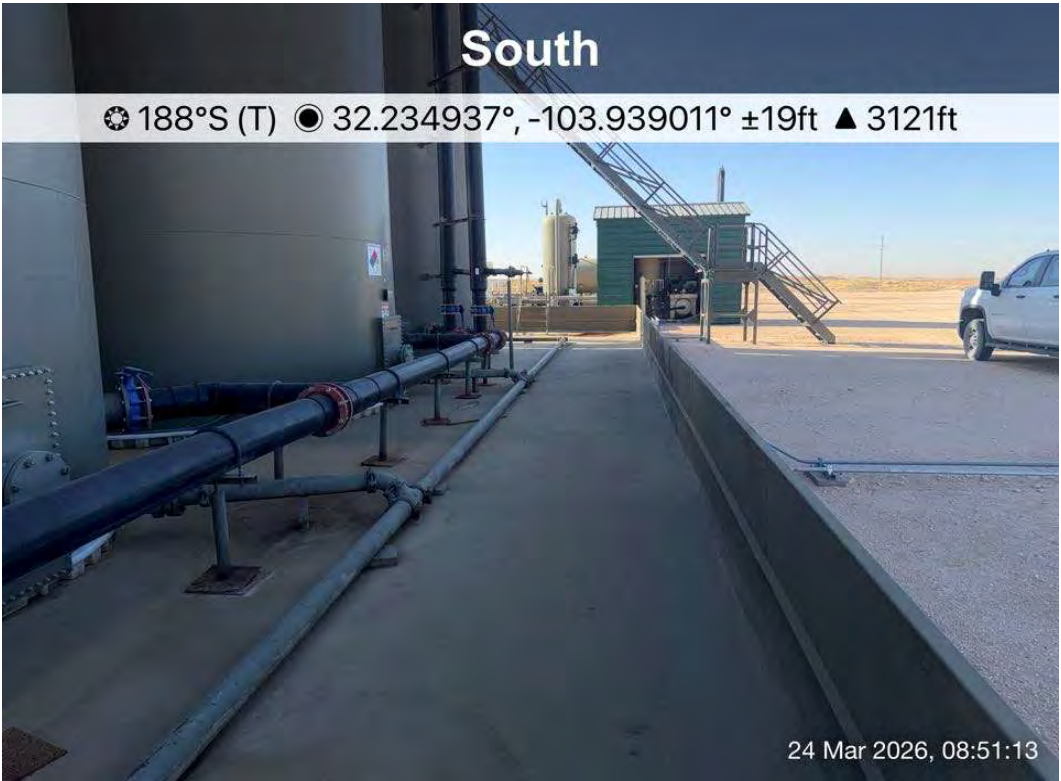
**South**

<b>Photo:</b>	<b>5</b>	<b>Description:</b> Liner Inspection
---------------	----------	--------------------------------------

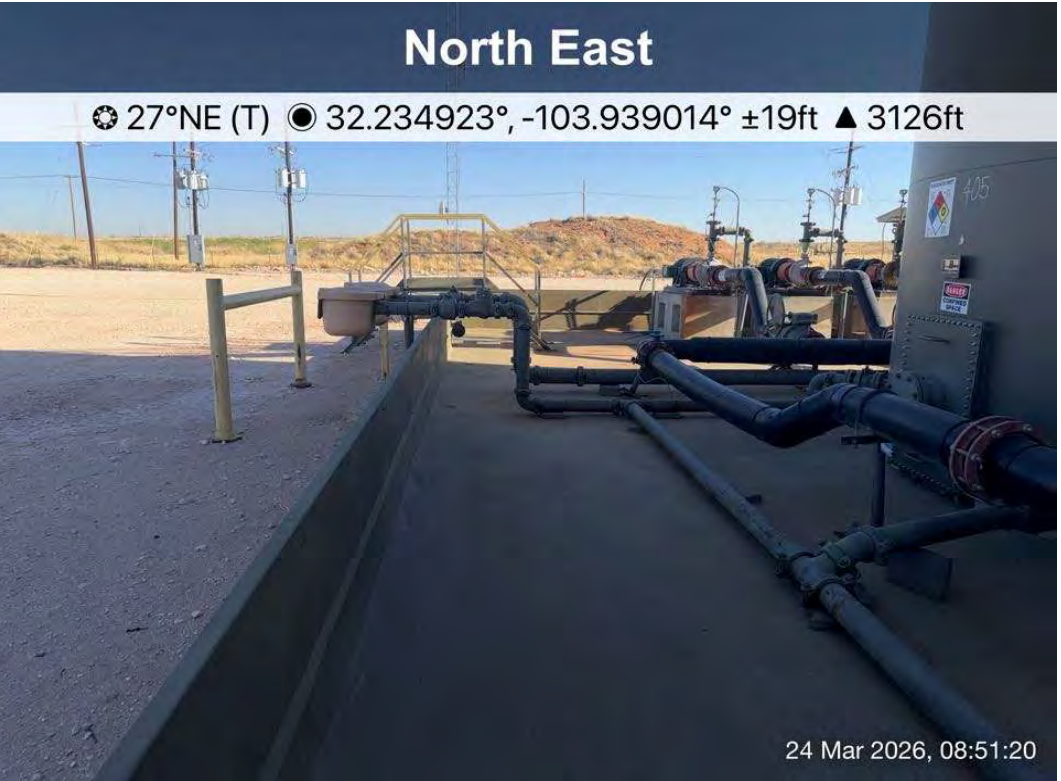
**North East**

<b>Photo:</b>	<b>6</b>	<b>Description:</b> Liner Inspection
---------------	----------	--------------------------------------

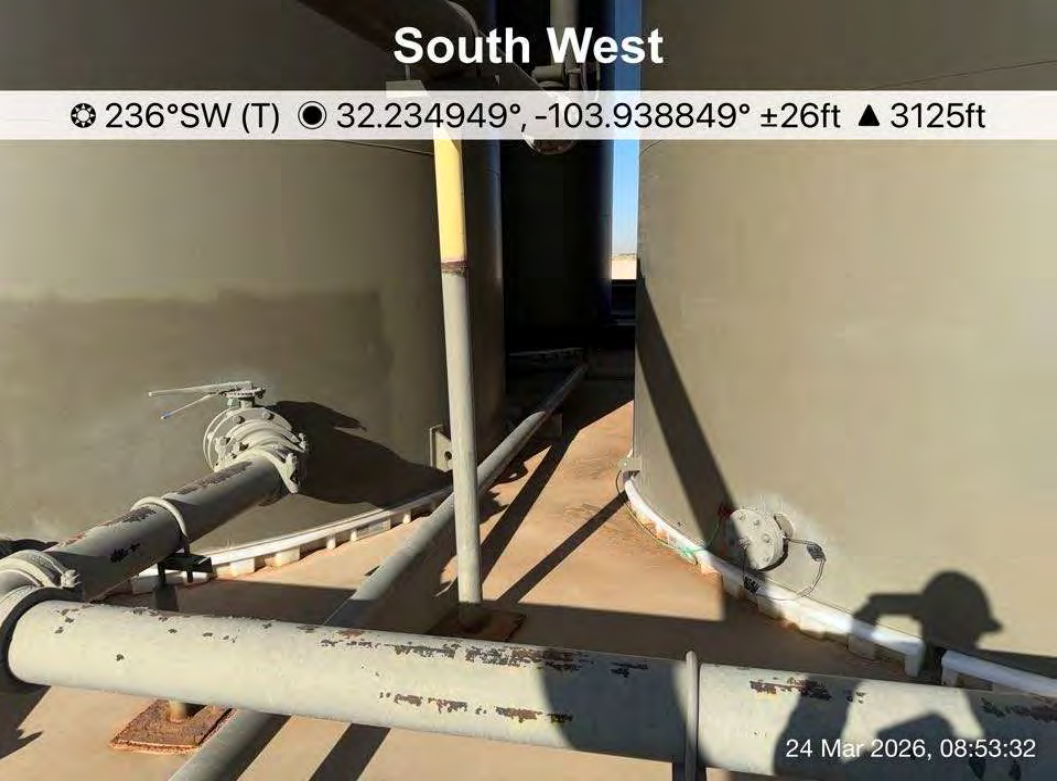
**South West**

<b>Photo:</b>	<b>14</b>	<b>Description:</b> Liner Inspection
---------------	-----------	--------------------------------------
