Our Ref.: 12683707-NMOCD-1

March 10, 2026

Closure Report
Devon Energy Production Company, LP
Thoroughbred 10 CTB 3
Unit Letter N, Section 10, TS26, R31E
GPS: 32.05247, -103.761778
Eddy County, New Mexico

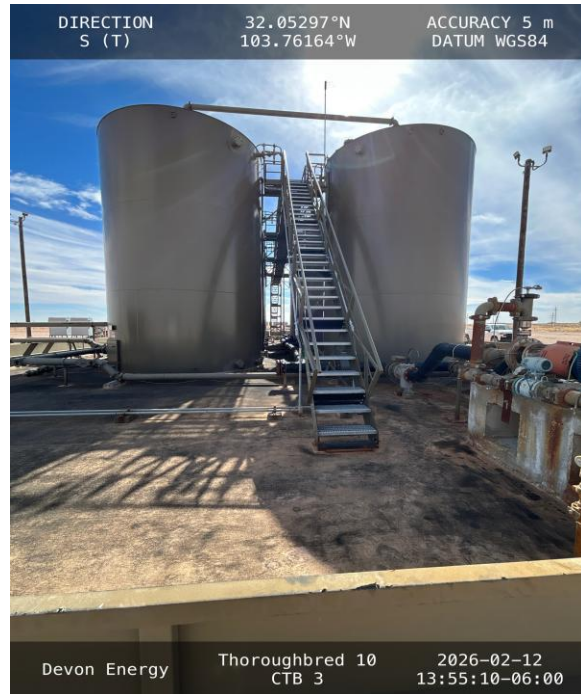
Photo 2 View of central portion of secondary containment.

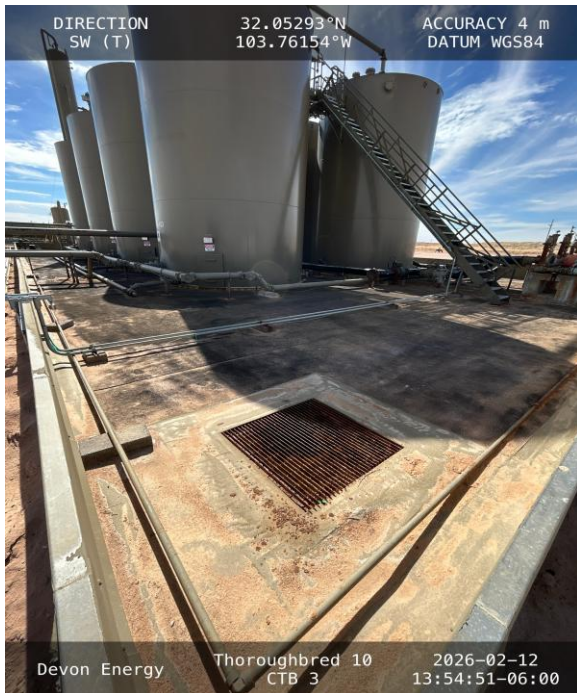
Photo 3 View of northeast corner of secondary containment.

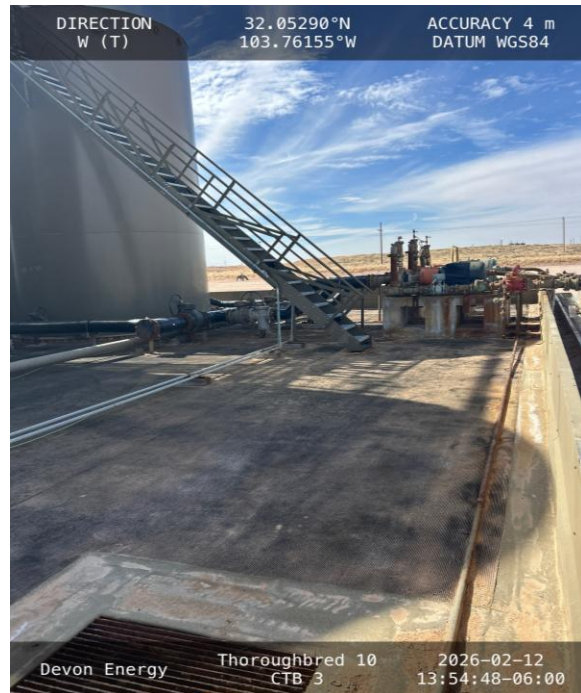
Photo 4 View of northside of secondary containment towards west.

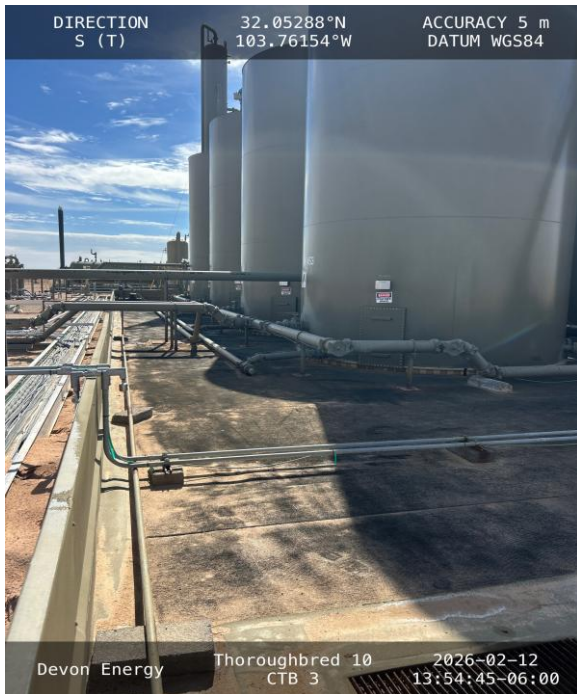
Photo 5 View of east side secondary containment towards south.

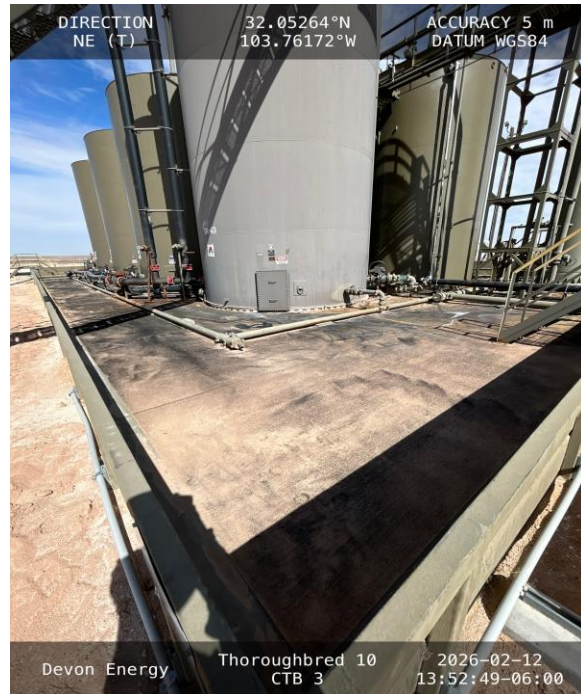
Photo 6 View of southwest corner of secondary containment.

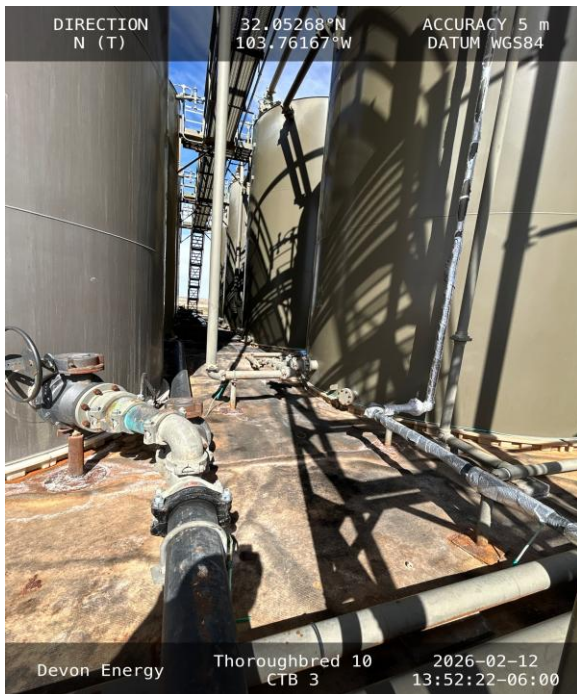
Photo 7 View of central portion of secondary containment.

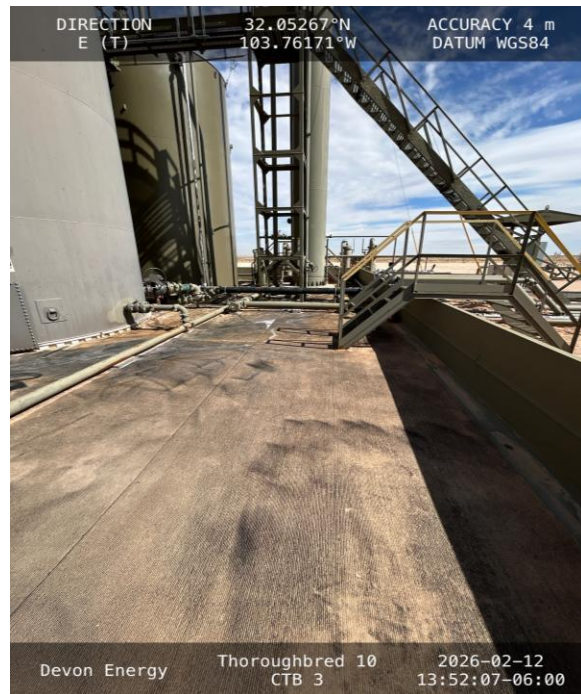
Photo 8 View of south side secondary containment towards east.

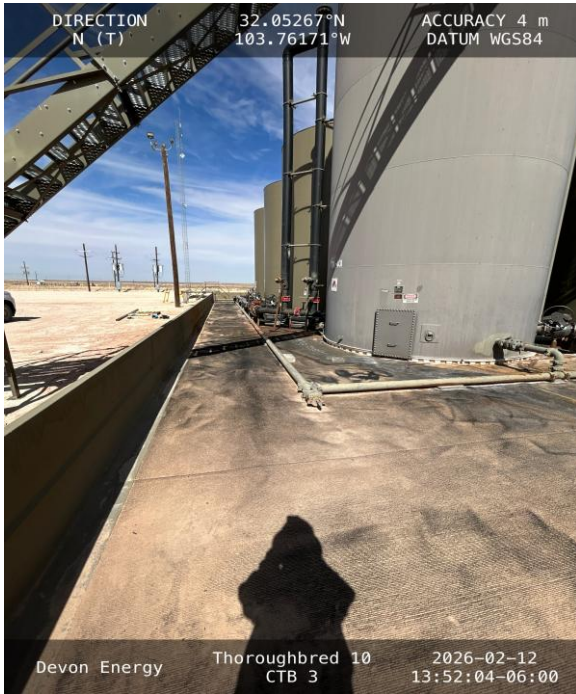
Photo 9 View of west side secondary containment towards north.

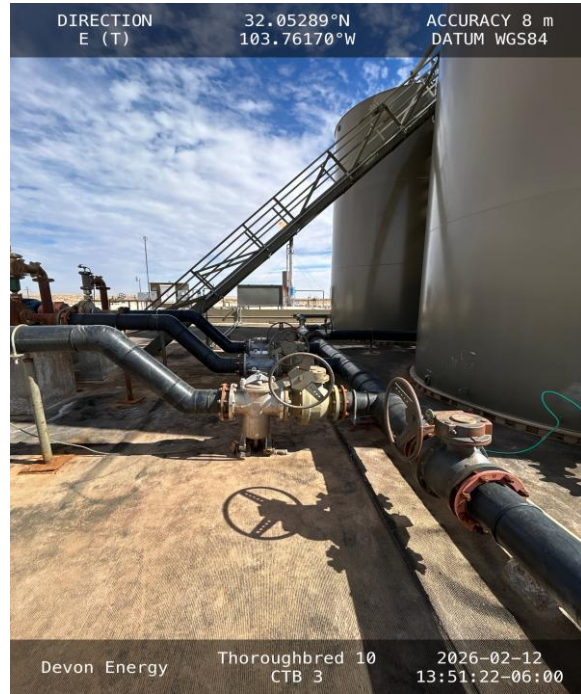
Photo 10 View of north side of secondary containment towards east.

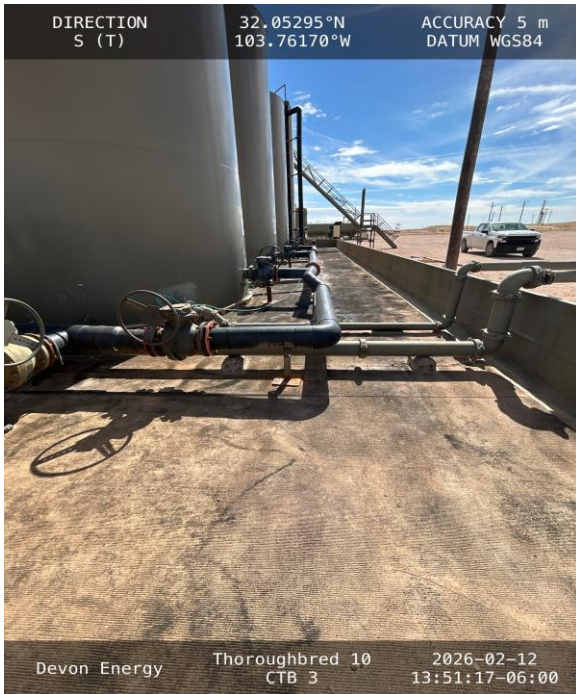
Photo 11 View of west side of secondary containment towards south.

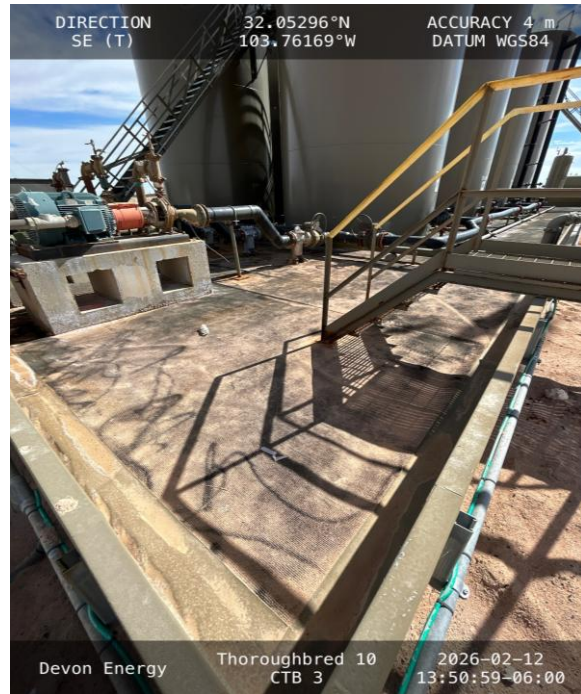
Photo 12 View of northwest corner of secondary containment.
