**Closure Report**  
**Salado Draw 23 Central Tank Battery (03.21.2026)**  
**Incident ID: nAPP2608050377**  
**Lea County, New Mexico**  
**Unit N, S14, T26S, R32E**  
**32.035793, -103.646698**

**Crude Oil & Produced Water Release**  
**Point of Release: Power Failure and Overflow of Production Tank into Lined Containment**  
**Release Date: 03.21.2026**  
**Volume Released: 29 Barrels of Crude Oil and 85 Barrels of Produced Water**  
**Volume Recovered: 28 Barrels of Crude Oil and 85 Barrels of Produced Water**

Re: **Closure Report**  
**Salado Draw 23 Central Tank Battery (03.21.2026)**  
**Incident ID: nAPP2608050377**  
**Chevron U.S.A., Inc.**  
**Site Location: Unit N, S14, T26S, R32E**  
**(Lat 32.035793°, Long -103.646698°)**  
**Lea County, New Mexico**

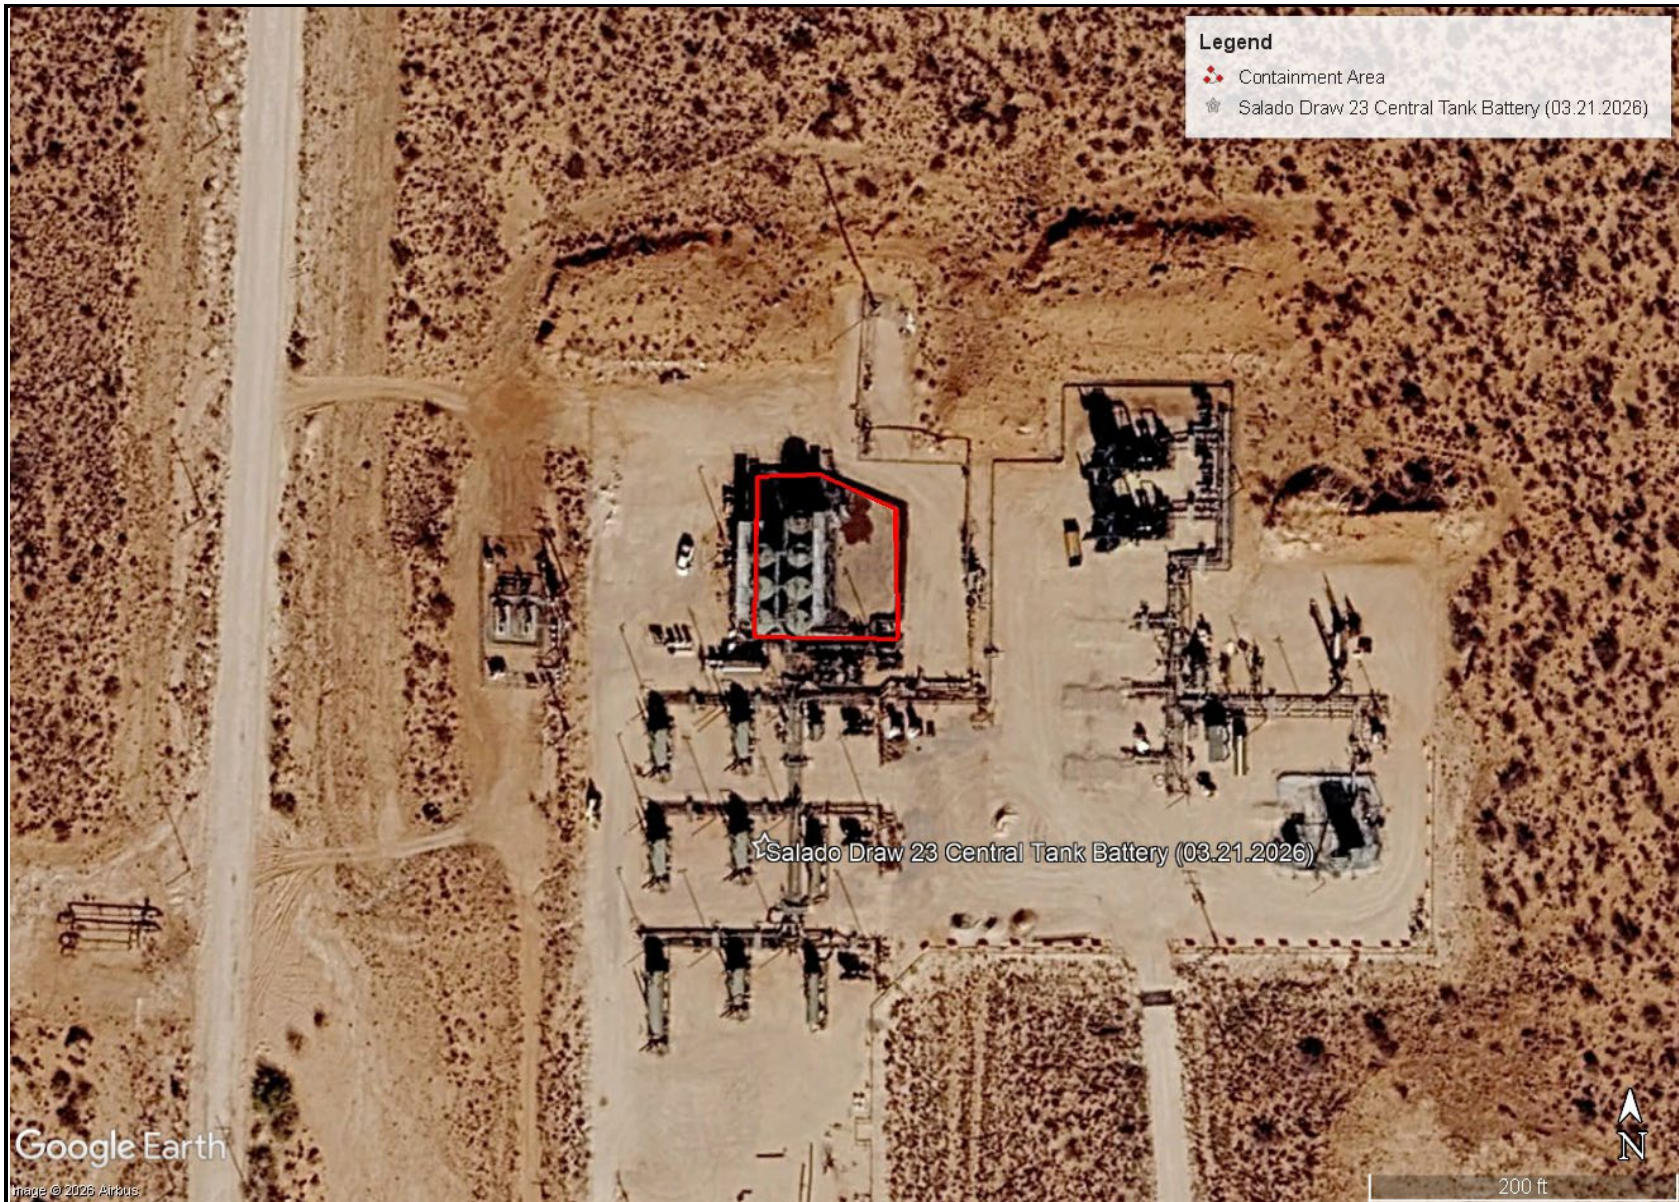
</p>	<p>FIGURE 3</p>
--	--	-----------------

Based on the initial C-141 obtained from the New Mexico Oil Conservation Division (NMOCD), the release was discovered on March 21, 2026, due to power failure and overflow of production tank into a lined containment. It resulted in approximately twenty-nine (29) barrels of crude oil and eighty-five (85) barrels of produced water being released inside the lined containment, with twenty-eight (28) barrels of crude oil and eighty-five (85) barrels of produced water recovered. The containment area is approximately 8,700 sq ft. The containment boundaries are shown in Figure 3. The initial C-141 form is attached in Appendix B.

Prior to Carmona Resources conducting a Liner Inspection, Chevron contractors removed all fluid and washed the containment. The NMOCD division office was notified via NMOCD portal on March 24, 2026, per Subsection D of 19.15.29.12 NMAC. See Appendix B for the NMOCD correspondence prior to performing the liner inspection. On March 27, 2026, Carmona Resources, LLC conducted liner inspection activities to assess the tank batteries lined containment integrity and determined there were no integrity issues. During that time, it was confirmed that all unrecovered fluid from the initial release had been captured in the gravel and was removed. Refer to the Photolog in Appendix A. Figure 3 shows the containment area outline.

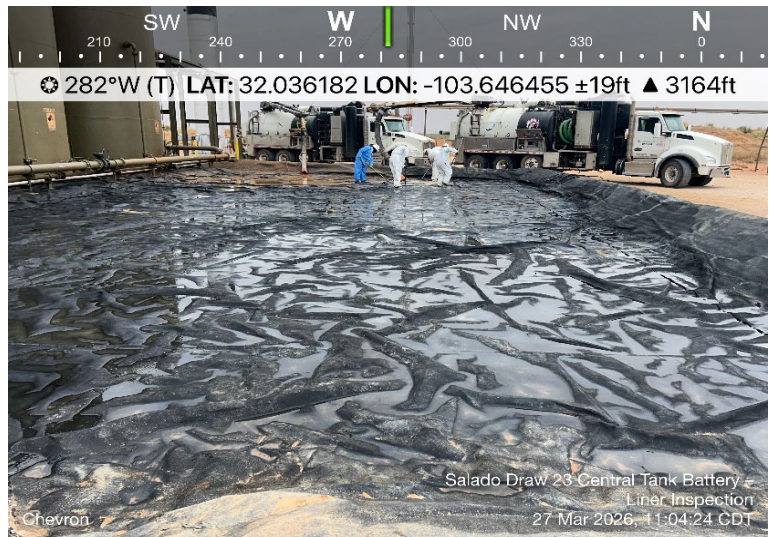
### Photograph No. 2

**Description:**  
View West of the exposed liner being washed.

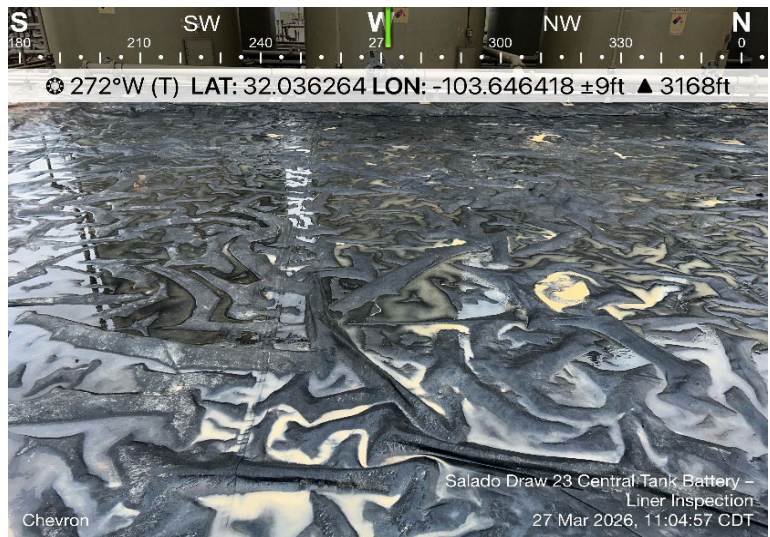
### Photograph No. 3

**Description:**  
View West of the exposed liner being washed.

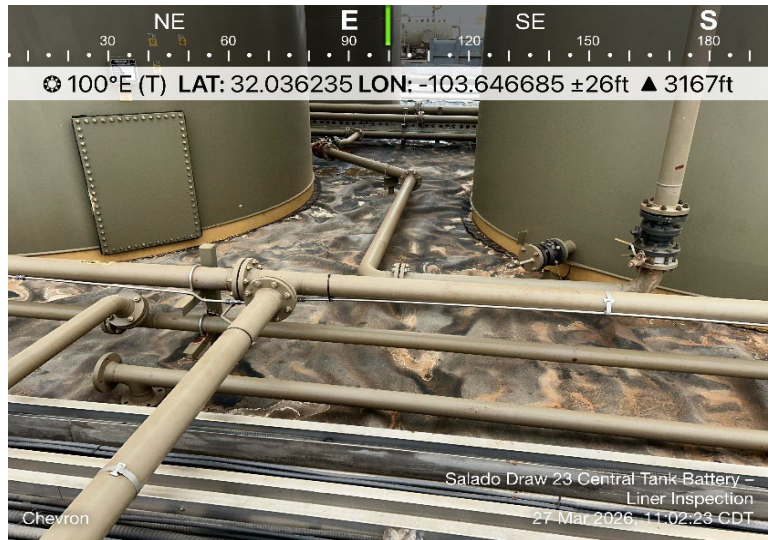
### Photograph No. 4

**Description:**  
View East of the exposed liner after being washed.

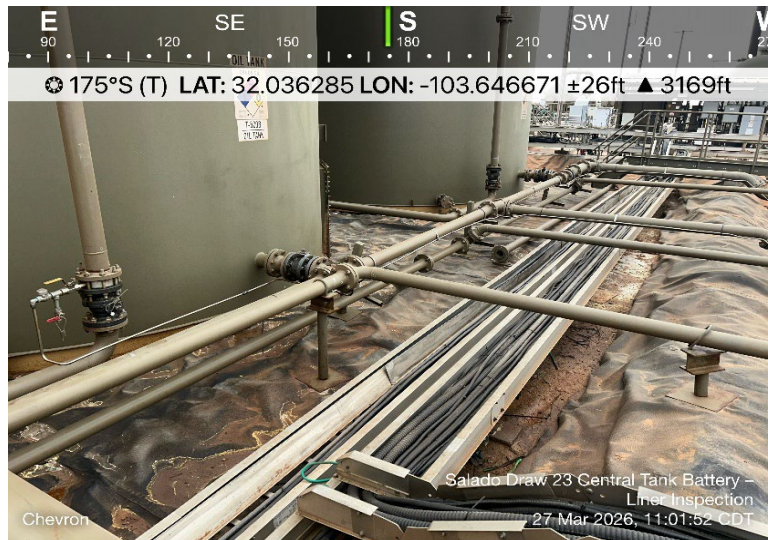
### Photograph No. 5

**Description:**  
View South of the exposed liner after being washed.

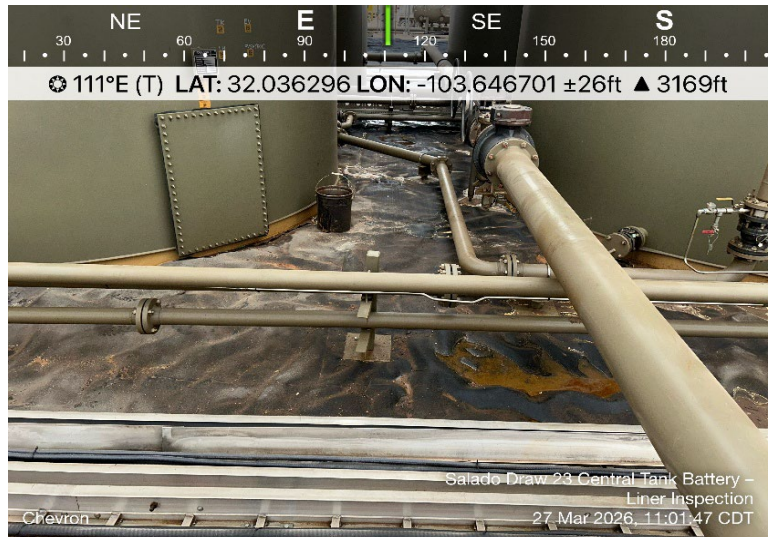
### Photograph No. 6

**Description:**  
View East of the exposed liner after being washed.

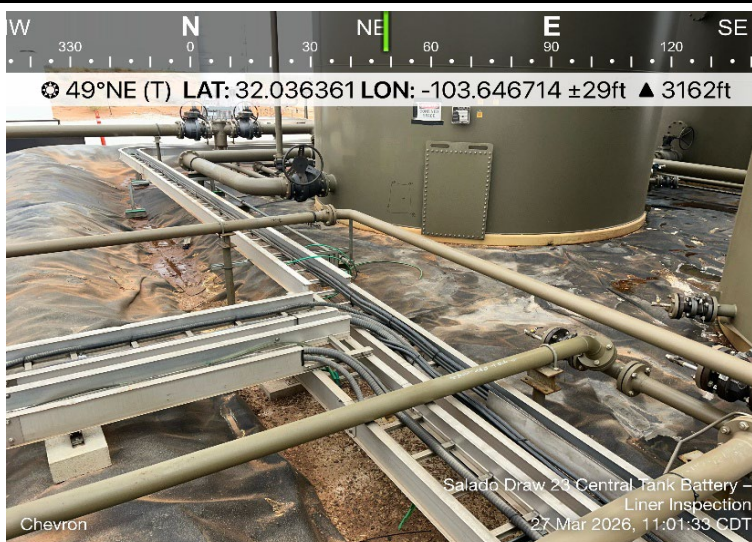
### Photograph No. 7

**Description:**  
View Northeast of the exposed liner after being washed.

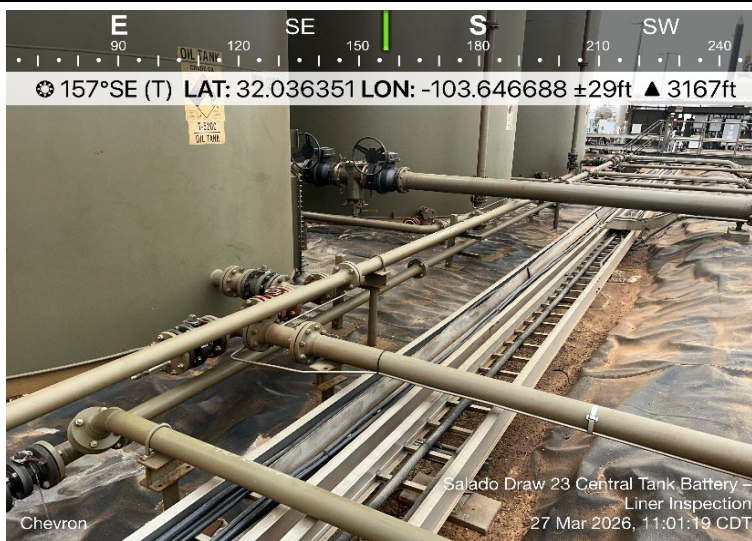
### Photograph No. 8

**Description:**  
View Southeast of the exposed liner after being washed.

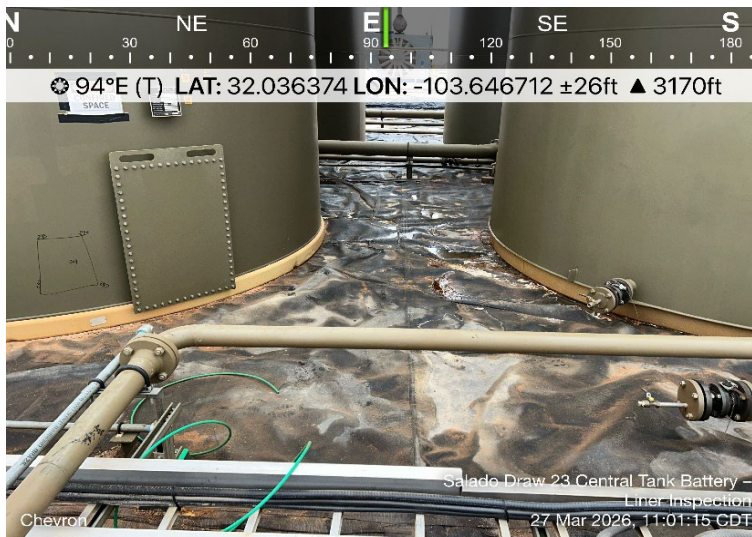
### Photograph No. 9

**Description:**  
View East of the exposed liner after being washed.
