Skelly Unit #973 TB

Incident ID NAPP2611028789

## Liner Inspection and Closure Report

June 24, 2026

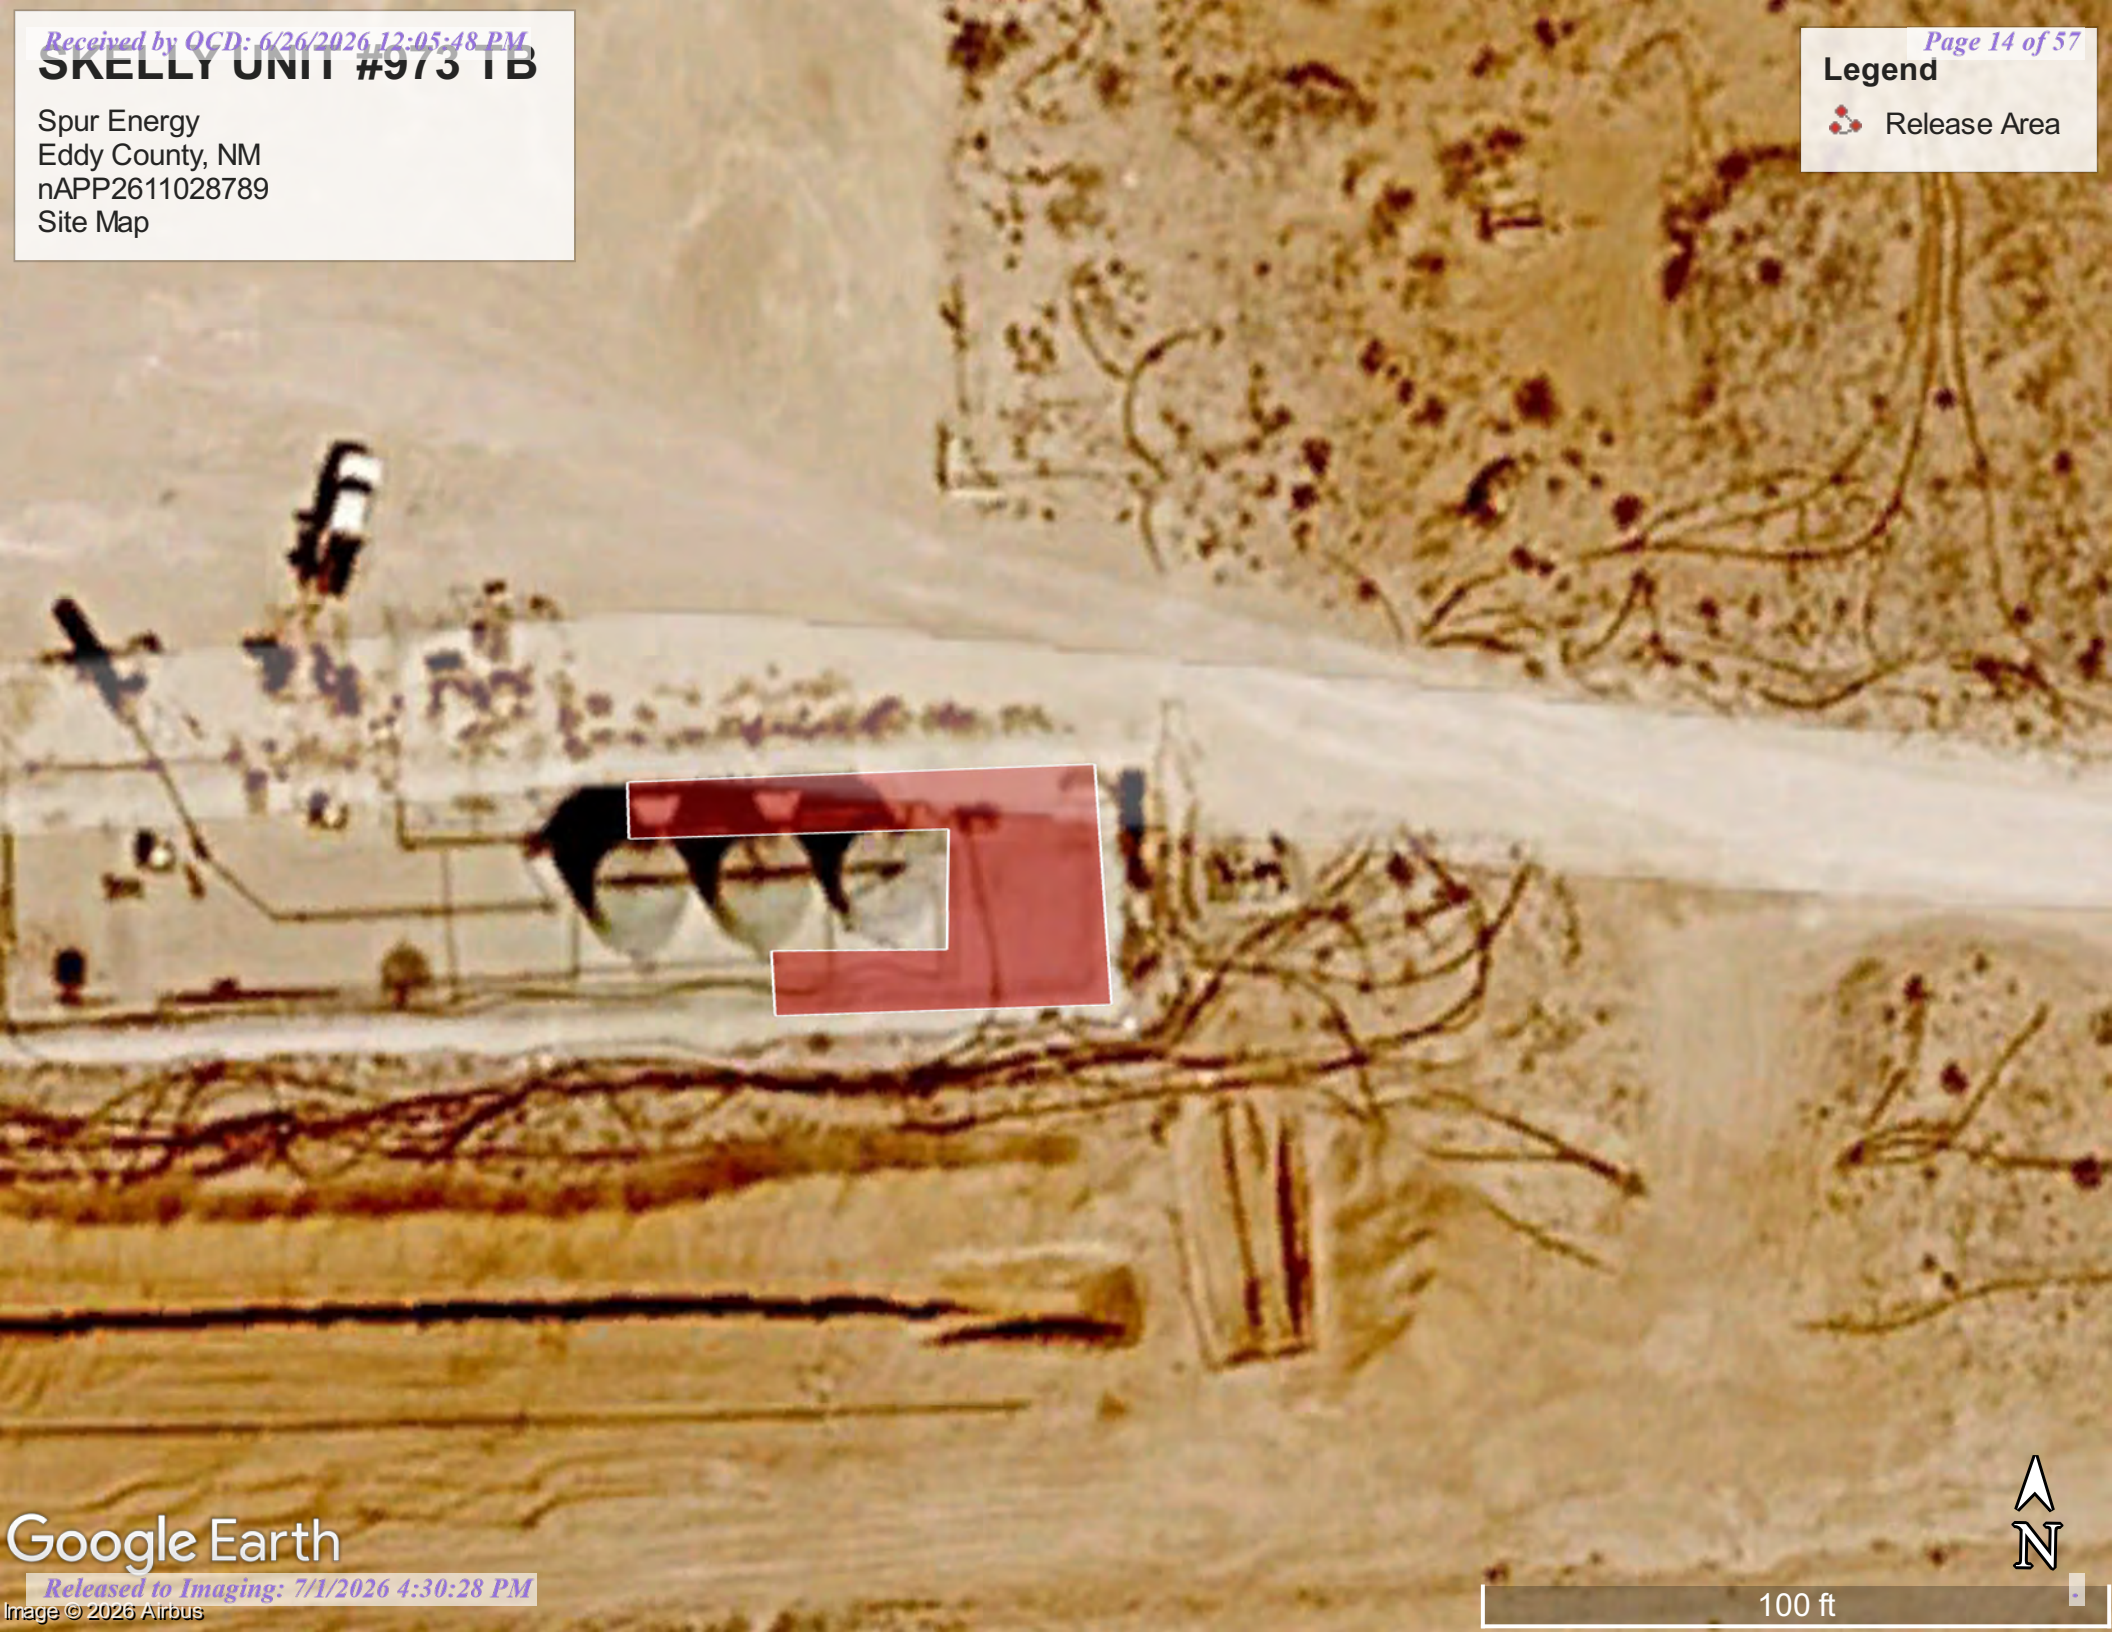
Figure 4- Site Map

**nAPP2611028789:** On April 17, 2026, an automation system failure caused a tank to overflow, resulting in the release of approximately 15 barrels of produced water into the lined secondary containment. Upon discovery of the incident, Spur personnel immediately initiated response and recovery actions to minimize the duration and extent of the release. Vacuum truck operations were mobilized, and all released fluids were successfully recovered from within the containment area. Following completion of recovery activities, the lined secondary containment was inspected to evaluate its performance and integrity. No evidence of fluid migration beyond the containment system was observed. Based on field observations, the secondary containment functioned as designed and effectively contained the released fluids, preventing impacts to surrounding soils and areas outside of the containment. Therefore, no environmental impacts occurred beyond the lined containment. A site map depicting the release location is provided in Figure 4.

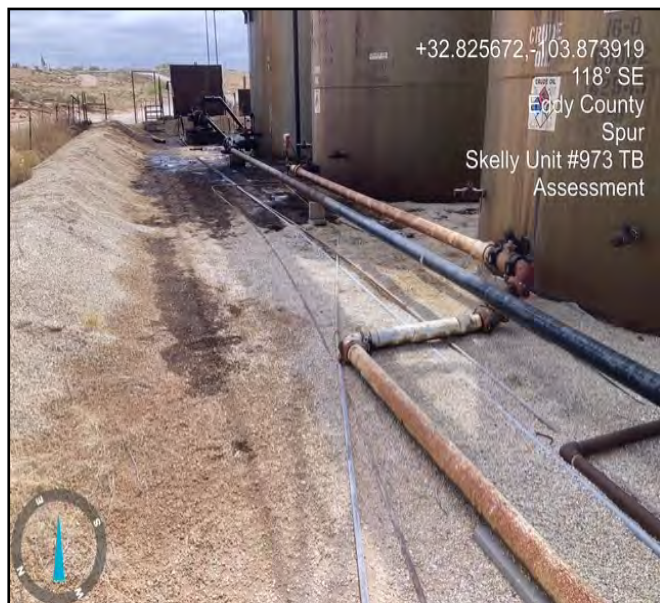
Photograph taken during initial assessment facing southeast.

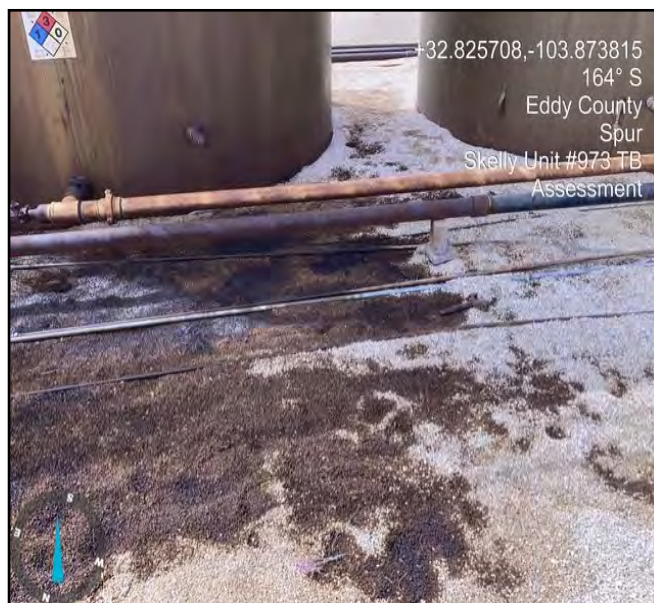
Photograph taken during initial assessment facing south.

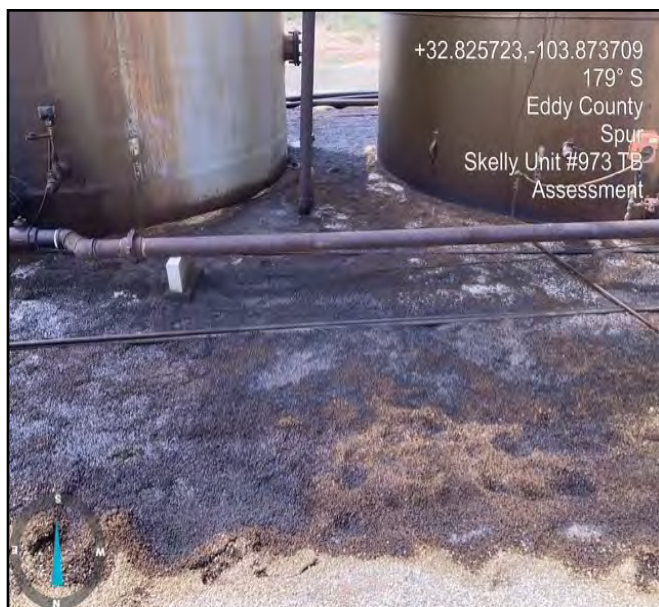
Photograph taken during initial assessment facing south.

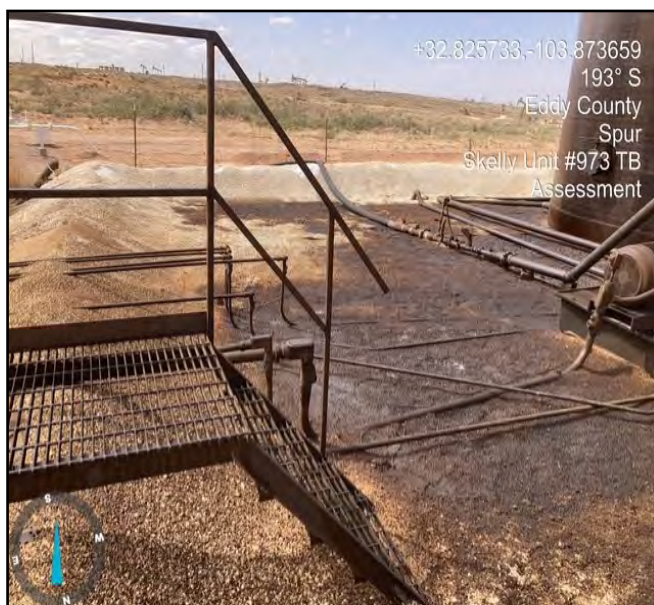
Photograph taken during initial assessment facing south.

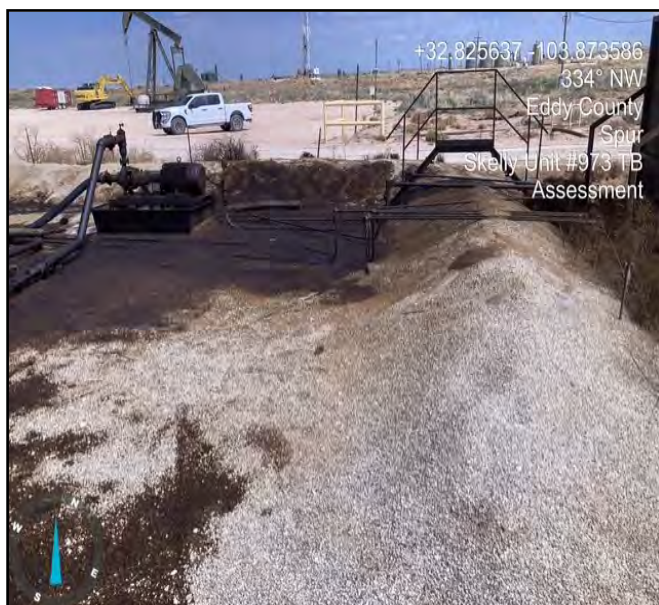
Photograph taken during initial assessment facing northwest.

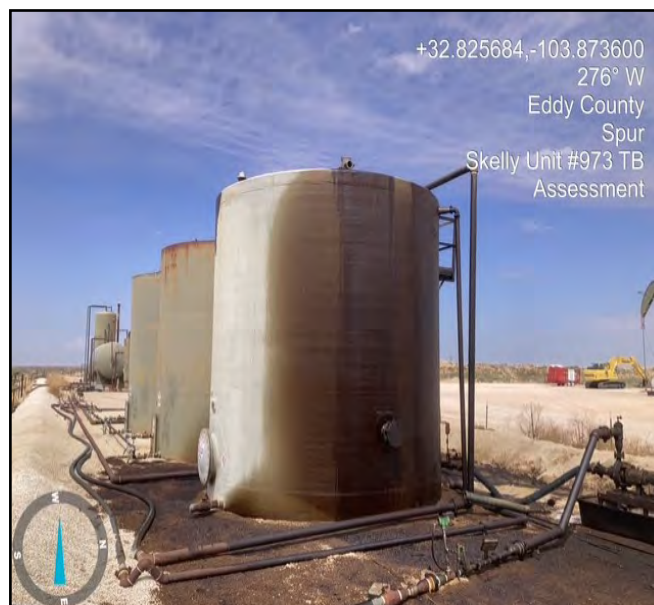
Photograph taken during initial assessment facing west.

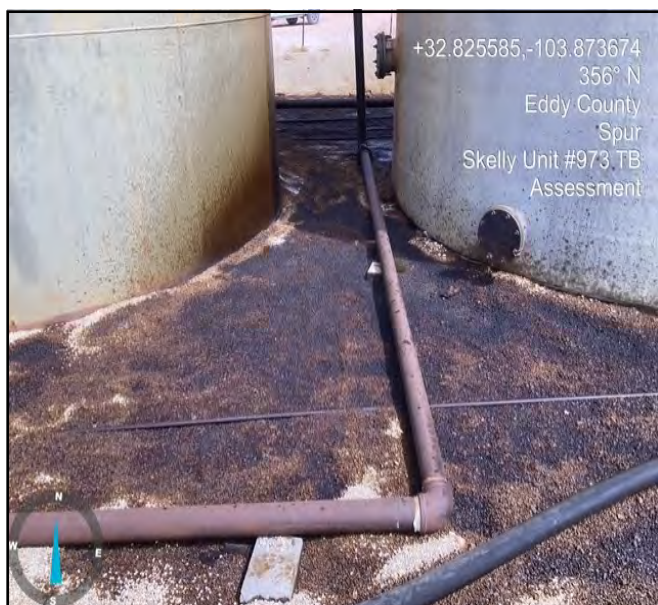
Photograph taken during initial assessment facing north.

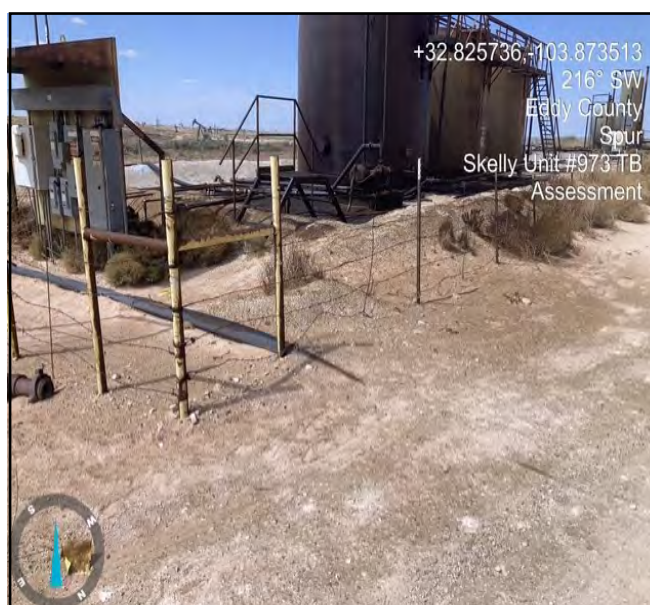
Photograph taken during initial assessment facing southwest.

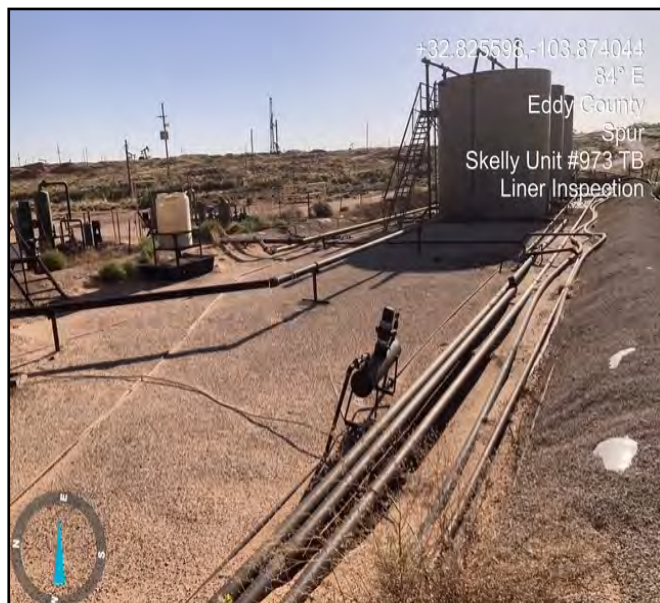
Upon completion of the cleaning activities, the exposed liner was inspected for signs of tears, punctures, seam failures, or other deficiencies that could compromise containment performance. The inspection confirmed that the liner remained intact and functioned as designed, successfully containing all released fluids within the lined containment area. No evidence of fluid migration beyond the containment system was observed. Based on these findings, the containment system was determined to have maintained its integrity throughout the release and effectively prevented impacts to surrounding soils and the environment. Documentation of the inspection activities, including photographic evidence, is provided in Appendices C and D.

Photograph taken during liner inspection facing east.

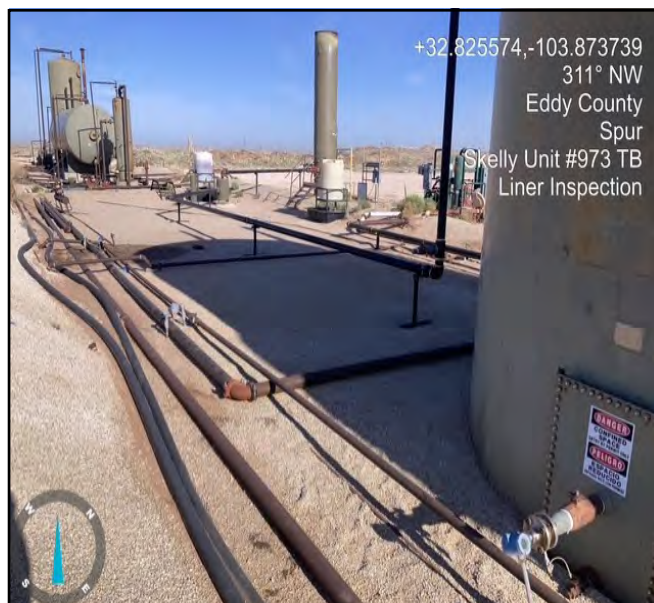
Photograph taken post powerwash facing northwest.

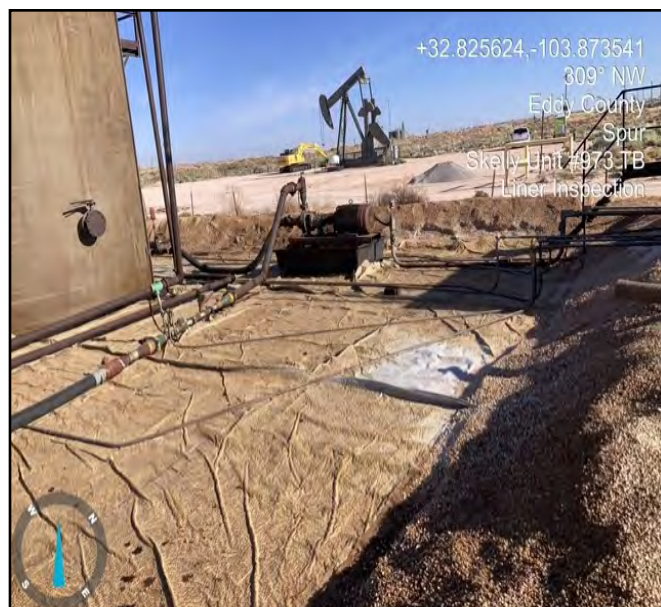
Photograph taken post powerwash facing northwest.

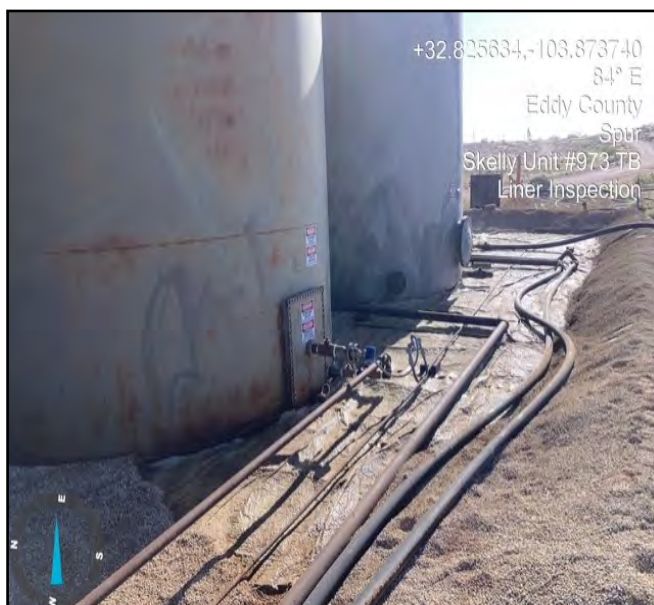
Photograph taken post powerwash facing east.
