## **Liner Inspection and Closure Request**

**Devon Energy Production Company, LP**

**Haflinger 22 CTB 1**

**NMOCD Incident # NAPP2616645847**

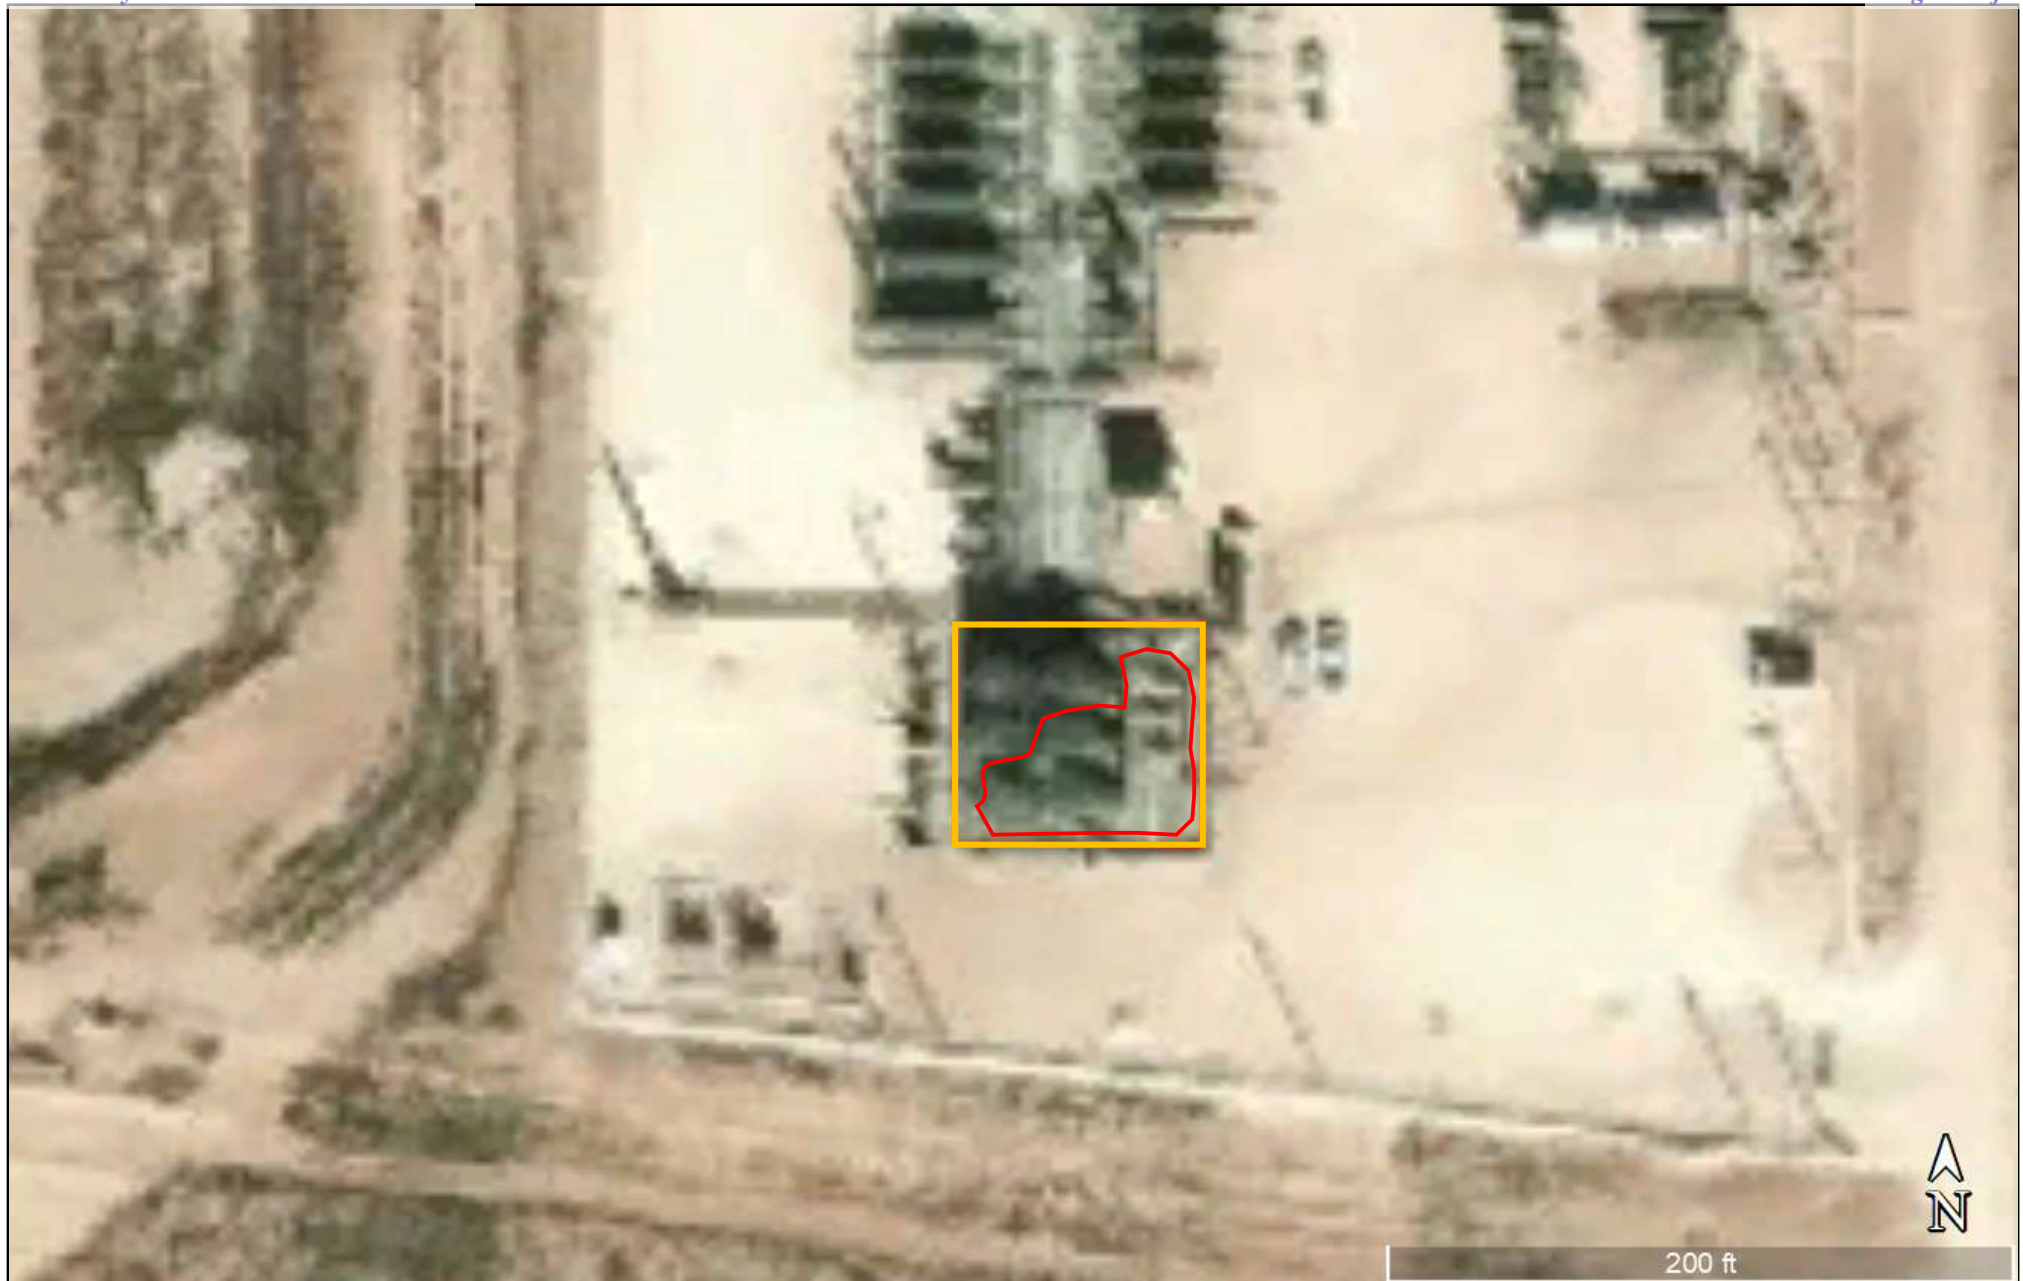
**Figure 4**

Liner Inspection Map  
Devon Energy Production Company, LP  
Haflinger 22 CTB 1  
GPS: 32.120028, -103.668022  
Lea County
