Bluetail 8 Fed 2 TB

Incident ID NAPP2503539371

PREPARED BY:  
PIMA ENVIRONMENTAL SERVICES, LLC

## Liner Inspection and Closure Report

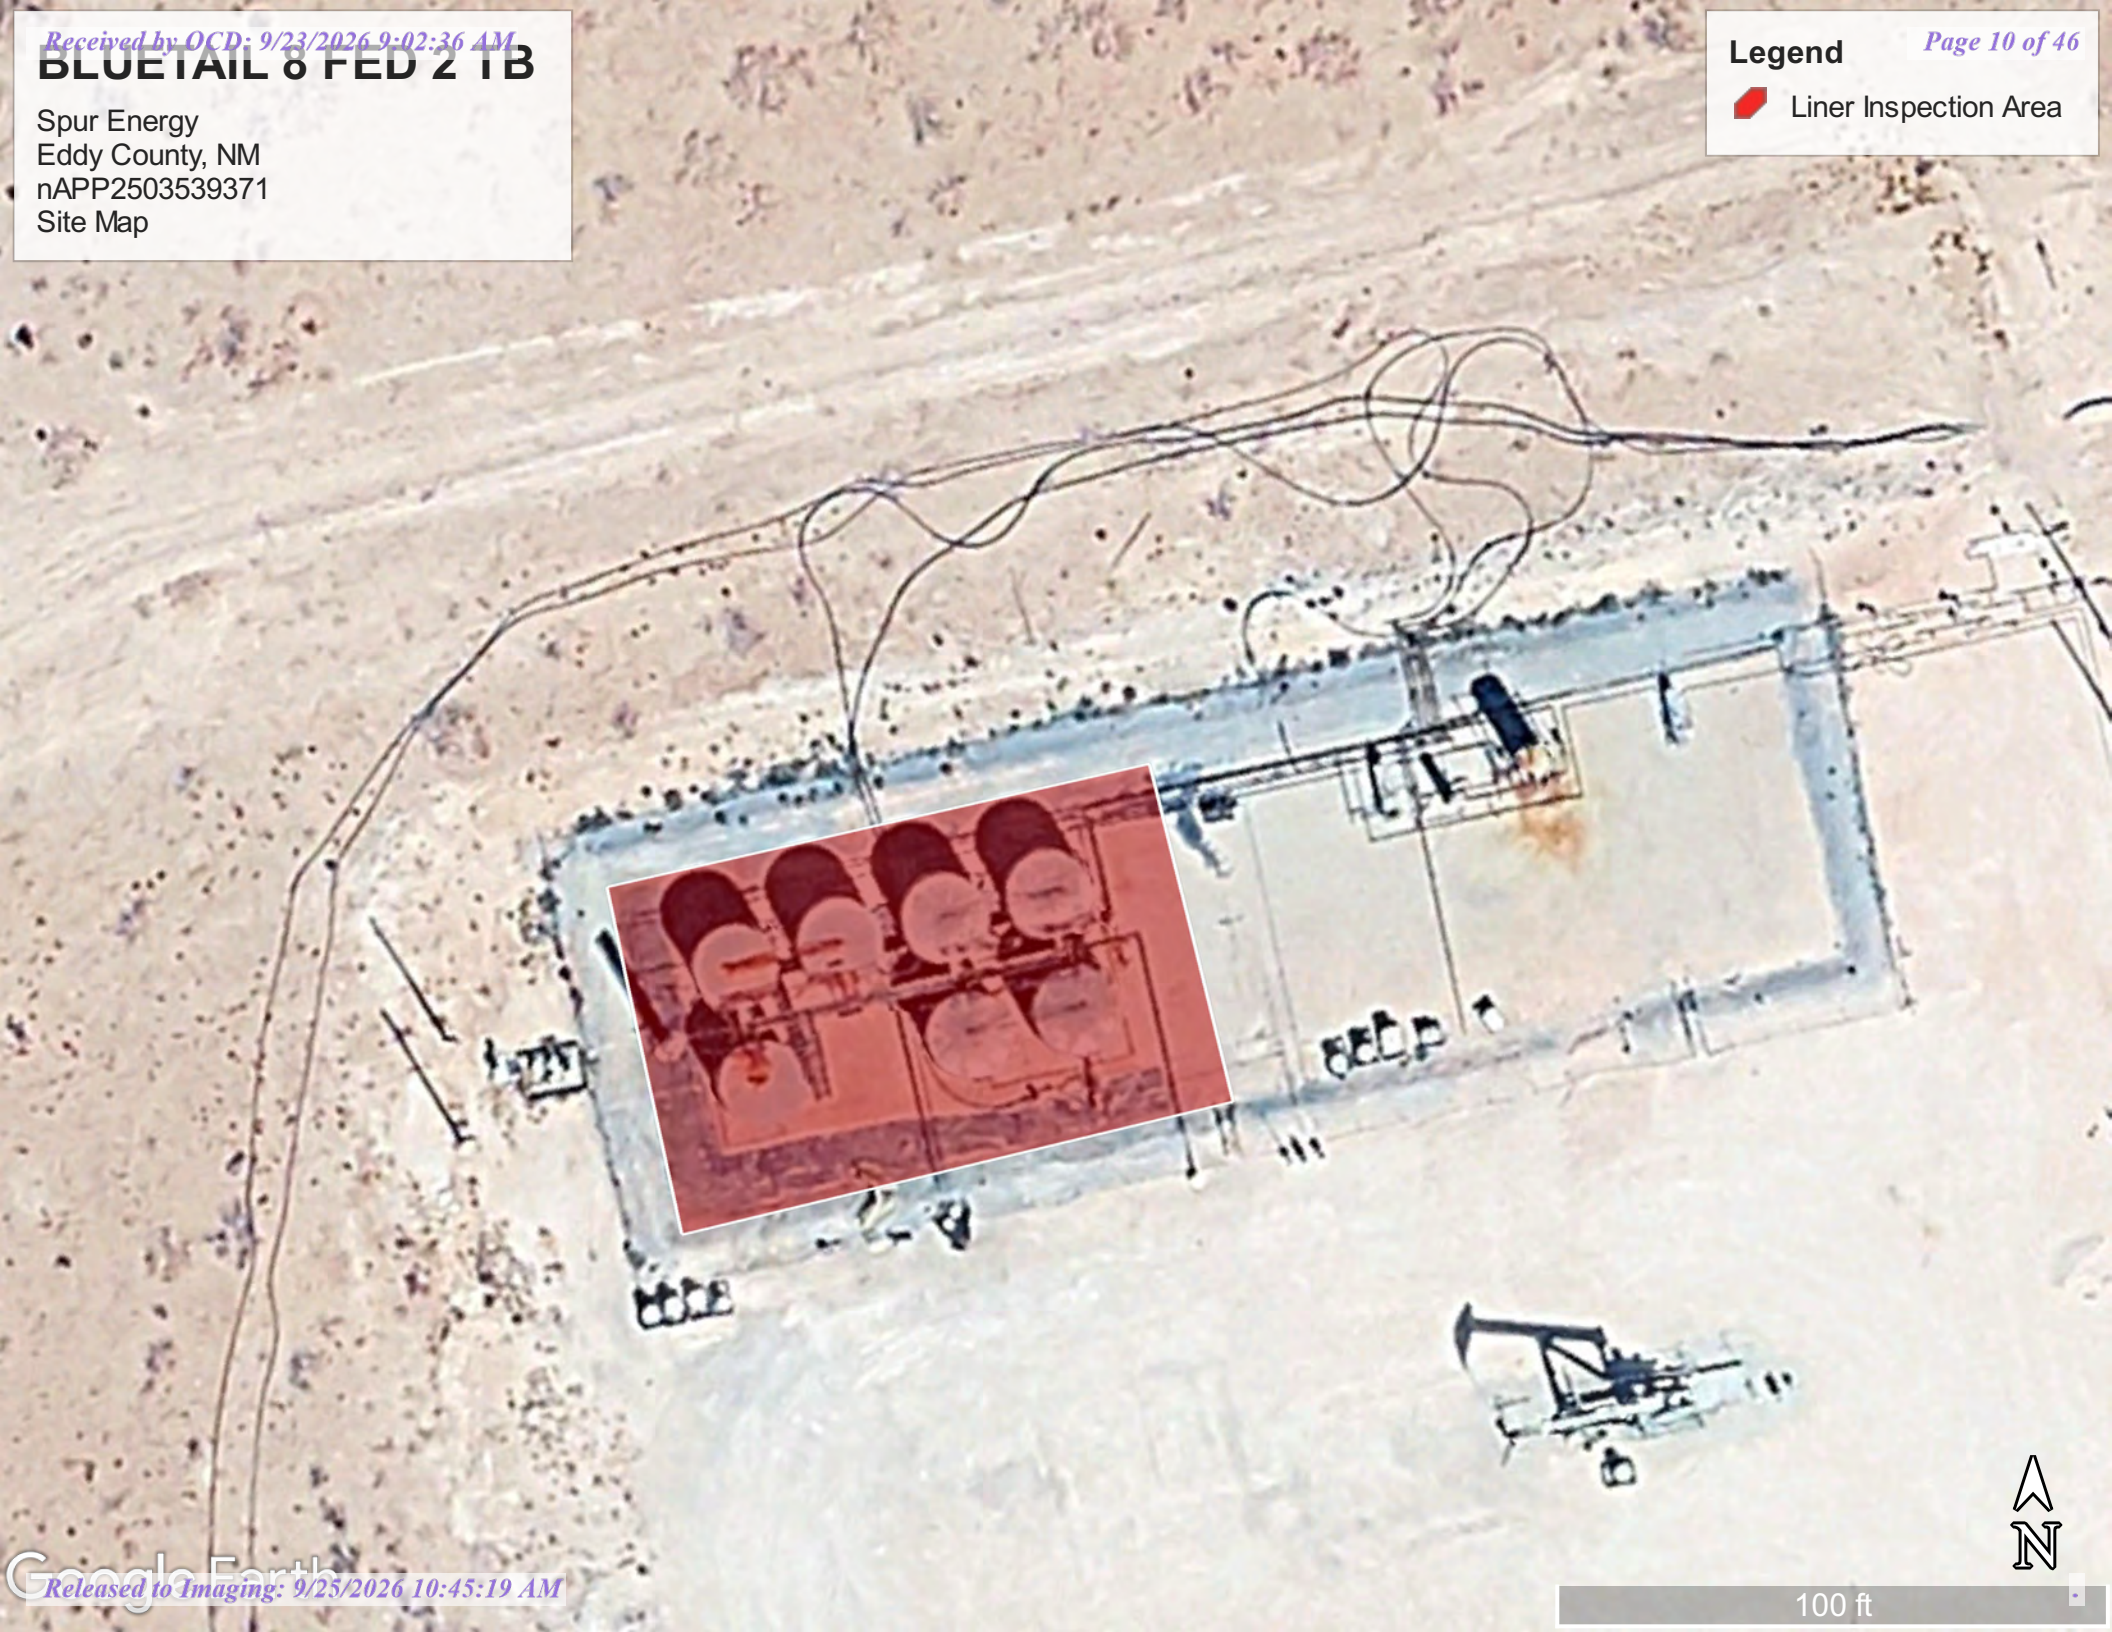
Figure 4- Site Map

Following the completion of recovery activities, the lined secondary containment was visually evaluated for evidence of fluid migration beyond the containment system. No evidence of fluid migration outside of the lined containment was observed. Based on field observations, the secondary containment functioned as designed and effectively contained the released fluids, preventing impacts to surrounding soils and areas outside of the containment. Therefore, no environmental impacts were observed beyond the lined secondary containment. A site map depicting the release location is provided in Figure 4.

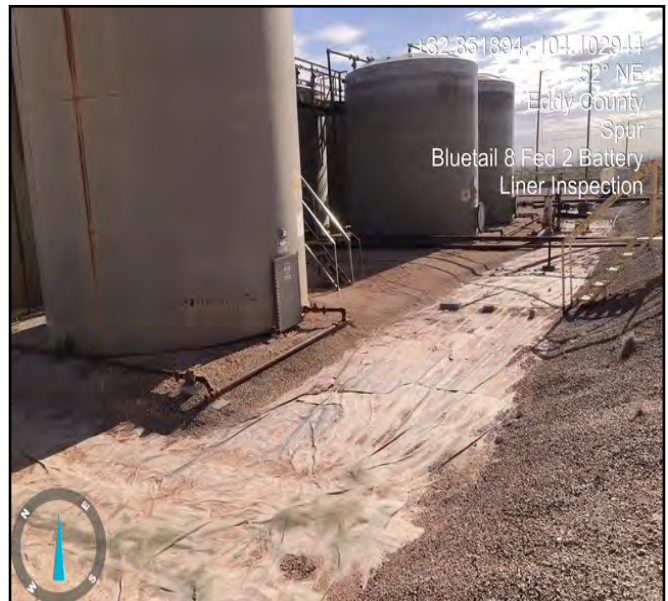
Photograph taken during liner inspection facing northeast.

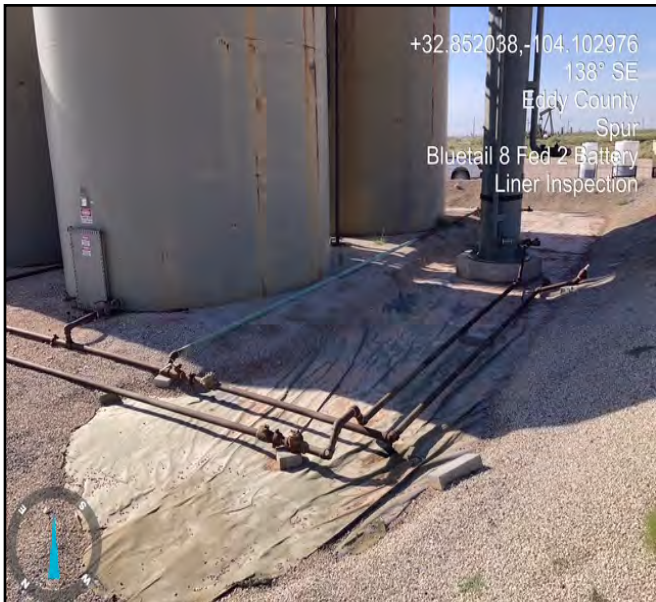
Photograph taken during liner inspection facing southeast.

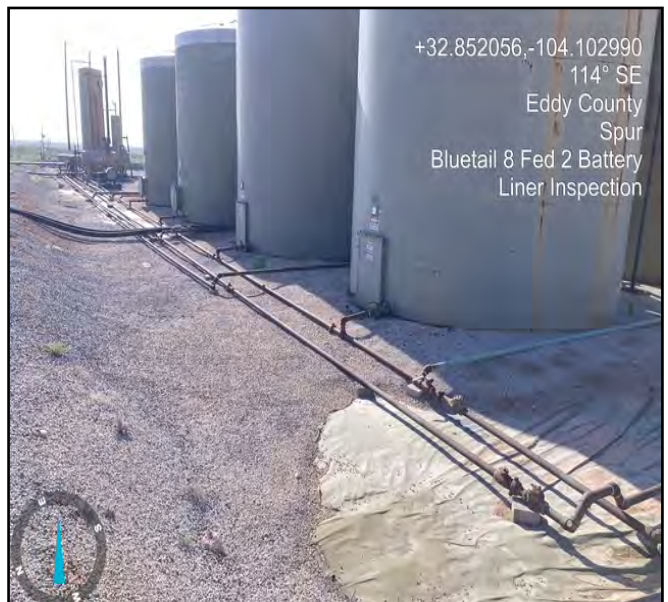
Photograph taken during liner inspection facing southeast.

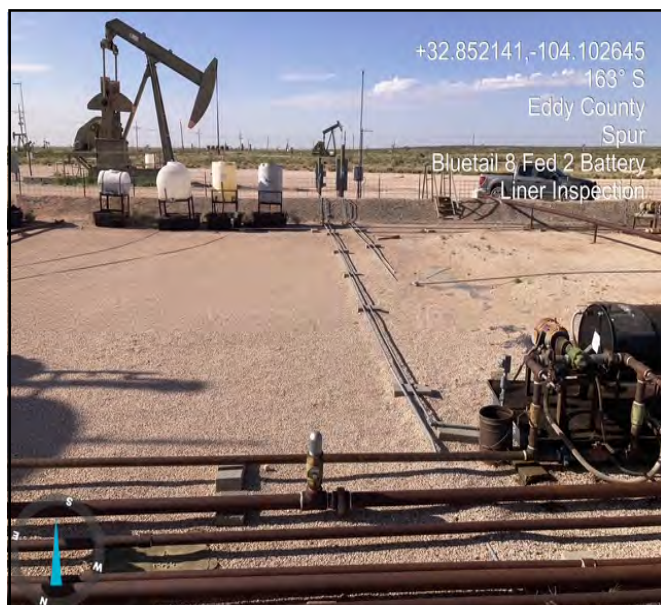
Photograph taken during liner inspection facing south.

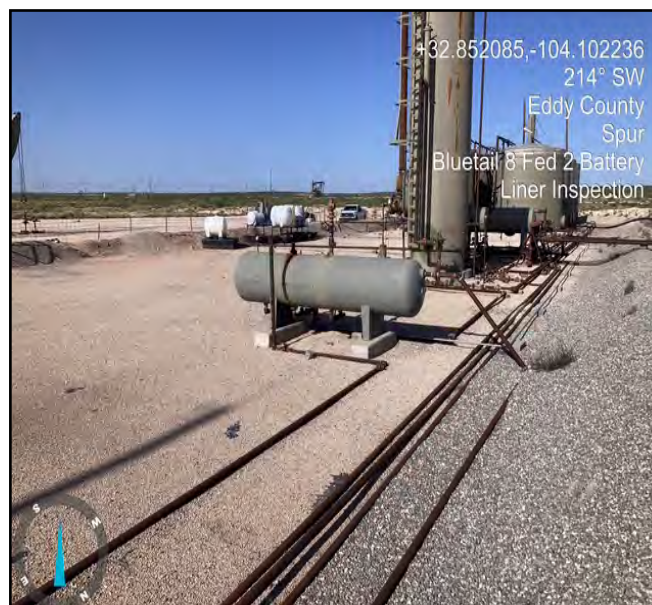
Photograph taken during liner inspection facing southwest.

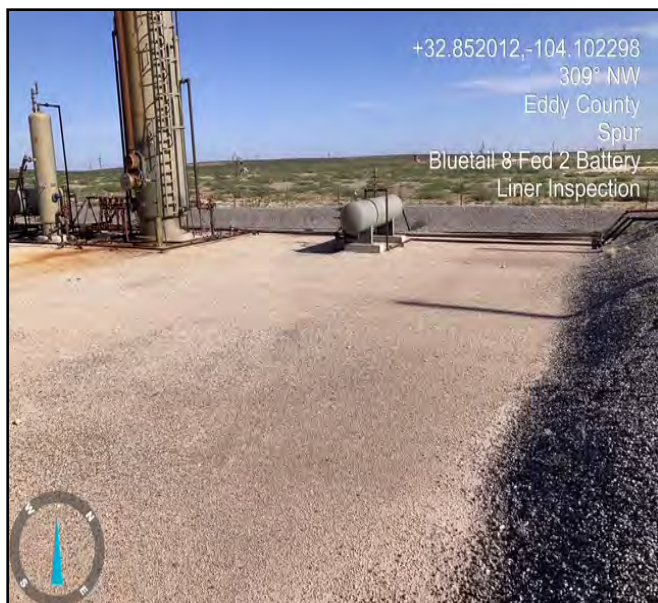
Photograph taken during liner inspection facing northwest.

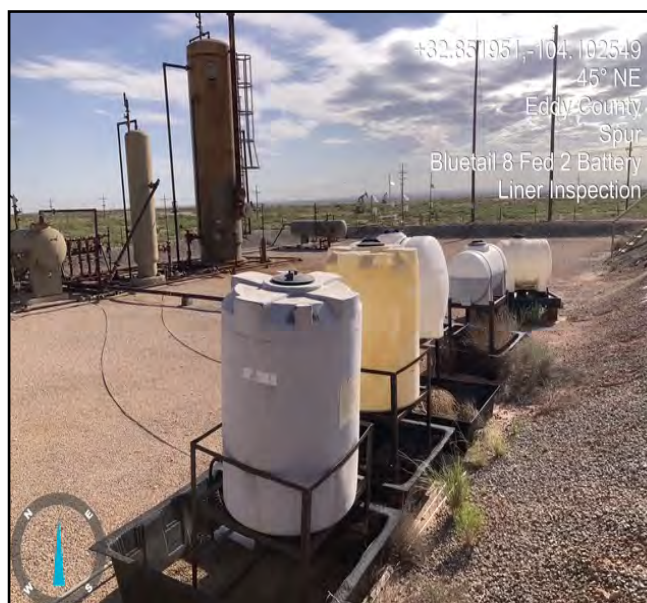
Photograph taken during liner inspection facing northeast.

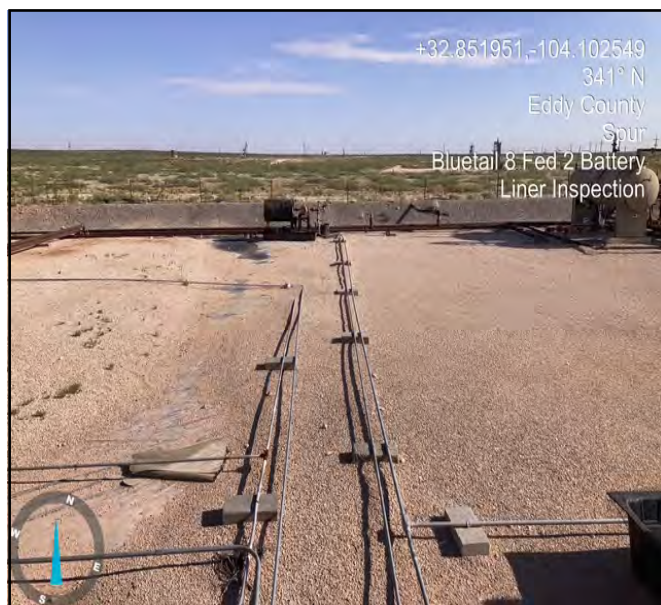
Photograph taken during liner inspection facing north.

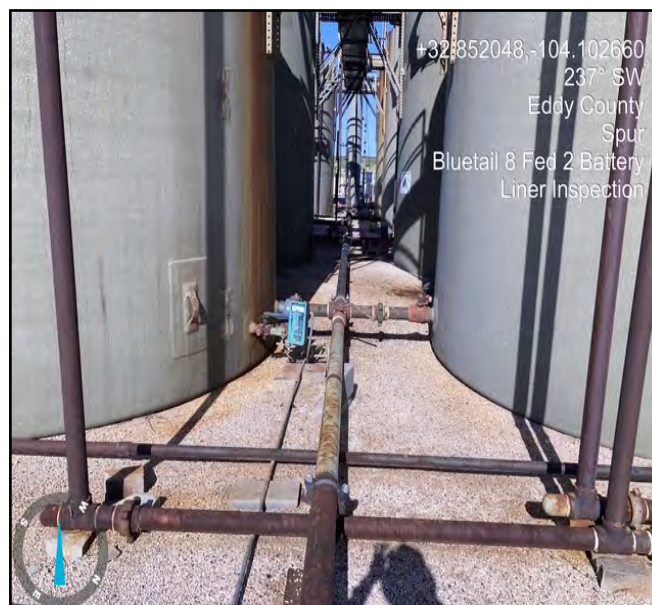
Photograph taken during liner inspection facing southwest.

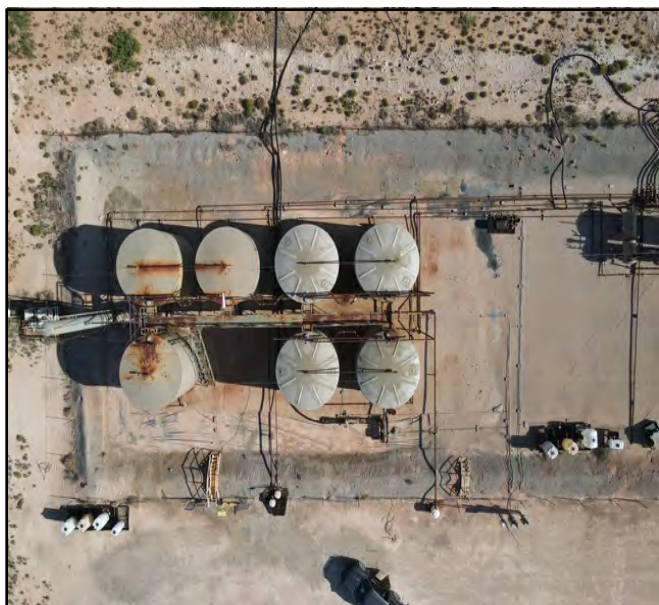
Aerial photo taken during liner inspection.

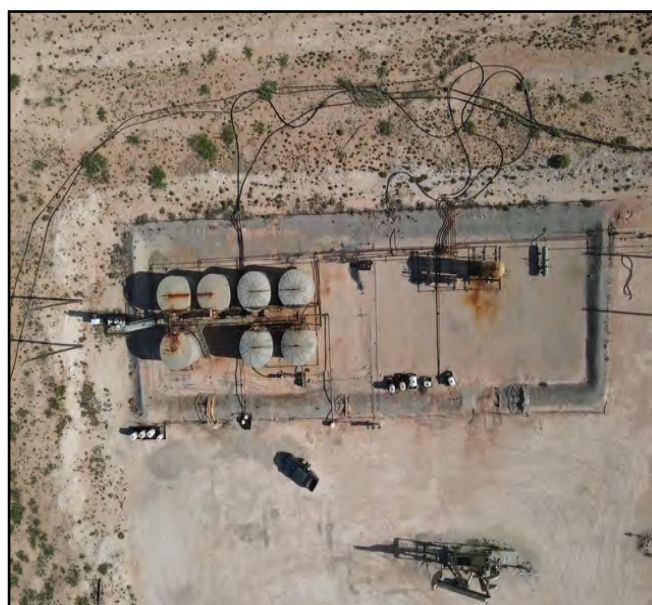
Aerial photo taken during liner inspection.
