Well Name: DIVIDE FEDERAL JW COM	Well Location: T17S / R24E / SEC 4 / NESW /	County or Parish/State: EDDY / NM
Well Number: 1	Type of Well: CONVENTIONAL GAS WELL	Allottee or Tribe Name:
Lease Number: NMNM7050	Unit or CA Name:	Unit or CA Number:
US Well Number: 300152264300X1	Well Status: Abandoned	Operator: EOG RESOURCES INCORPORATED

Subsequent Report

Surface Reclamation Complete Report

Well Name: DIVIDE FEDERAL JW COM #001

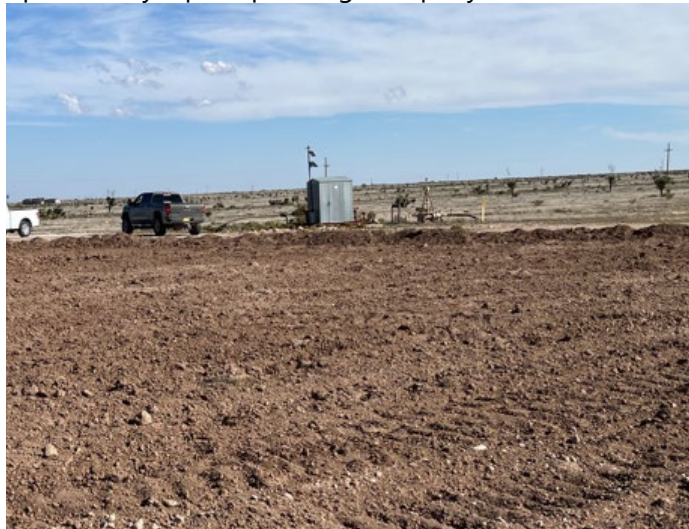
Meter house on the south side of pad belongs to Durango and services the State 1624 #291 operated by Opal Operating Company LLC. See attached email from Durango.
