Souder, Miller & Associates ♦ 201 S. Halagueno St. ♦ Carlsbad, NM 88220  
(575) 689-8801

May 6, 2024

SUBJECT: Reclamation Report for the Artesia Metex Unit #018, Eddy County, New Mexico

## Artesia Metex Unit #018 Reclamation Report

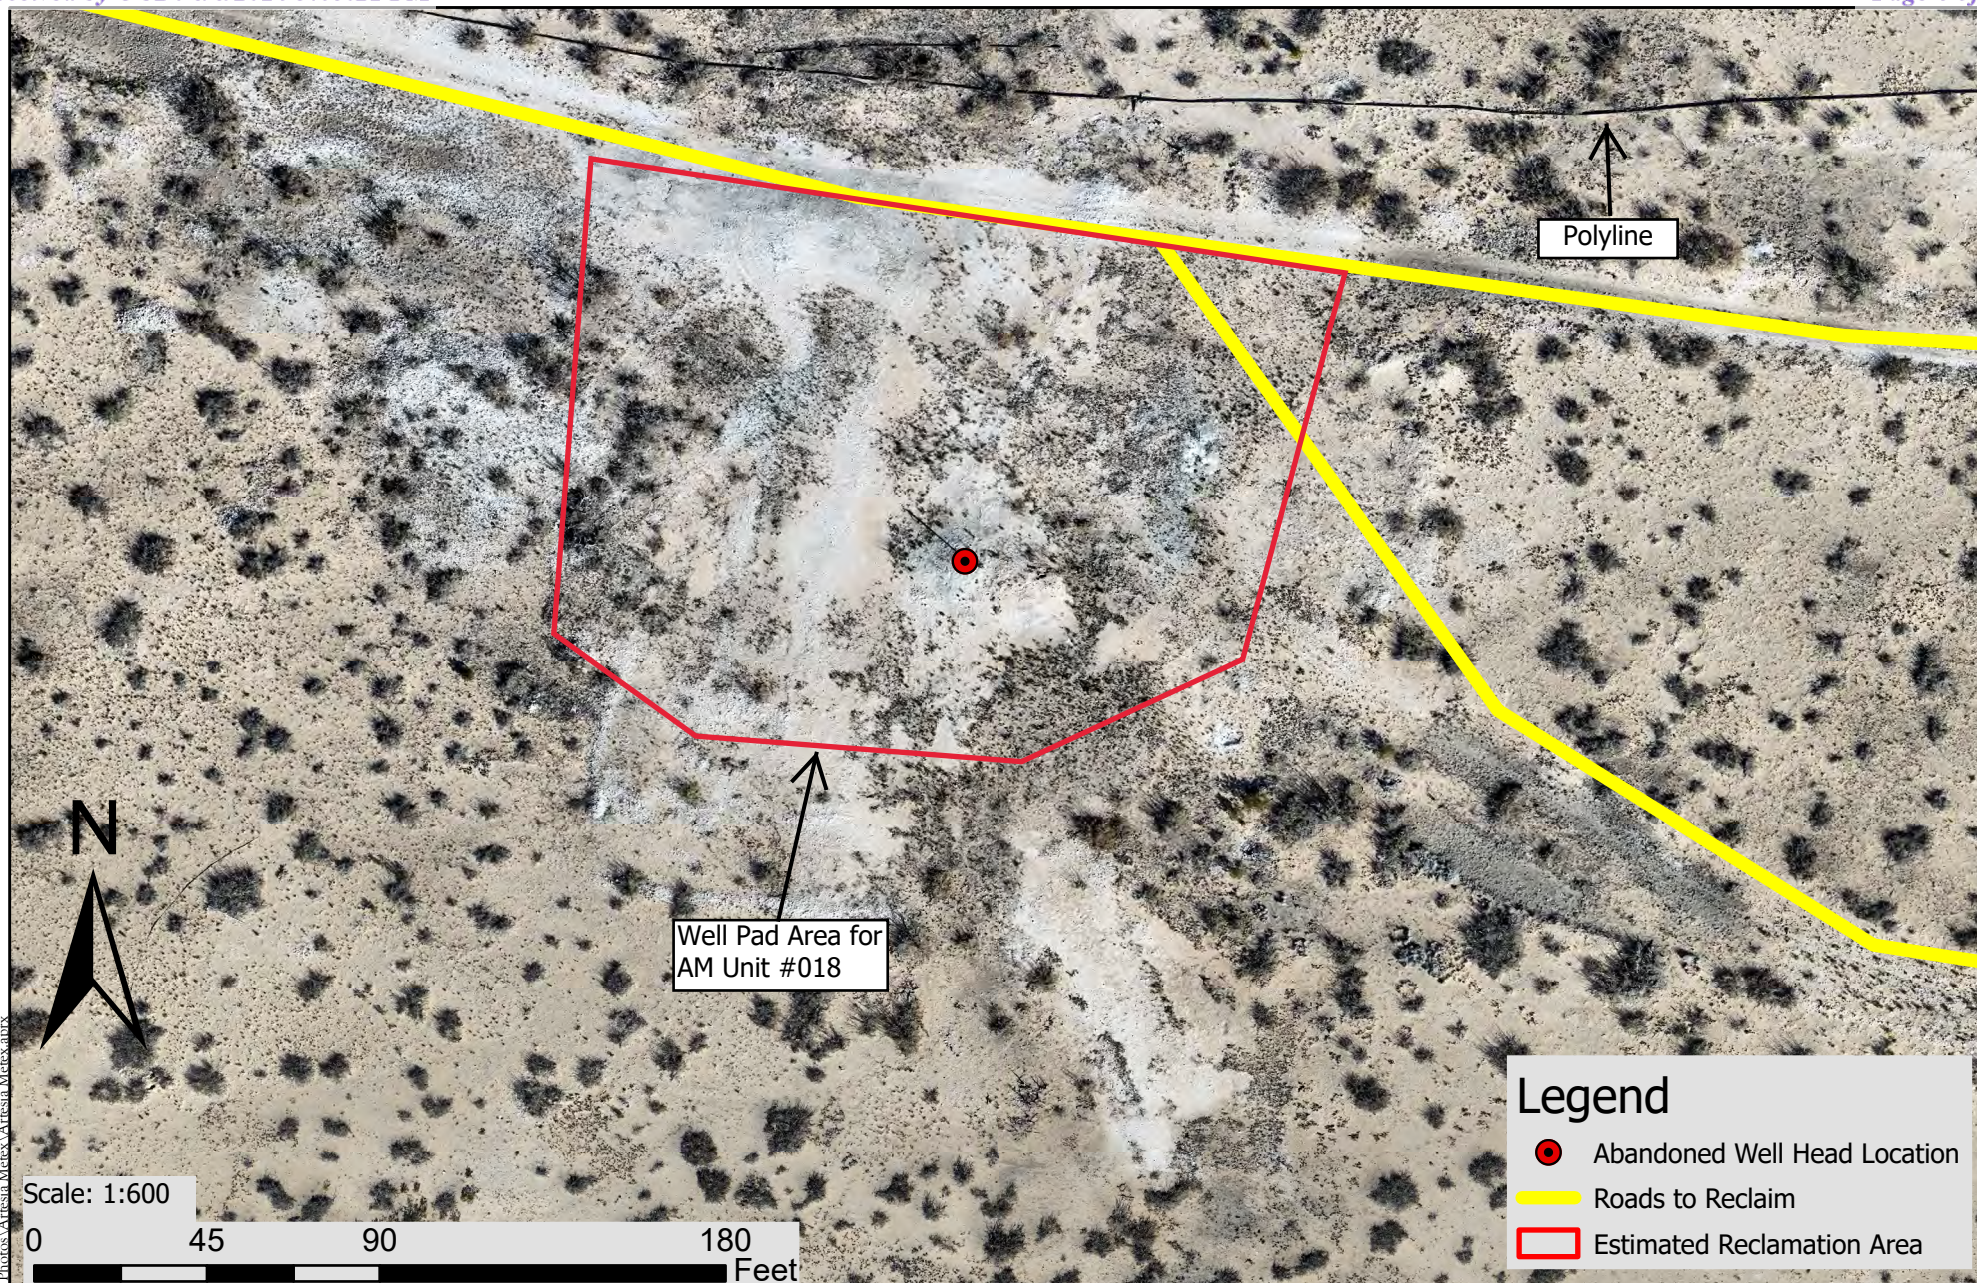
Figure 1

Along with the NORM assessment, on January 9, 2024, SMA performed a drone sweep of the area to obtain an aerial image prior to reclamation, as shown in Figure 1. Upon completion of reclamation activities, a second drone sweep was completed on April 3, 2024, to show the completion of reclamation activities, as shown in Figure 2. Figures 3 through 5 display post-reclamation of the access roads to and from AM Unit #018.

Artesia Metex Unit #018  
Pre-Reclamation and Reseeding

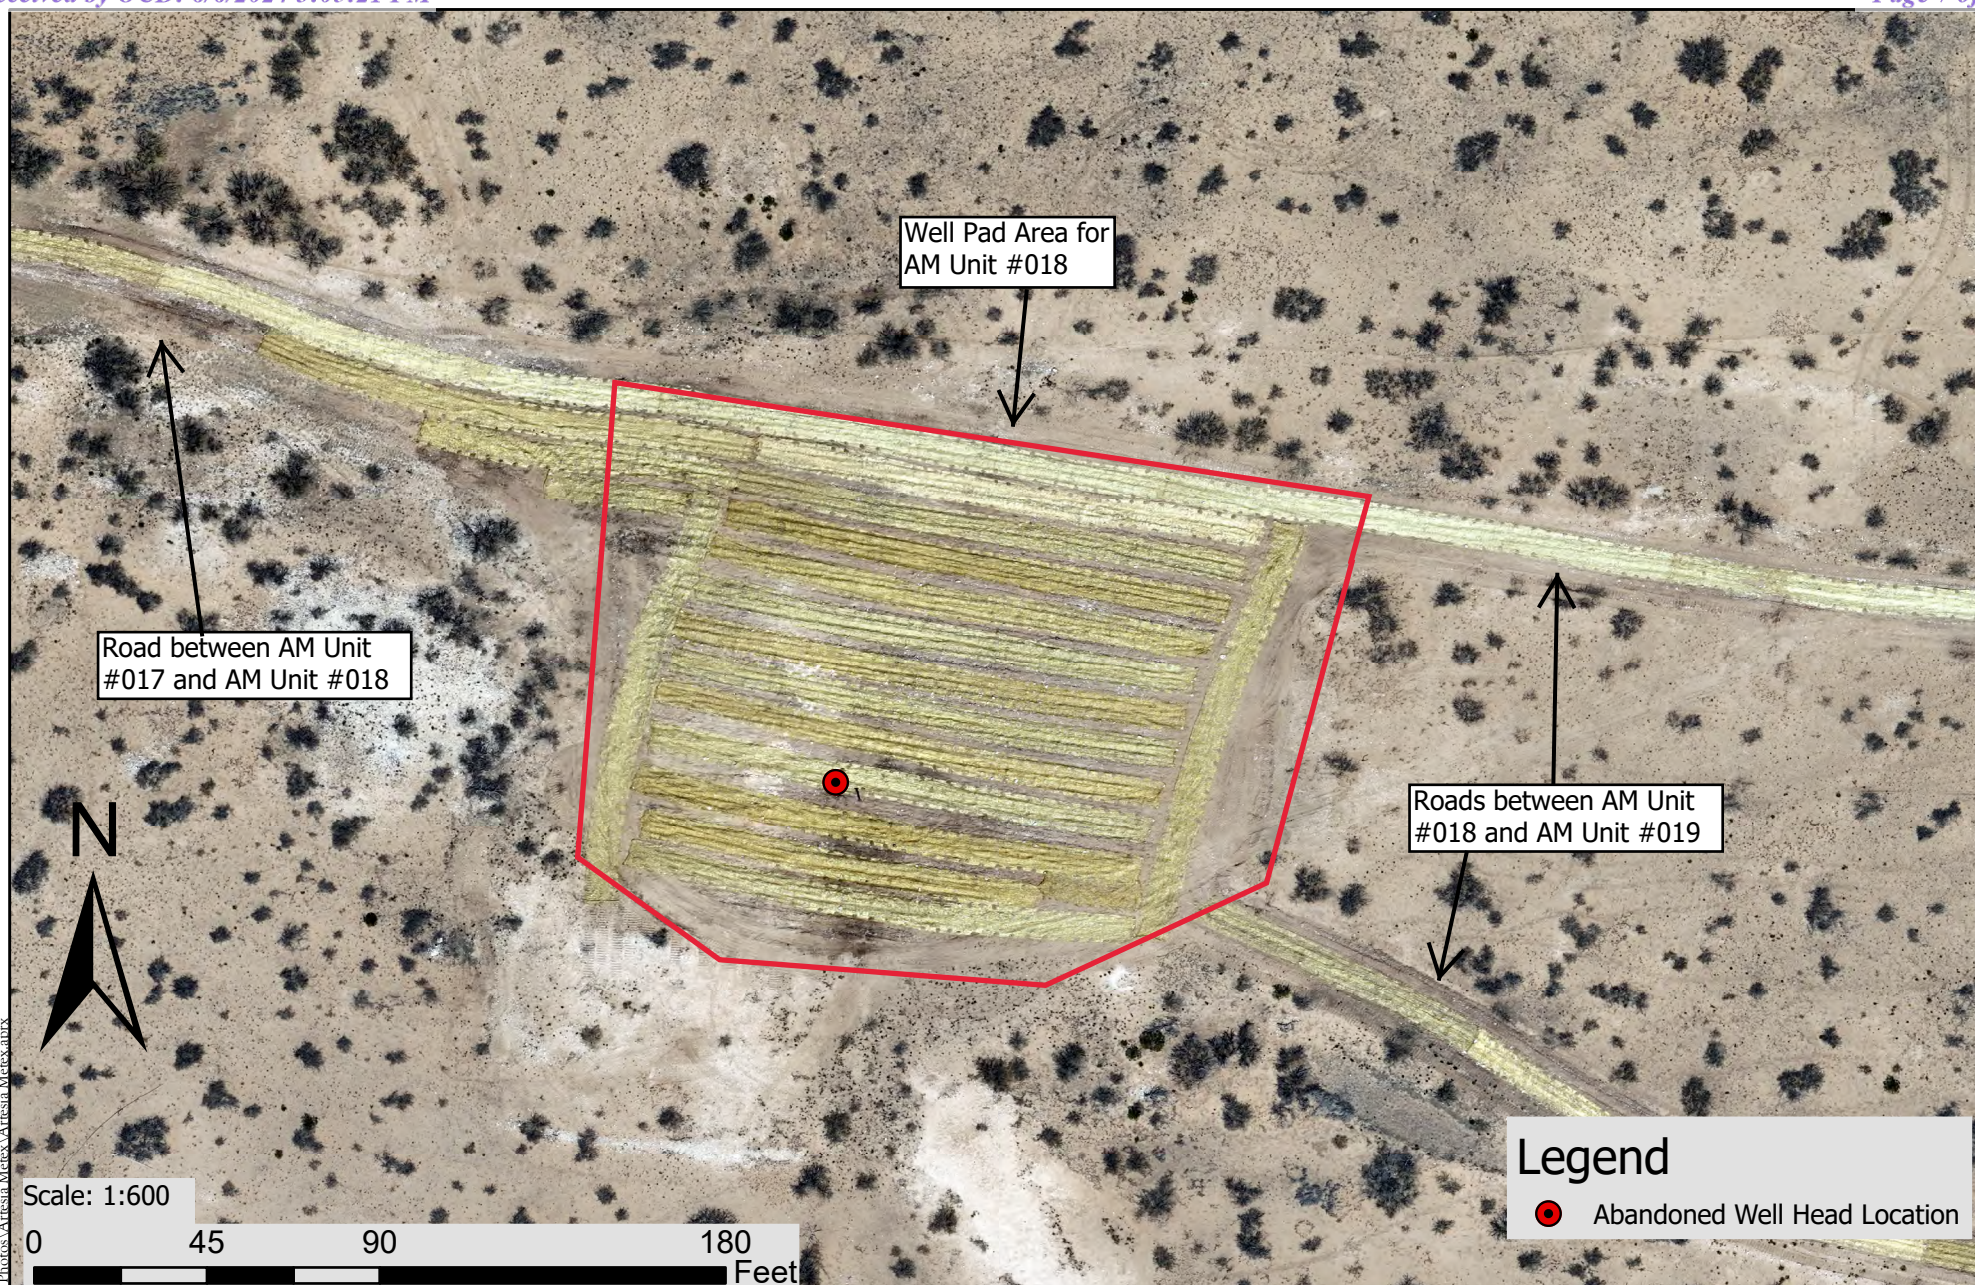
Figure 2

Artesia Metex Unit #018  
Post - Reclamation and Reseeding

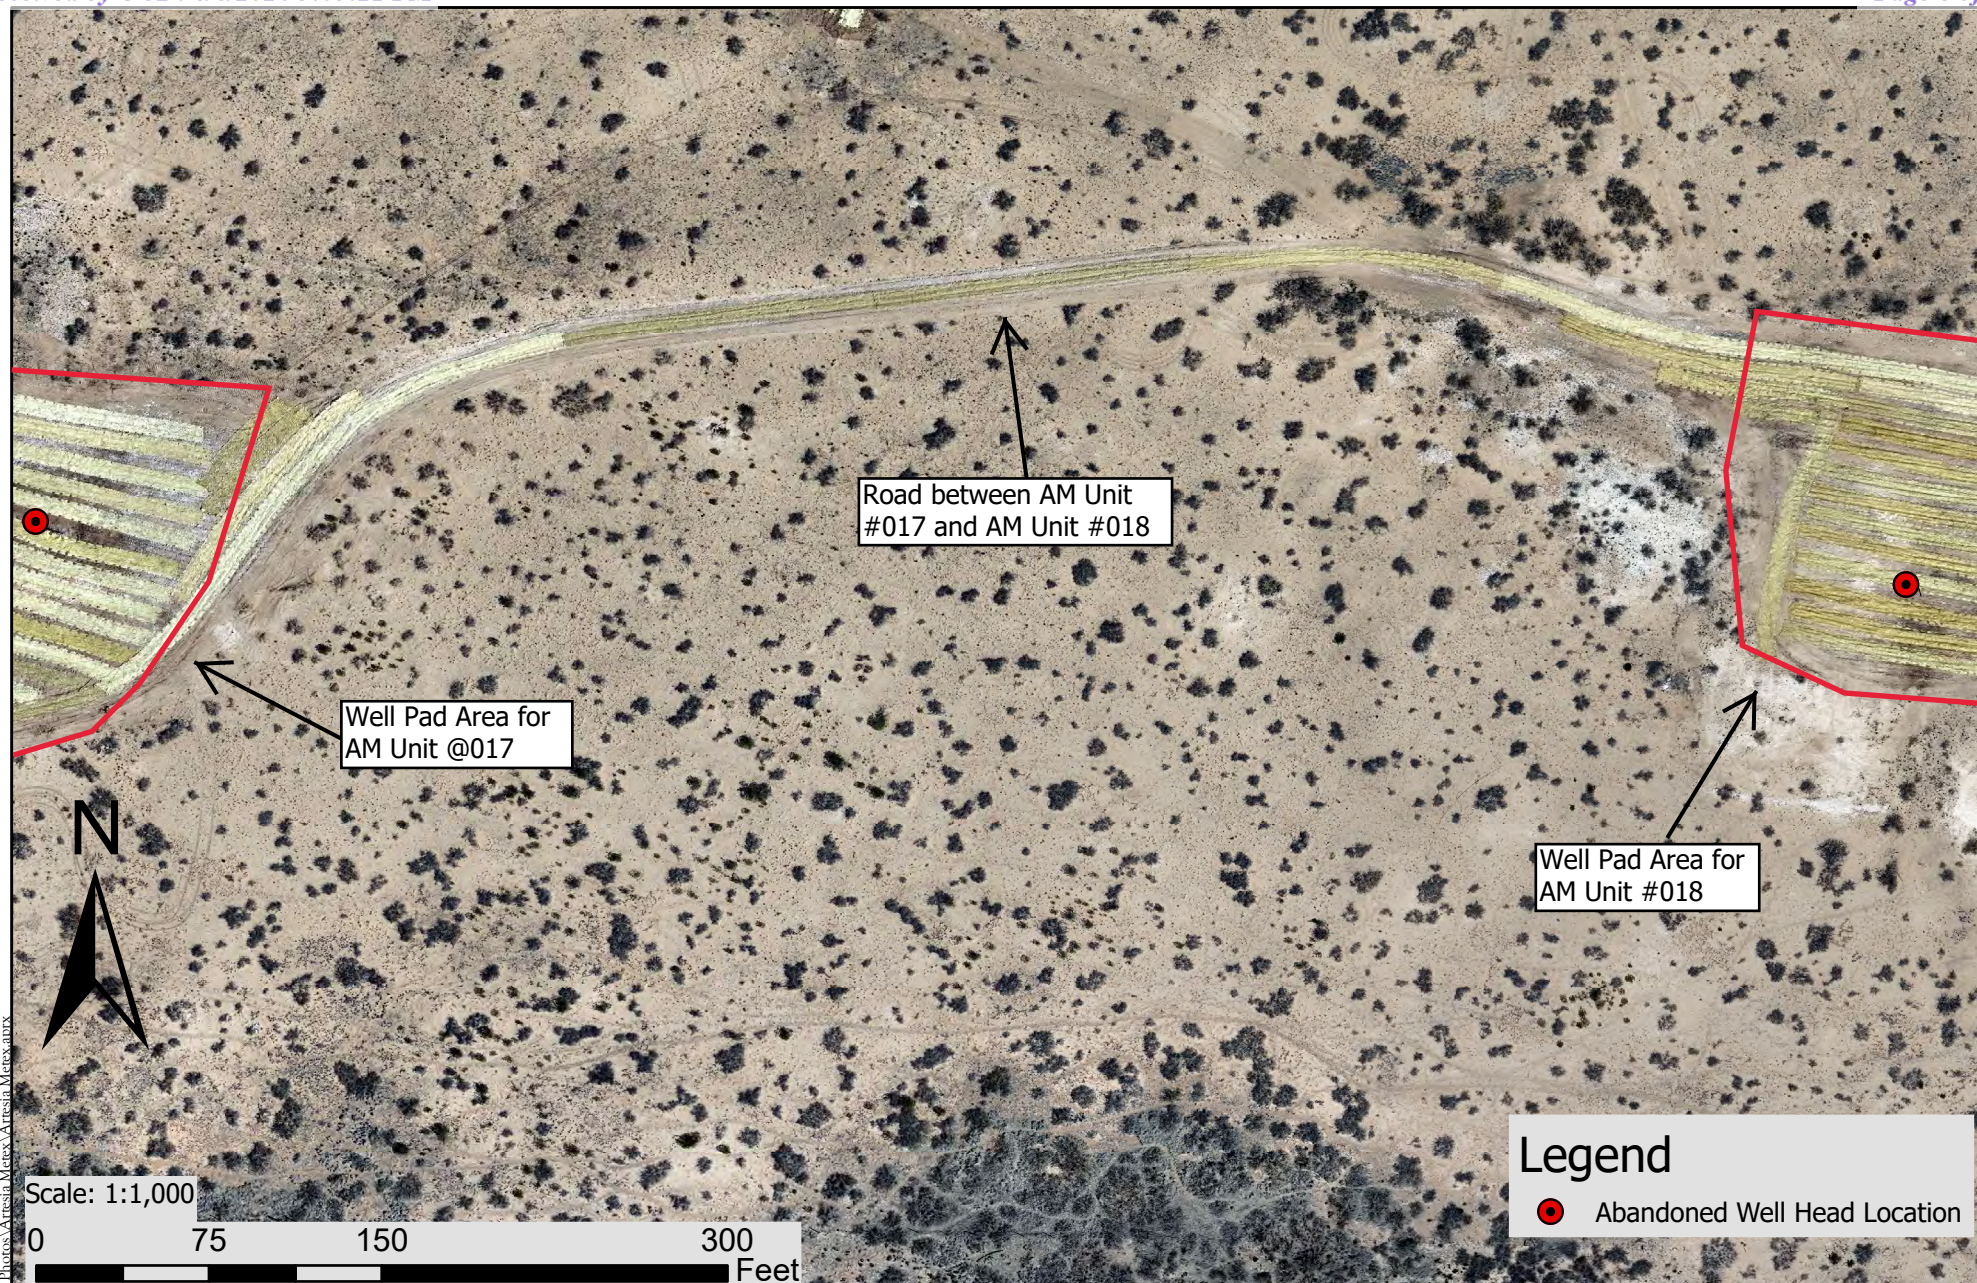
Figure 3

Artesia Metex Unit #017 and  
Artesia Metex Unit #018  
Road Between AM 017 to AM 018  
Post - Reclamation and Reseeding

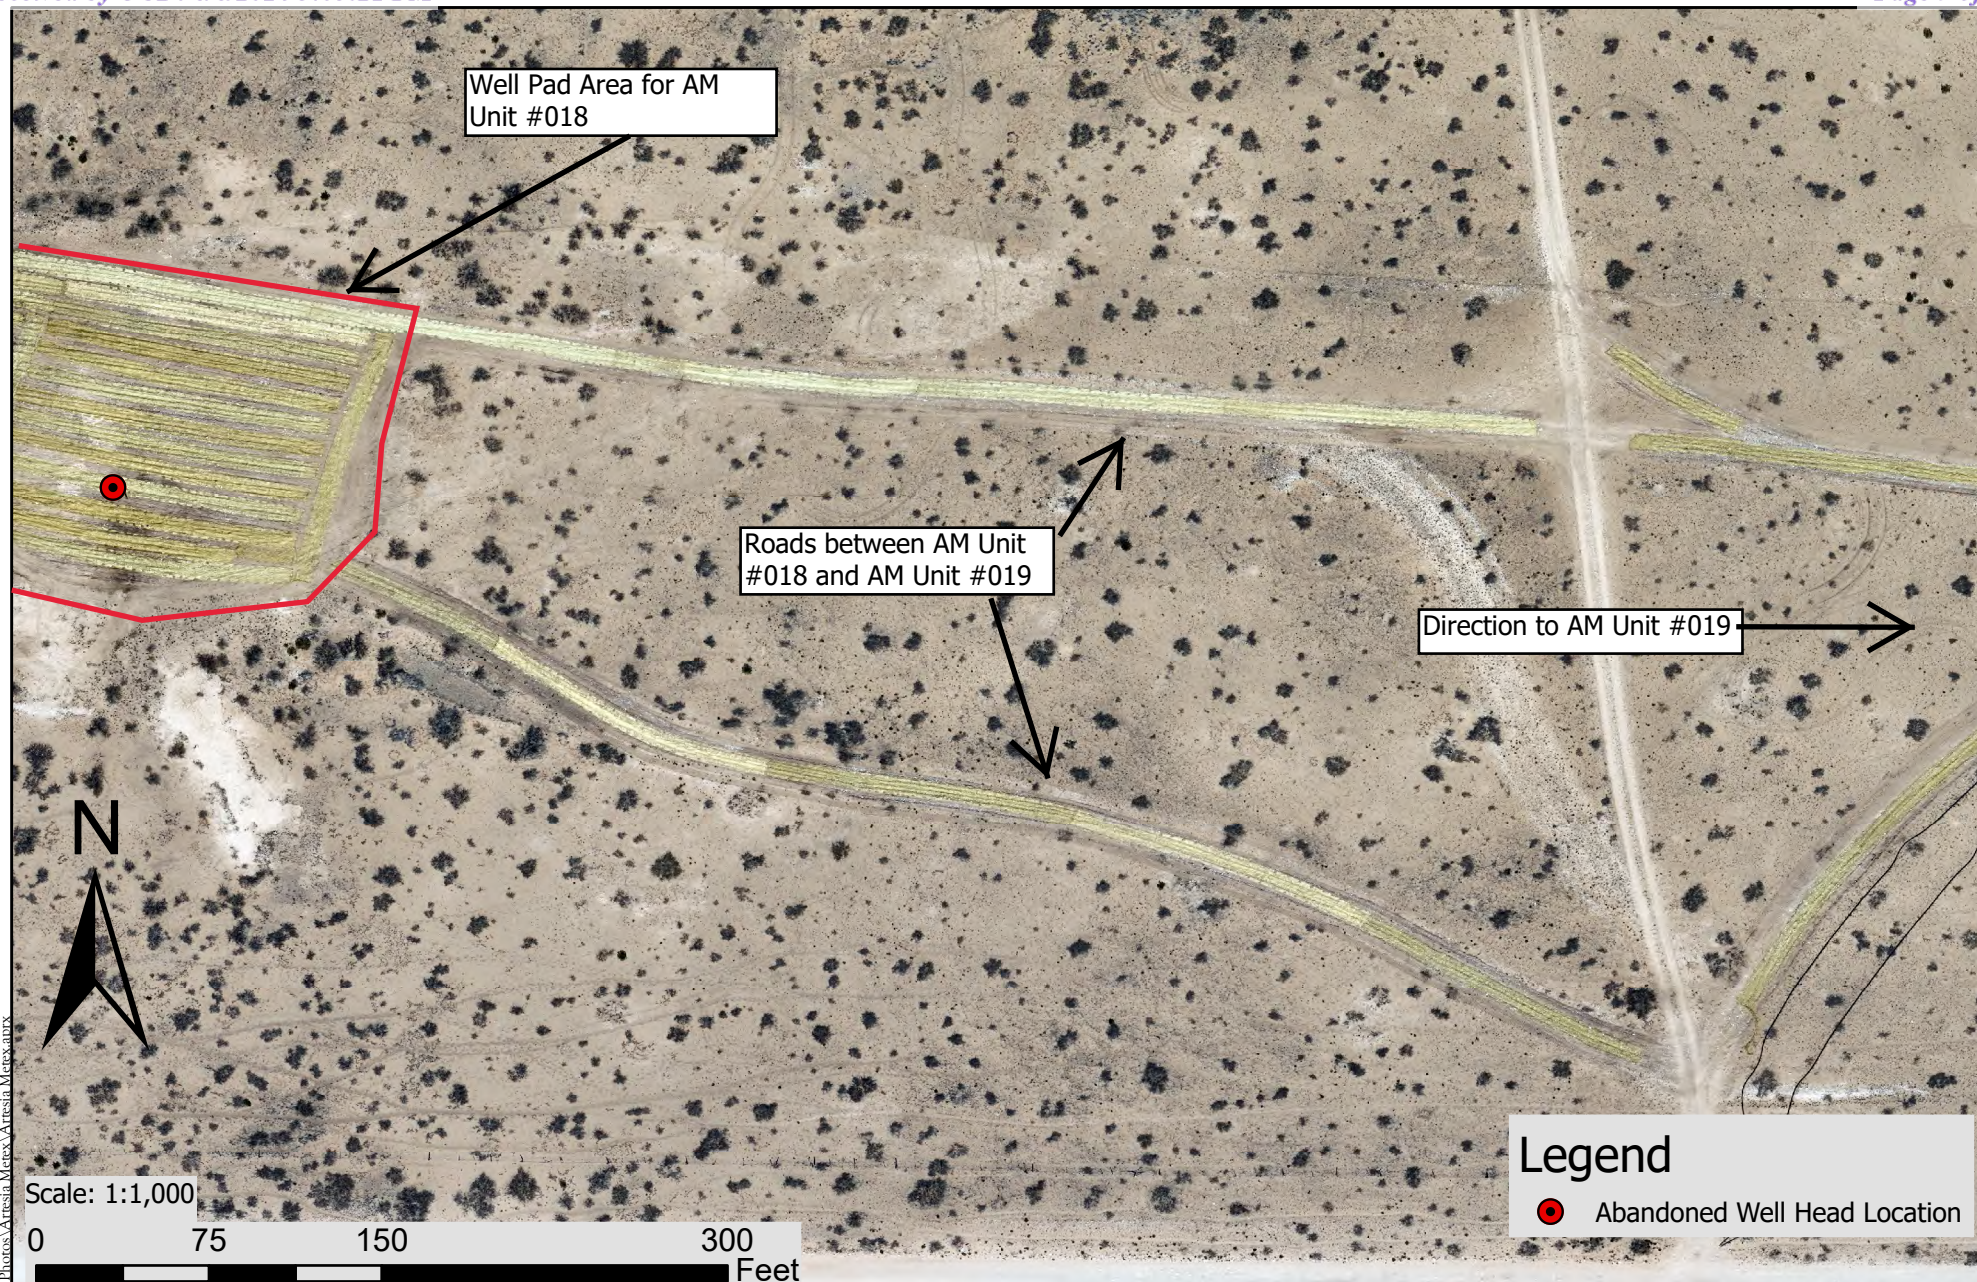
Figure 4

Artesia Metex Unit #018  
Road Between AM 018 to AM 019  
Post - Reclamation and Reseeding

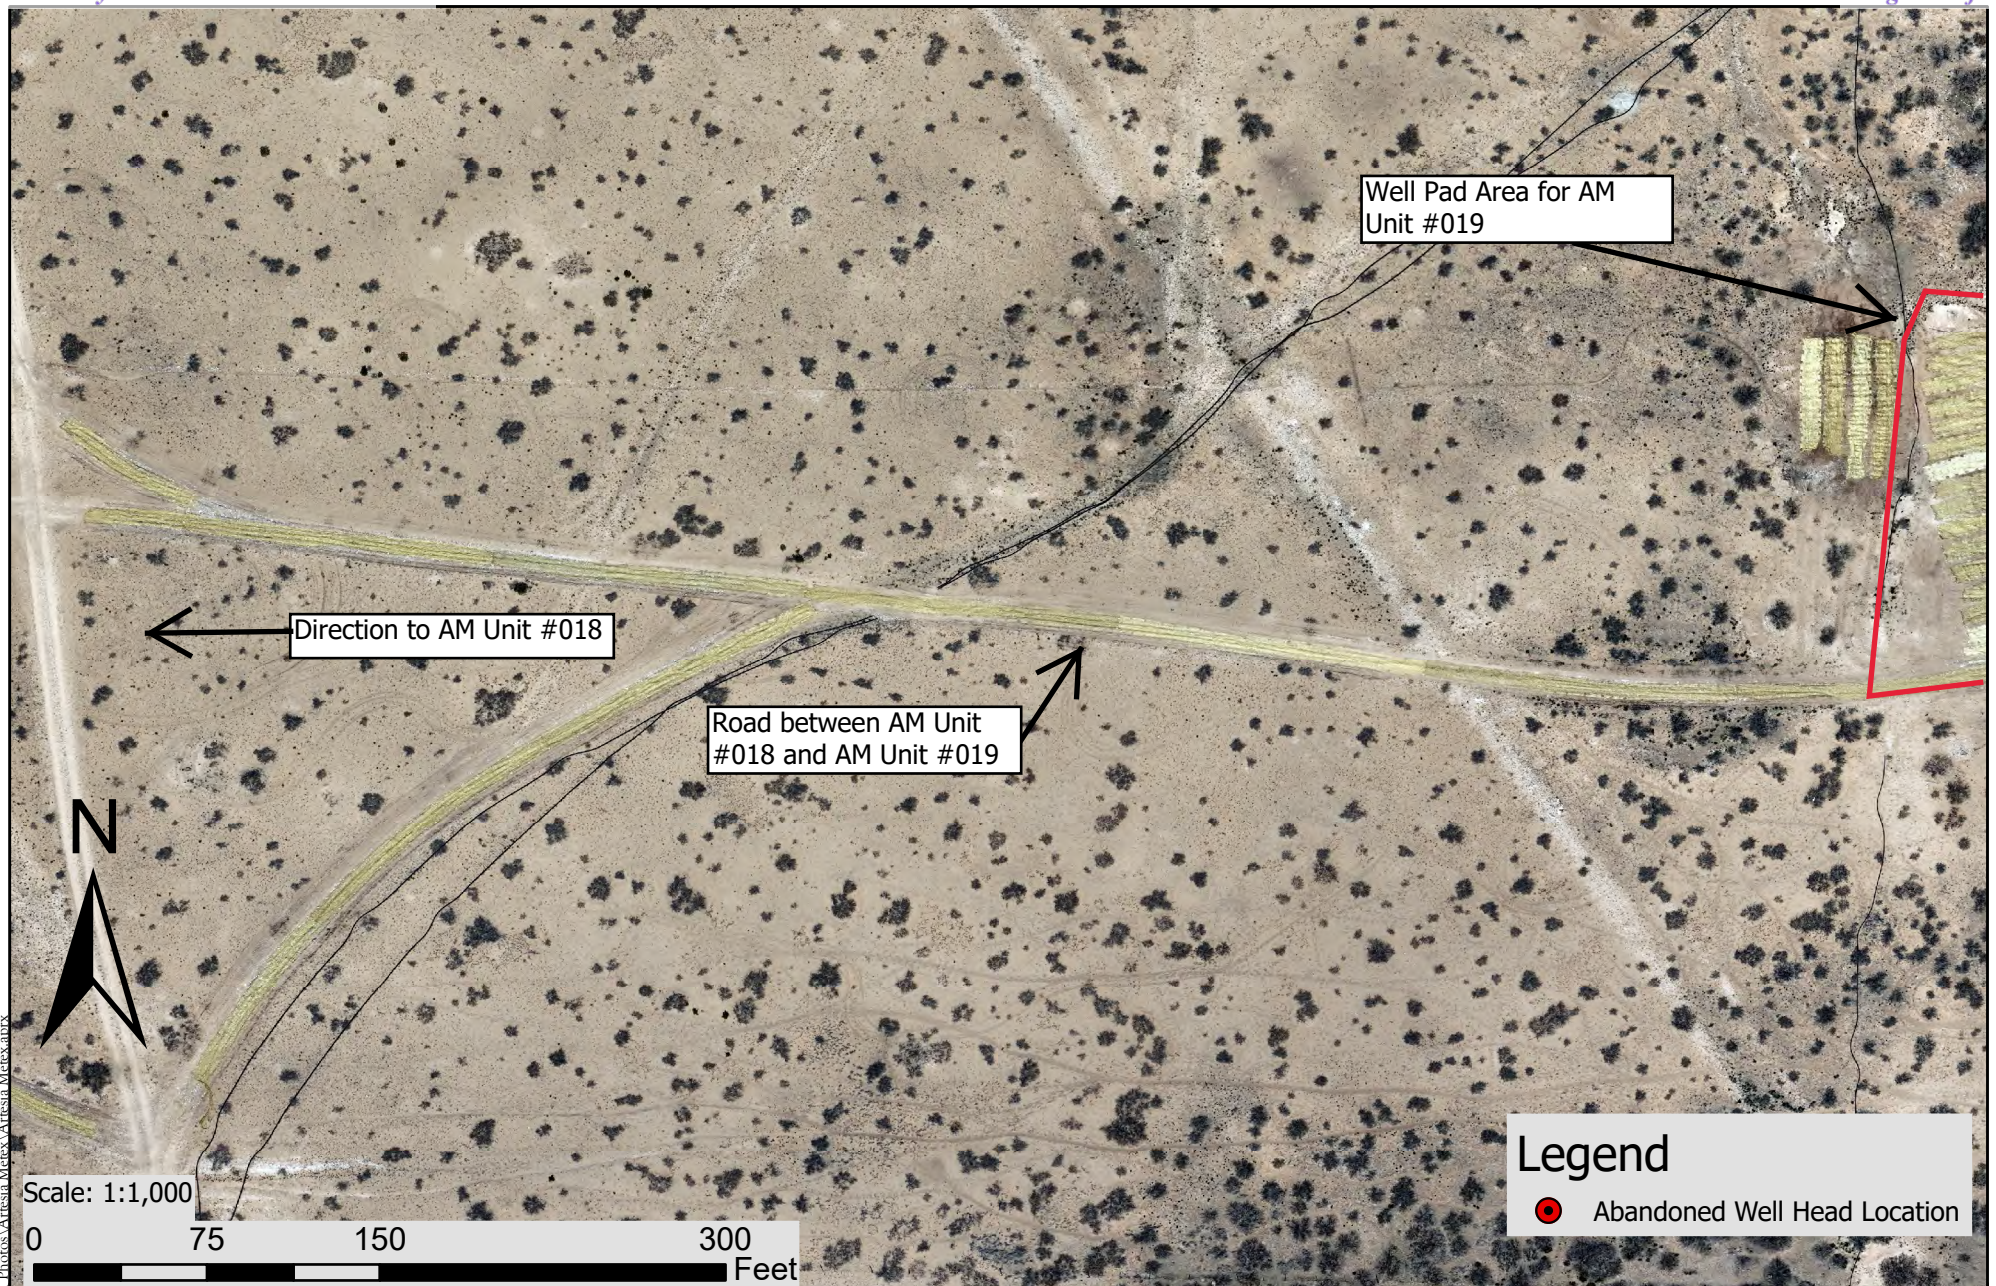
Figure 5

Artesia Metex Unit #019  
 Road Between AM 018 to AM 019  
 Post - Reclamation and Reseeding

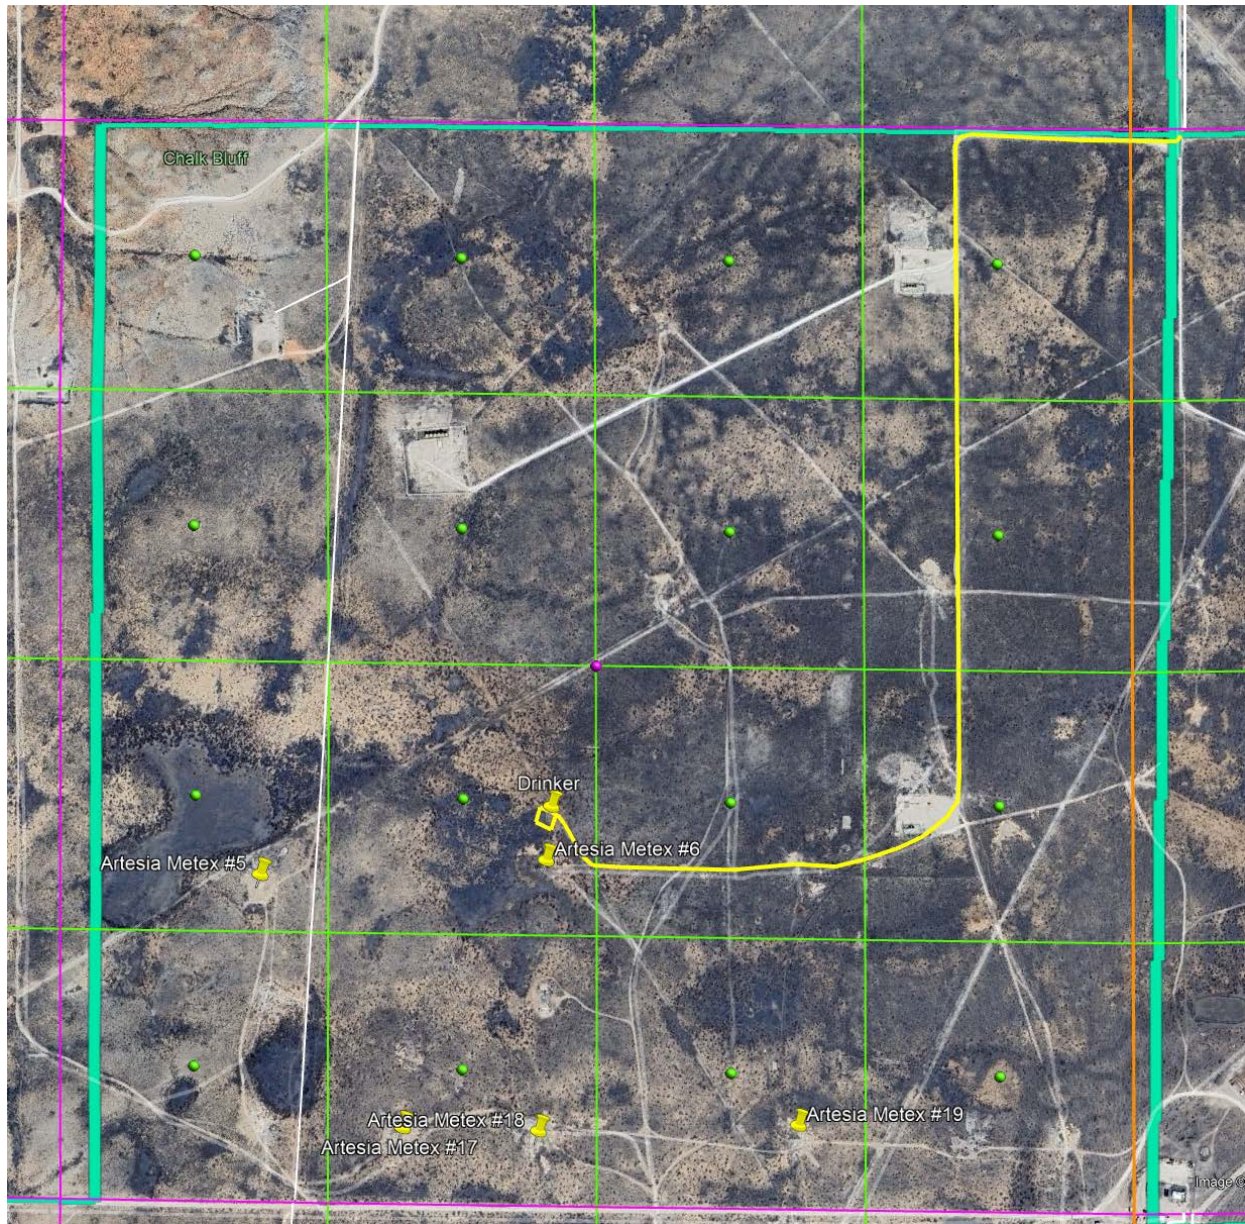
Per the land owner, **DO NOT** disturb the yellow highlighted road below:

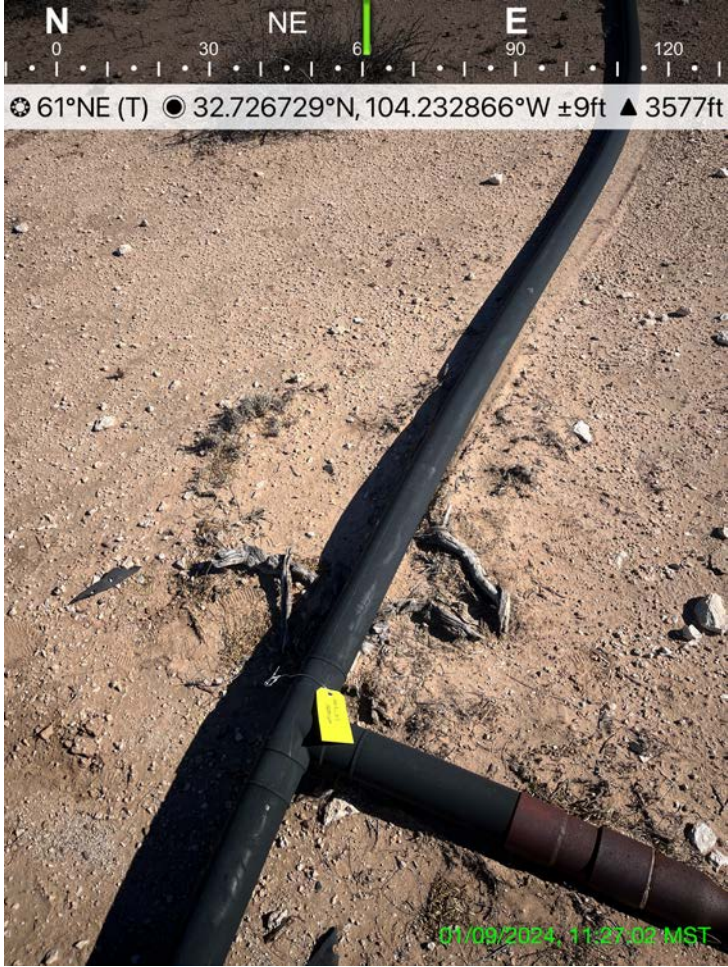
Photograph #12

Client: New Mexico OCD	
Site Name: Artesia Metex Unit #018	
Date Photo Taken: 01.09.2024	
Equipment Location: 32.726729N -104.232866W  S: 24 T: 18S R: 27E Eddy County, New Mexico	
Photo Taken by: Sarahmay Schlea	Description: Unit #018 debris, polyline T-junction with metal piping, NORM = 1500 cpm.

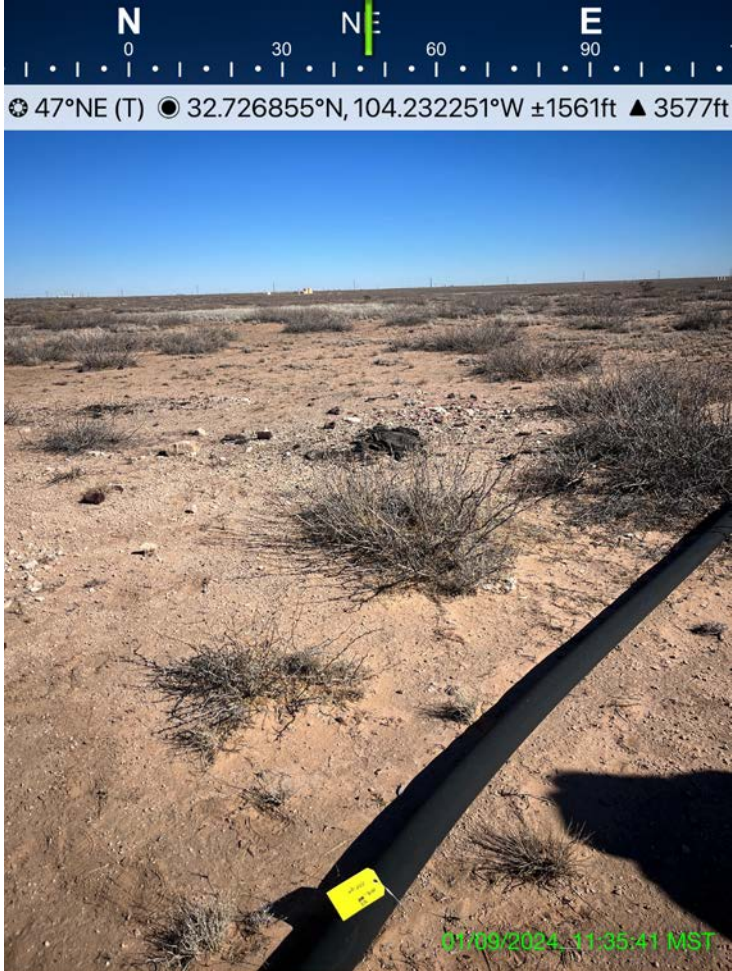
Photograph #13

Client: New Mexico OCD	
Site Name: Artesia Metex Unit #018	
Date Photo Taken: 01.09.2024	
Equipment Location: 32.726855N -104.232251W  S: 24 T: 18S R: 27E Eddy County, New Mexico	
Photo Taken by: Sarahmay Schlea	Description: Unit #018 debris, polyline, NORM = 1500 cpm.

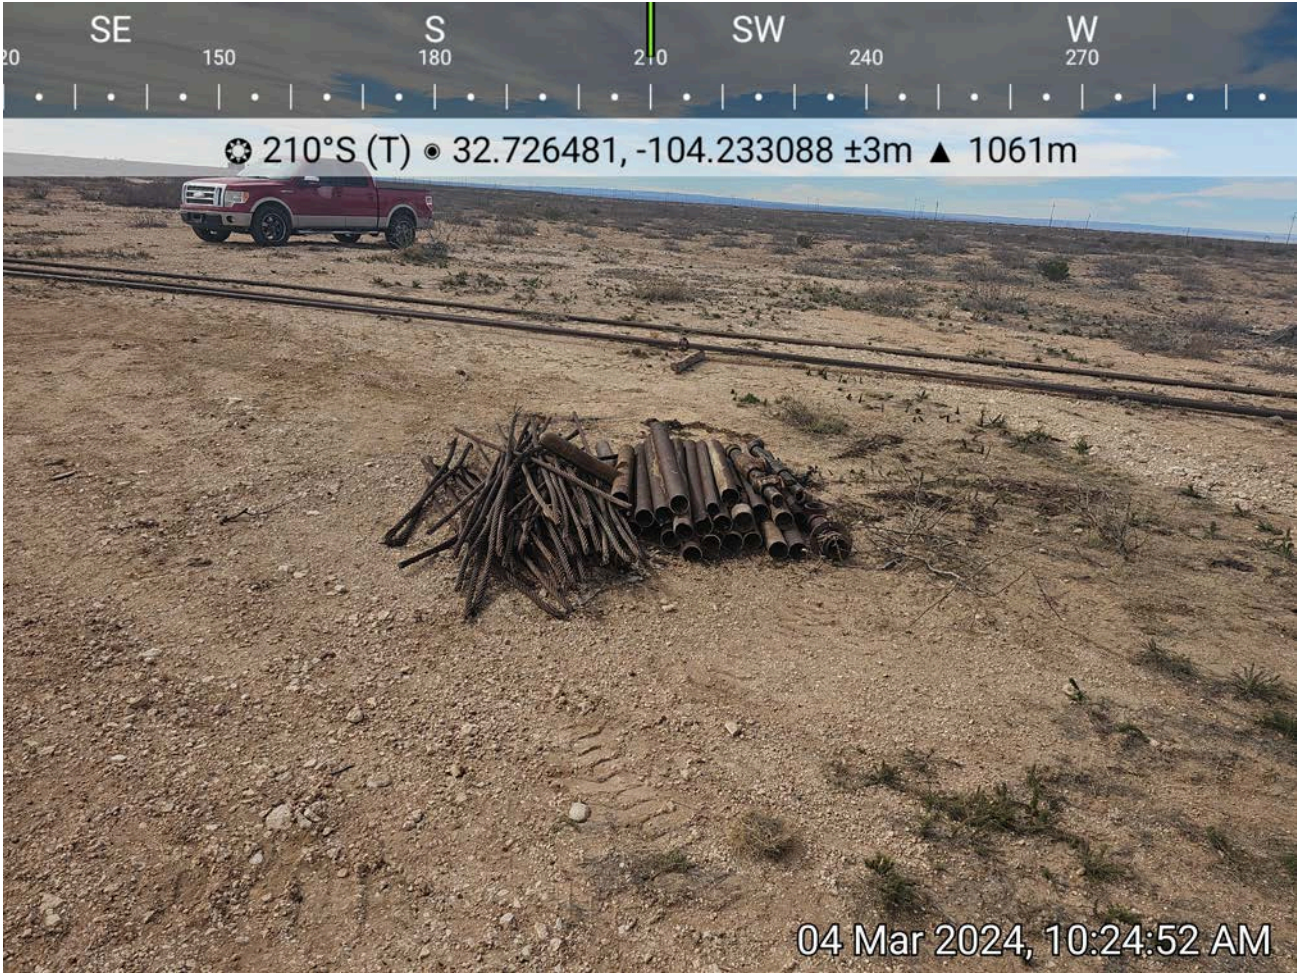
Photograph #23

Client: New Mexico OCD	
Site Name: Artesia Metex Unit #018	
Date Photo Taken: 03.04.2024	
Site Location: 32.72646N -104.23312W  S: 24 T: 18S R: 27E Eddy County, New Mexico	
Photo Taken by: Georgeann Goodman	Description: Cutting of metal piping gathered at AM Unit #018.

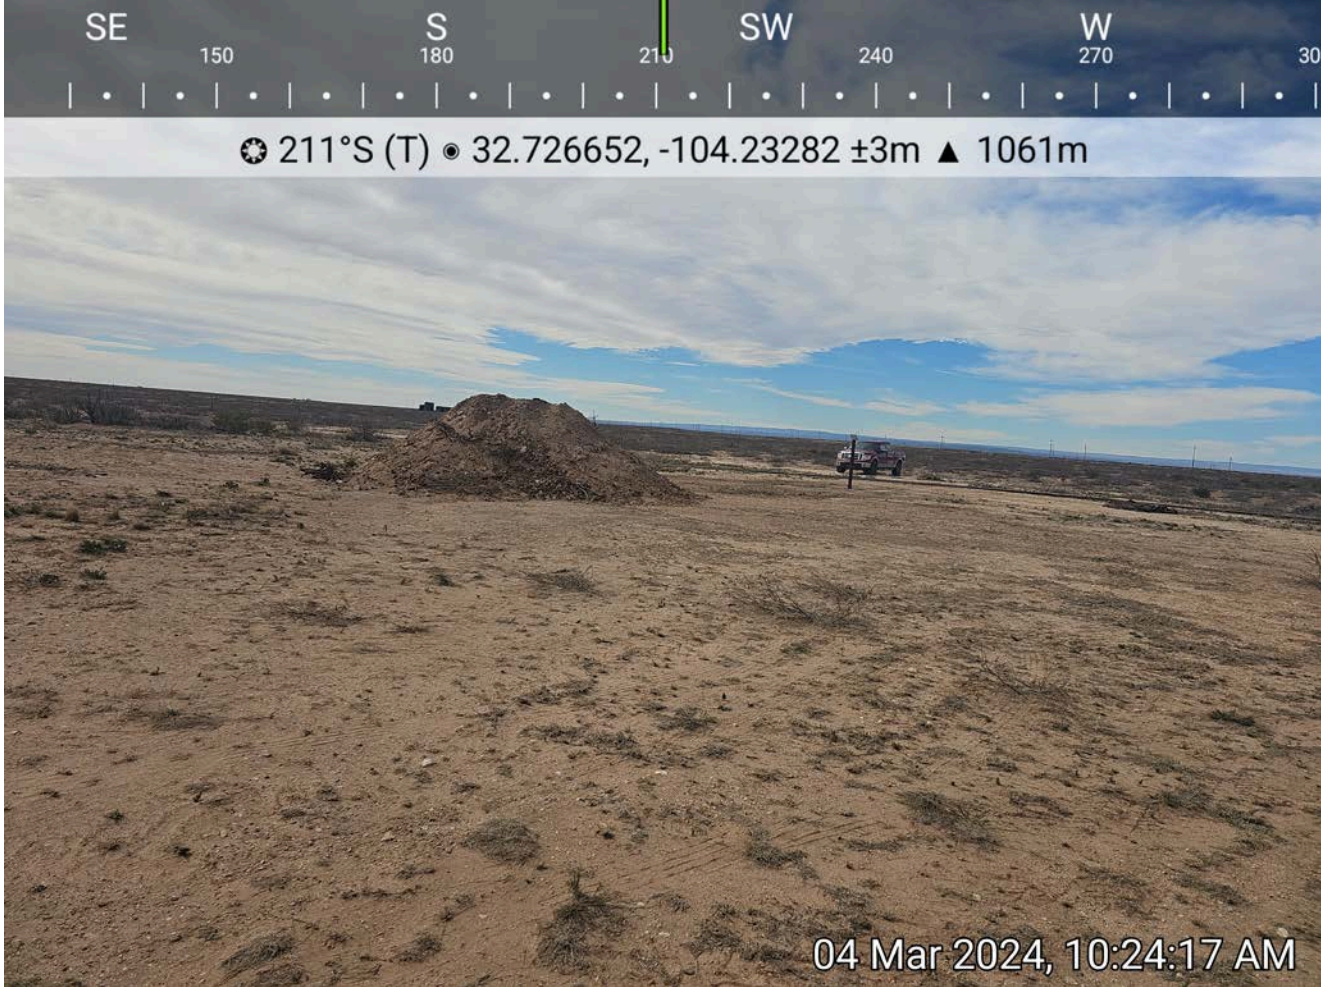
Photograph #25

Client: New Mexico OCD	
Site Name: Artesia Metex Unit #018	
Date Photo Taken: 03.04.2024	
Site Location: 32.72646N -104.23312W  S: 24 T: 18S R: 27E Eddy County, New Mexico	
Photo Taken by: Georgeann Goodman	Description: Surface scraping of operational staining stockpiled on wellpad.
