May 6, 2024

SUBJECT: Reclamation Report for the Artesia Metex Unit #019, Eddy County, New Mexico

Artesia Metex Unit #019 Reclamation Report

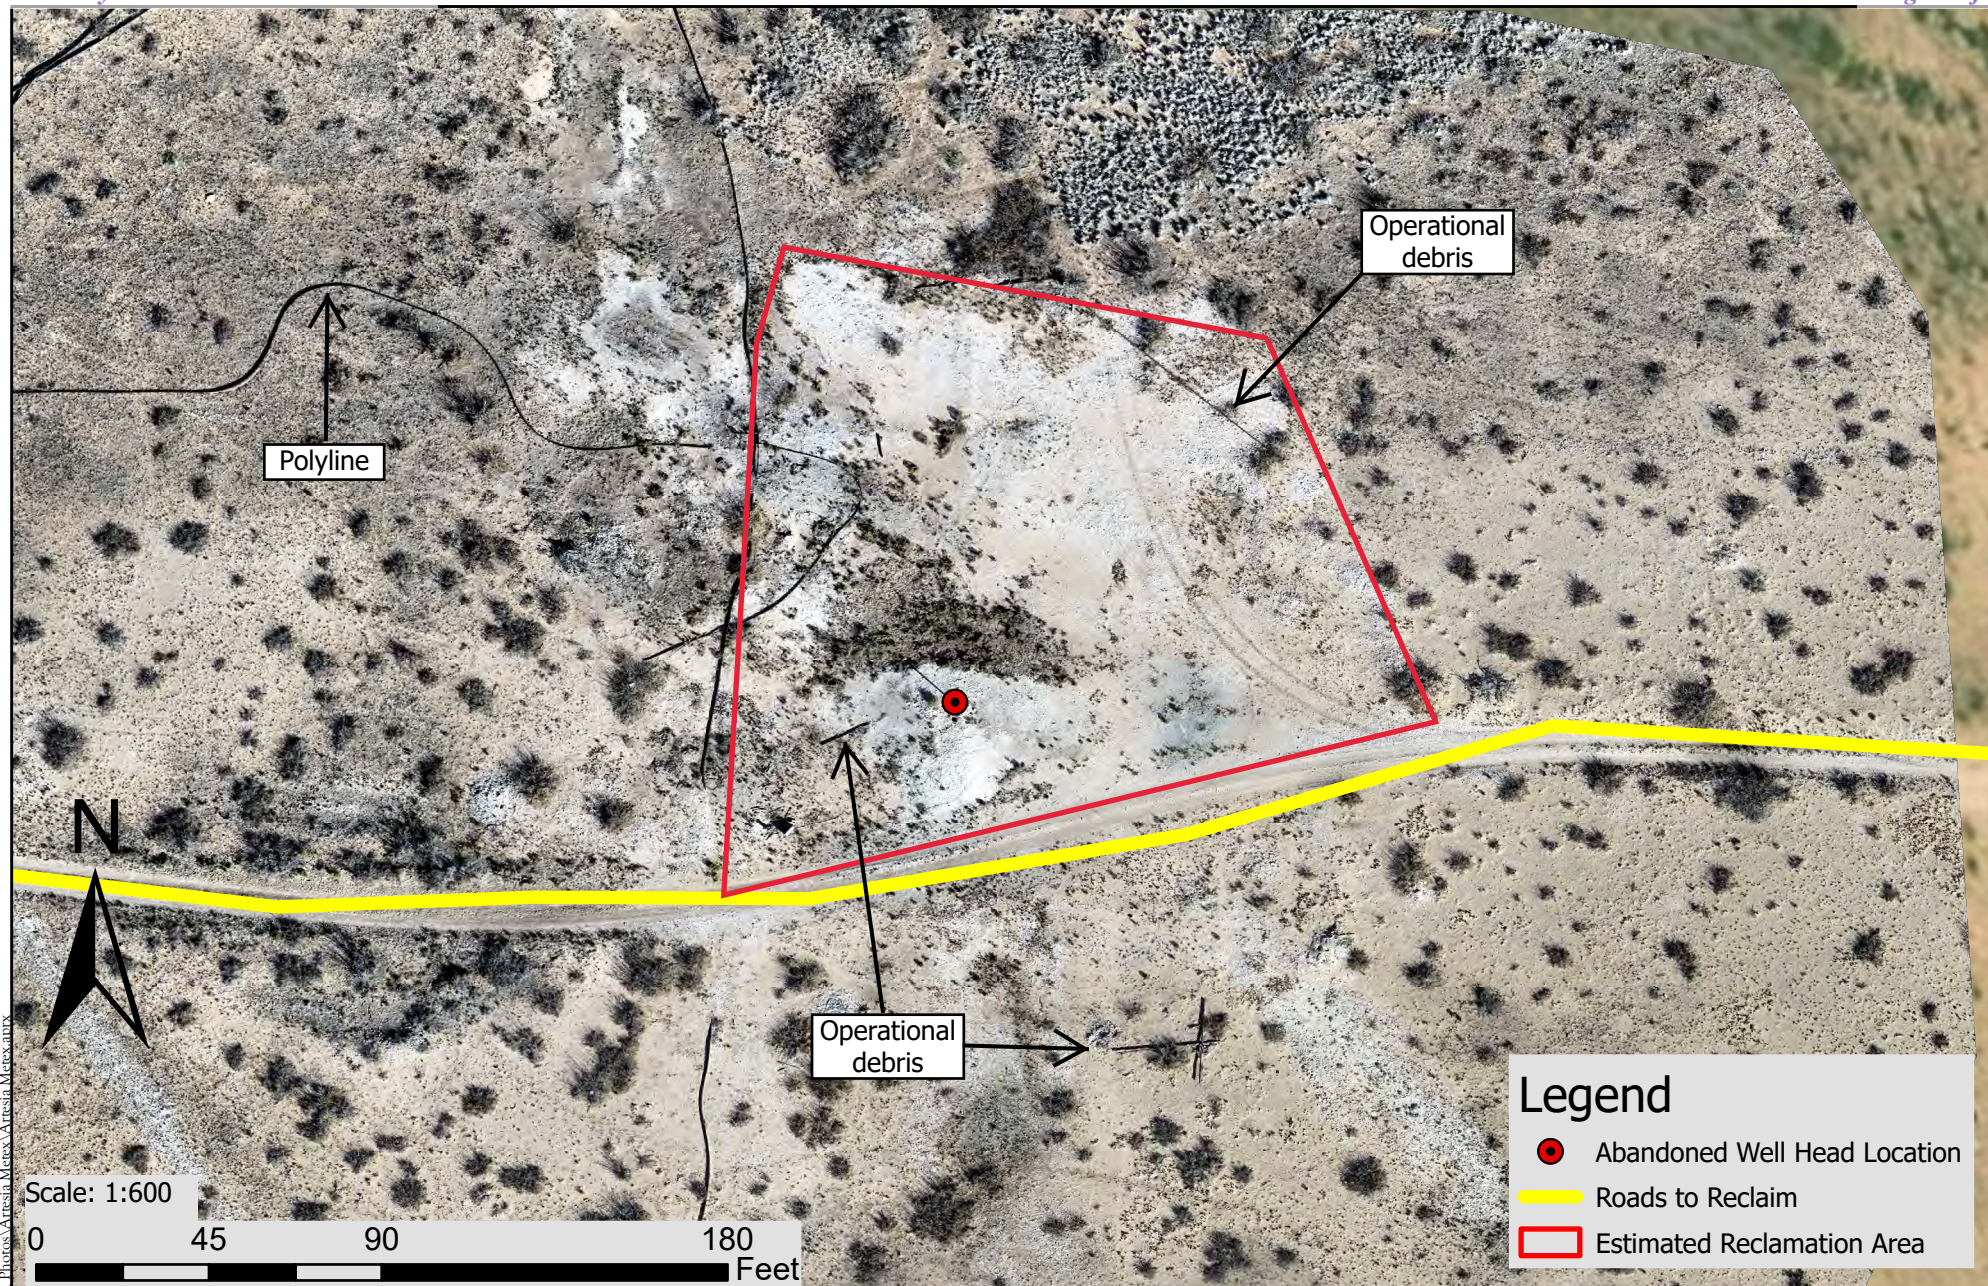
Figure 1

Artesia Metex Unit #019
 Pre-Reclamation and Reseeding

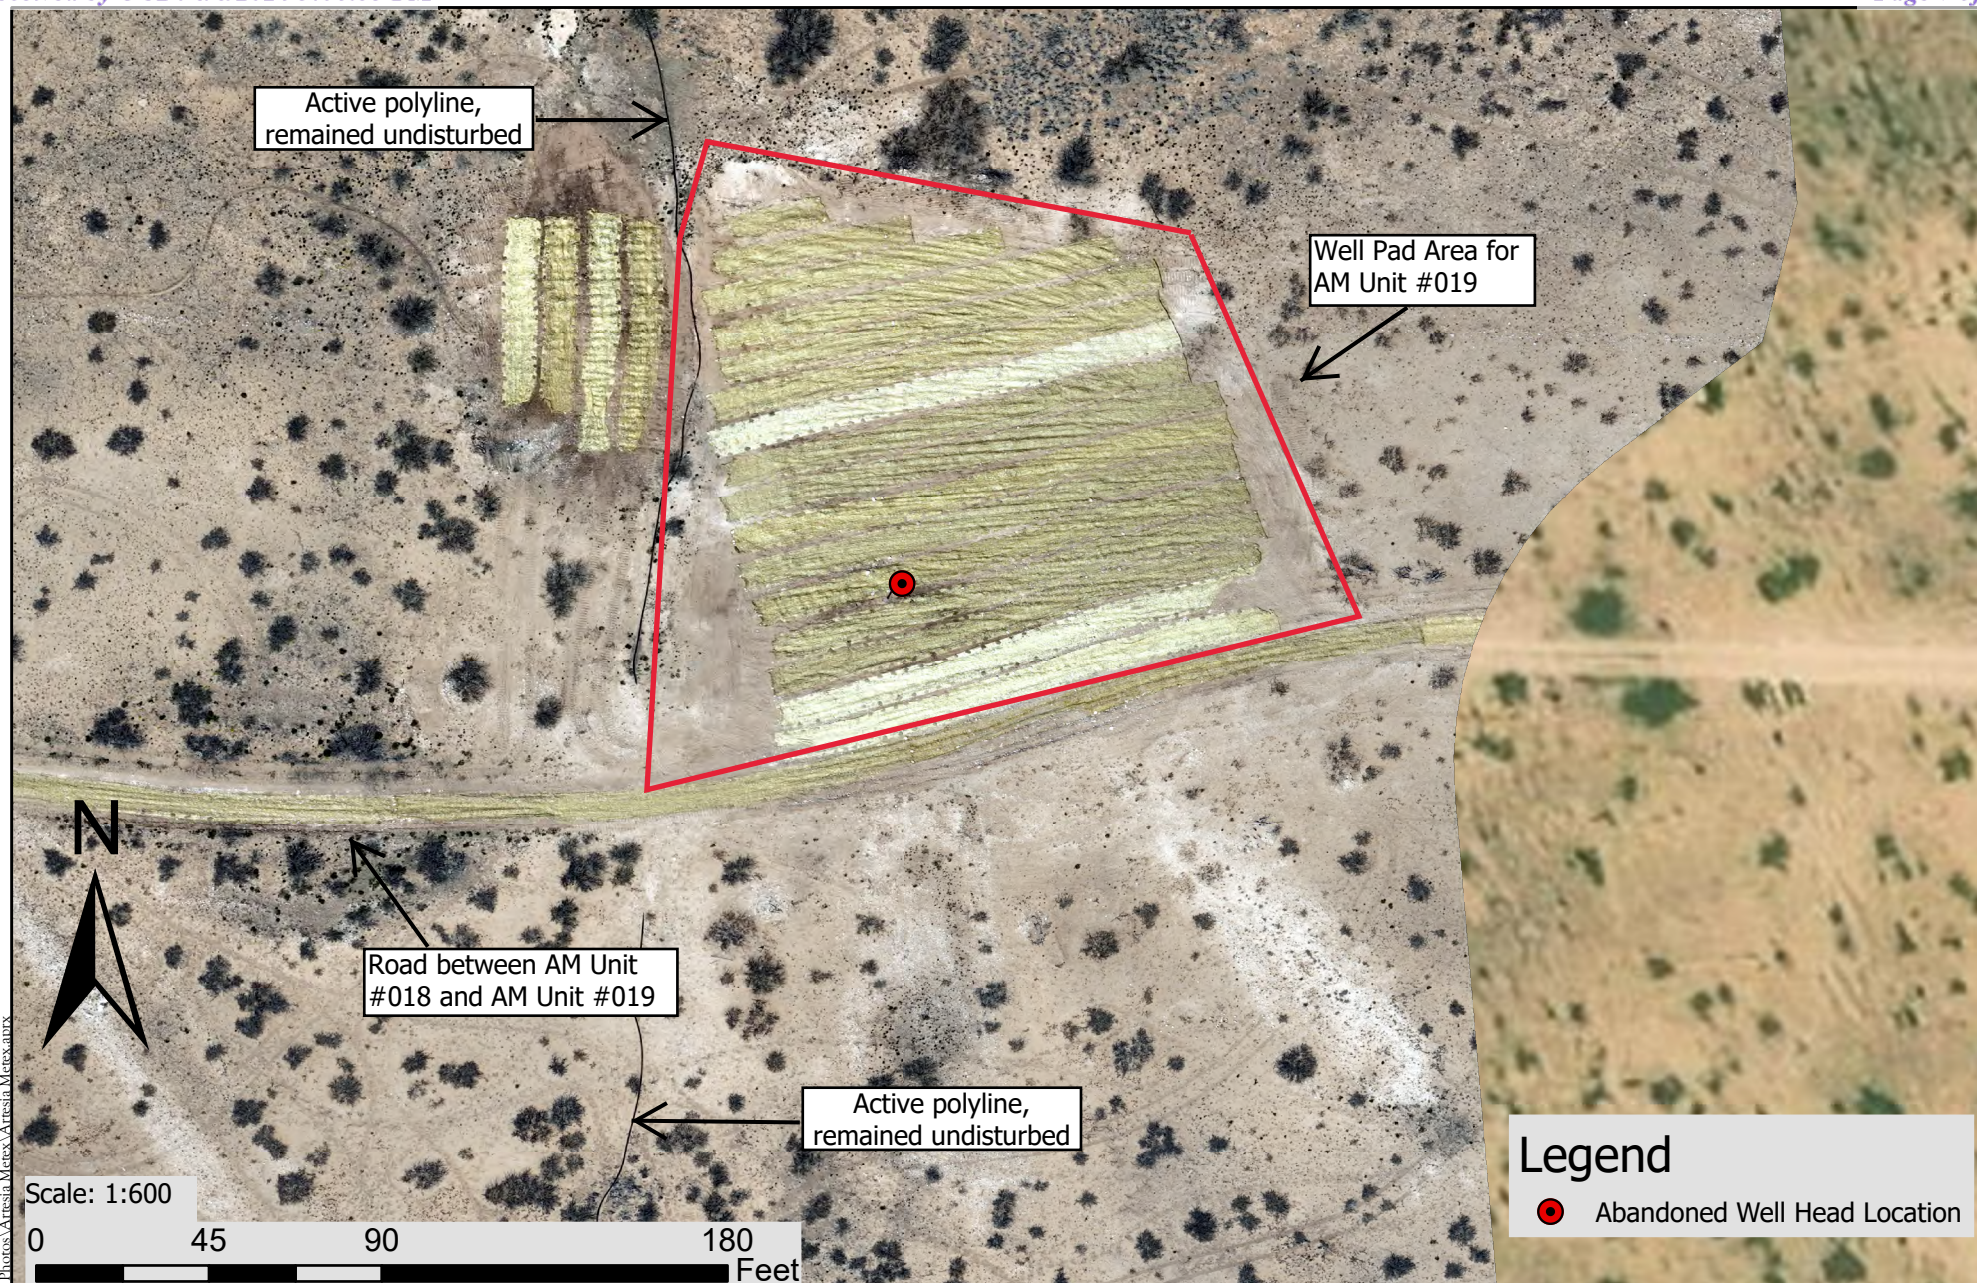
Figure 2

Artesia Metex Unit #019
Post - Reclamation and Reseeding

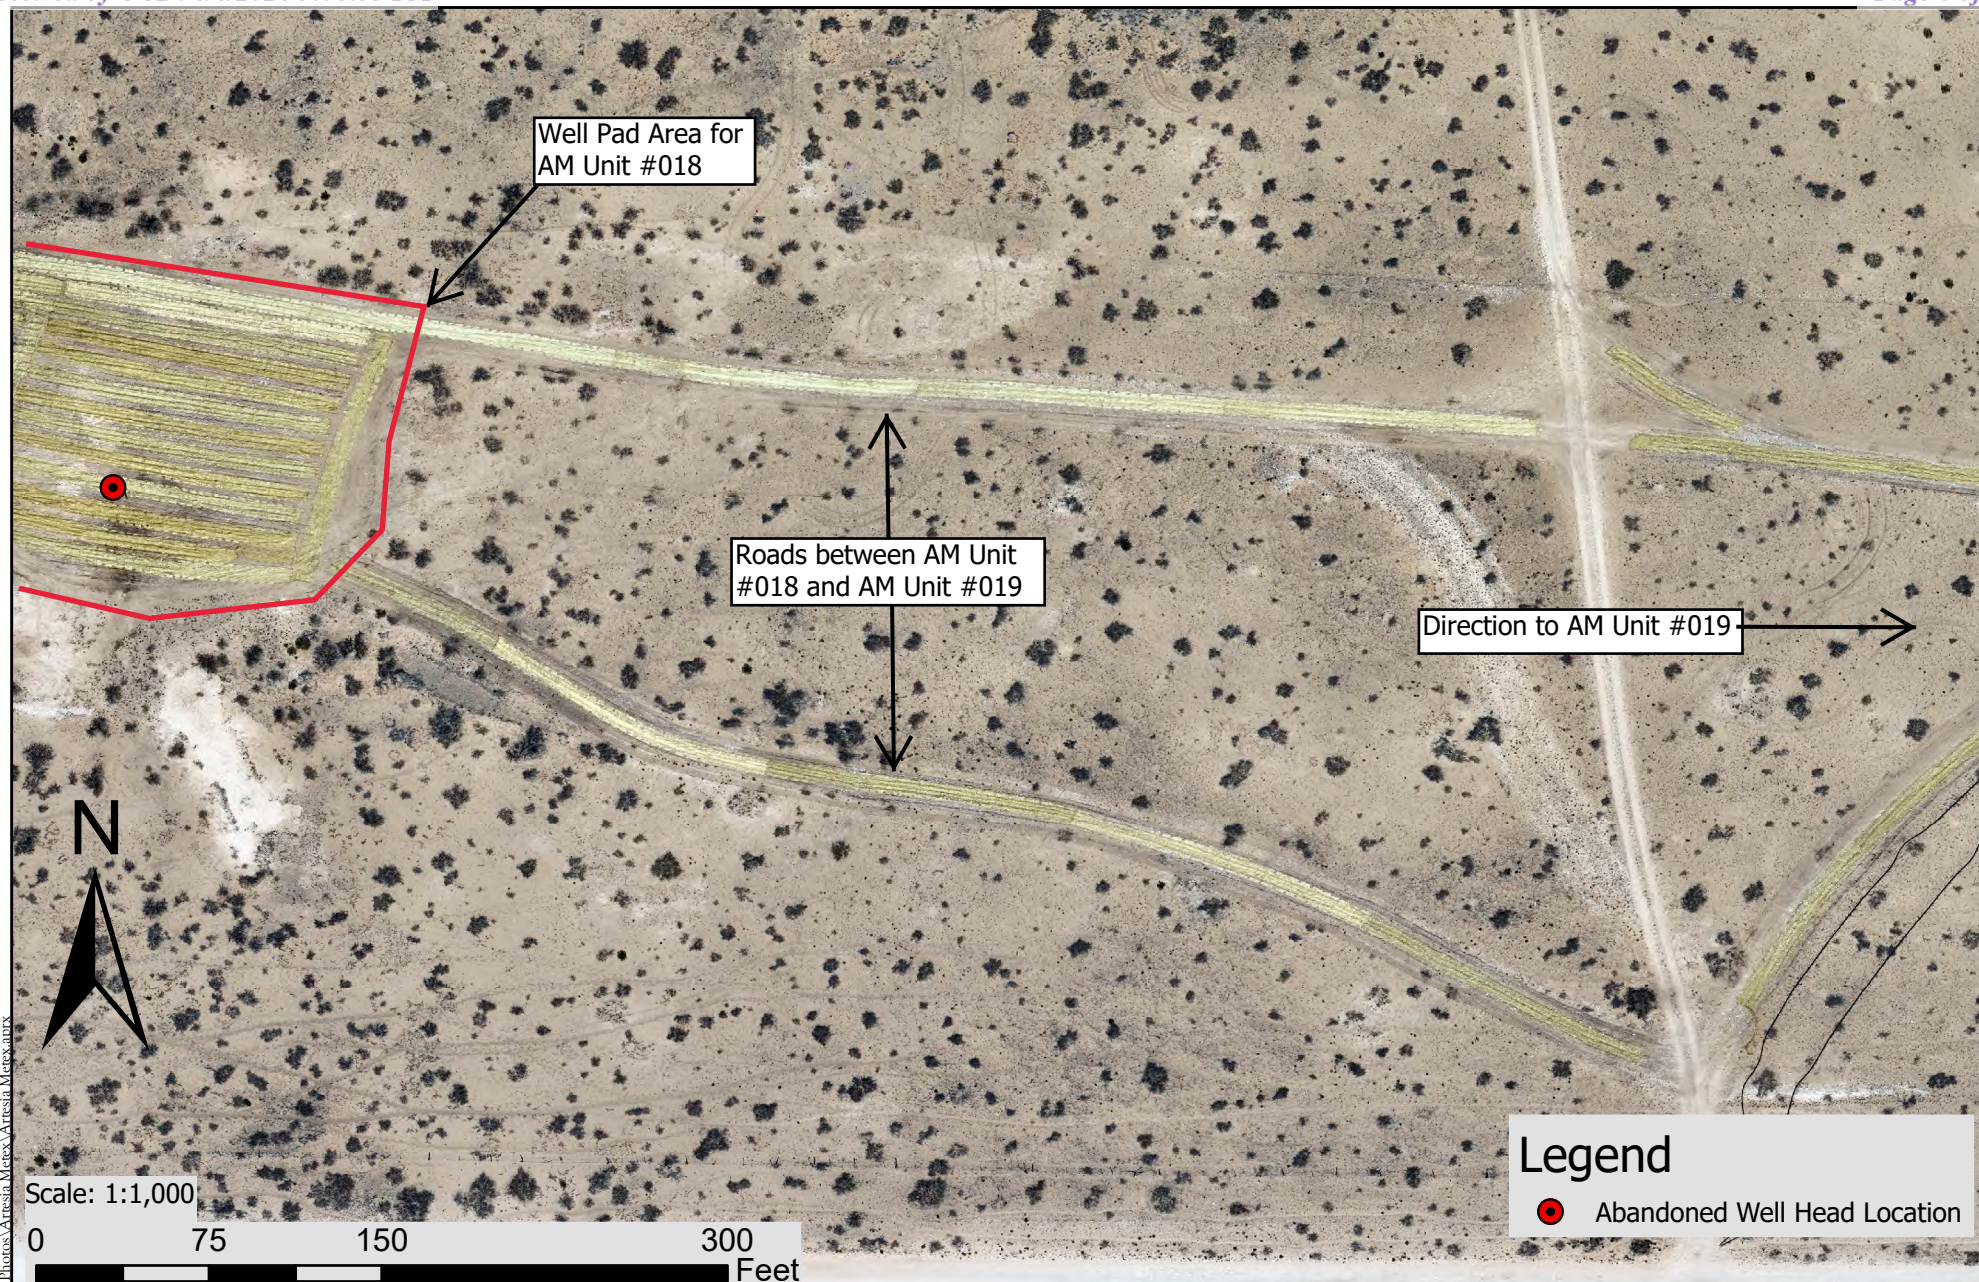
Figure 3

Artesia Metex Unit #018
Road Between AM 018 to AM 019
Post - Reclamation and Reseeding

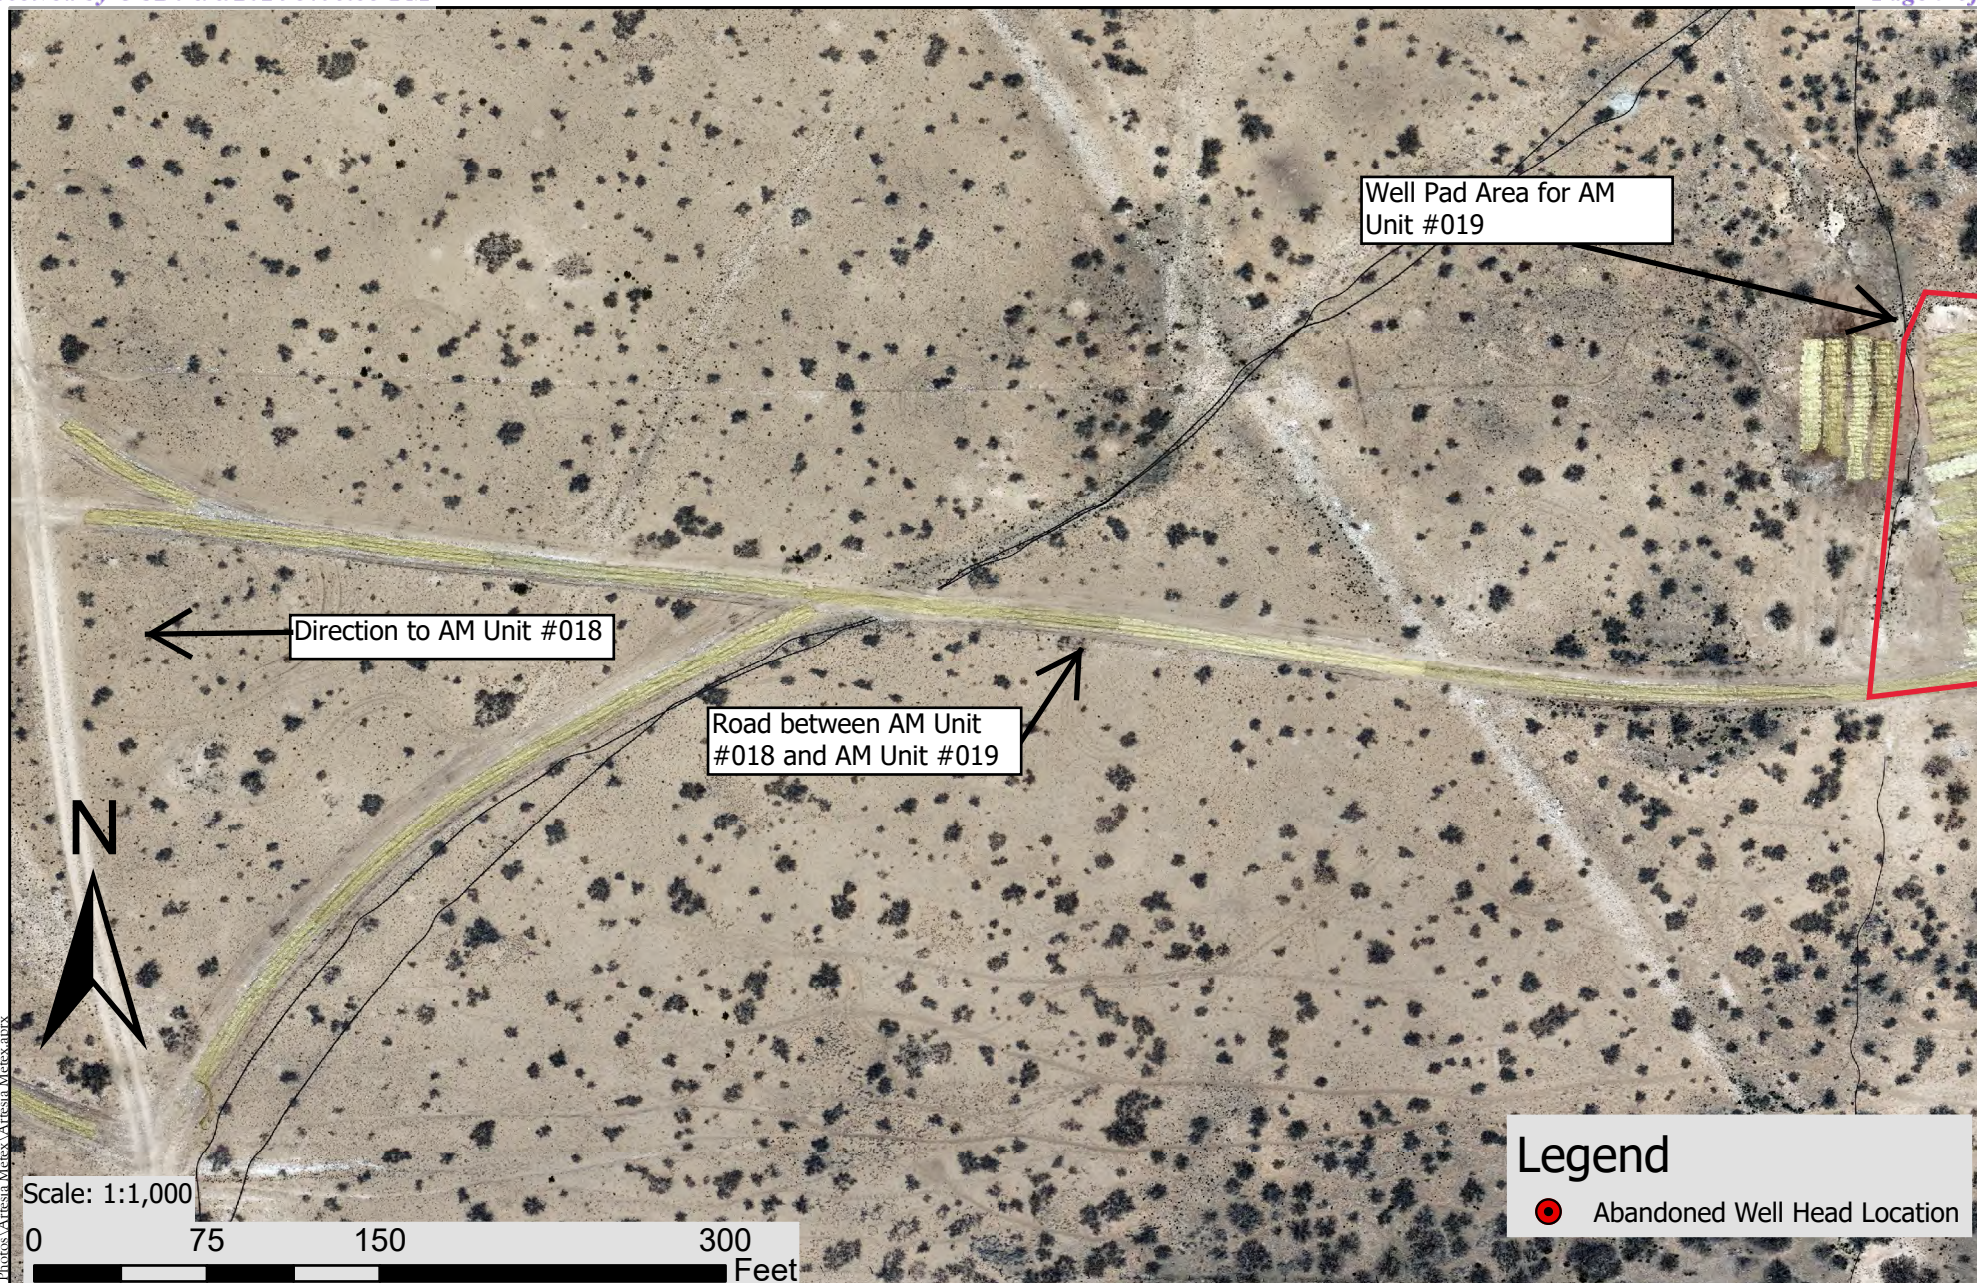
Figure 4

Artesia Metex Unit #019
Road Between AM 018 to AM 019
Post - Reclamation and Reseeding

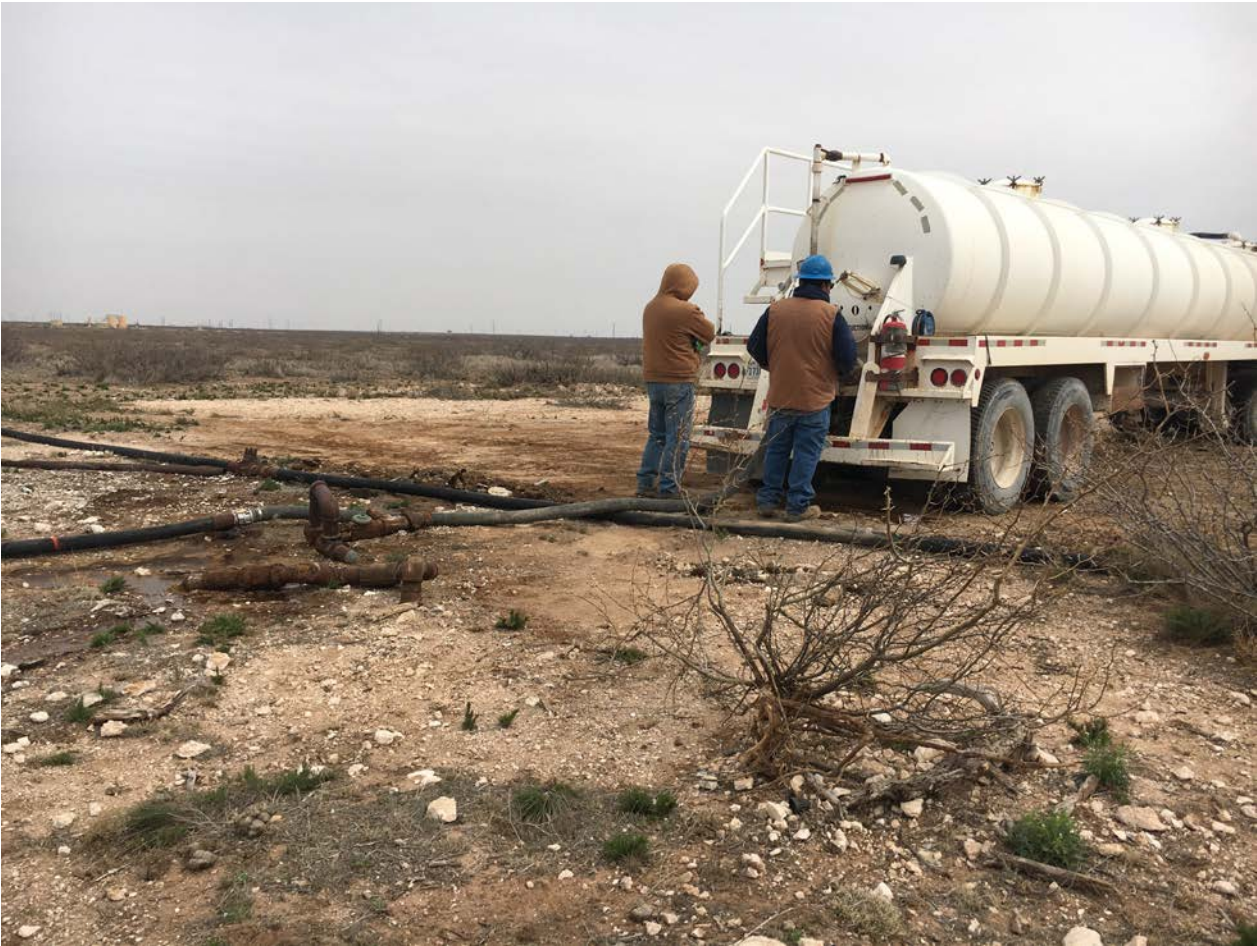
Photograph #20

Client: New Mexico OCD	
Site Name: Artesia Metex Unit #019	
Date Photo Taken: 02.28.2024	
Site Location: 32.72641N -104.22887W S: 24 T: 18S R: 27E Eddy County, New Mexico	
Photo Taken by: Stephanie Hinds	Description: Polyline flushing connection to the freshwater truck. Freshwater truck was staged at Unit #019.

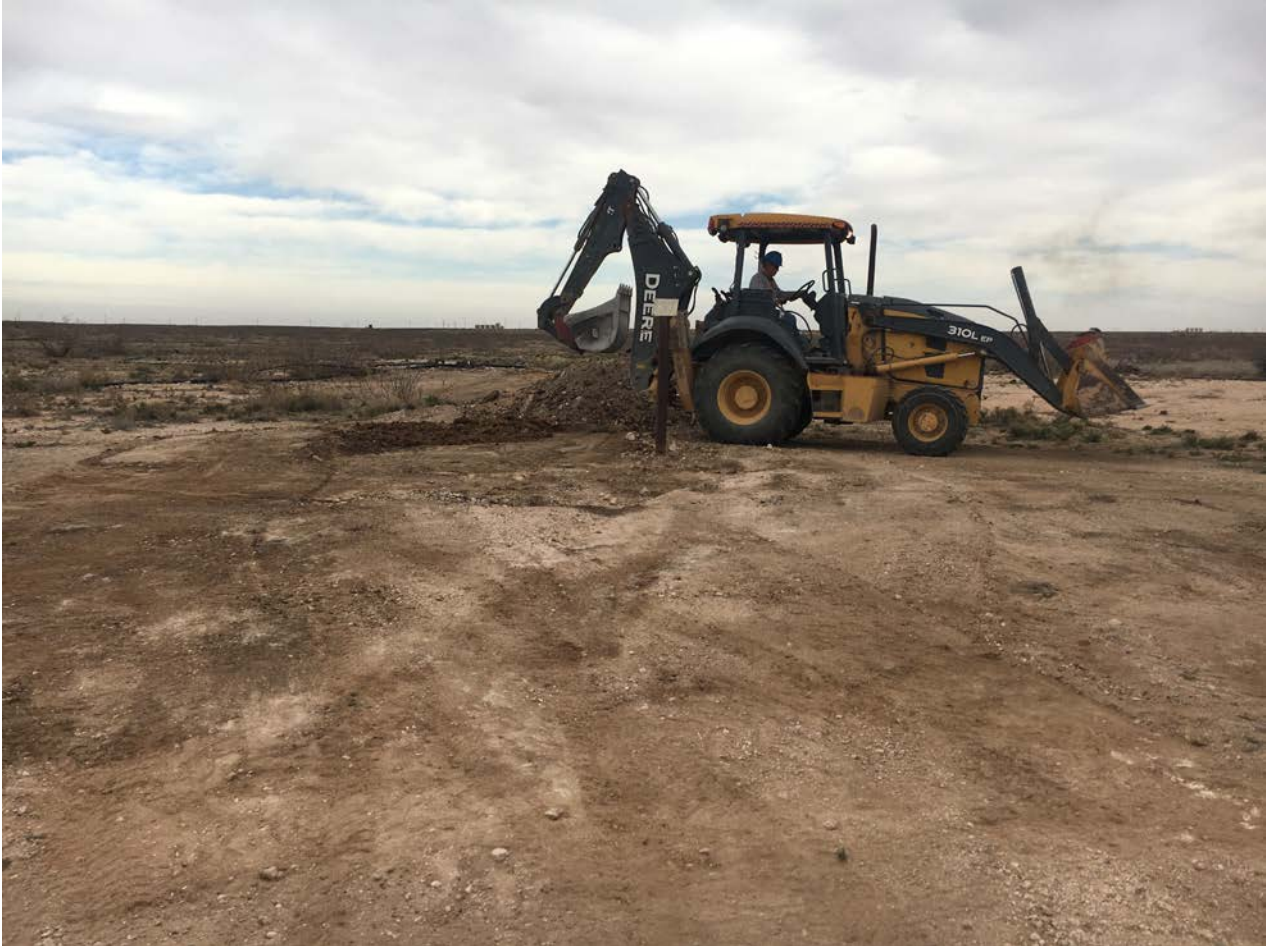
Photograph #21

Client: New Mexico OCD	
Site Name: Artesia Metex Unit #019	
Date Photo Taken: 03.14.2024	
Release Location: 32.725752N -104.231078W S:24 T:18S R:27E Eddy County, New Mexico	
Photo Taken by: Georgeann Goodman	Description: Continued surface scraping of operational staining.
