Sundry Print Report

Well Name: JULANDER FEDERAL Well Location: T29N / R11W / SEC 31 /

Procedure Description: Bradenhead Remediation - Please see attached 3rd proposed repair procedure and wellbore

Julander 1E NOI for Bradenhead Remediation

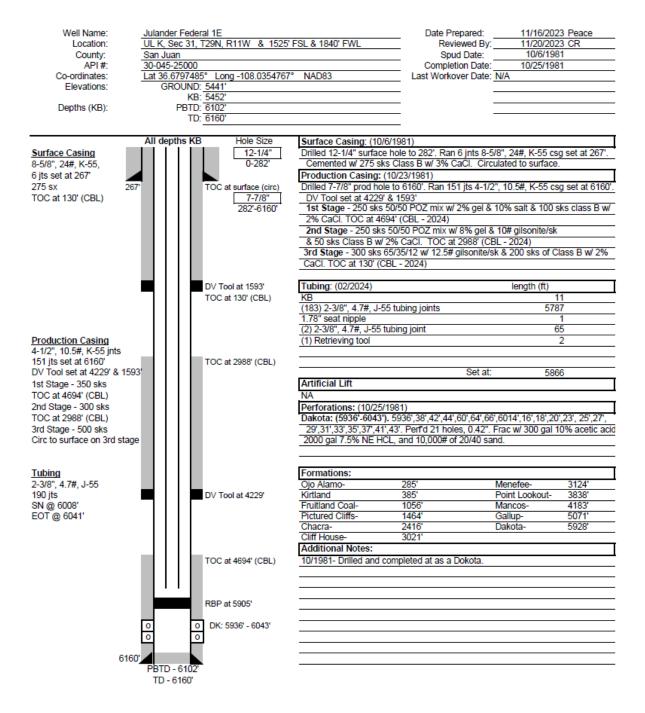
Well Schematic

Based on the bond log and noise log results, the well has been diagnosed with a micro annulus.

Rig up wireline with Local Expander Tool. Conduct a series of 8 casing expansions to seal the microannulus and cut off the path of gas migration that was identified during the diagnostic process (acoustic anomaly was identified at ~1450', top of PC at 1464', top of Fruitland Coal at

Expansion to be placed at the following depths:

- 1. Deep protection of the PC
 - a. Sequence 1: 1479'-1481' (3 expansions per sequence)
 - b. Sequence 2: 1472'-1474' (3 expansions per sequence)
- 2. Deep isolation of the potential leak path, shallow protection of the PC

- a. Sequence 3: 1417'-1419' (3 expansions per sequence)
- 3. Tertiary shallow isolation of the potential leak path
 - a. Sequence 4: 1377'-1379'
- 4. Secondary shallow isolation of the potential leak path

- a. Sequence 5: 1369'-1371'
- 5. Primary shallow isolation of the potential leak path
 - a. Sequence 6: 1359'-1361'
- 6. Primary isolation of the Fruitland Coal top and surface path

- a. Sequence 7: 1043'-1045'
- 7. Secondary isolation of the Fruitland Coal top and surface path
 - a. Sequence 8: 1009'-1011'
- 2. Rig down, move wireline off location.
