February 4, 2016

Subject: **Remediation and Closure Report**
Devon Energy Production Company, LP
Playa 2 State #1H
API # 30-025-40405 (1RP-3587)

Devon Energy Corporation (Devon) has contracted Talon/LPE (Talon) to perform soil assessment and remediation services at the above referenced location. The incident description, soil sampling results, remediation activities and closure request are submitted herein.

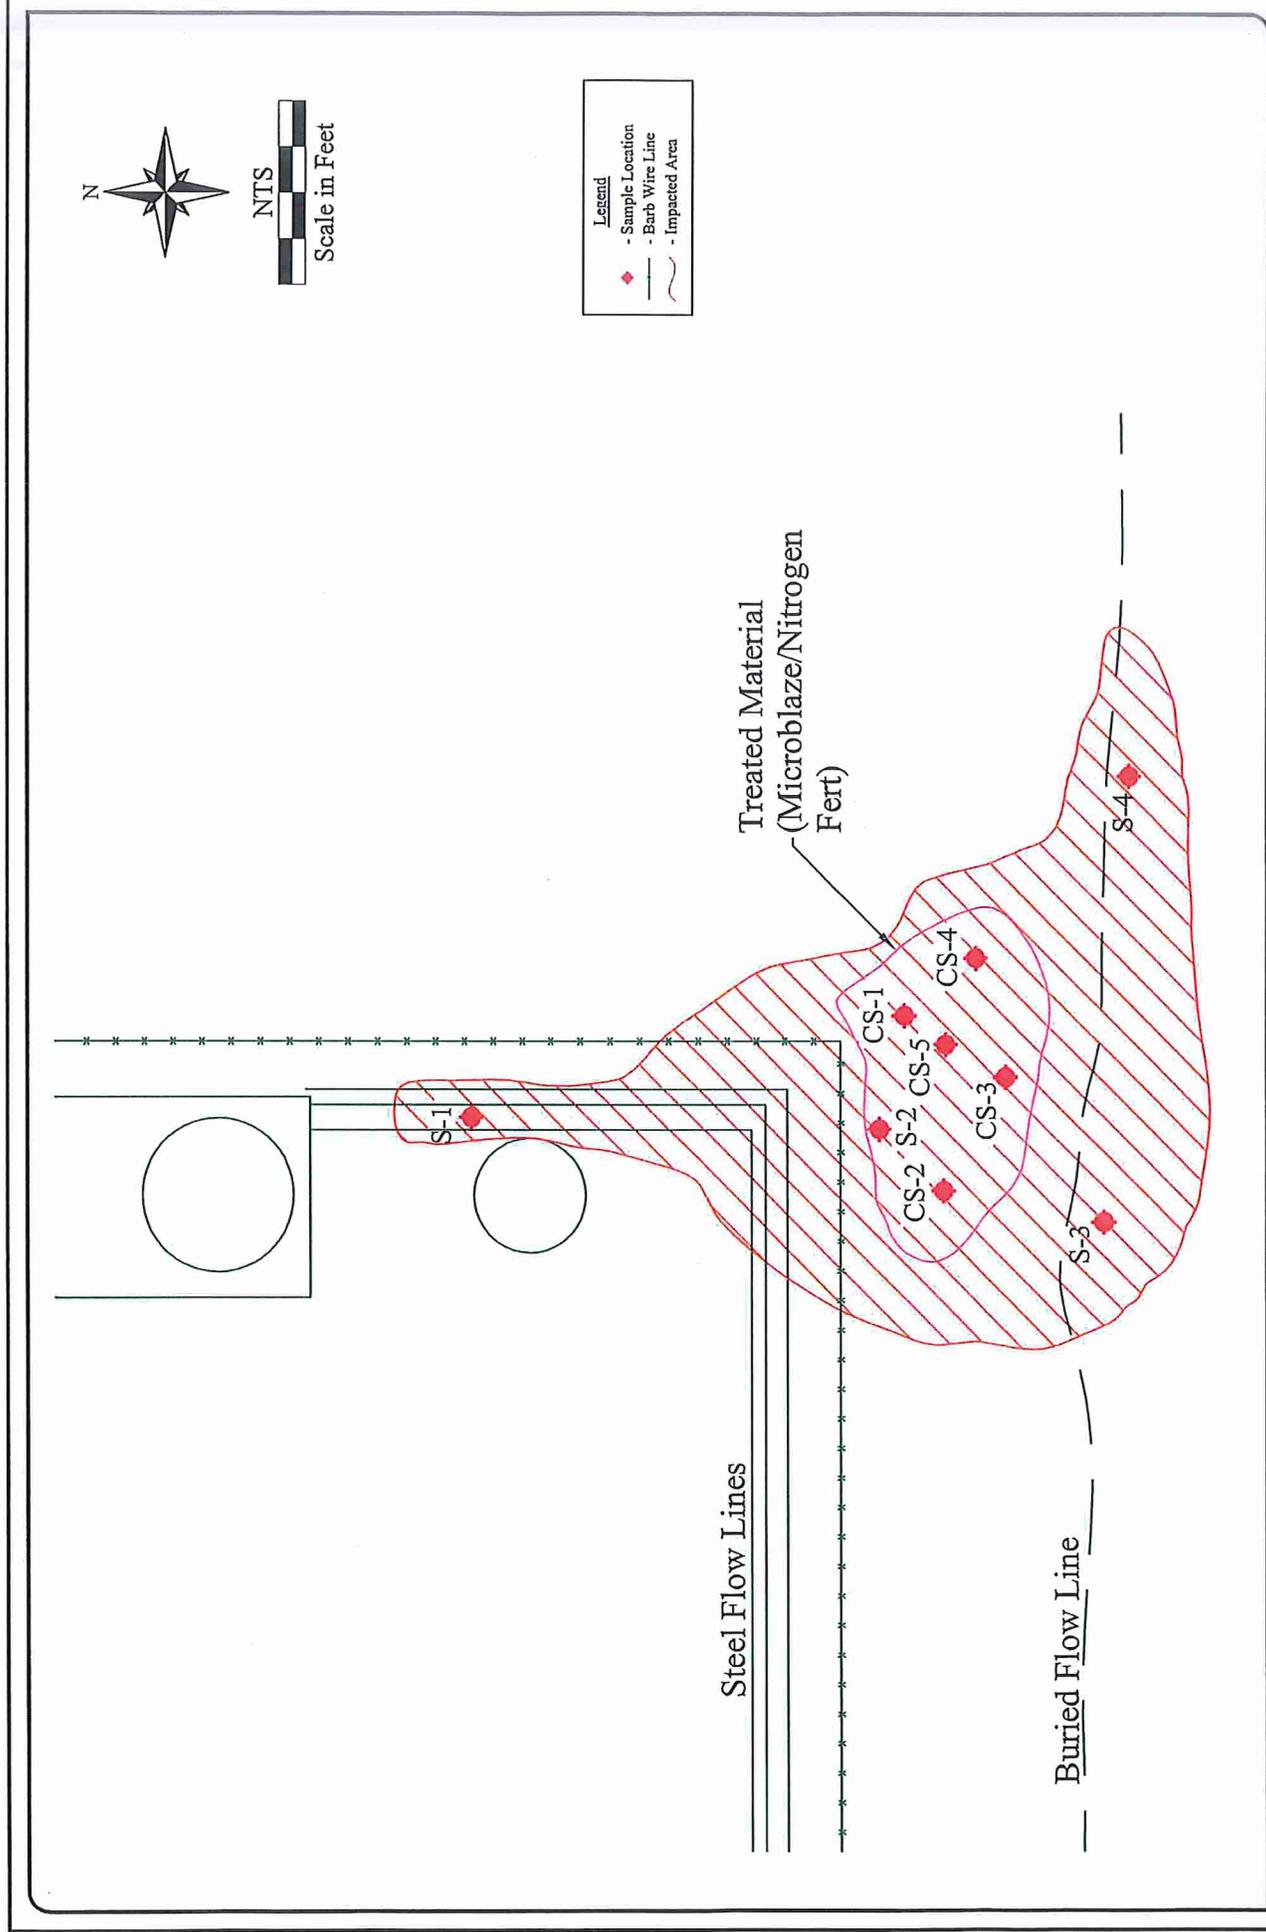
Playa 2 State #1
 Devon Energy Corporation
 Lea County, New Mexico
 Figure 2 - Site Plan

A 3-inch valve failed causing a release of approximately 18bbbls of oil. The oil flowed from the release point and south into the pasture for approximately 47-feet where it pooled. A vacuum truck was immediately dispatched to the location to recover the standing fluids. Approximately 15bbbls were recovered.

Following site assessment activities and a work plan approved by NMOCD, Talon mobilized personnel to perform remediation activities. The impacted areas were excavated, placed on plastic and was treated with mircoblaze. A confirmation sample was collected by taking a 5-point composite from the stockpiled material to verify effectiveness of treatment.

Upon NMOCD granting permission to backfill, the excavated area was backfilled with caliche and recontoured to match the surrounding location.
