December 4, 2020

Mr. Kyle Alpers
Armstrong Energy Corporation
P.O. Box 1973
Roswell, New Mexico 88202

Subject: Liner Inspection and Closure Report
Dora Dean 24 #1
NRM1926756372
Roosevelt County, New Mexico

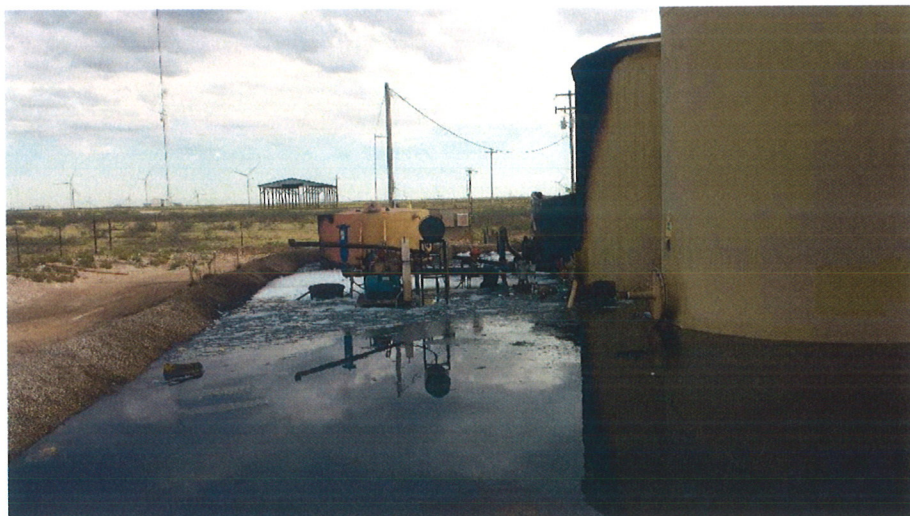
Photo of
Release
contained in
earthen berm.
No staining is
observed
outside of the
earthen berm.
Photo Date:
9/1/2019

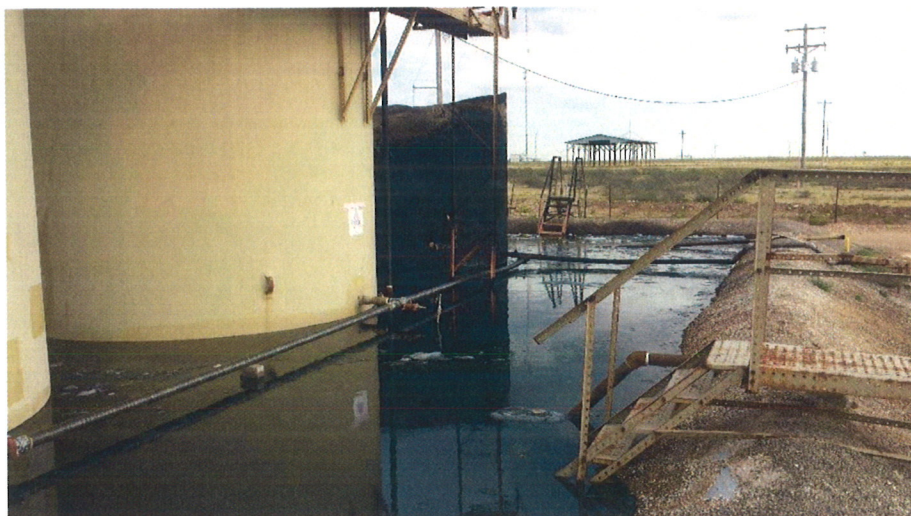
Photo of
Release
contained in
earthen berm.
No staining is
observed
outside of the
earthen berm.
Photo Date:
9/1/2019

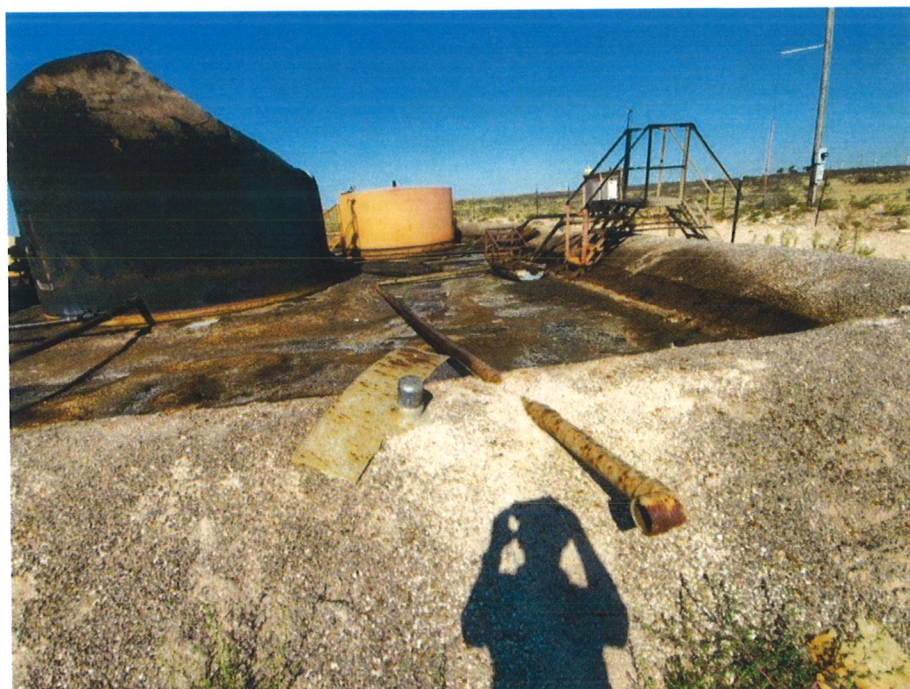
On September 3, 2019, after the released fluid was removed from the lined earthen berm, Armstrong conducted a site visit and took photographs of the lined earthen berm (Attachment B, Photographs). No holes or breaches were observed in the lined earthen berm. Additionally, these photographs show the maximum fluid line within the berm; which based on its consistency across the berm in addition to the absence of stained soil outside of the berm, demonstrate that the lined earthen berm fully contained the release. Based on these photographs, HRL has determined that the lined earthen berm fully contained the release (Attachment C, Inspection Form).

Photo of lined earthen berm after fluids were removed. No staining is observed outside of the earthen berm. Photo Date: 9/3/2019

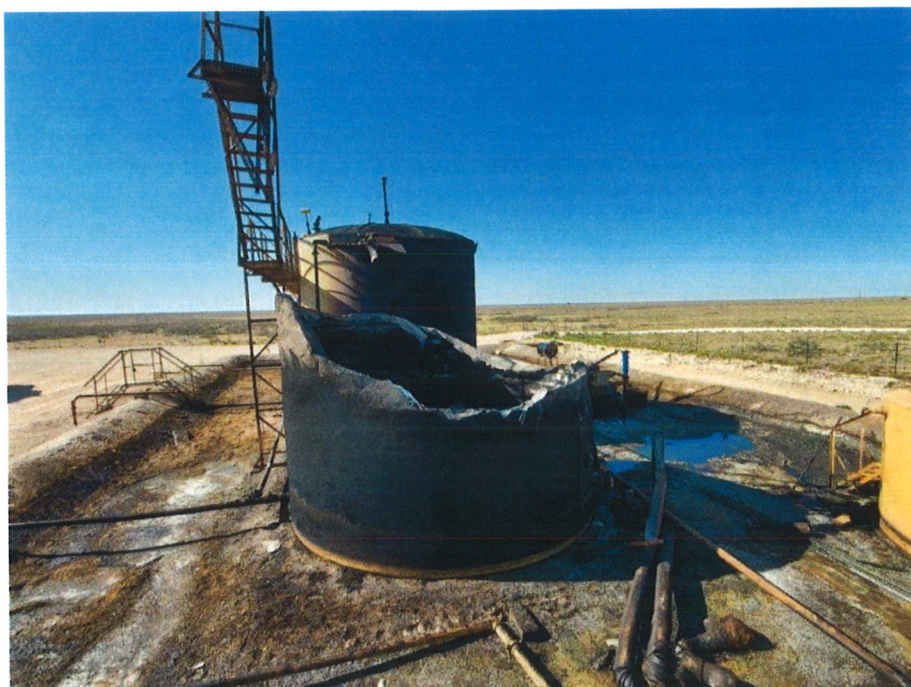
Photo of lined earthen berm after fluids were removed. No staining is observed outside of the earthen berm. Photo Date: 9/3/2019

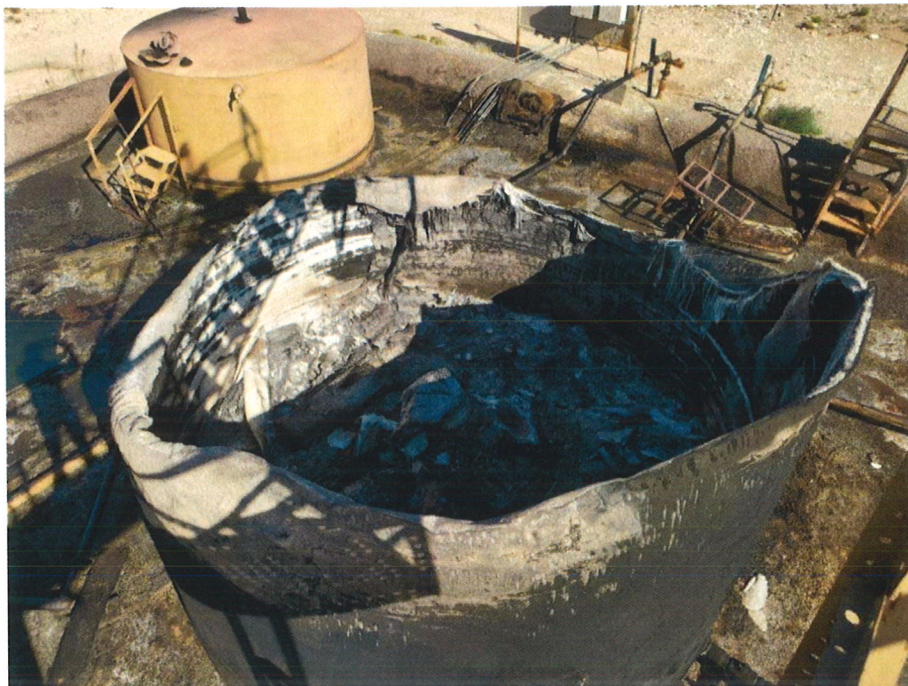
Photo of lined earthen berm after fluids were removed. No staining is observed outside of the earthen berm. Photo Date: 9/3/2019
