Release Notification

Site Name FRPC 4 1	Site Type Gas Well
Date Release Discovered 9/25/2019 @ 3:15pm	API# (if applicable) 30-045-31995

**Subject: Remediation and Deferral Report – Subsequent Liner Installation Letter
FRPC 4-1
Hilcorp Energy Company
San Juan County, New Mexico
NMOCD Incident Number: NCS1929541151**

PHOTOGRAPHIC LOG		
HILCORP ENERGY COMPANY	FRPC 4-1 SAN JUAN COUNTY, NEW MEXICO	TE017819013

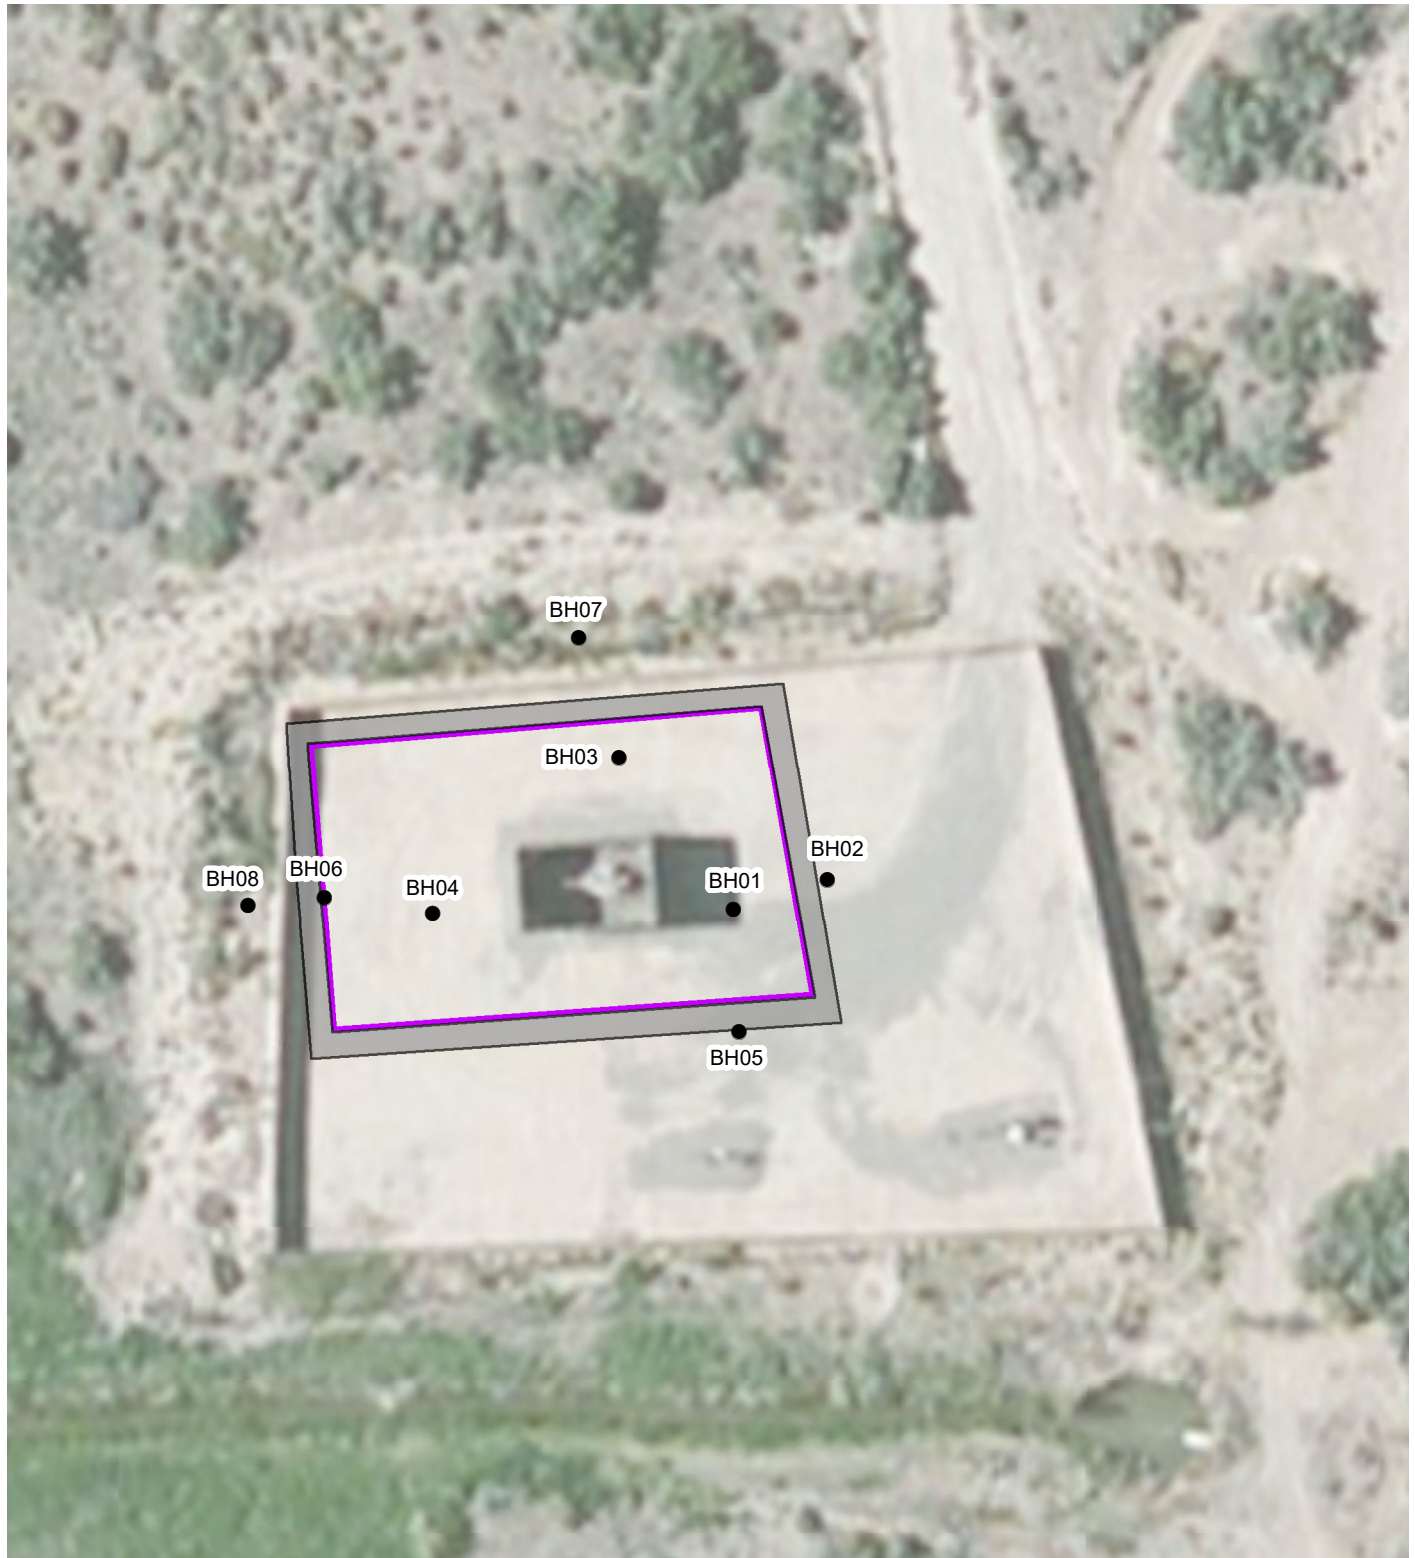
FIGURE 1
TRENCH AND LINER LOCATION
FRPC 4-1
UNIT D SEC 4-T29N-R13W
SAN JUAN COUNTY, NEW MEXICO
HILCORP ENERGY COMPANY

On August 24, 2021 Hilcorp installed a 20-mil linear low-density polyethylene (LLDPE) liner laterally at the base of the excavation and vertically down the trench sidewalls (approximately 8 feet below ground surface) surrounding the excavation. The liner dimensions are approximately 72 feet by 120 feet, and it covers the entire base of the excavation as well as the trench sidewalls (shown on Figure 1). After installation of the 20-mil liner the entire excavation was backfilled with non-waste containing soil. Approximately 1,500 cubic yards of soil were used to backfill the excavation. Backfilling operations were completed on August 26, 2021. Pictures documenting the liner installation and backfilling can be found in the Enclosure A.

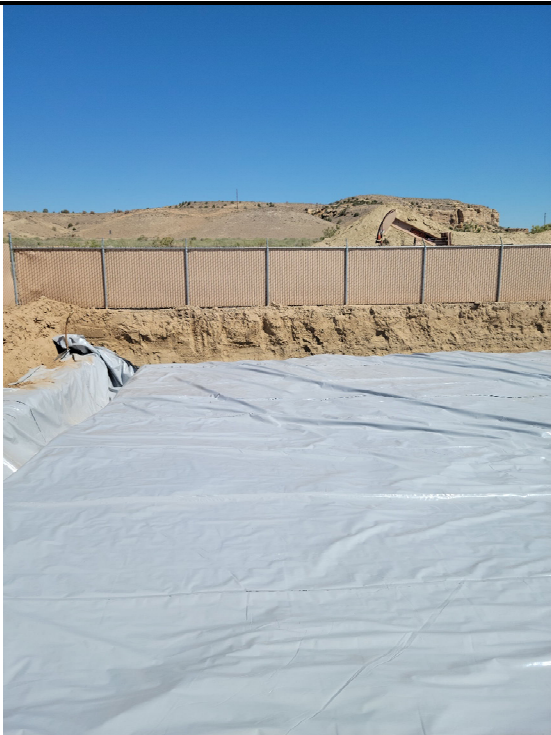
Photo No.	Date	
2	8/24/2021	
View of the northwestern edge of the 20-mil liner.

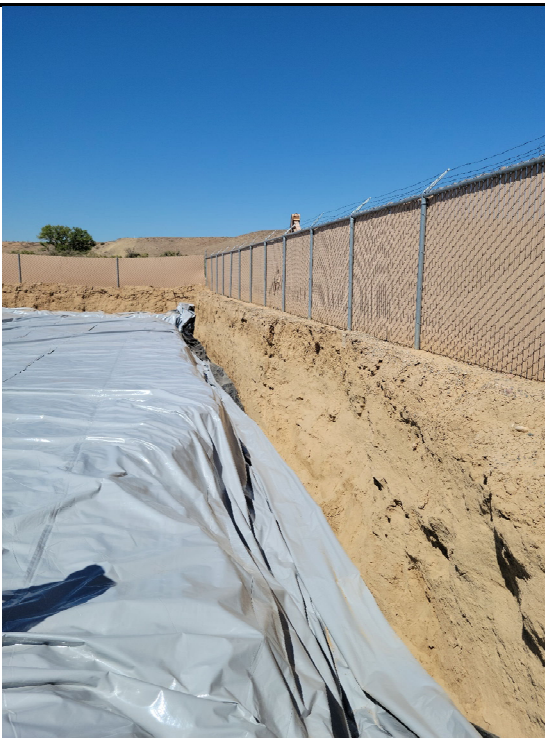
Photo No.	Date	
3	8/24/2021	
View of the 20-mil liner within the northern trench surrounding the excavation.

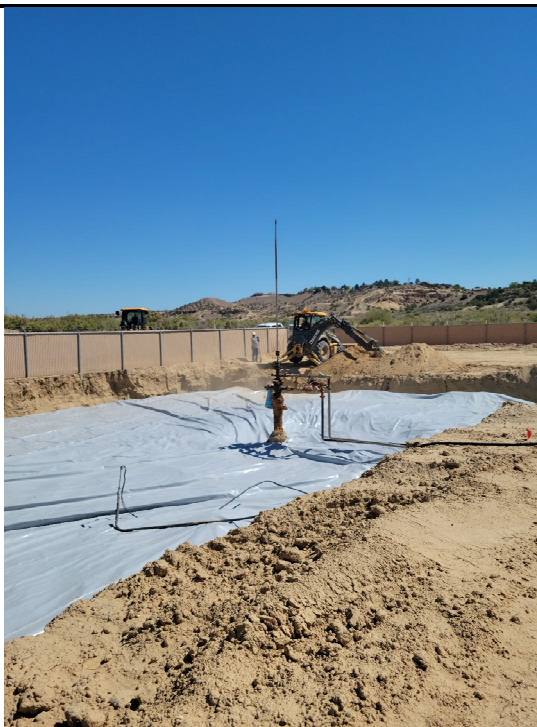
Photo No.	Date	
4	8/24/2021	
View of the central portion of the liner around the wellhead.

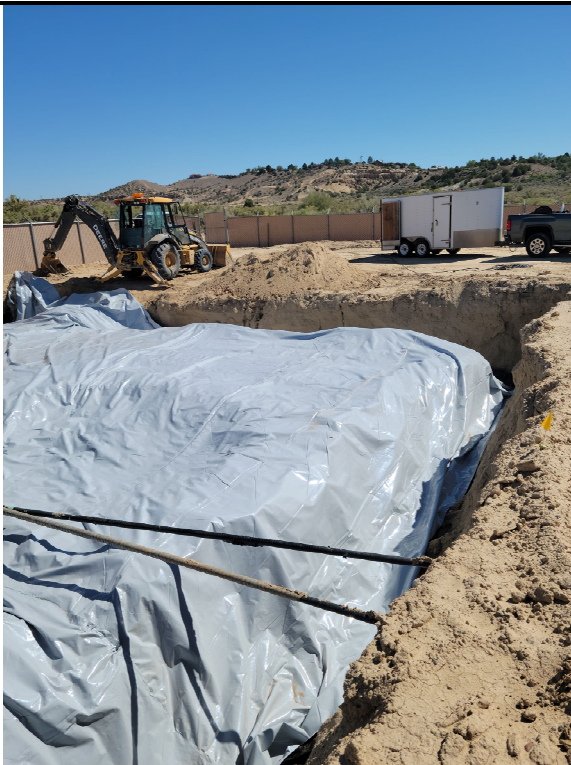
Photo No.	Date	
5	8/24/2021	
View of eastern edge of the 20-mil liner.

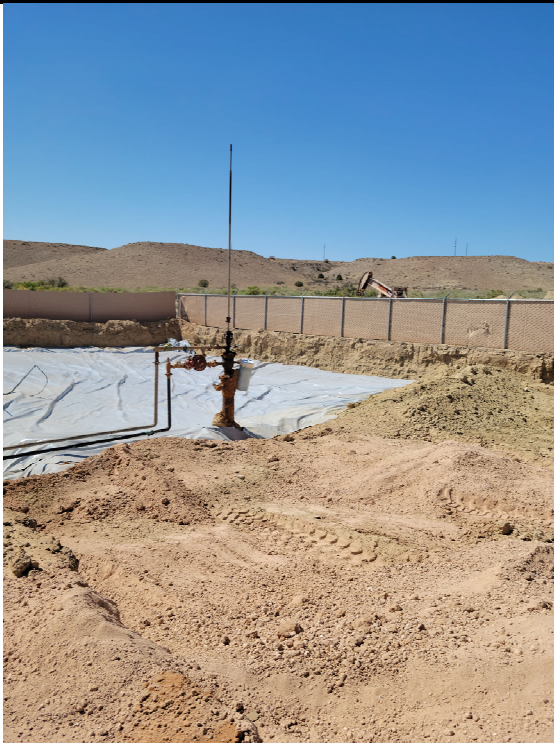
Photo No.	Date	
6	8/24/2021	
View of the south edge of the 20-mil liner.

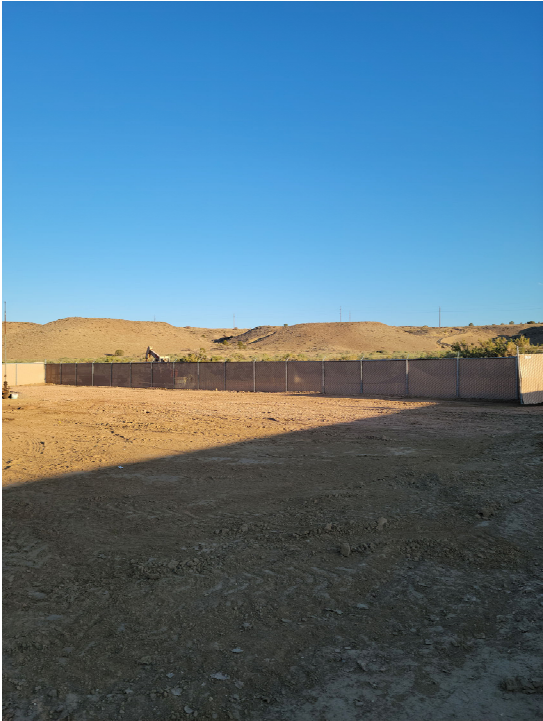
Photo No.	Date	
7	8/26/2021	
View of excavation after backfilling was completed.

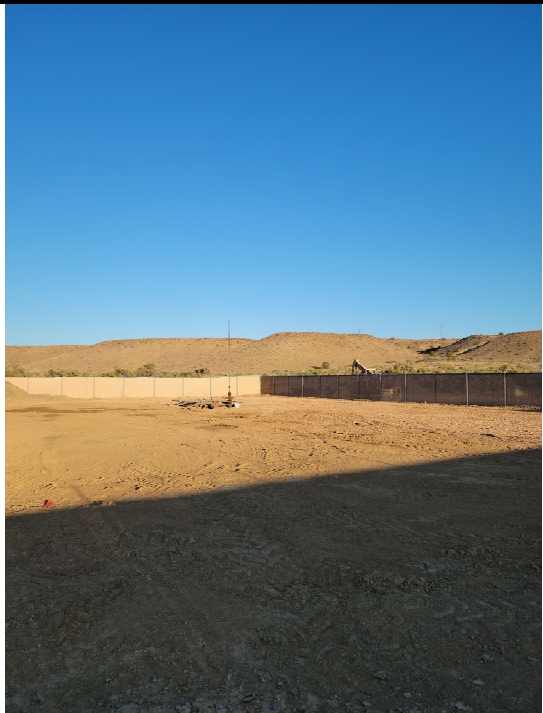
Photo No.	Date	
8	8/26/2021	
View of excavation after backfilling was completed.
