May 10, 2022

Vertex Project #: 22E-01335

**Spill Closure Report:** Ross Draw Unit 42 Tank Battery (Section 22, Township 26 South, Range 30 East)  
API: 30-015-40623  
County: Eddy  
Incident Report: nAPP2210326434

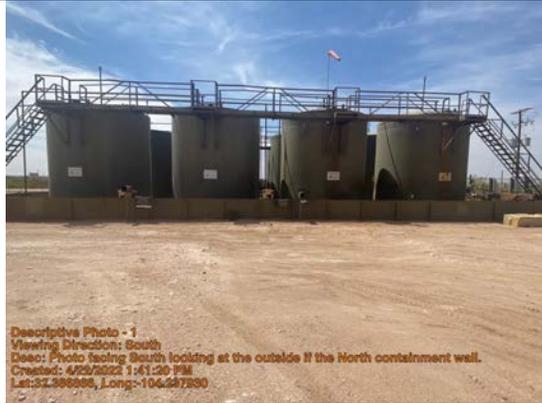
**Viewing Direction: South**

Descriptive Photo - 1  
Viewing Direction: South  
Desc: Photo facing South looking at the outside of the North containment wall.  
Created: 4/22/2022 1:41:20 PM  
Lat:32.386988, Long:-104.237890

Photo facing South looking at the outside of the North containment wall.

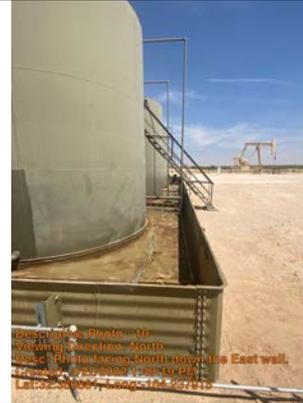
**Viewing Direction: North**

Descriptive Photo - 10  
Viewing Direction: North  
Desc: Photo facing North down the East wall.  
Created: 4/22/2022 1:40:48 PM  
Lat:32.386988, Long:-104.237890

Photo facing North down the East wall.

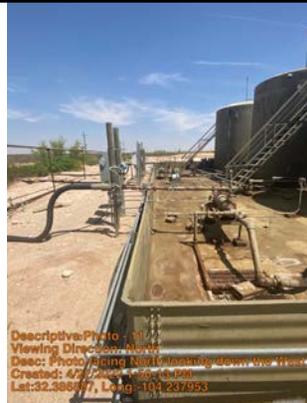
**Viewing Direction: North**

Descriptive Photo - 11  
Viewing Direction: North  
Desc: Photo facing North looking down the West wall.  
Created: 4/22/2022 1:40:48 PM  
Lat:32.386987, Long:-104.237893

Photo facing North looking down the West wall.

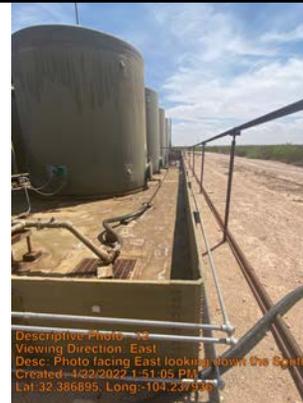
**Viewing Direction: East**

Descriptive Photo - 12  
Viewing Direction: East  
Desc: Photo facing East looking down the South wall.  
Created: 4/22/2022 1:51:05 PM  
Lat:32.386895, Long:-104.237890

Photo facing East looking down the South wall.

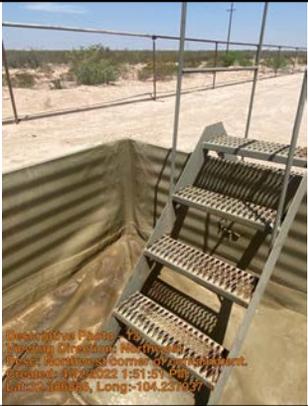
**Viewing Direction: Northwest**

Descriptive Photo - 13  
Viewing Direction: Northwest  
Desc: Northwest corner of containment.  
Created: 4/22/2022 1:51:58 PM  
Lat: 32.86895, Long: -104.23792

Northwest corner of containment.

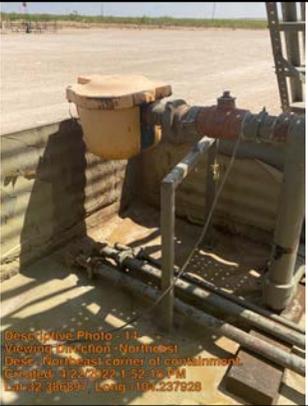
**Viewing Direction: Northeast**

Descriptive Photo - 14  
Viewing Direction: Northeast  
Desc: Northeast corner of containment.  
Created: 4/22/2022 1:52:16 PM  
Lat: 32.86897, Long: -104.23792

Northeast corner of containment.

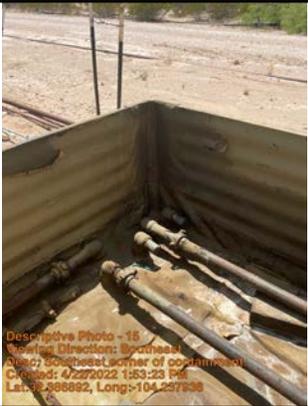
**Viewing Direction: Southeast**

Descriptive Photo - 15  
Viewing Direction: Southeast  
Desc: Southeast corner of containment.  
Created: 4/22/2022 1:53:23 PM  
Lat: 32.86892, Long: -104.23793

Southeast corner of containment.

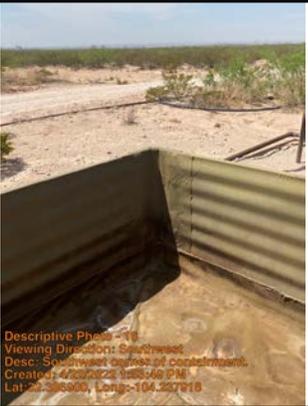
**Viewing Direction: Southwest**

Descriptive Photo - 16  
Viewing Direction: Southwest  
Desc: Southwest corner of containment.  
Created: 4/22/2022 1:53:40 PM  
Lat: 32.86890, Long: -104.23791

Southwest corner of containment.

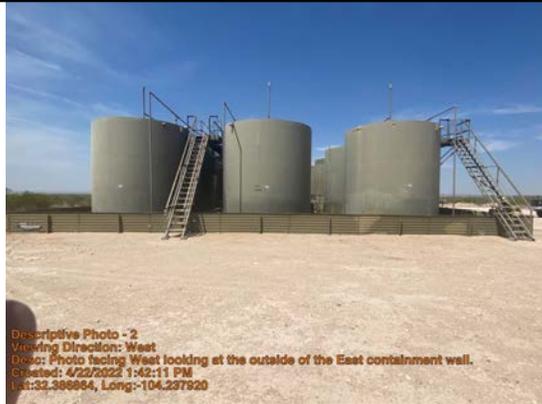
**Viewing Direction: West**

Descriptive Photo - 2  
Viewing Direction: West  
Desc: Photo facing West looking at the outside of the East containment wall.  
Created: 4/22/2022 1:42:11 PM  
Lat:32.386864, Long:-104.237920

Photo facing West looking at the outside of the East containment wall.

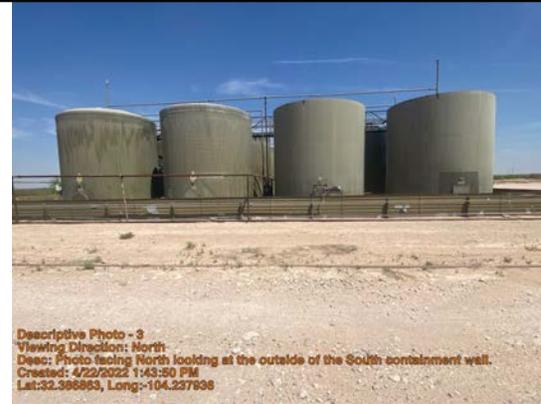
**Viewing Direction: North**

Descriptive Photo - 3  
Viewing Direction: North  
Desc: Photo facing North looking at the outside of the South containment wall.  
Created: 4/22/2022 1:43:50 PM  
Lat:32.386863, Long:-104.237936

Photo facing North looking at the outside of the South containment wall.

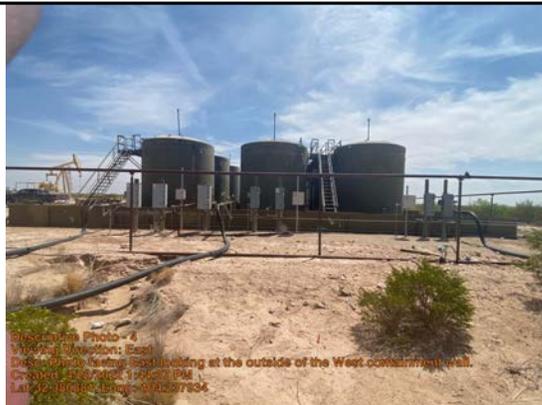
**Viewing Direction: East**

Descriptive Photo - 4  
Viewing Direction: East  
Desc: Photo facing East looking at the outside of the West containment wall.  
Created: 4/22/2022 1:44:37 PM  
Lat:32.386864, Long:-104.237934

Photo facing East looking at the outside of the West containment wall.

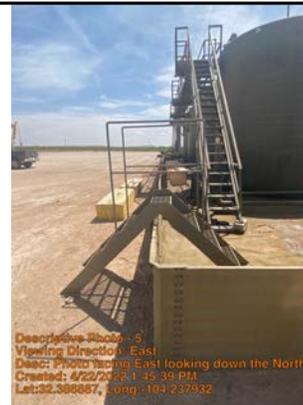
**Viewing Direction: East**

Descriptive Photo - 5  
Viewing Direction: East  
Desc: Photo facing East looking down the North wall.  
Created: 4/22/2022 1:45:39 PM  
Lat:32.386867, Long:-104.237932

Photo facing East looking down the North wall.

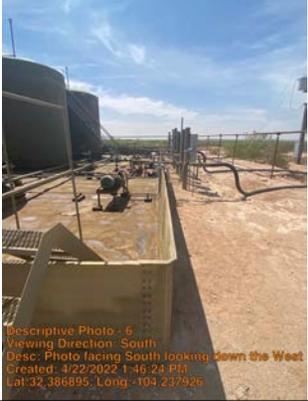
**Viewing Direction: South**

Descriptive Photo - 6  
Viewing Direction: South  
Desc: Photo facing South looking down the West  
Created: 4/22/2022 1:46:24 PM  
Lat:32.386895, Long: -104.237926

Photo facing South looking down the West wall.

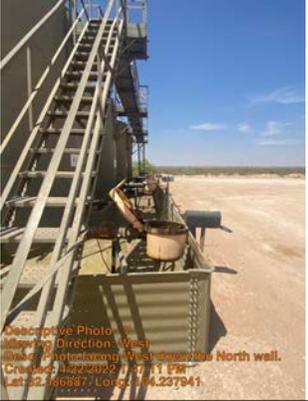
**Viewing Direction: West**

Descriptive Photo - 7  
Viewing Direction: West  
Desc: Photo facing West down the North wall.  
Created: 4/22/2022 1:47:11 PM  
Lat:32.386887, Long: -104.237941

Photo facing West down the North wall.

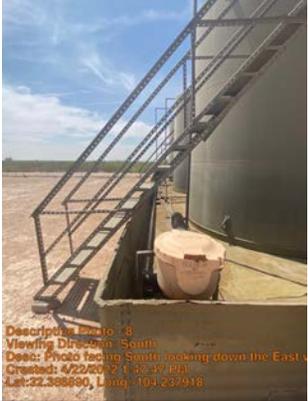
**Viewing Direction: South**

Descriptive Photo - 8  
Viewing Direction: South  
Desc: Photo facing South looking down the East  
Created: 4/22/2022 1:48:17 PM  
Lat:32.386895, Long: -104.237918

Photo facing South looking down the East wall.

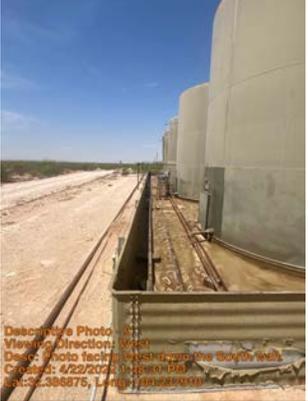
**Viewing Direction: West**

Descriptive Photo - 9  
Viewing Direction: West  
Desc: Photo facing West down the South wall.  
Created: 4/22/2022 1:49:11 PM  
Lat:32.386875, Long: -104.237926

Photo facing West down the South wall.
