LINER INSPECTION AND CLOSURE REPORT

Spur Energy Partners

Bradley 8 Fee #2H

Incident ID: ~~NRM2020535132~~ NRM2020535132

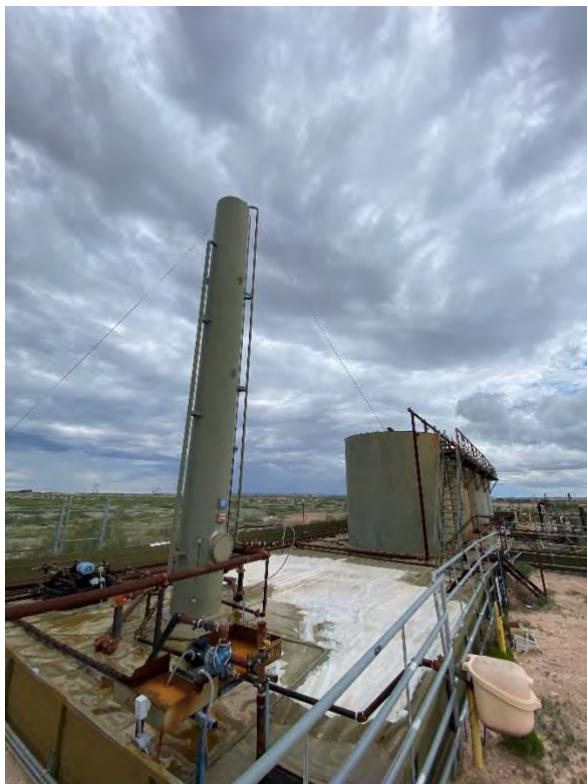
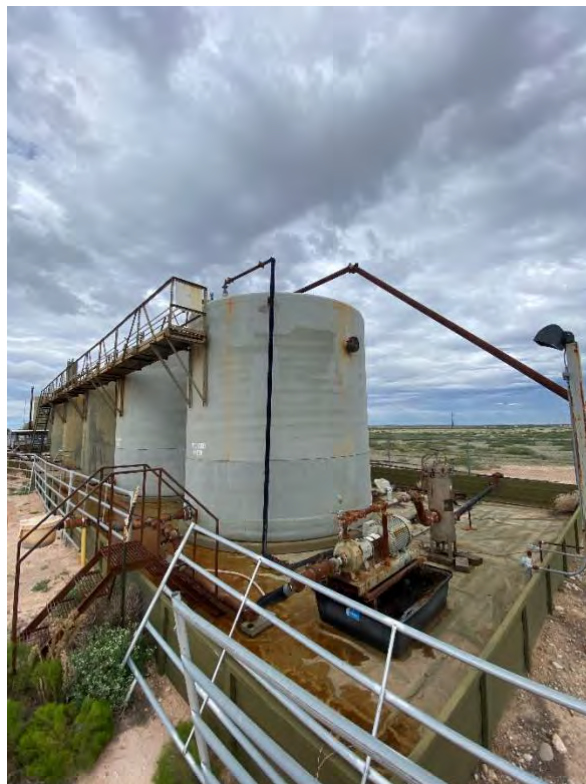
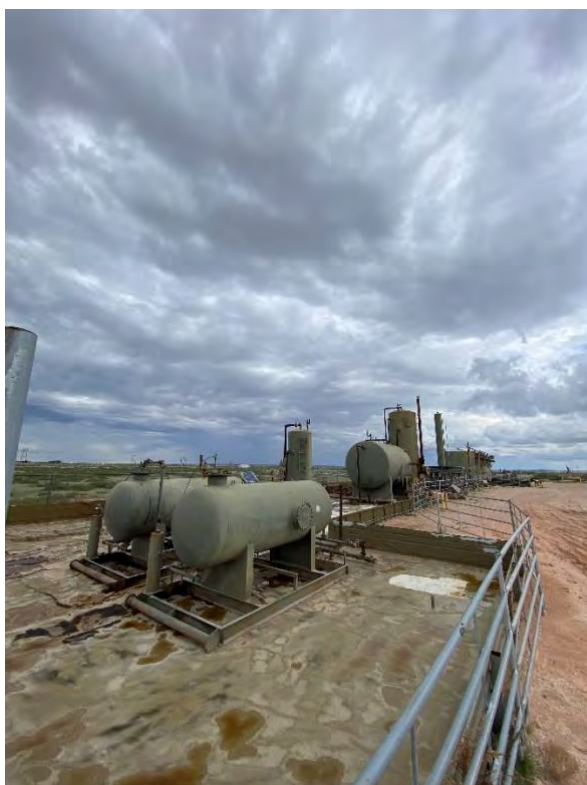
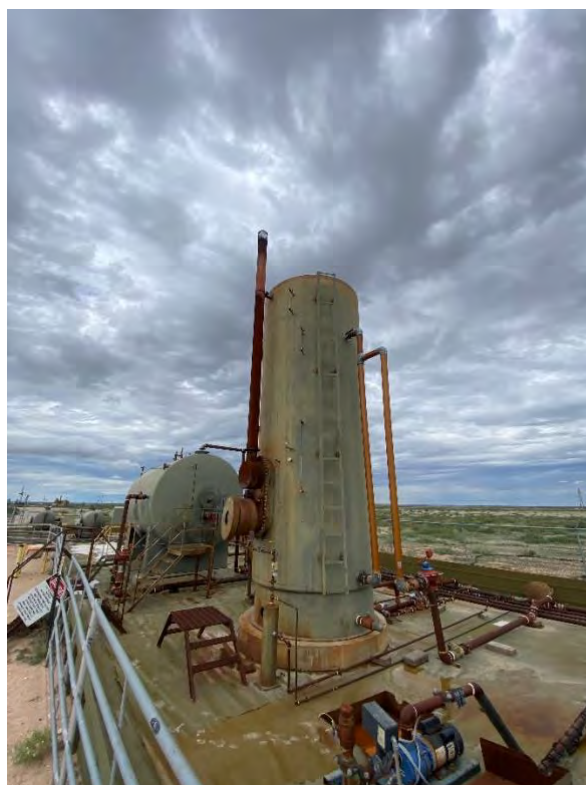
Liner Inspection

On July 20, 2022, Paragon returned to the site to conduct a liner inspection. A 48-hour notification was sent to the NMOCD on July 18, 2022. The liner inspection concluded that the liner was all intact and in good condition. The integrity of the liner appears to have the ability to contain spills. See Appendix D for the email notification and liner report.

Visualization	Yes	No	Comments
Is there a tear in the liner?		x	
Are there holes in the liner?		x	
Is the liner retaining any fluids?		x	
Does the liner have integrity to contain a leak?	x
