September 25, 2020

**Subject: Liner Inspection and Closure Report
 Rattlesnake 16 SWD#001 (October 2017)
 nOY1727954743
 Lea County, New Mexico**

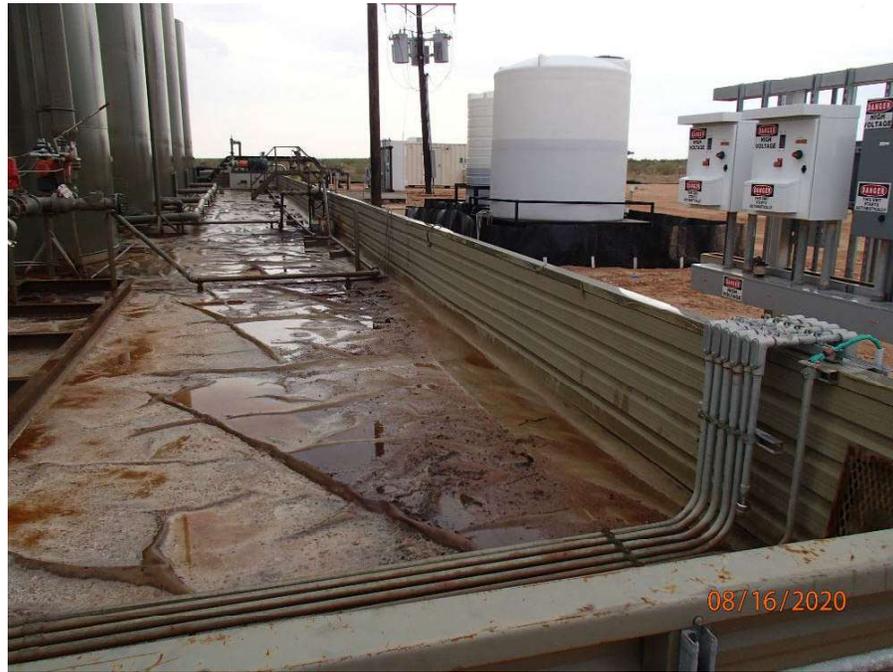
On August 16, 2020, after the released fluid was removed, HRL conducted an inspection to evaluate the integrity of the liner (Attachment B, Photographs). No tears or holes were observed in the liner and the liner was retaining a small amount of water and oil. Based on this inspection, HRL has determined that the liner remains intact and fully contained the release (Attachment C, Inspection Form).

Interior of the secondary containment

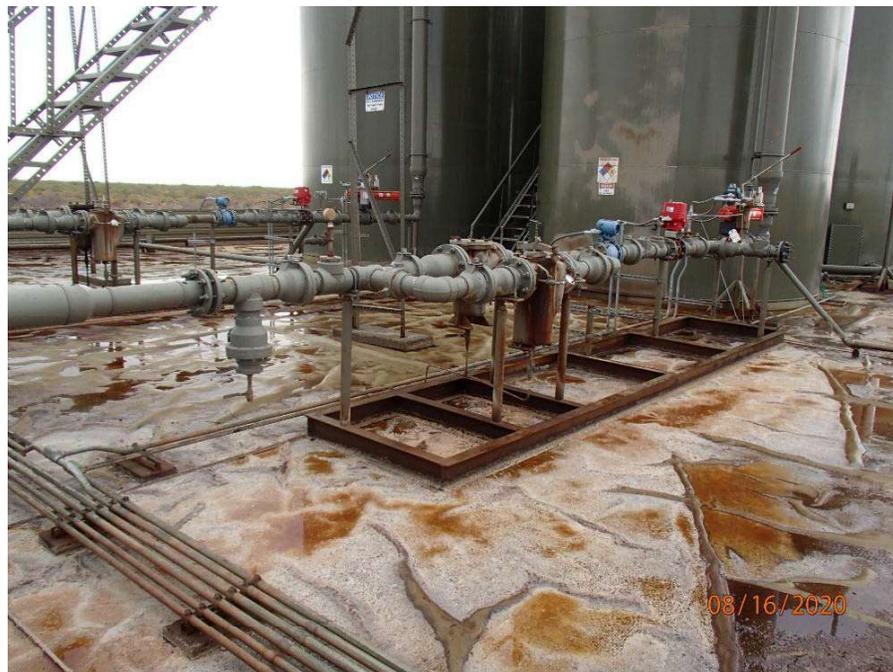
Interior of the secondary containment

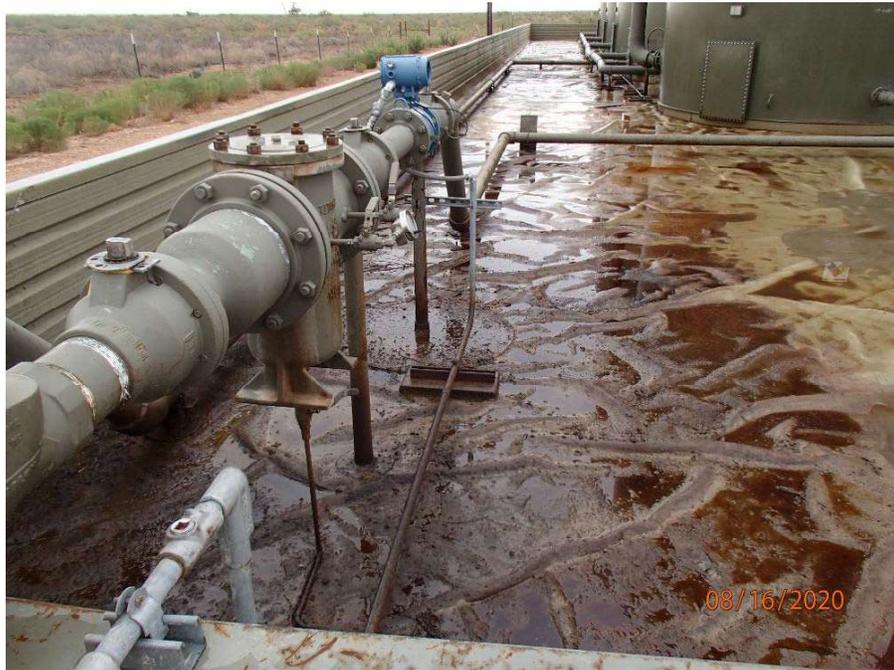
Interior of the secondary containment

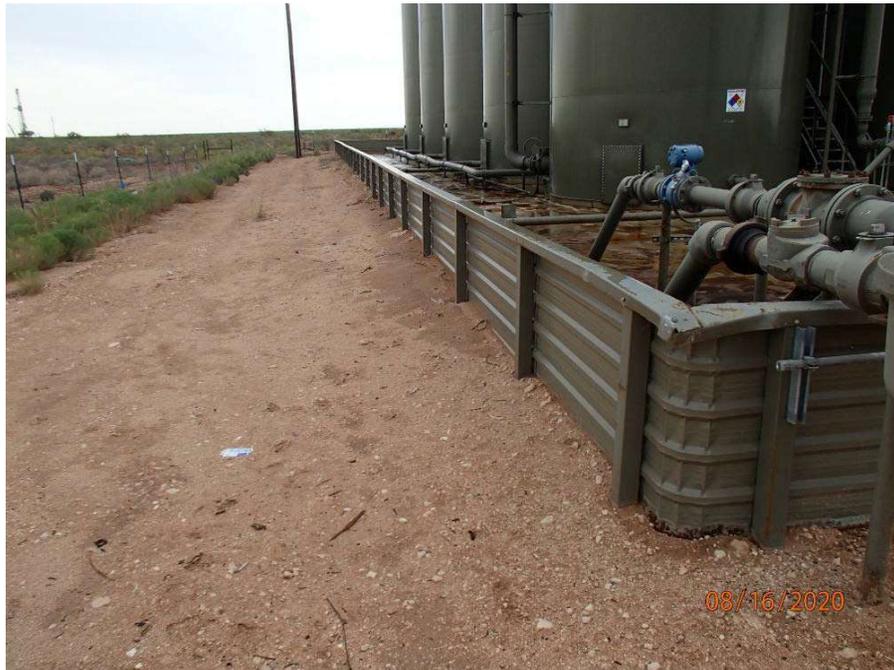
Exterior of the secondary containment

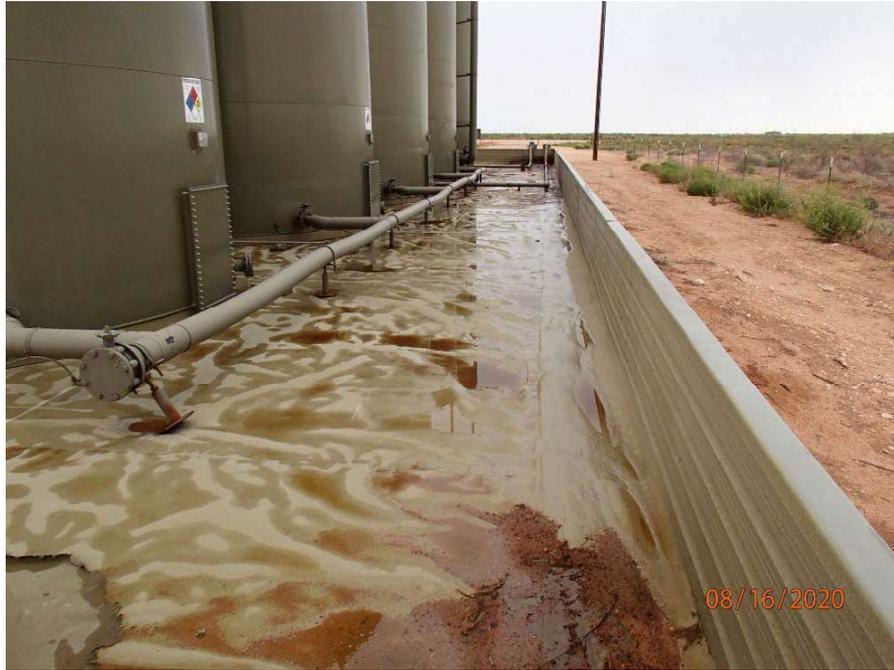
Interior of the secondary containment

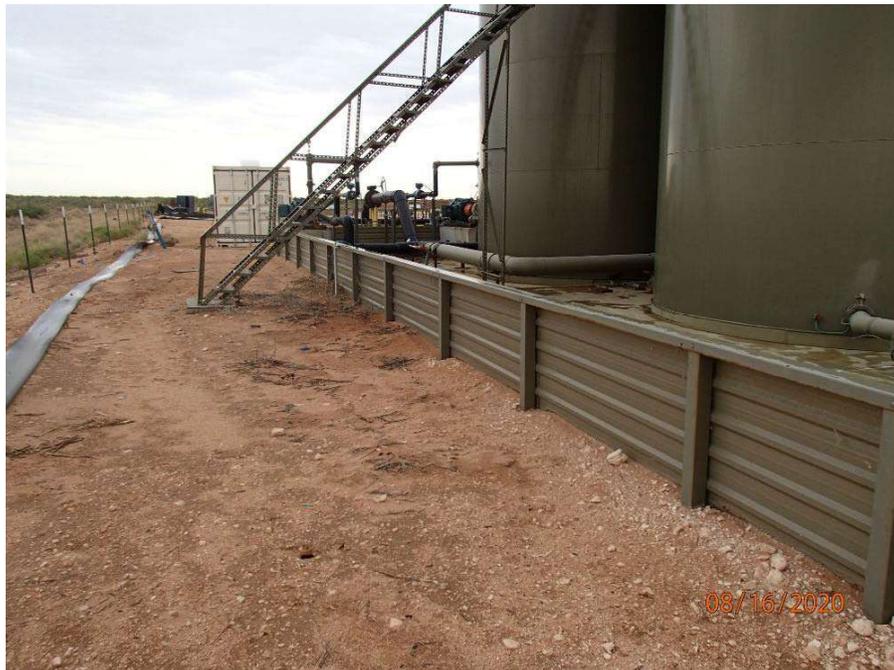
Exterior of the secondary containment

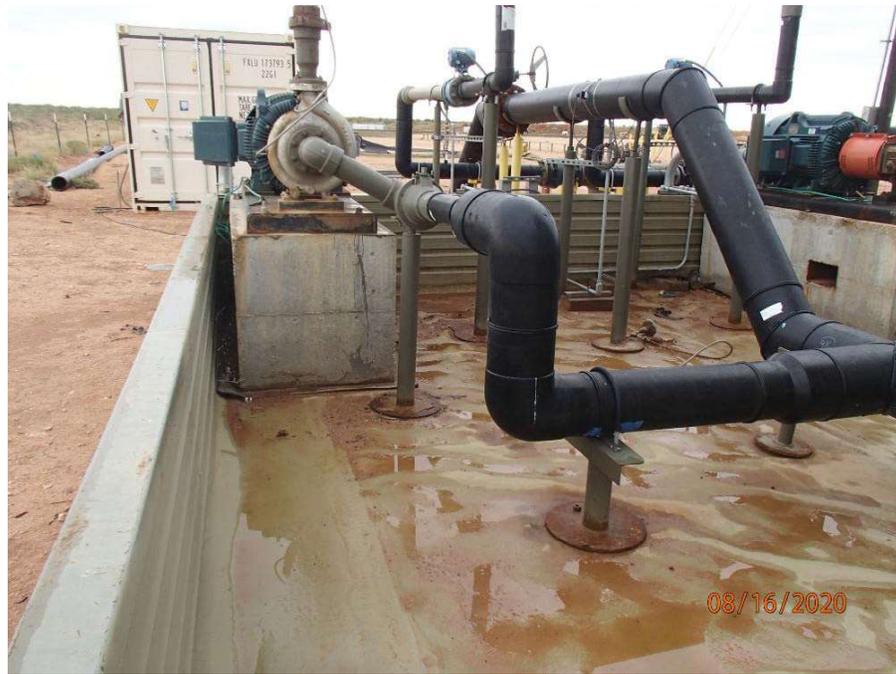
Interior of the
secondary
containment
