**Pima Environmental Services
5614 N. Lovington Highway
Hobbs, NM 88240
575-964-7740**

June 22, 2022

**RE: Liner Inspection and Closure Report
Thistle Unit #52H
API No. 30-025-41897
GPS: Latitude 32.2824745 Longitude -103.5799866
UL- C, Section 28, Township 23S, Range 33E
NMOCD Reference No. NJXK1619355827**

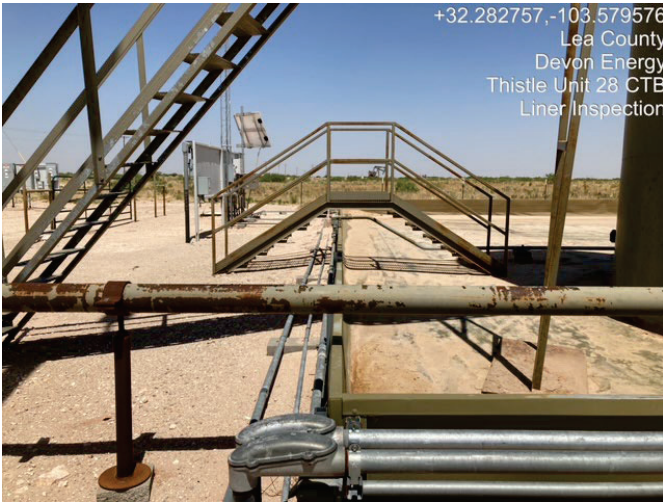
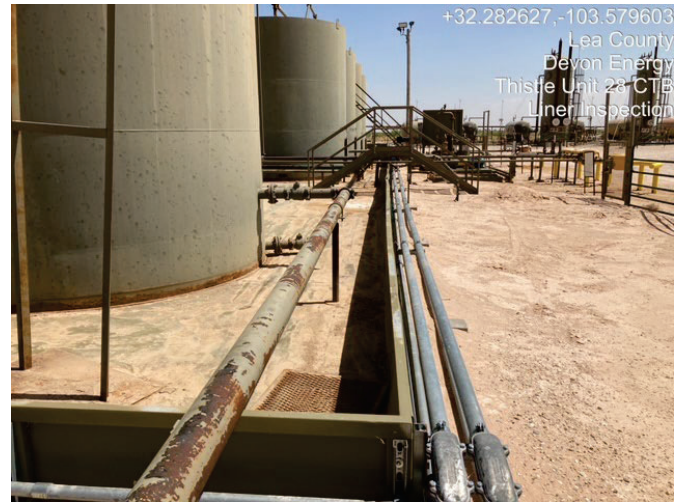
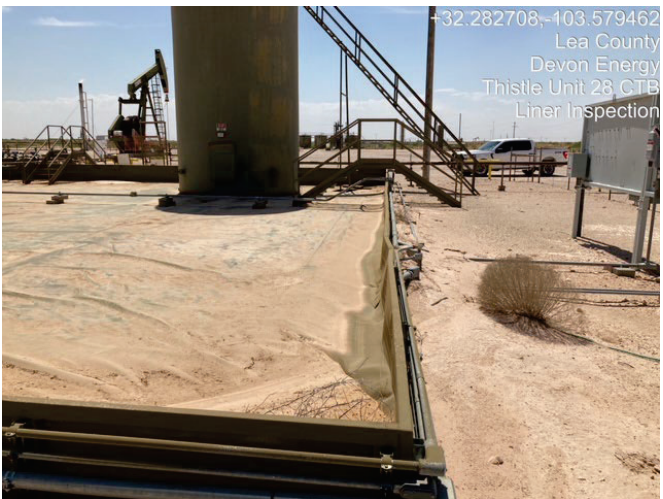
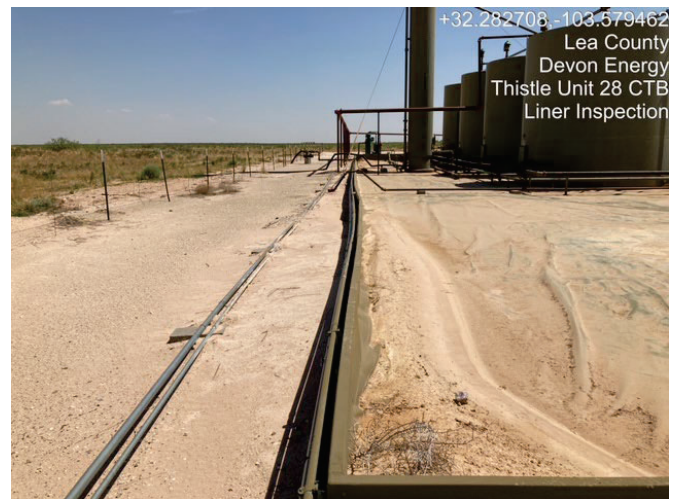
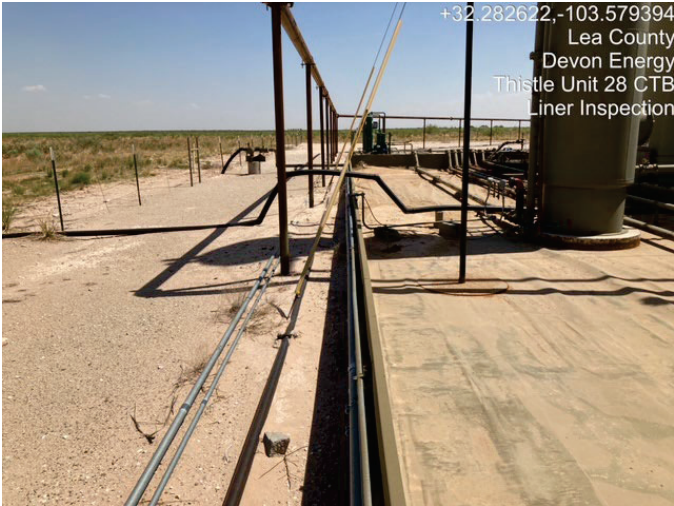
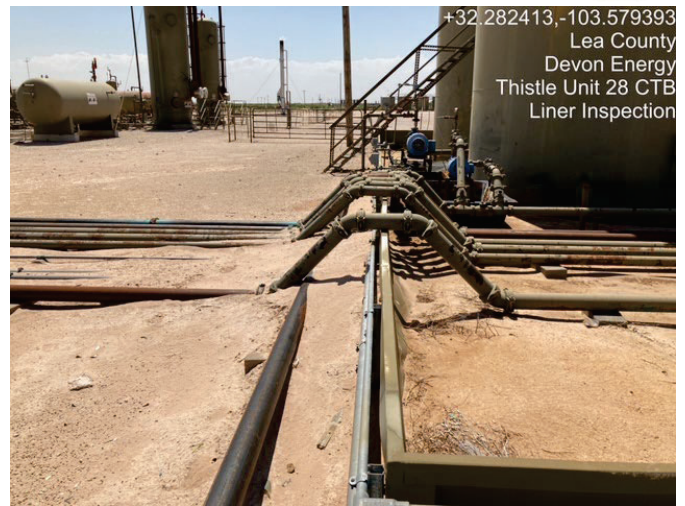
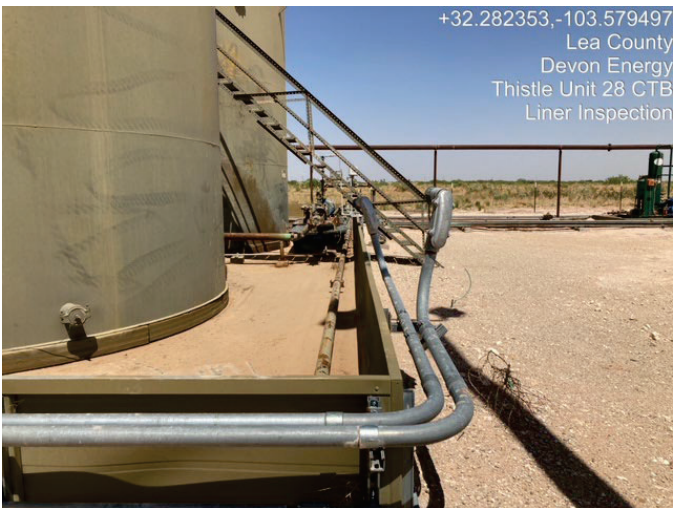
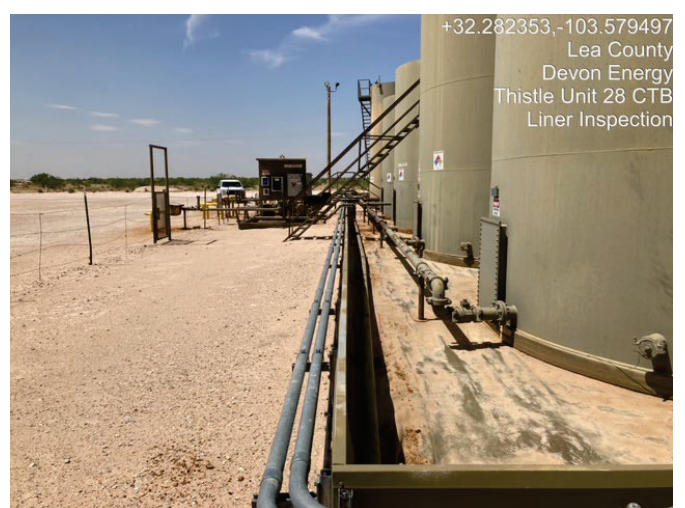
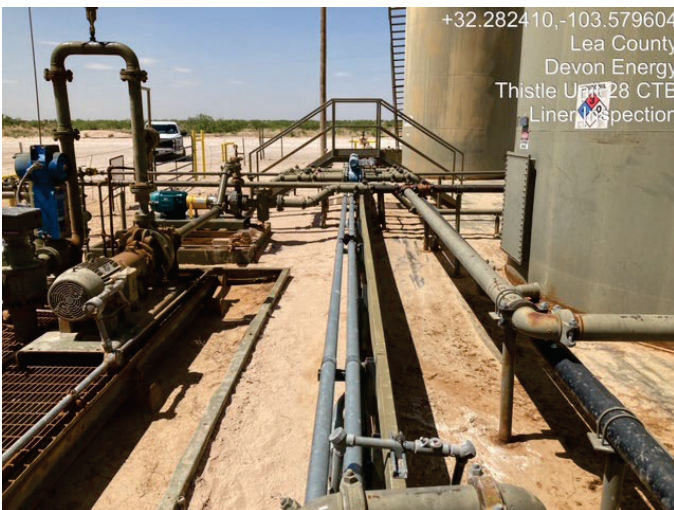
SITE PHOTOGRAPHS DEVON ENERGY – LINER INSPECTION

On June 17, 2022, after sending the 48-hour notification via email, Pima Environmental conducted a liner inspection at this location. We concluded that this liner and containment maintained its integrity and was able to retain the fluids. The liner inspection form and photographic documentation can be found in Appendix C.

Visualization	Yes	No	Comments
Is there a tear in the liner?		X	
Are there holes in the liner?		X	
Is the liner retaining any fluids?		X	
Does the liner have integrity to contain a leak?	X
