## Release Notification

Site Name Rio Bravo SWD	Site Type Well
Date Release Discovered: 6/19/2022 @ 11:00am (MT)	API# 30-045-33583

## Executive Summary

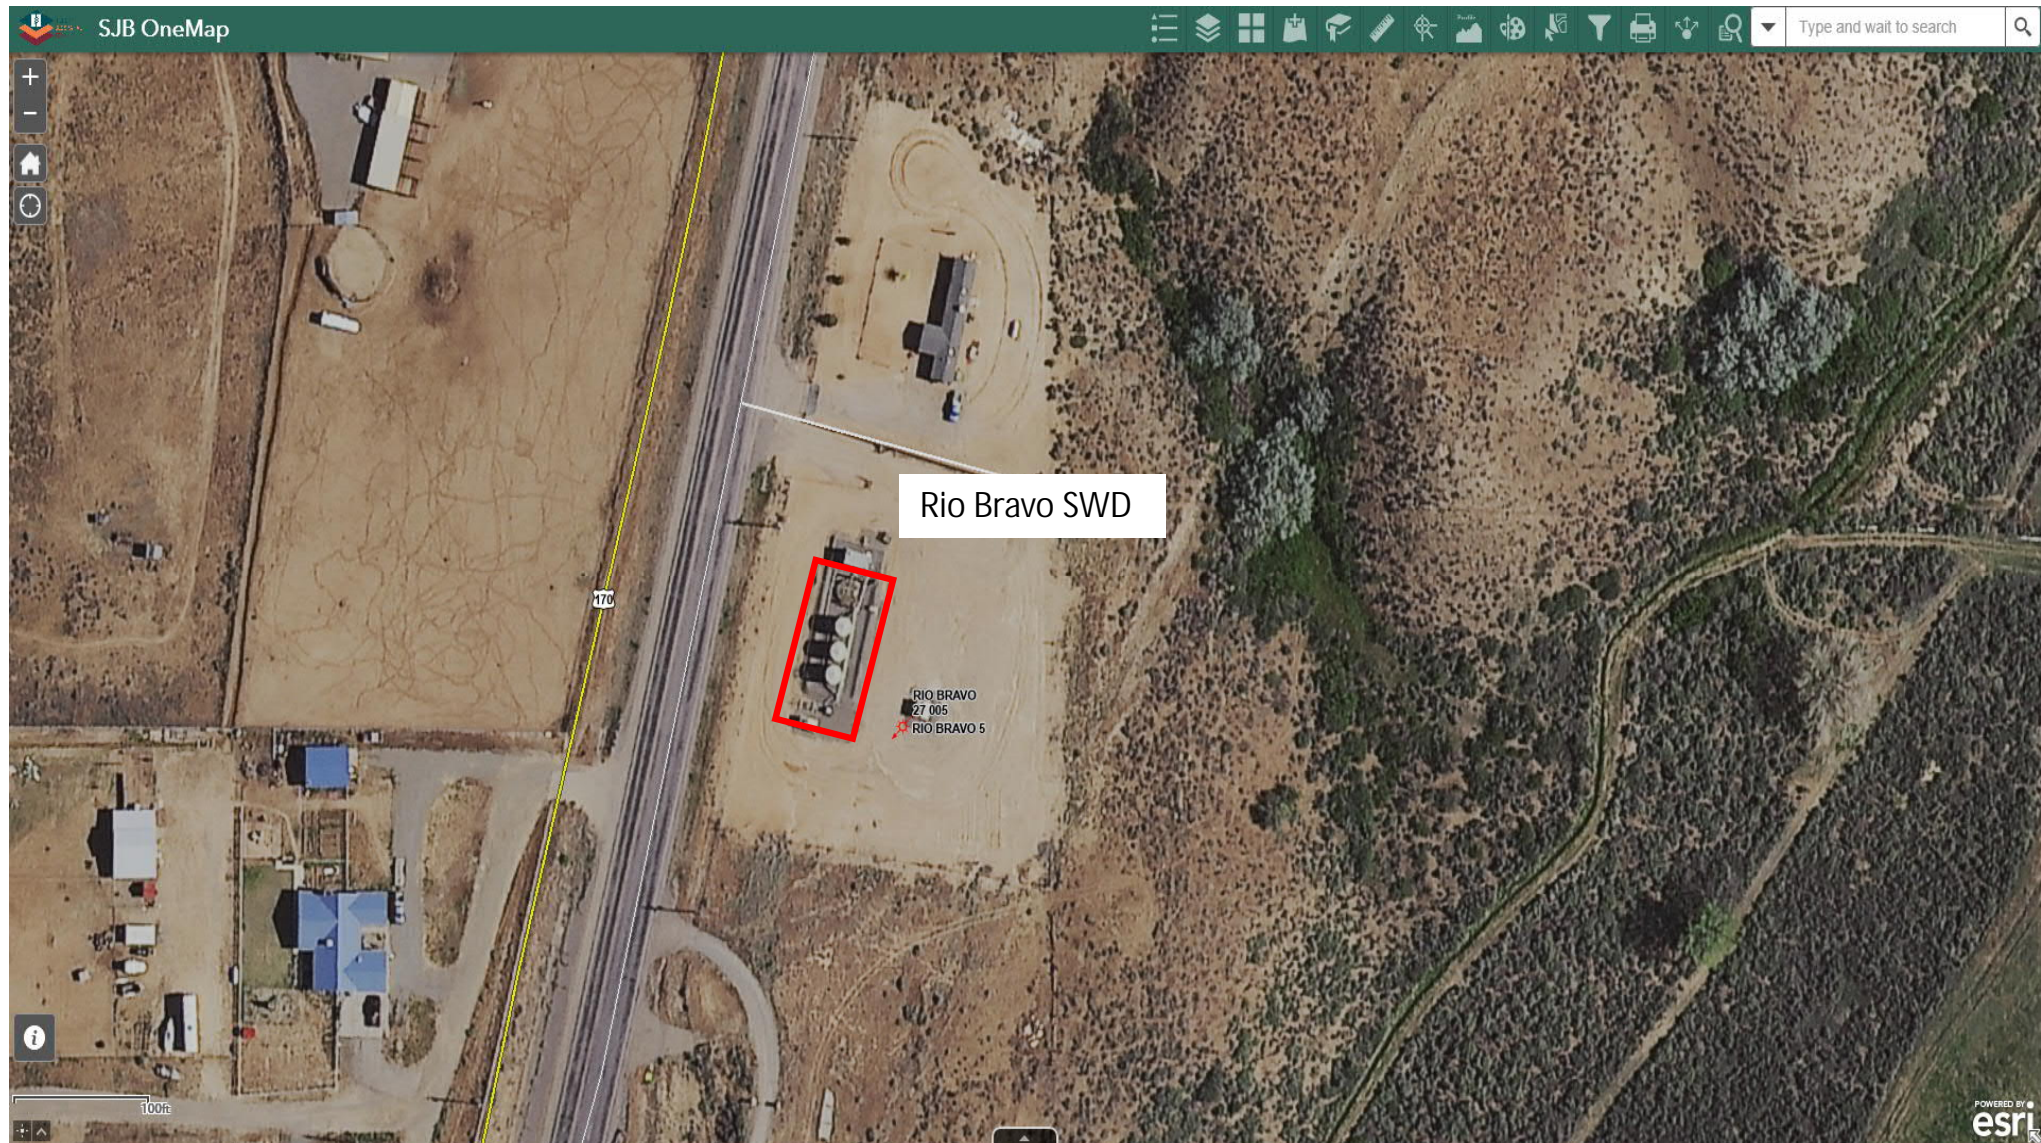
Release Area

Note: The spill event originated at the middle 300-bbl water storage tank within secondary containment (immediately south of the BGT).

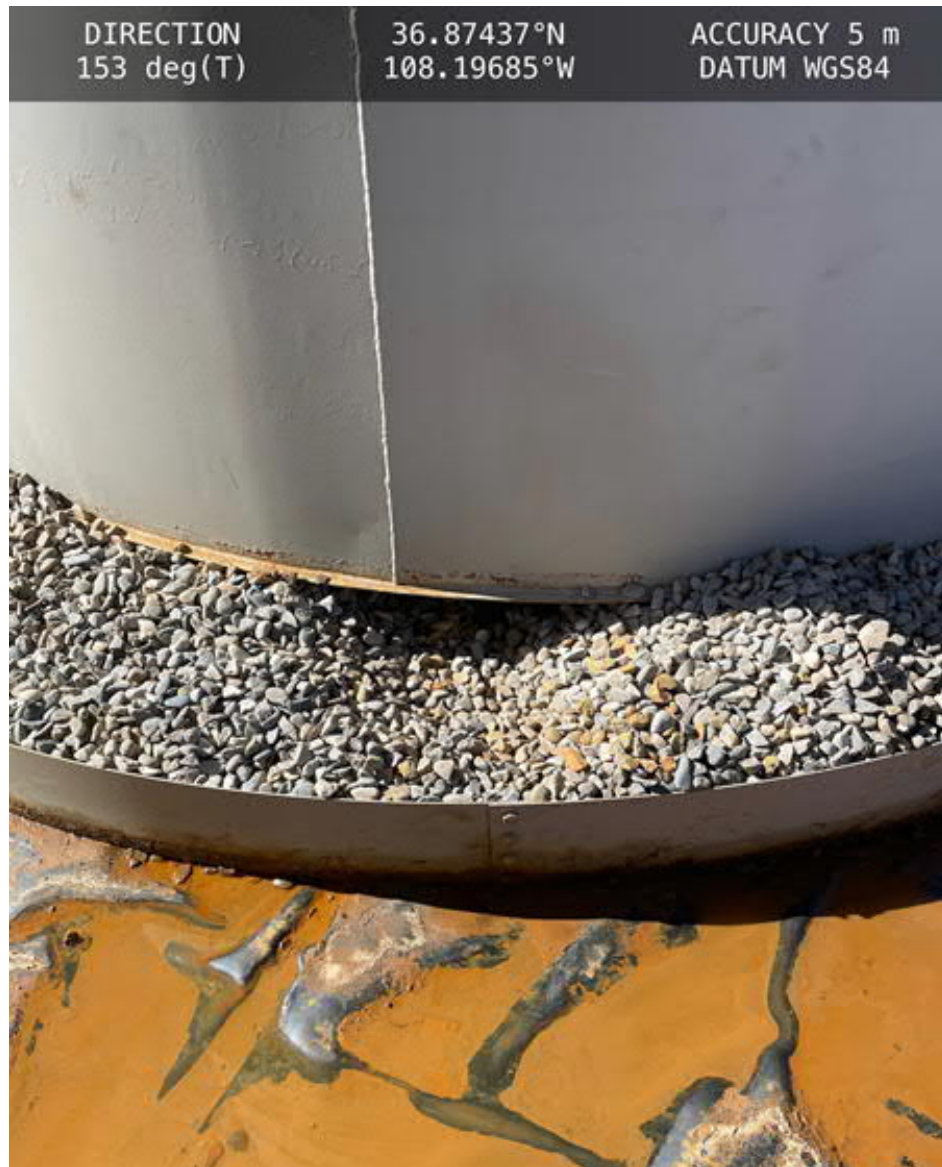
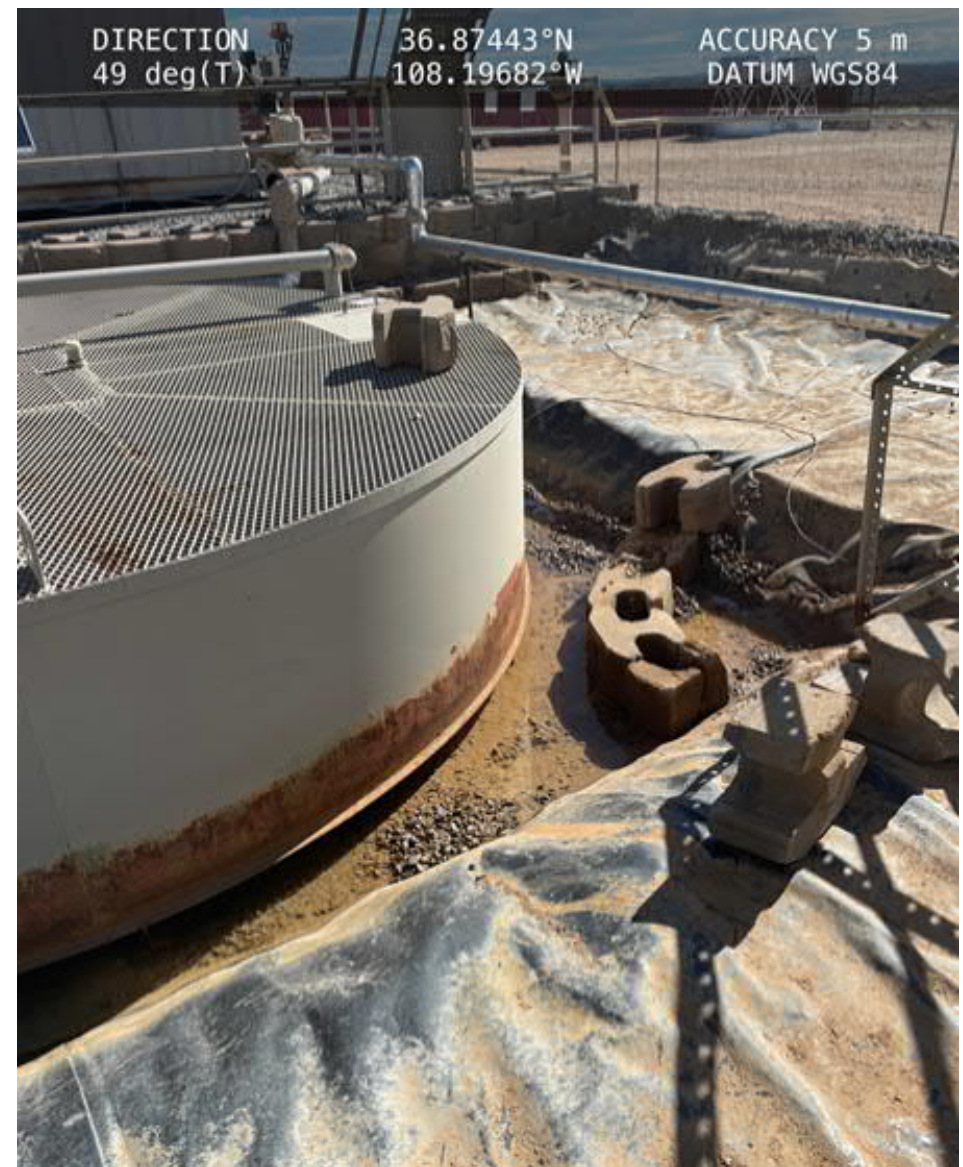
# Integrity Inspection 1

Hilcorp personnel removed the gravel to fully expose the liner for an integrity assessment and to ensure that the liner remained intact.

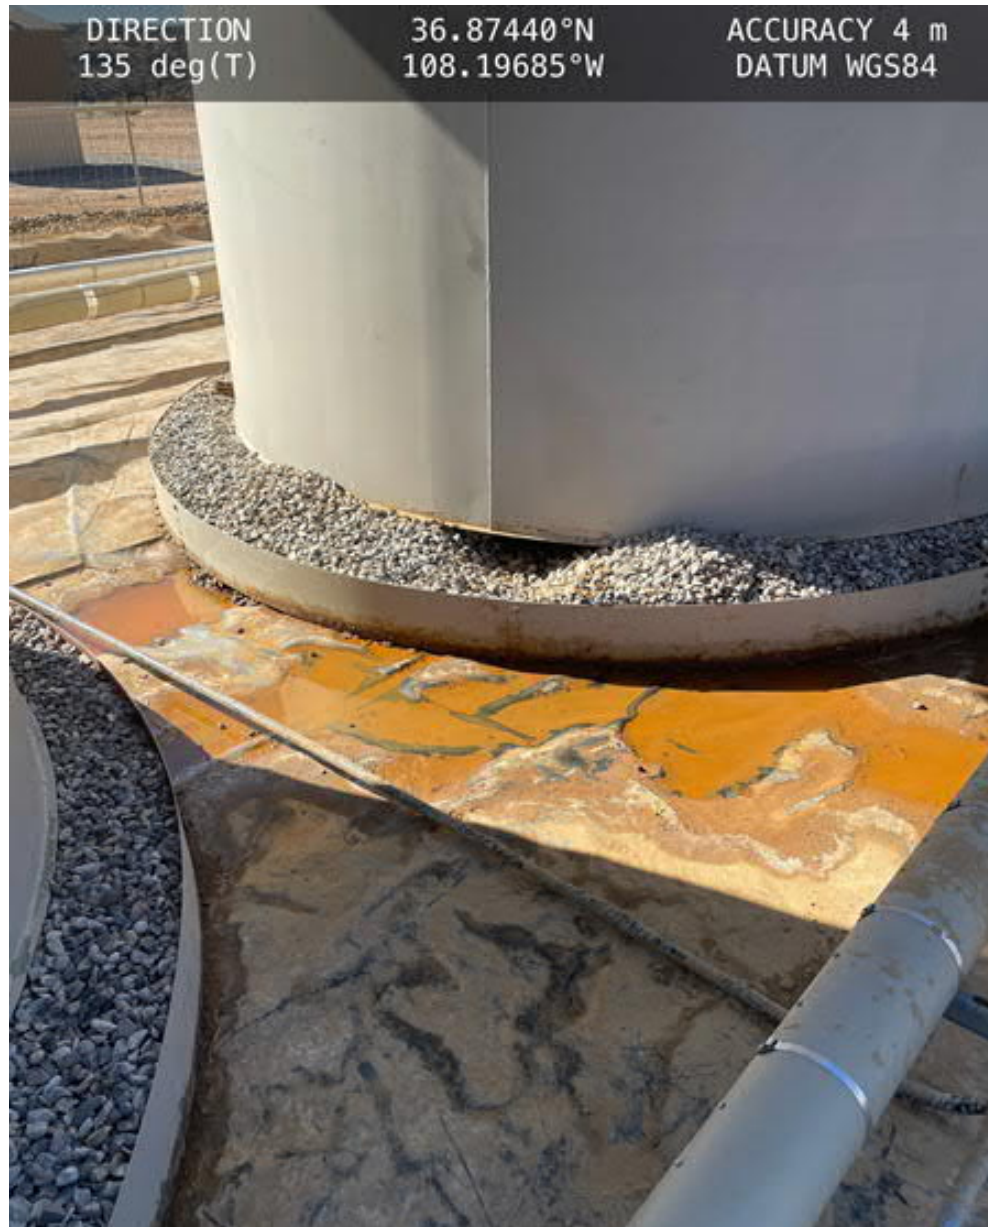
# Integrity Inspection 2

Taken 6/23/2022

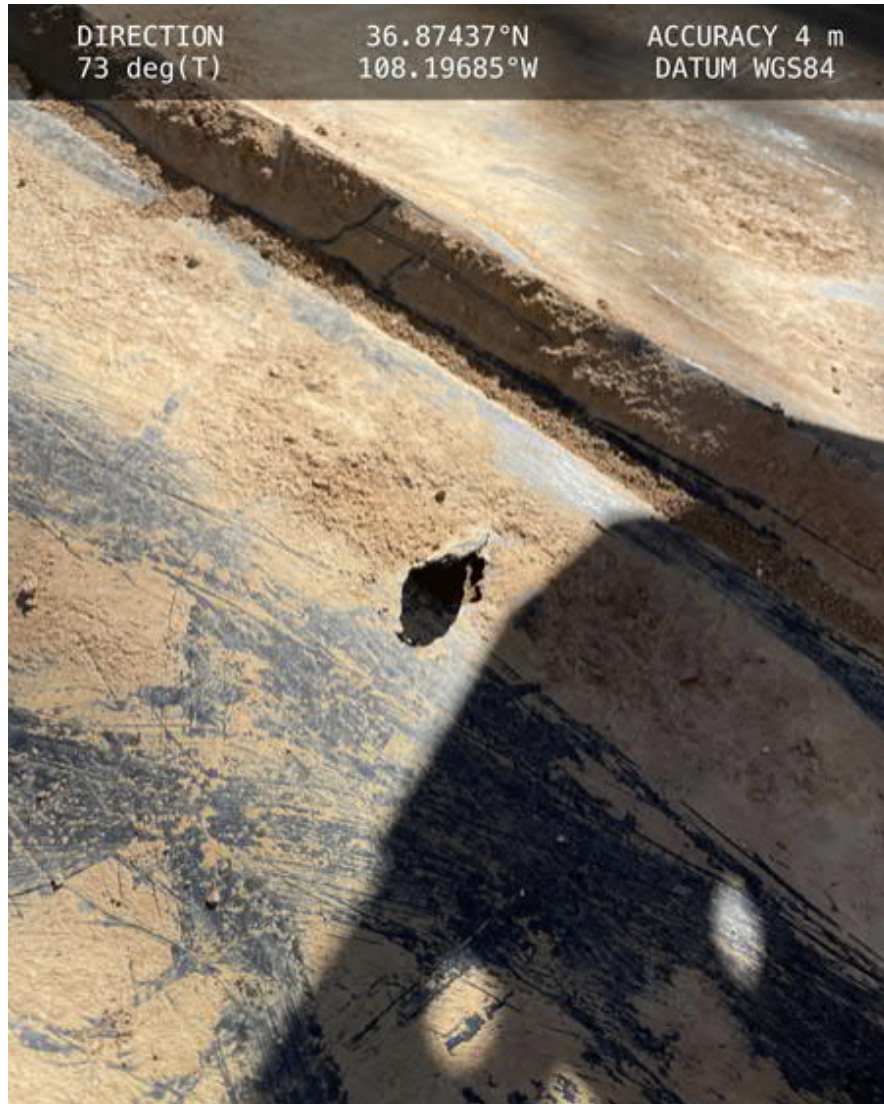
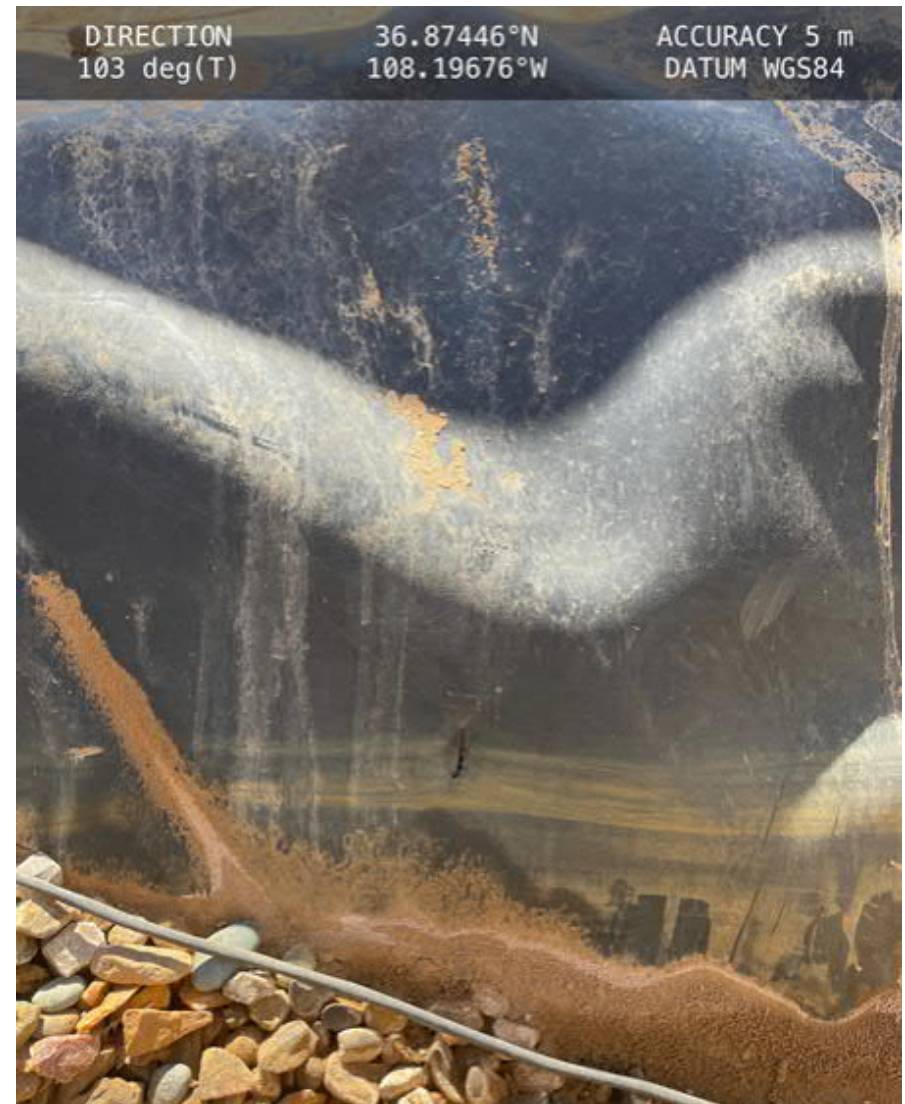
# Integrity Inspection 3

Example photographs are shown from the day of the liner inspection. However, as discussed with the NMOCD via email on June 28, 2022, when pulling back the gravel to expose the liner, shovels being used caused a few abrasions in the liner. This is not a trend all over the liner, but in a few random areas where the liner got poked on the day of the gravel removal. However, all abrasions observed were patched up.
