Site Characterization-Delineation Report

Double L Queen Tank Battery

Incident # NAPM2303746352

February 16, 2023

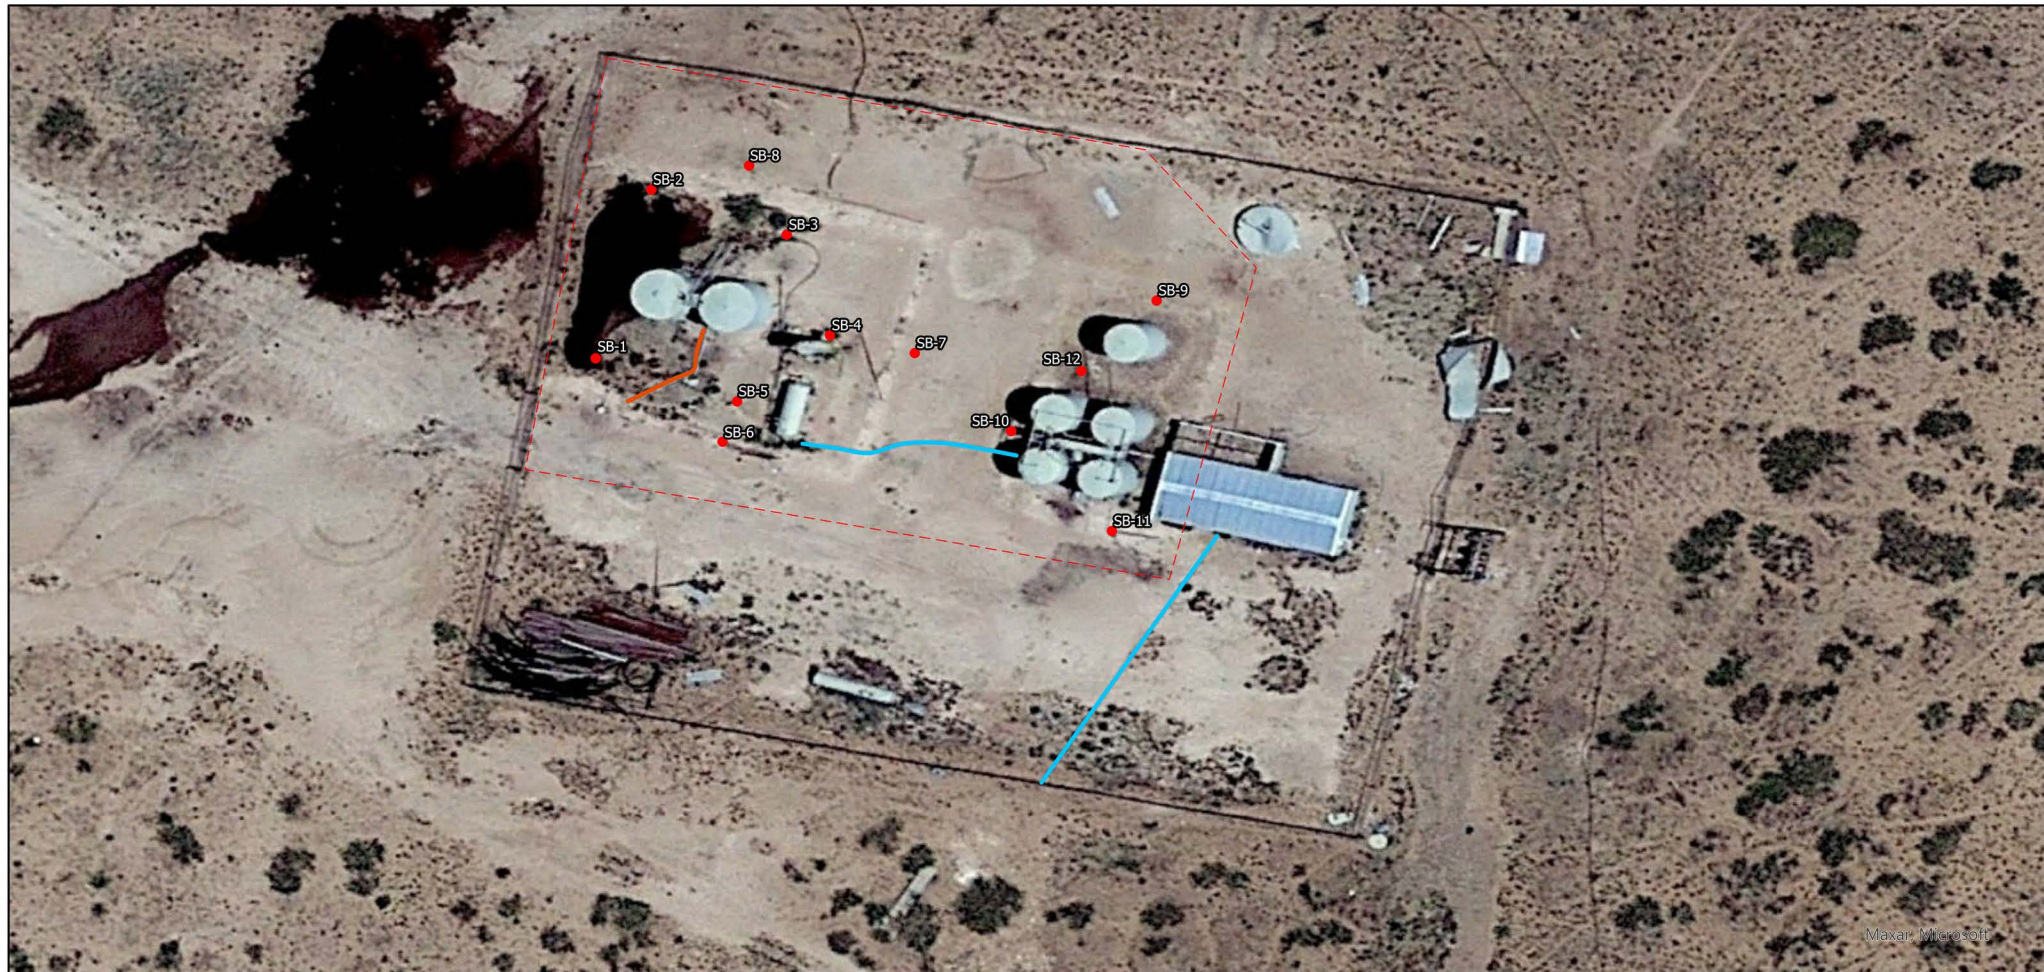
Figure # 3, Facility
Delineation Map

1. Approximately 26,652 square feet within the facility fencing is contaminated. Average depth of contamination is 2 to 3 feet bgs, with localized areas extending to 4 to 5 feet bgs. With an average depth of 3 feet, the estimated volume of impacted soil, including a 1.2 "soil fluff" factor, is 3,553 cubic yards. Note, these measurements do not include the pit located on the north central portion of the property (1997 aerial).

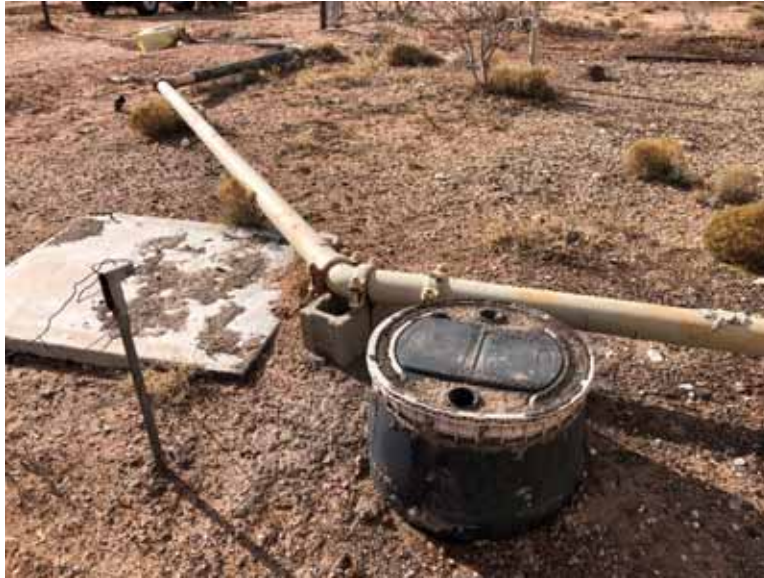
Photo 3: Surface Lines Tank Battery #1

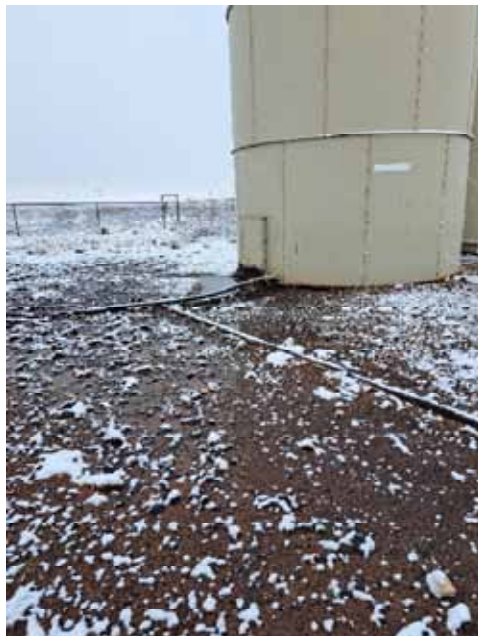
Photo 6: Tank #1 Release

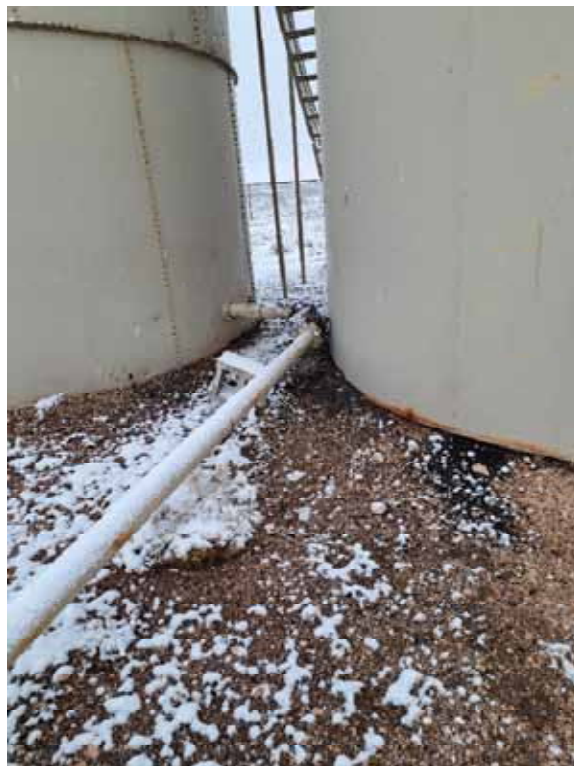
Photo 7: Release Between Tanks 1 and 2

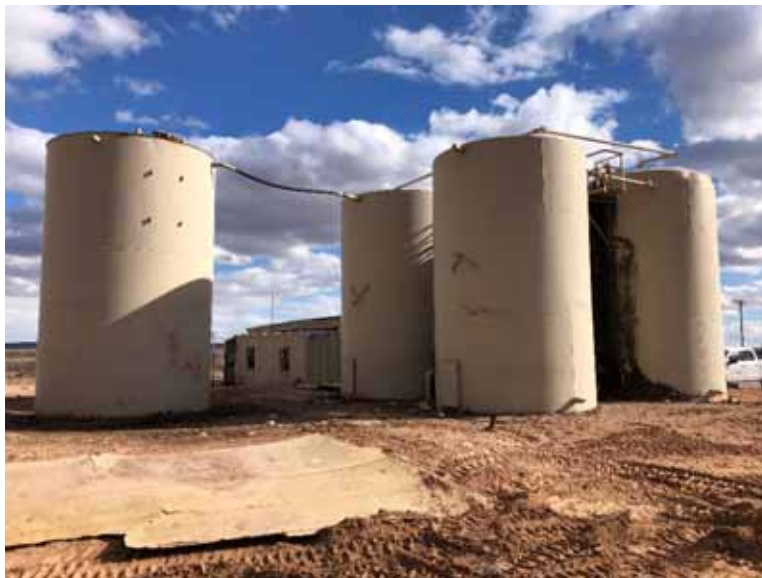
All tanks, except for #4 and #7, had atmospheres measured utilizing a calibrated four-gas meter. All atmospheres measured 0 parts per million (ppm) for hydrogen sulfide, carbon monoxide, and methane. Oxygen level was reported as 20.9% for all the tanks assessed. Significant surface staining was observed in both tank batteries and evidence of overflow was observed from the tanks in battery #2; see **Appendix C**.

Photo 9: Overflow Evidence Tank Battery #2

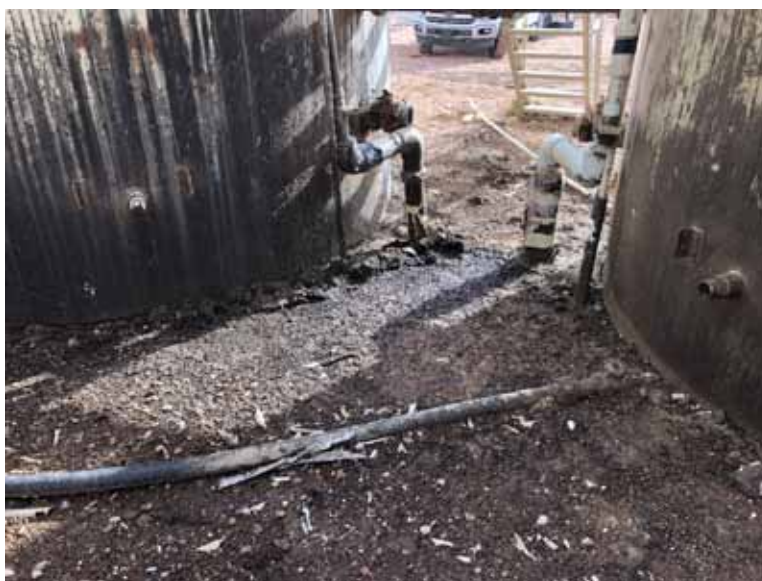
Photo 10: Release in Tank Battery #2

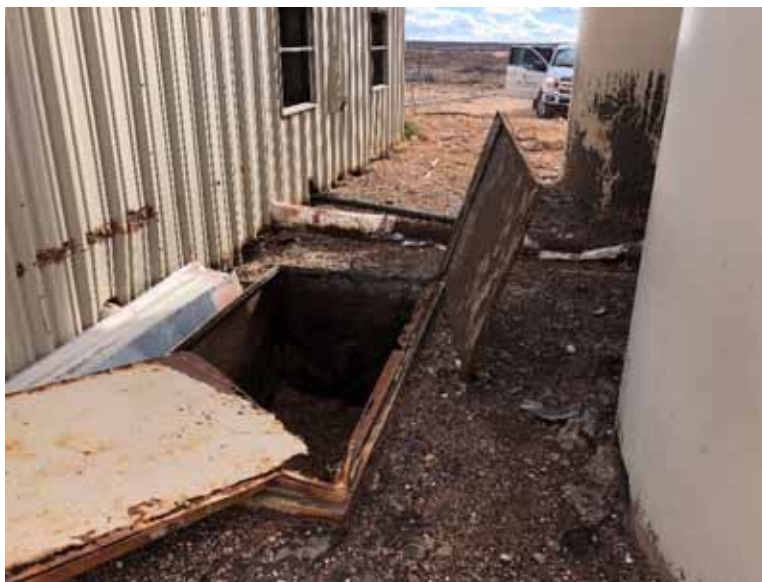
Photo 11: Contaminated Sump in Tank Battery #2

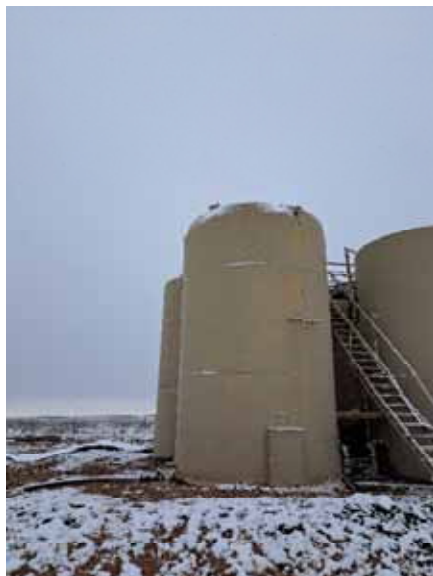
Tank 3: 380 bbl tank with 0.4 feet of tank bottoms/sludge. Tank shows evidence of expansion on the top and base.

Photo 15: Tank #3 with Expansion Damage

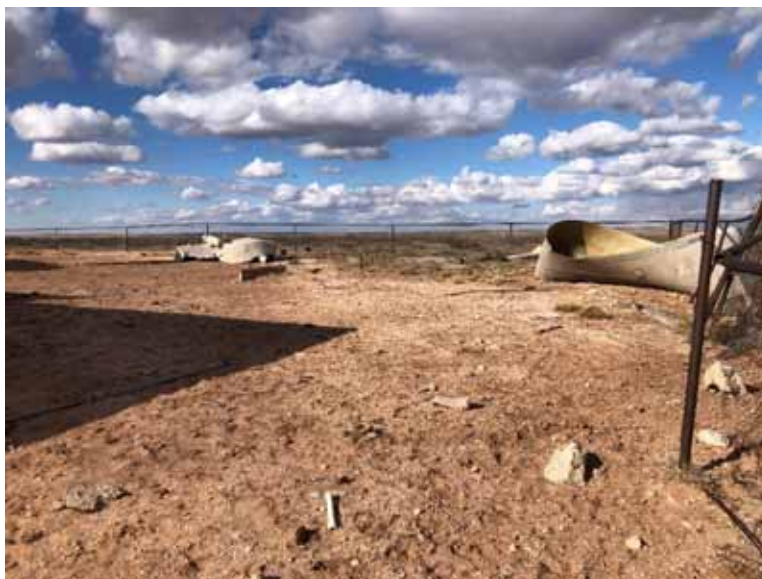
Equipment debris including pipes, damaged fiberglass tanks, a metal vessel, and office furniture were observed along the perimeter of the yard and inside the building. Surface lines were observed from: tank battery #1 to the containment berm; from the separator to tank battery #2;

Photo 16: Debris

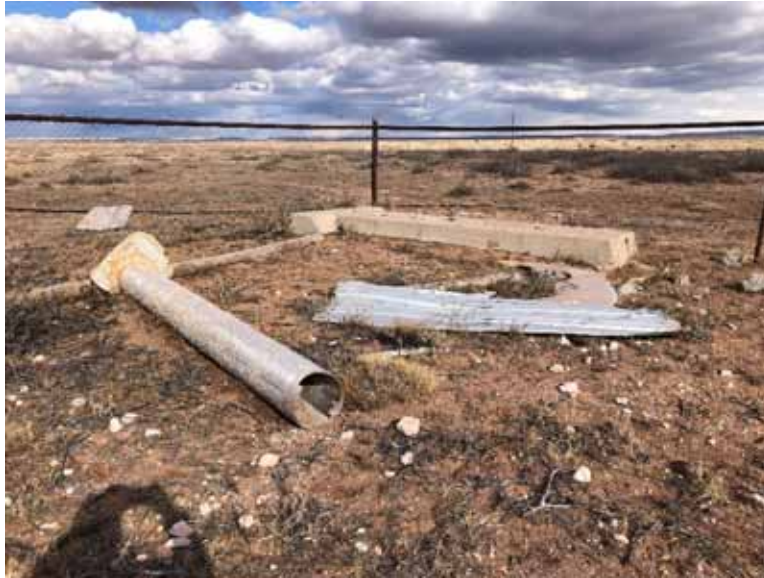
Photo 17: Debris

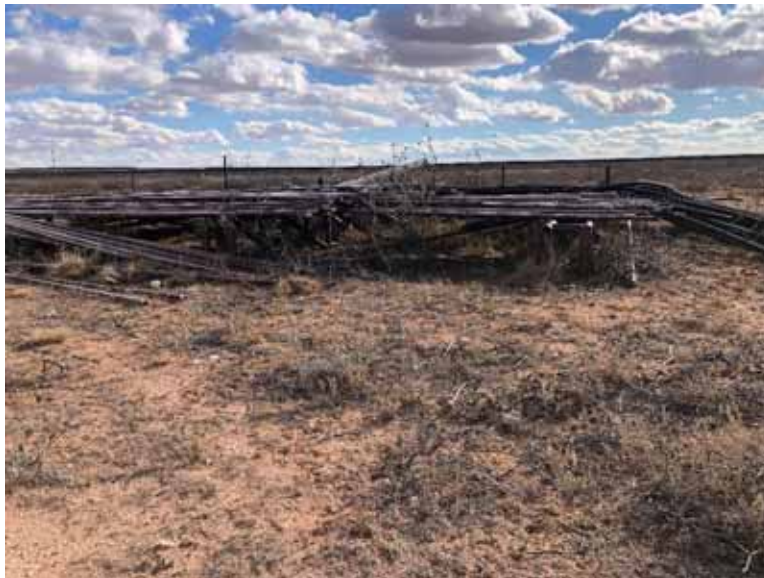
Photo 18: Pipe Debris

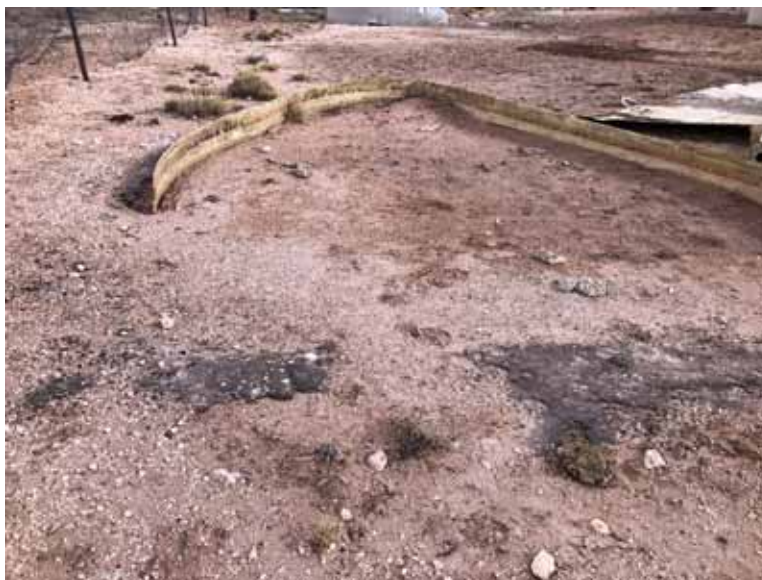
Photo 19: Asphaltine in Former Pit Area

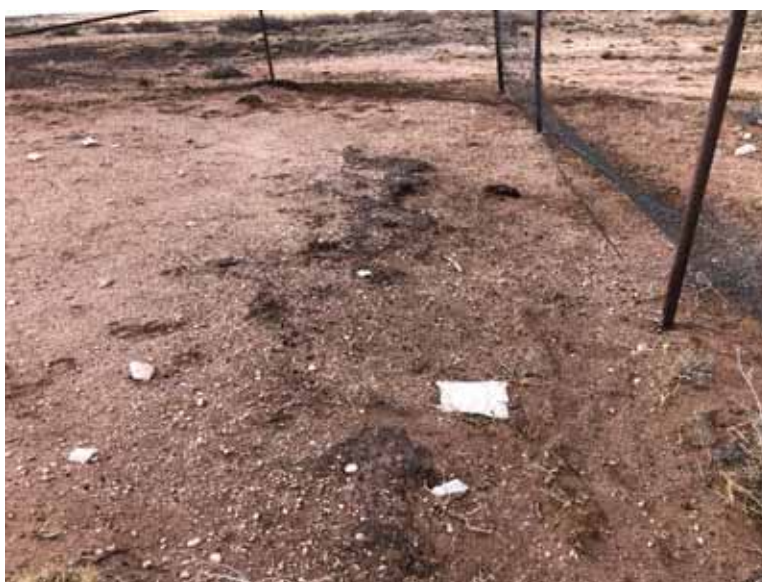
Photo 20: Asphaltine in Northwest Corner

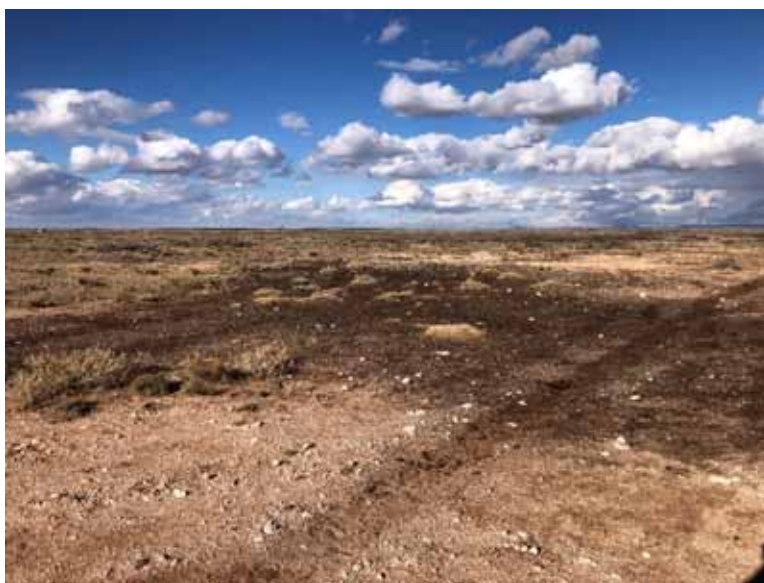
2. The spill path and bare area outside of fence encompass approximately 26,300 square feet. The average depth of contamination along the spill path is 2 feet bgs, with localized areas extending to 4 feet. Based on these measurements approximately 2,500 cubic yards can be anticipated to undergo remediation actions.
3. Facility demolition debris is estimated to include seven (7) tanks, 165 to 200 cubic yards of building debris, three (3) vessels, and miscellaneous metal and fiberglass debris (pipes, windblown metal etc).

Photo 22: Release Outside of Facility
