LINER INSPECTION AND CLOSURE REPORT **REPORTABLE RELEASE**

Spur Energy Partners
Clydesdale 1 Fee #6H Battery
Incident ID: NAPP2130547657
Eddy County, NM

Paragon Environmental LLC
1601 N. TURNER ST. STE.500
Hobbs, NM 88240
575-964-7814

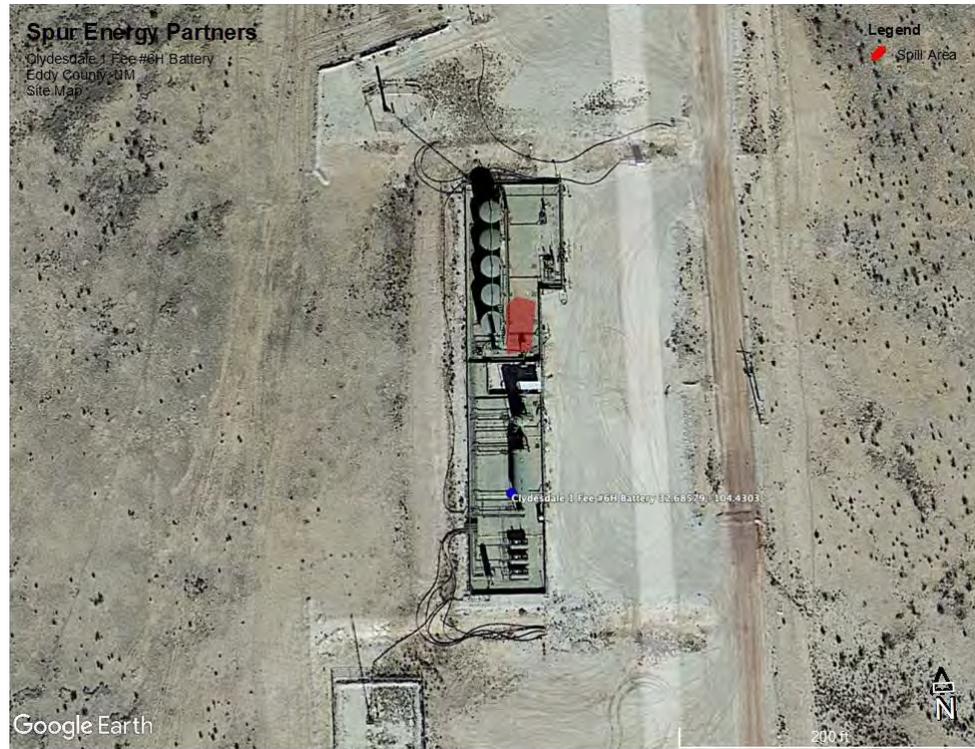
On July 12, 2022, Paragon went to the Clydesdale and conducted an initial assessment. There was obvious staining on the liner from the spill. There was nothing outside the containment that showed any signs that the liner had been breached. Therefore, no samples were taken. See the site map below showing the affected area.

On July 18, 2022, Paragon returned to the site with equipment and personnel to conduct cleanup activities. We initially sprayed the affected area with surface cleaner. We then power washed and squeegeed the runoff to where the vacuum truck could capture the fluids.

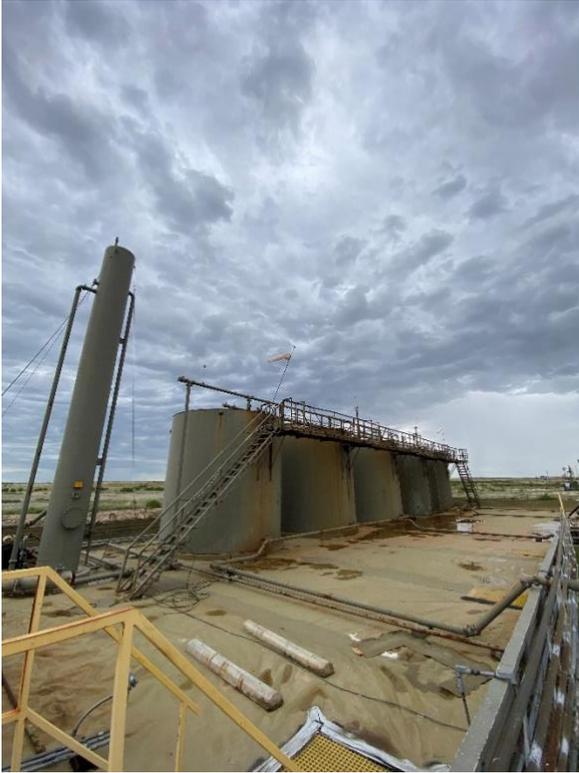
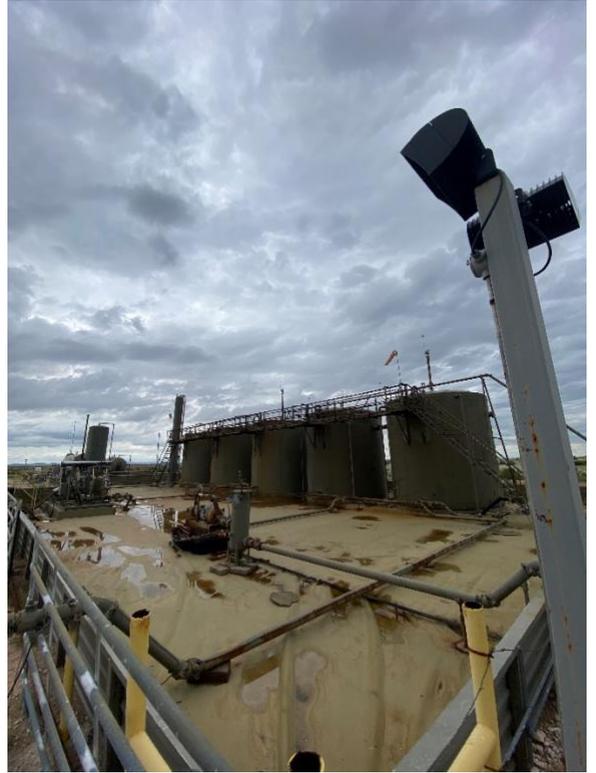
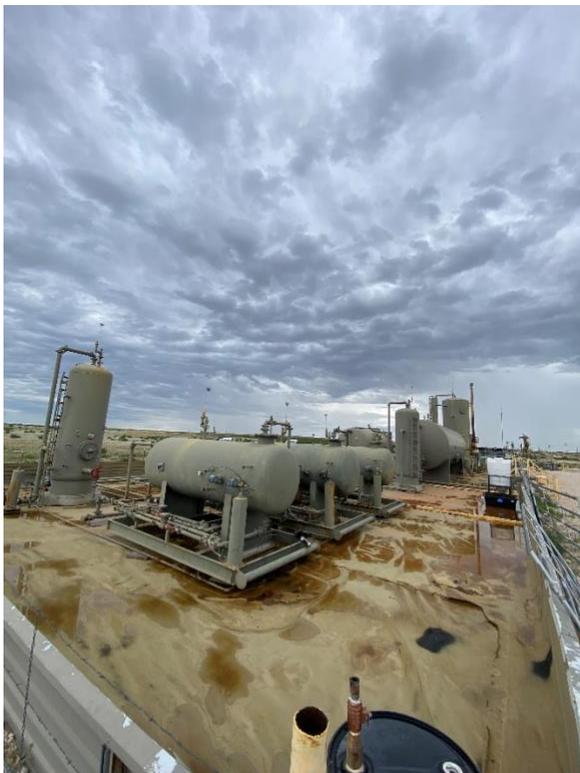
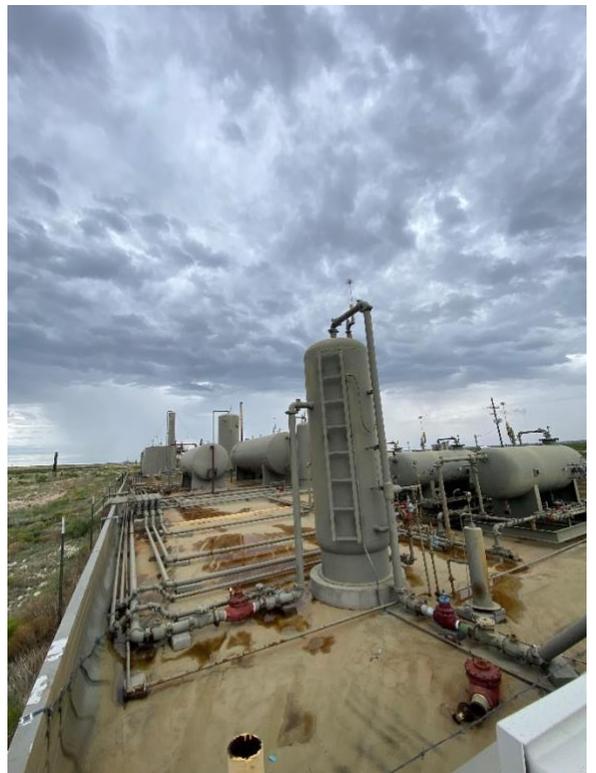
Liner Inspection

On July 20, 2022, Paragon returned to the site to conduct a liner inspection. A 48-hour notification was sent out to the NMOCD on July 18, 2022. The liner inspection concluded that the liner was all intact and in good condition. The integrity of the liner appears to have the ability to contain spills. See Appendix D for the email notification and liner report.

Visualization	Yes	No	Comments
Is there a tear in the liner?		x	
Are there holes in the liner?		x	
Is the liner retaining any fluids?		x	
Does the liner have integrity to contain a leak?	x
