# LINER INSPECTION CLOSURE REPORT

Incident ID NAPP2418140217

Big Cat 16 CTB 9

Prepared By: Pima Environmental Services, LLC

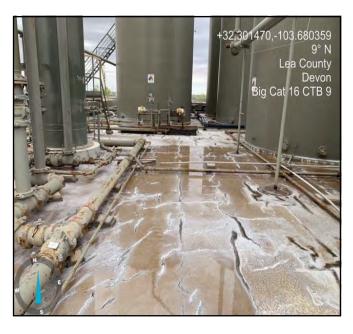
Photo of liner prior to power washing, taken facing North.

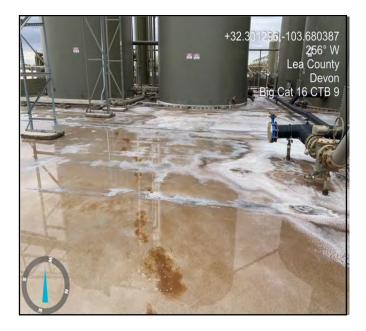
Photo of liner prior to power washing, taken facing West.

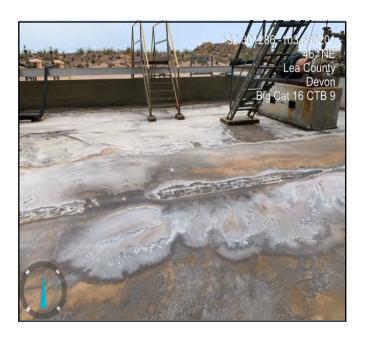
Photo of liner prior to power washing, taken facing Northeast.

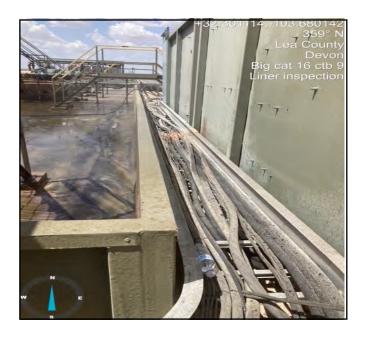
Photo taken of liner after power washing, taken facing North.

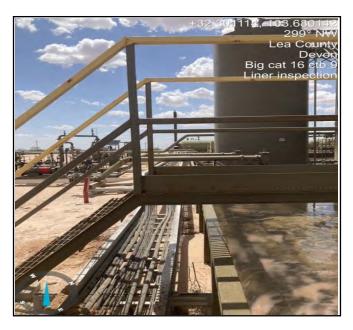
Photo taken of liner after power washing, taken facing Northwest.

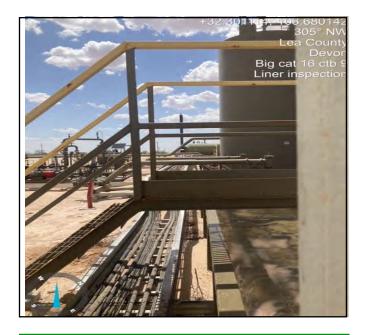
Photo taken of liner after power washing, taken facing Northwest

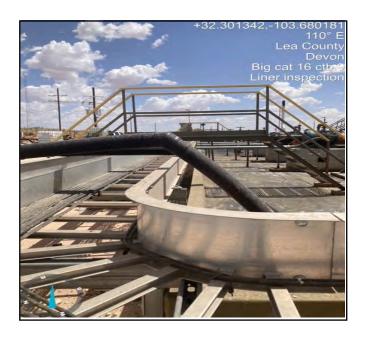
Photo taken of liner after power washing, taken facing Southeast.

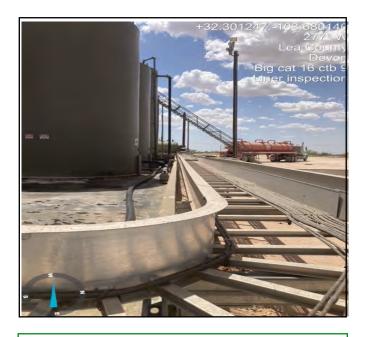
Photo of liner taken after power washing, taken facing Northwest.

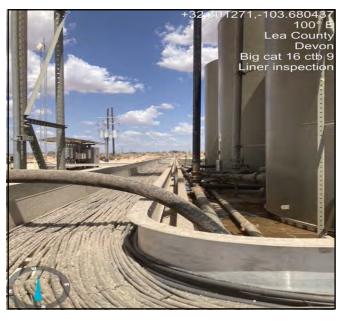
Photo of liner after power washing, taken facing Southeast.

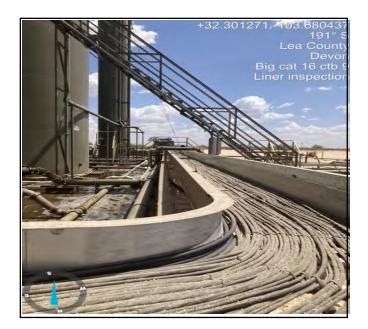
Photo of liner taken after power washing, taken facing Southwest.

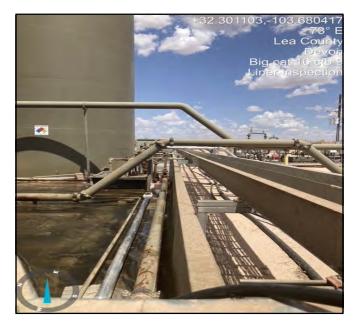
Photo of liner taken after power washing, taken facing Northeast.

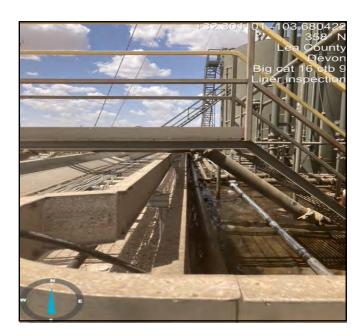
Photo of liner taken after power washing, taken facing North.
