RE: Liner Inspection and Closure Report

Fighting Okra 18 CTB 3

NMOCD Reference No. NAPP2415971627

Devon Energy Production Company (Devon) has contracted Pima Environmental Services, LLC (Pima) to perform a liner inspection and prepare this closure report for a produced water release that happened at the Fighting Okra 18 CTB 3 (Fighting Okra). This incident was assigned Incident ID: NAPP2415971627, by the New Mexico Oil Conservation Division (NMOCD).

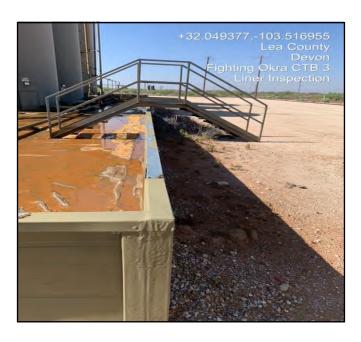
Northwest facing South photo of lined containment prior to power washing. (Fluid from release.)

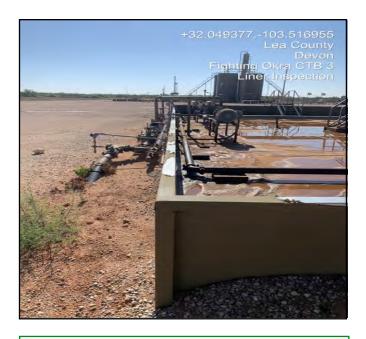
Northwest facing West photo of lined containment prior to power washing. (Fluid from release.)

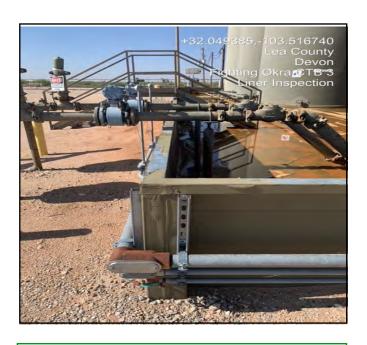
Northeast facing South photo of lined containment prior to power washing. (Fluid from release.)

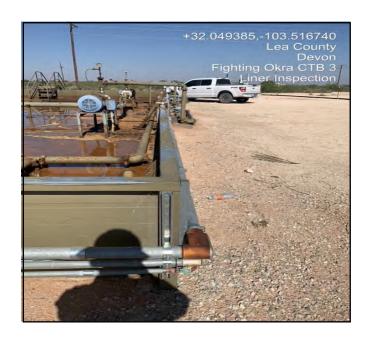
Northeast facing West photo of lined containment prior to power washing. (Fluid from release.)

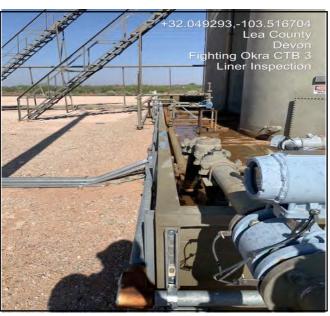
Southwest facing West photo of lined containment prior to power washing. (Fluid from release.)

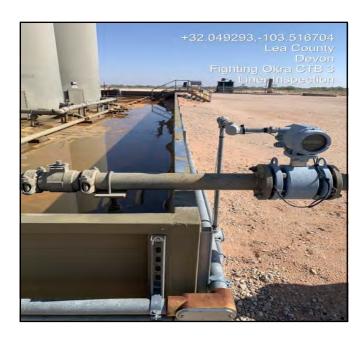
Southeast facing North photo of lined containment prior to power washing. (Fluid from release.)

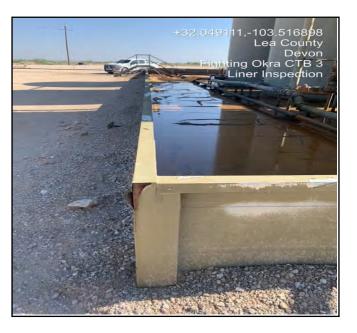
Southwest facing North photo of lined containment prior to power washing. (Fluid from release.)

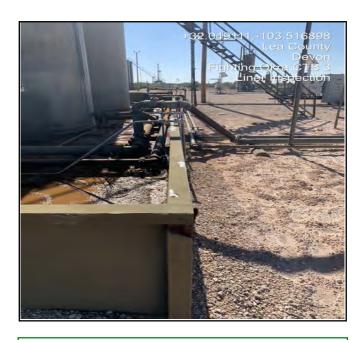
Southwest facing East photo of lined containment prior to power washing. (Fluid from release.)

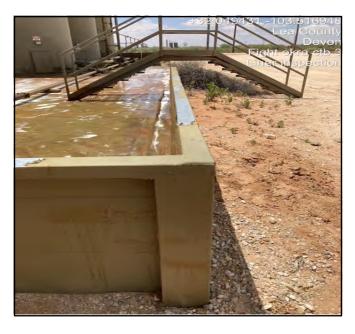
Northwest facing South photo of lined containment after power washing. (Fluid from power washing.)

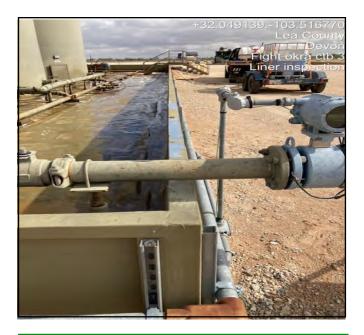
Southeast facing North photo of lined containment after power washing. (Fluid from power washing.)

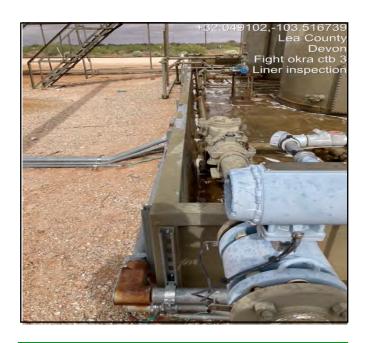
Southeast facing West photo of lined containment after power washing. (Fluid from power washing.)

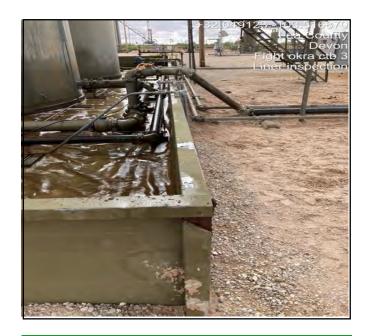
Southwest facing East photo of lined containment after power washing. (Fluid from power washing.)

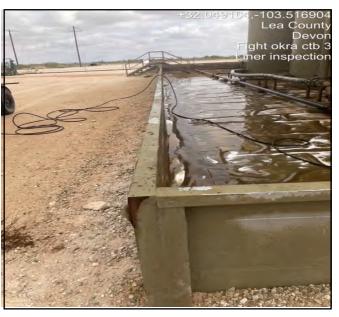
Southwest facing North photo of lined containment after power washing. (Fluid from power washing.)

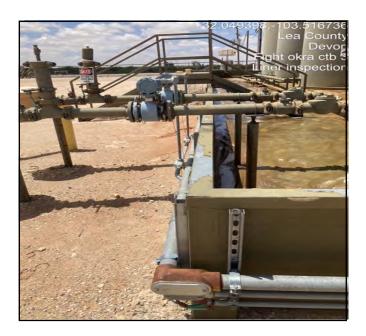
Northeast facing South photo of lined containment after power washing. (Fluid from power washing.)

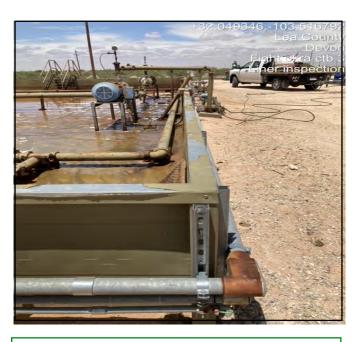
Northeast facing West photo of lined containment after power washing. (Fluid from power washing.)

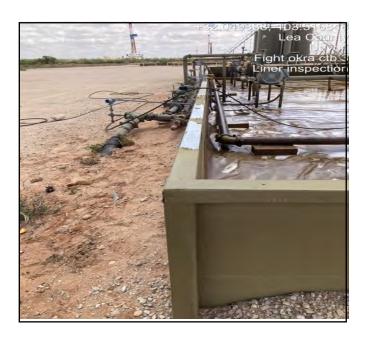
Northwest facing East photo of lined containment after power washing. (Fluid from power washing.)

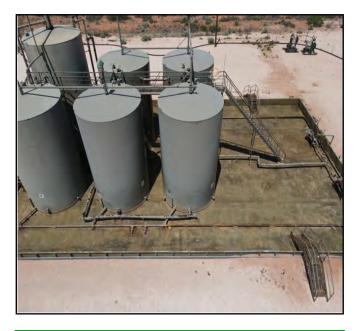
East facing West Aerial photo of lined containment after power washing.

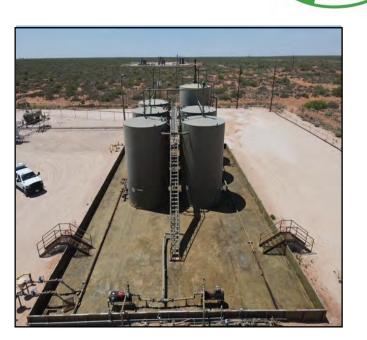
North facing South Aerial photo of lined containment after power washing.

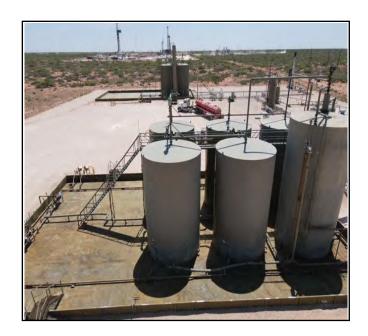
West facing East Aerial photo of lined containment after power washing.

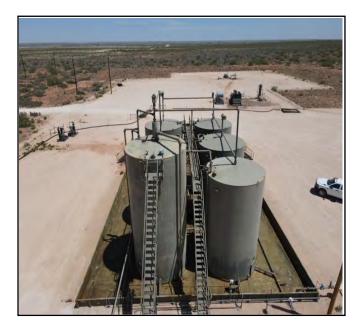
South facing North Aerial photo of lined containment after power washing.
