# LINER INSPECTION CLOSURE REPORT

**Big Cat 16 CTB 9**

**RE: Liner Inspection and Closure Report**  
**Big Cat 16 CTB 9**  
**Facility ID: fAPP2129926862**  
**GPS : Latitude 32.30099102 Longitude -103.680727**  
**UL- K, Section 16, Township 23S, Range 32E**  
**Lea County, NM**  
**NMOCD Reference No. NAPP2421123414**

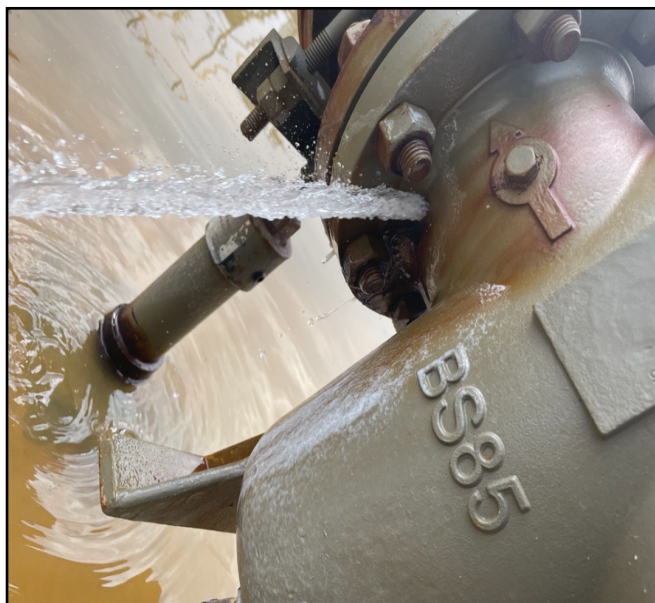
Photo documenting point of release, prior too powerwashing.

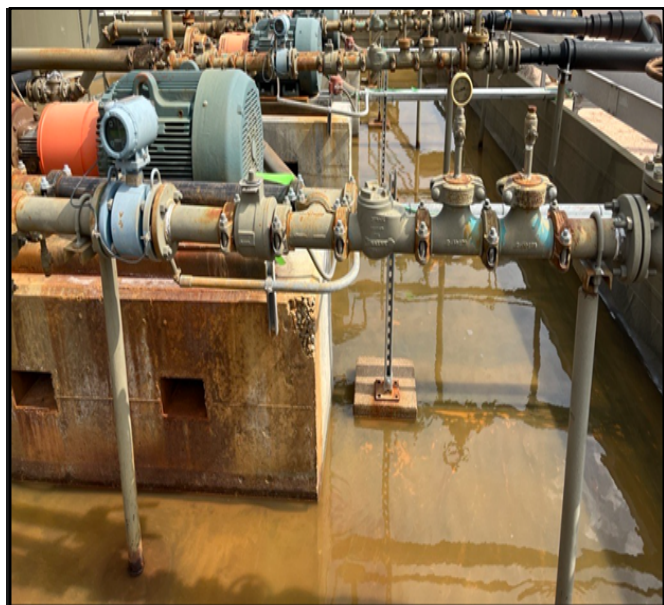
Photo documenting release, prior to power washing.

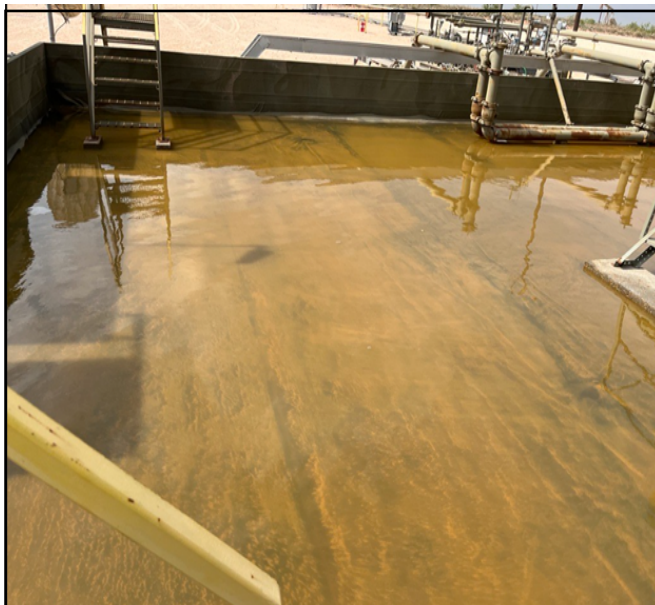
Photo documenting release, prior to power washing.

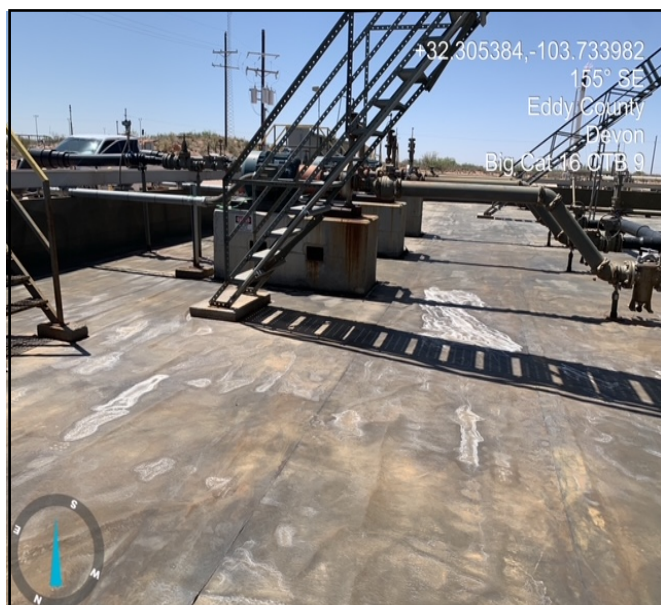
Photograph depicting the condition of the liner following the extraction of produced water by a vacuum truck, oriented facing Southeast.

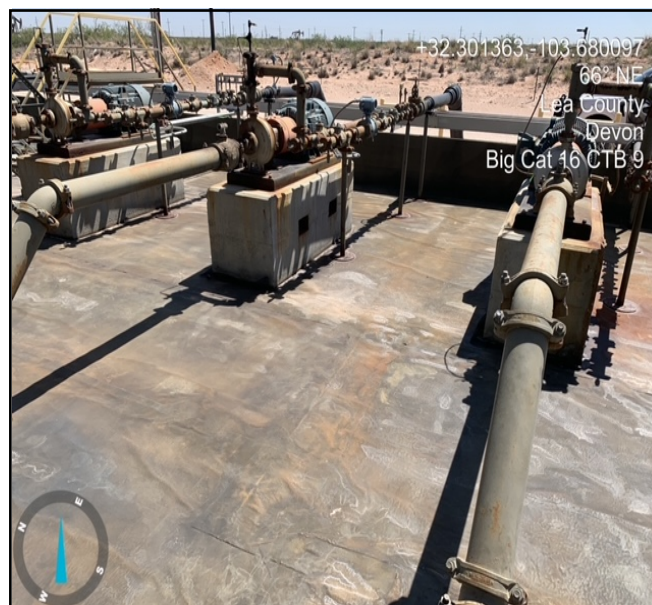
Photograph depicting the condition of the liner following the extraction of produced water by a vacuum truck, oriented facing Northeast.

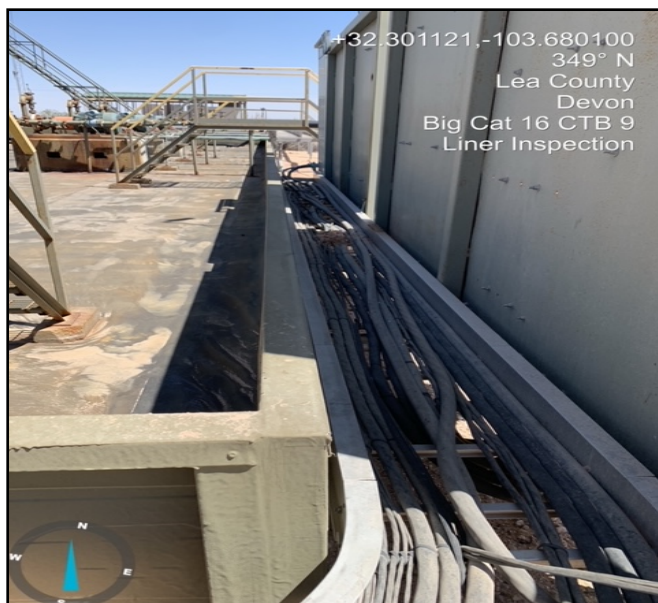
Photograph depicting the condition of the liner following the extraction of produced water by a vacuum truck, oriented facing North.

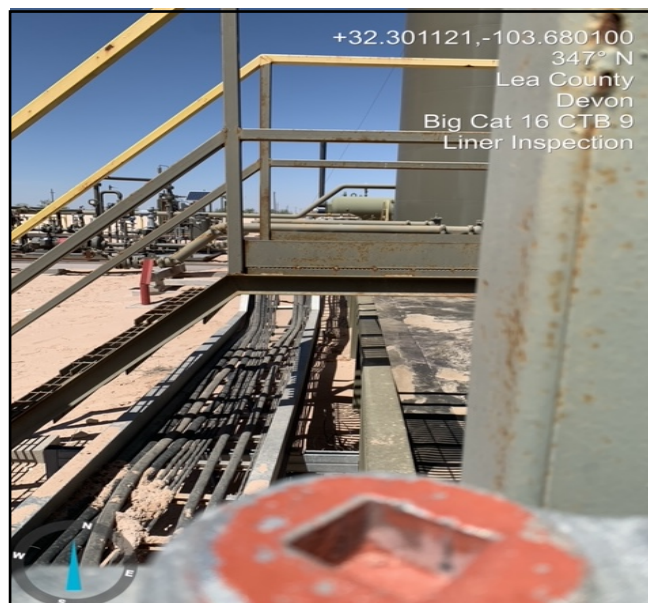
Photograph depicting the condition of the liner following the extraction of produced water by a vacuum truck, oriented facing North.

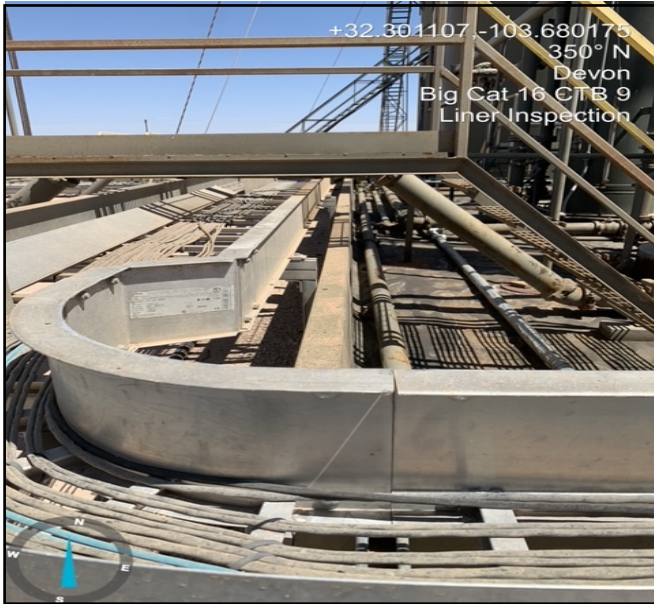
Photograph depicting the condition of the liner following the extraction of produced water by a vacuum truck, oriented facing North.

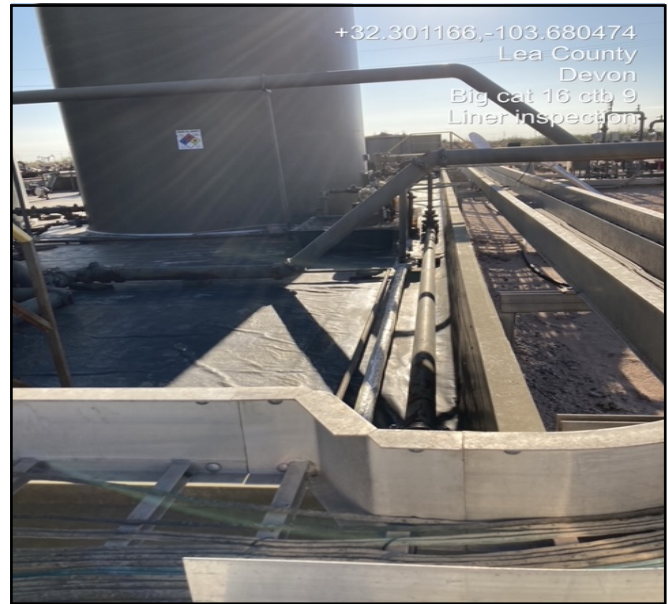
Photograph depicting the condition of the liner following the extraction of produced water by a vacuum truck.

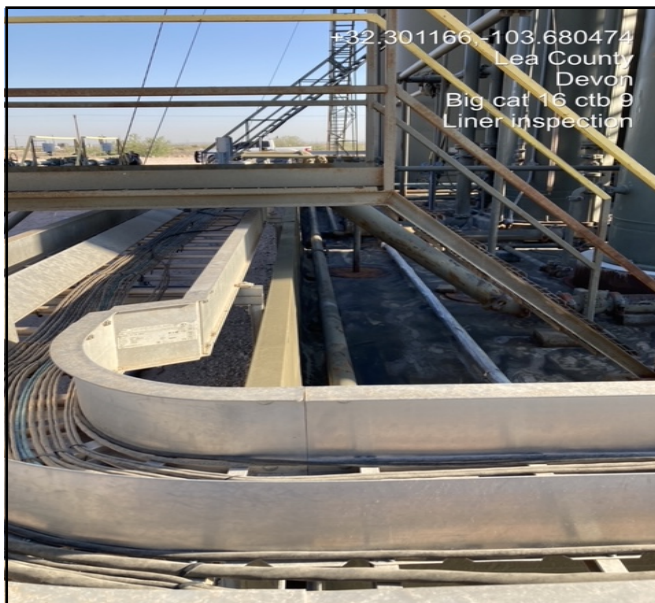
Photograph depicting the condition of the liner following the extraction of produced water by a vacuum truck, oriented facing.

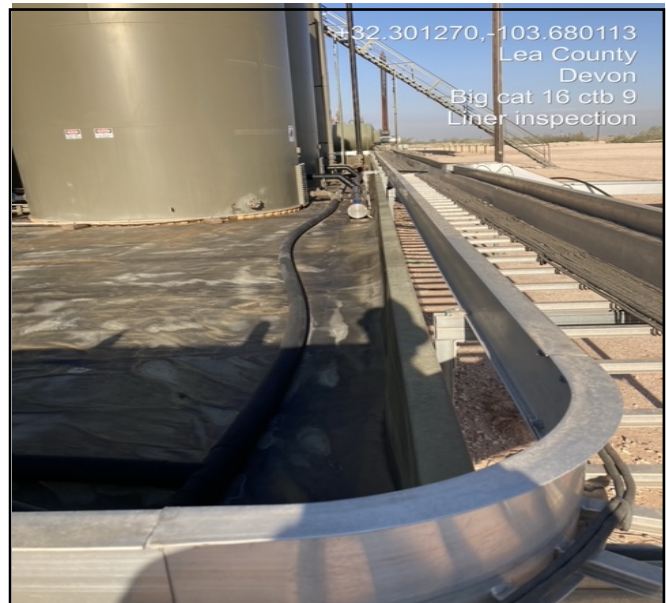
Photograph depicting the condition of the liner following the extraction of produced water by a vacuum truck, oriented facing.

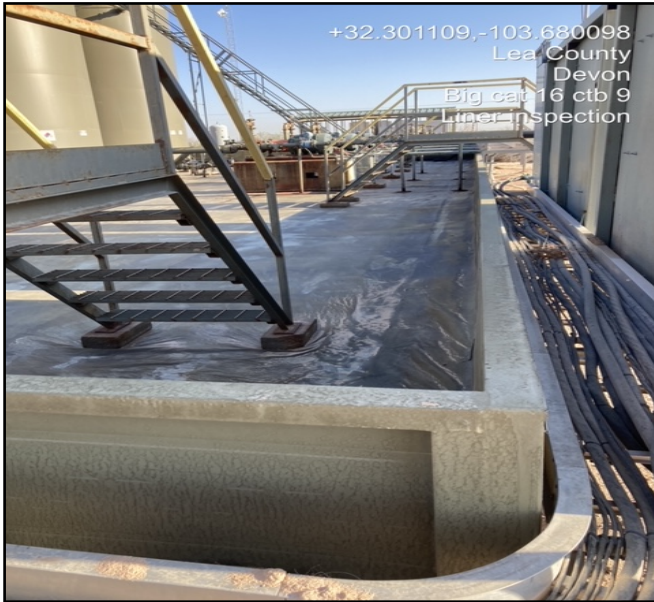
Photograph depicting the condition of the liner following the extraction of produced water by a vacuum truck, oriented facing.

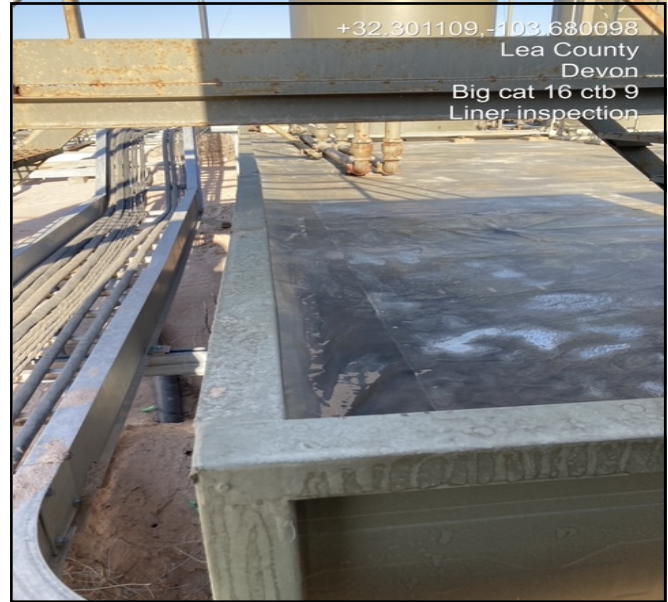
Photograph depicting the condition of the liner following the extraction of produced water by a vacuum truck, oriented facing.

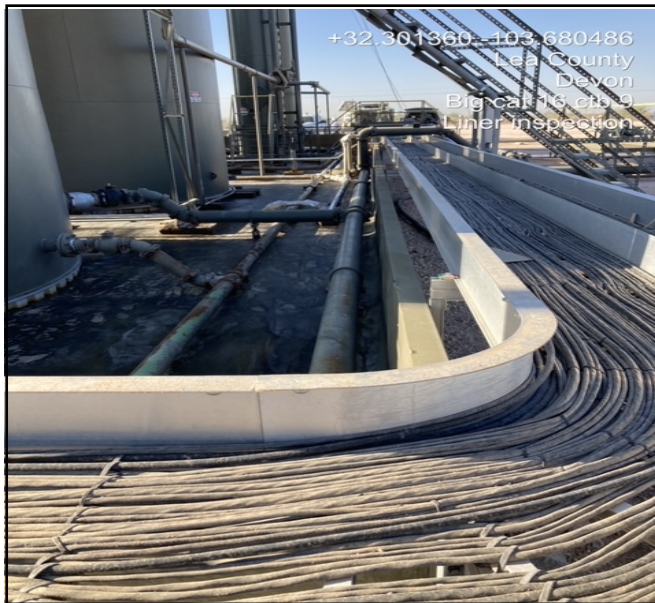
Photograph depicting the condition of the liner following the extraction of produced water by a vacuum truck, oriented facing.

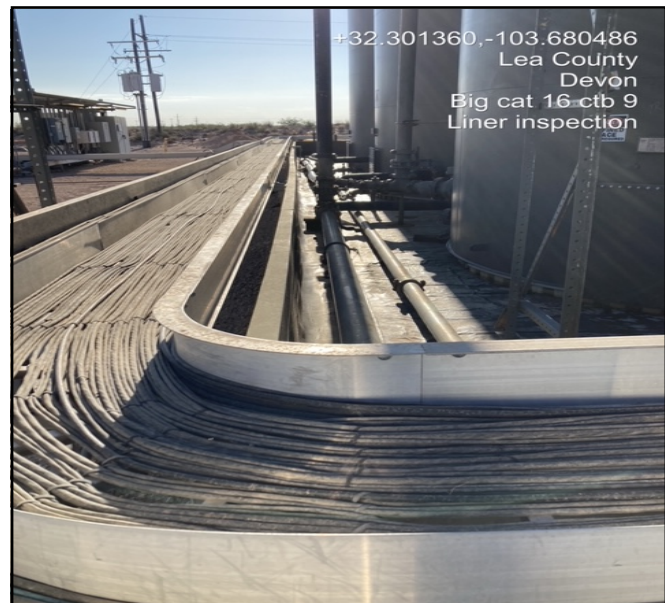
Photograph depicting the condition of the liner following the extraction of produced water by a vacuum truck, oriented facing.

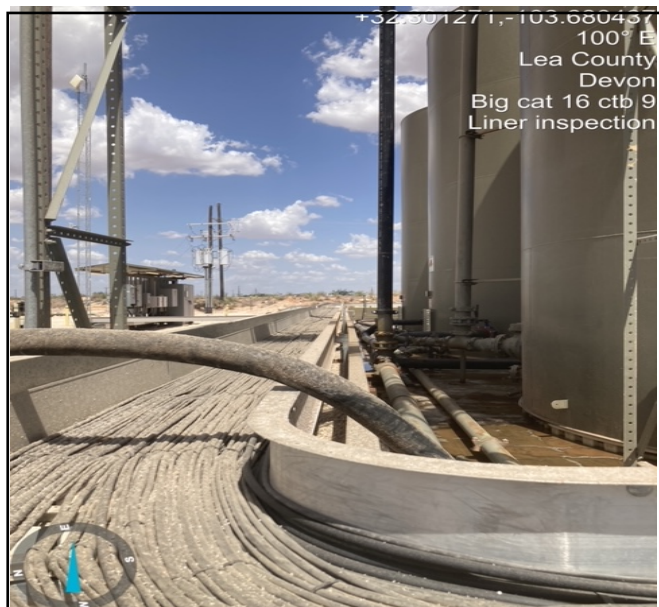
Photo of liner pursuant to power washing, taken facing Southeast. (Fluid from power washing.)

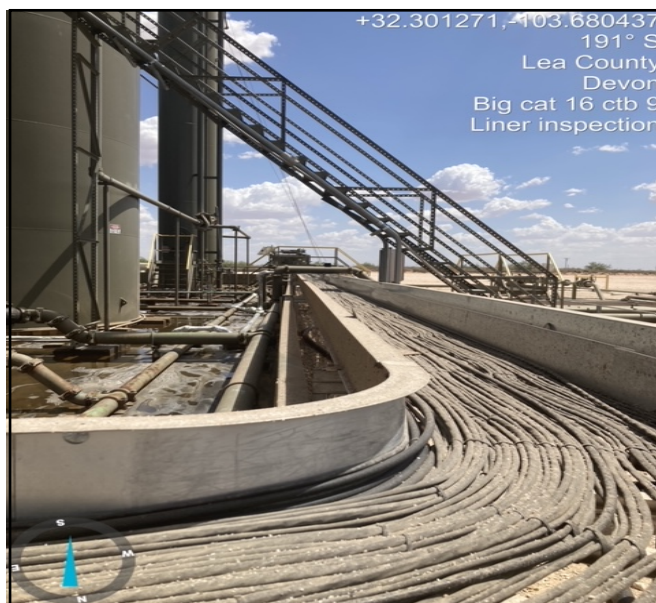
Photo of liner pursuant to power washing, taken facing Southwest. (Fluid from power washing.)

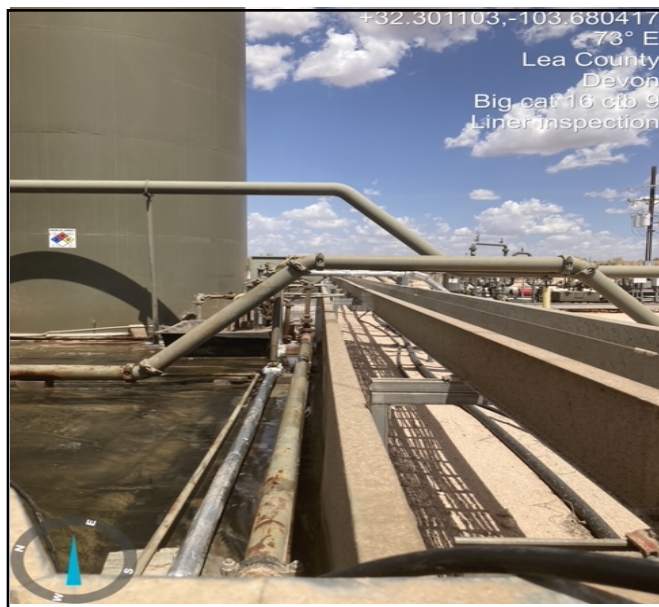
Photo of liner pursuant to power washing, taken facing Northeast. (Fluid from power washing.)

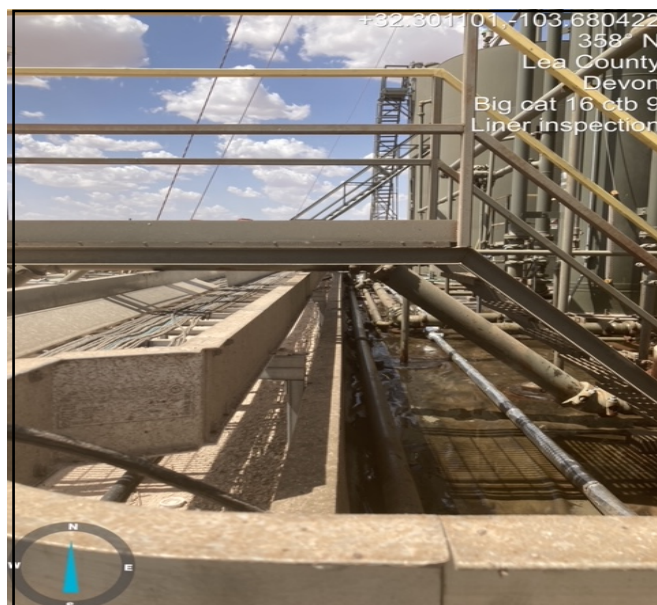
Photo of liner pursuant to power washing, taken facing North. (Fluid from power washing.)

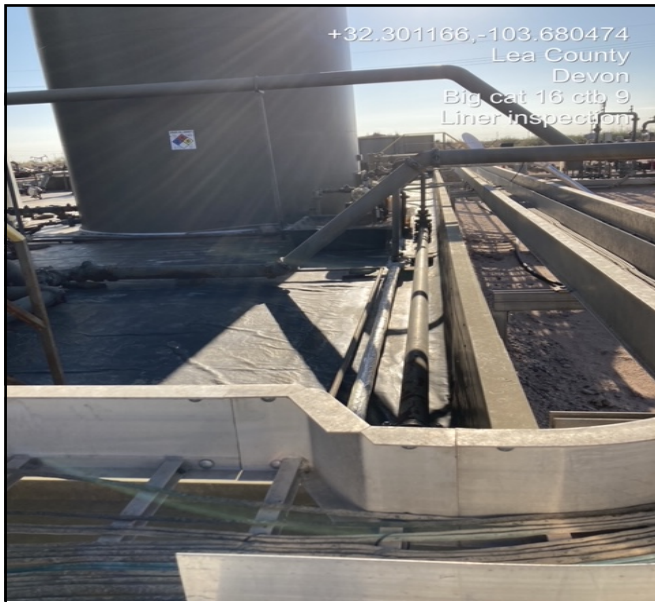
Photo of liner pursuant to power washing.  
(Fluid from power washing.)

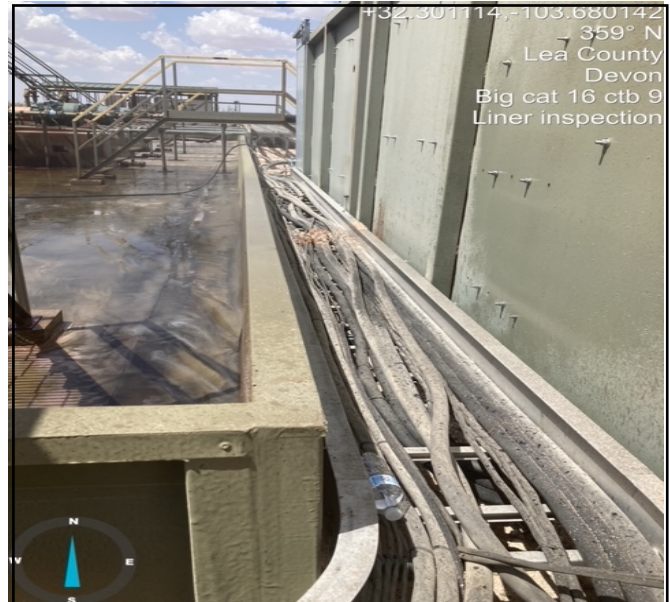
Photo of liner pursuant to power washing, taken facing North. (Fluid from power washing.)

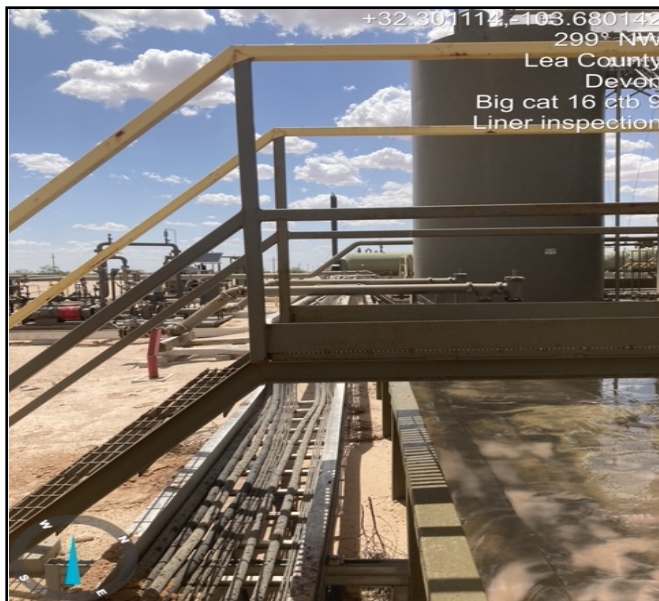
Photo of liner pursuant to power washing, taken facing Northwest. (Fluid from power washing.)

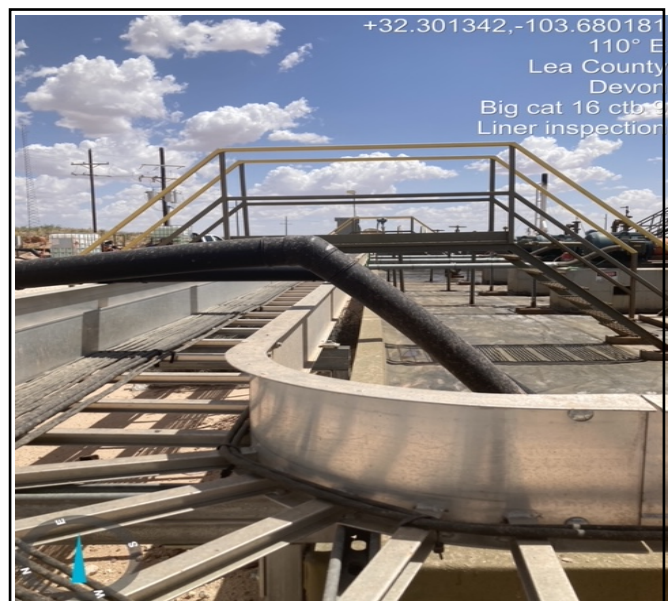
Photo of liner pursuant to power washing, taken facing Southeast. (Fluid from power washing.)

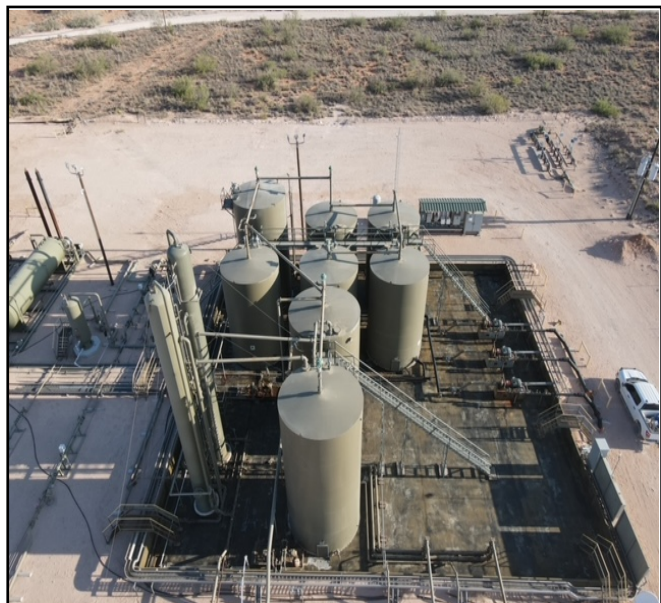
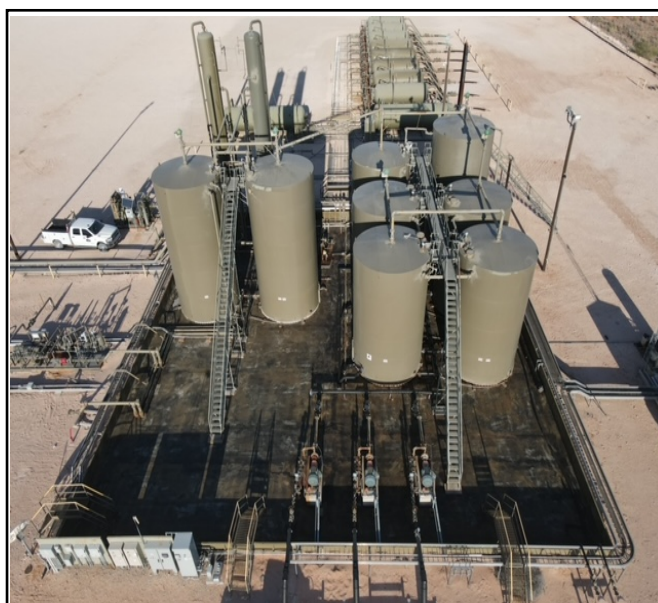
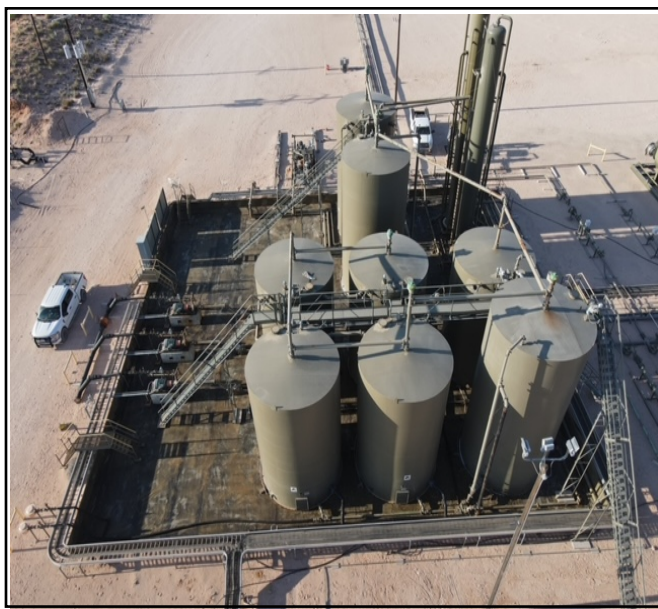
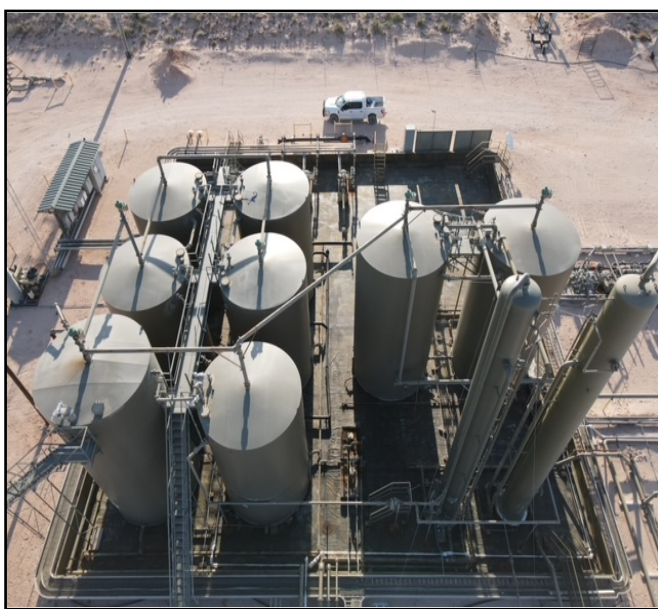
Aerial photo of liner.
