# Liner Inspection Closure Report

Incident ID nAPP2422072363

## Coral PWU 28 Battery

Prepared by Pima Environmental Services, LLC for  
Devon Energy Production, LP

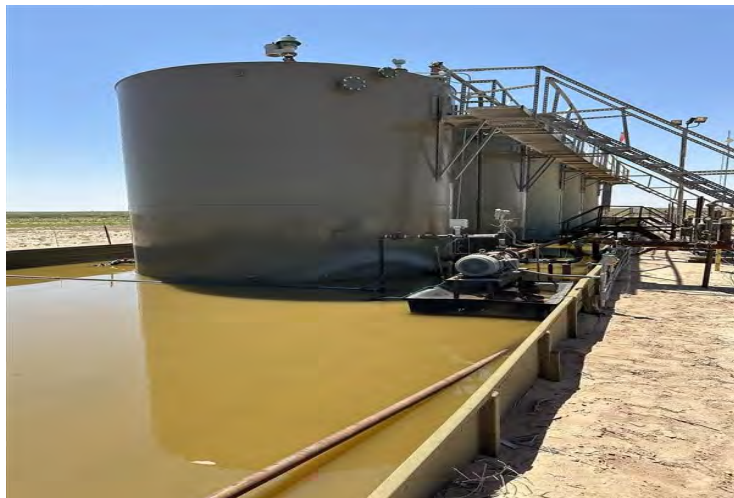
Contained spill 1

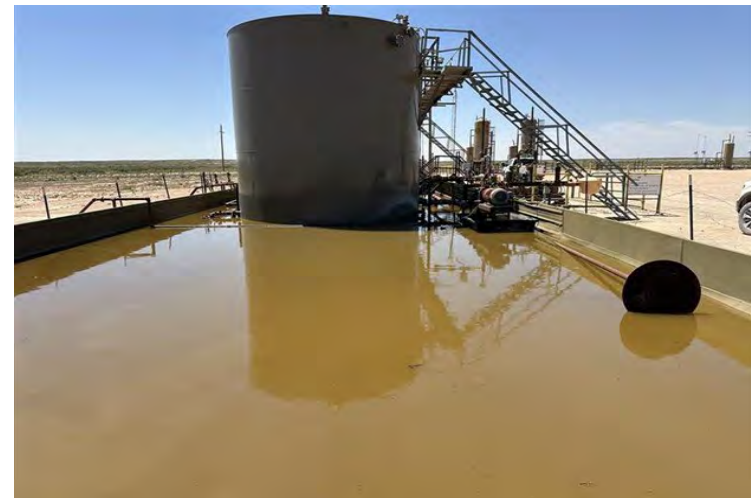
Contained spill 2
