# LINER INSPECTION CLOSURE REPORT

**FLOOFY CAT 21 CTB 2**

Prepared By:  
Pima Environmental Services, LLC

**RE: Liner Inspection and Closure Report  
Floofy Cat 21 CTB 2  
Facility ID: fAPP2311542151  
GPS : Latitude 32.2856501 Longitude -103.6794717  
UL- O, Section 21, Township 23S, Range 32E  
Lea County, NM  
NMOCD Reference No. NAPP2424476743**

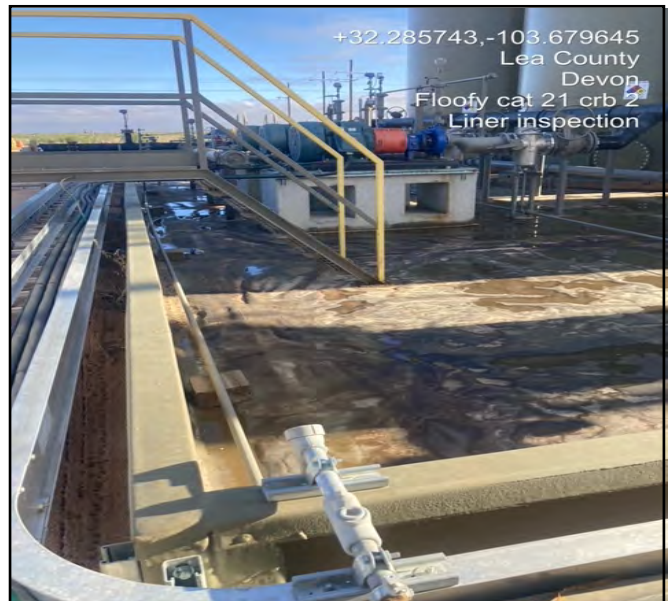
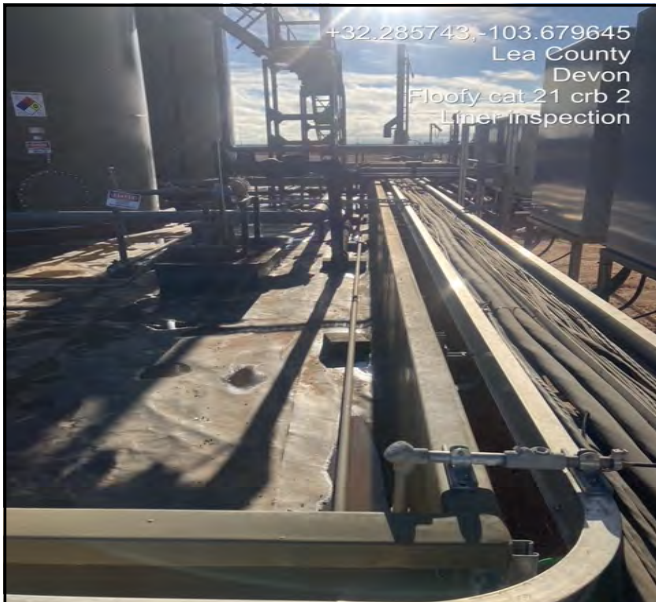
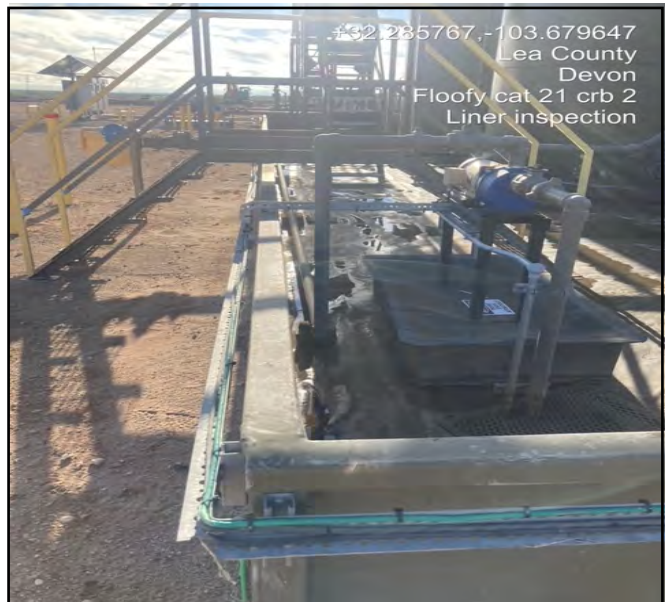
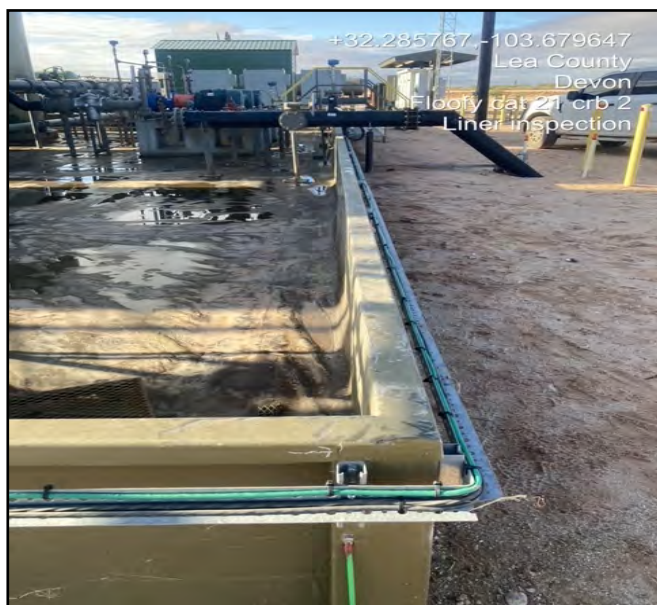
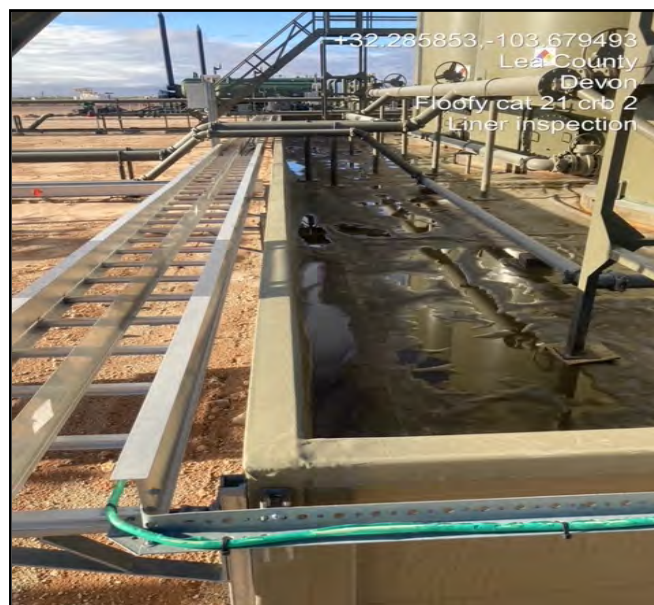
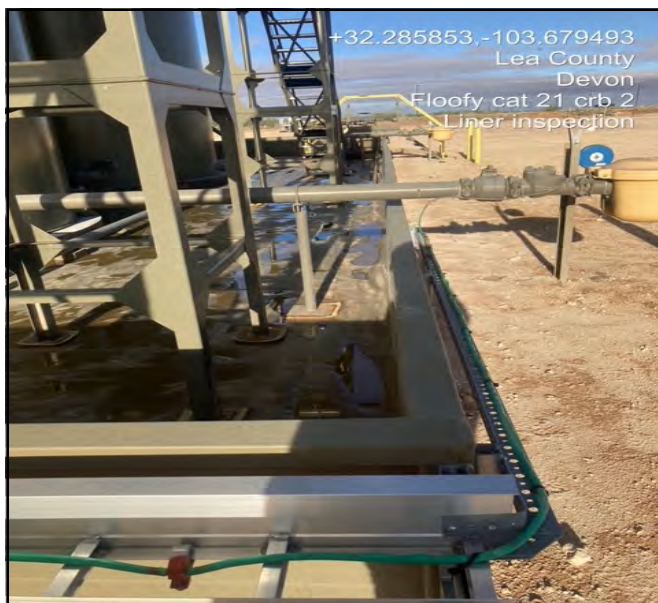
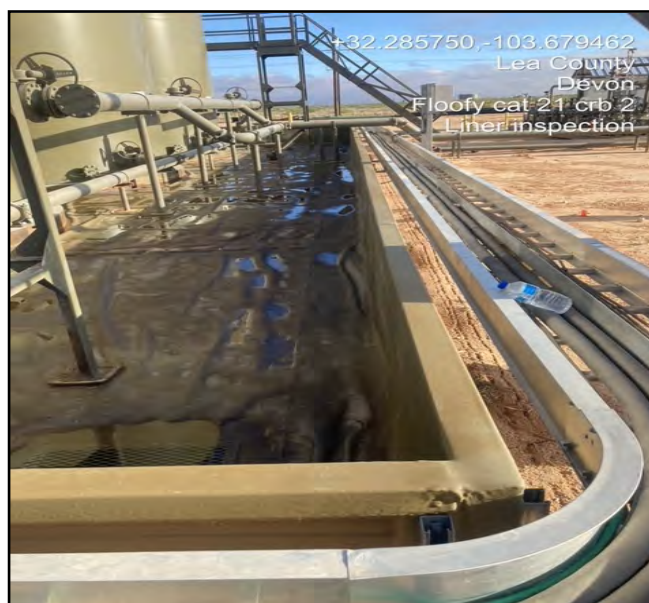
On September 11, 2024, after submitting the 48-hour notification application ID: 381656 to the OCD, Pima Environmental conducted a liner inspection at this location. Pima concluded that the liner and containment maintained their integrity and successfully retained the fluids. The 48- hour notification and liner inspection form can be found in Appendix C. Photographic documentation can be found in Appendix D.

Photograph depicting the condition of the liner.

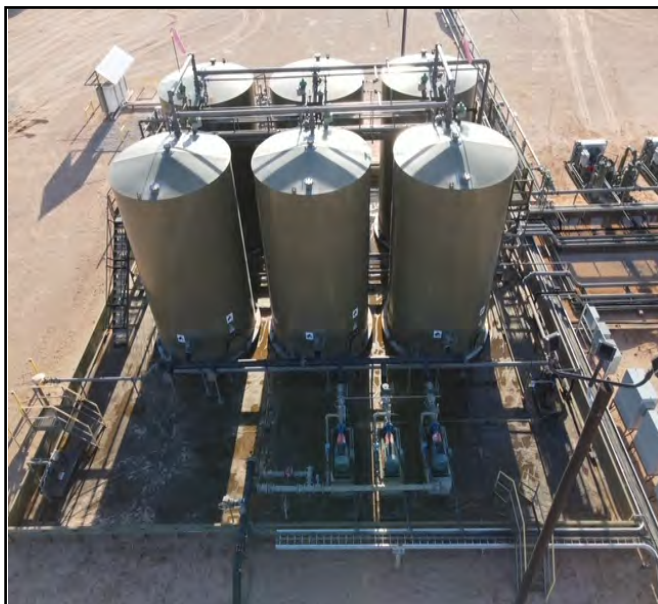
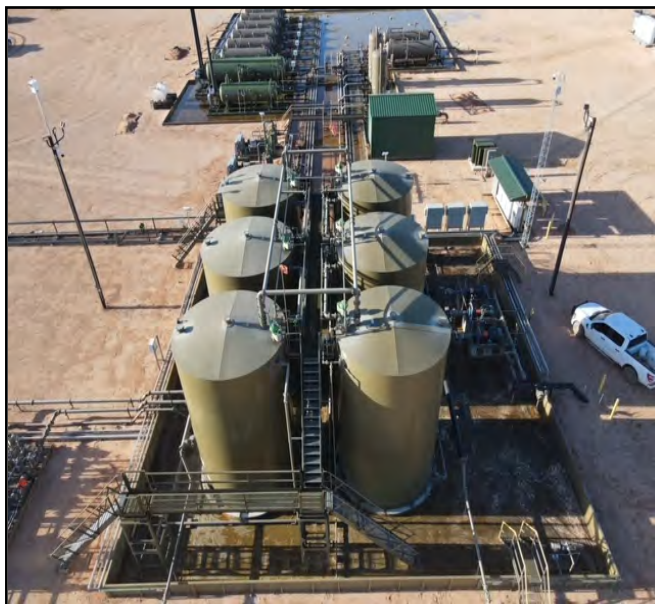
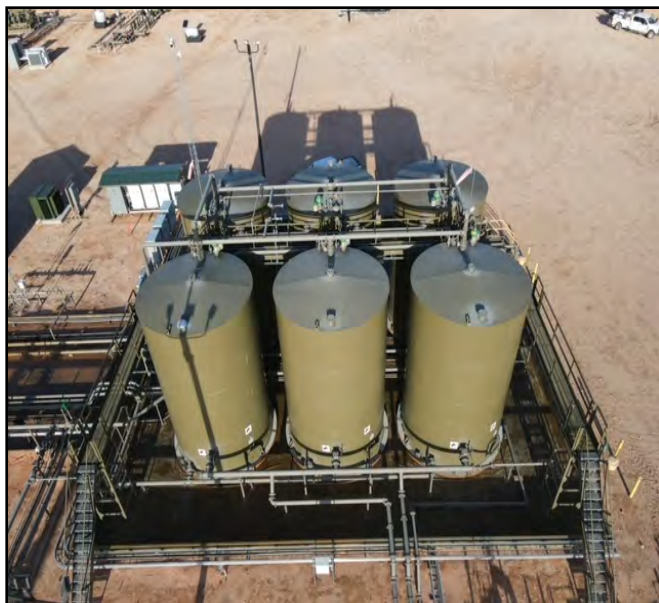
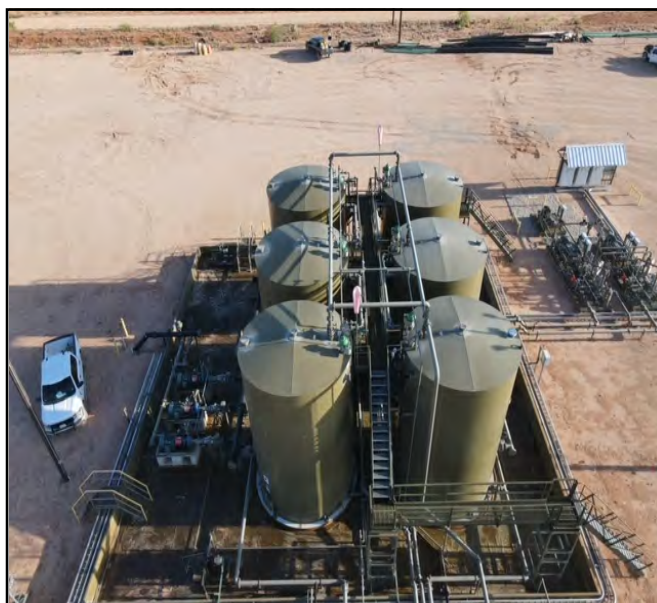
Photograph depicting the condition of the liner taken from a drone.

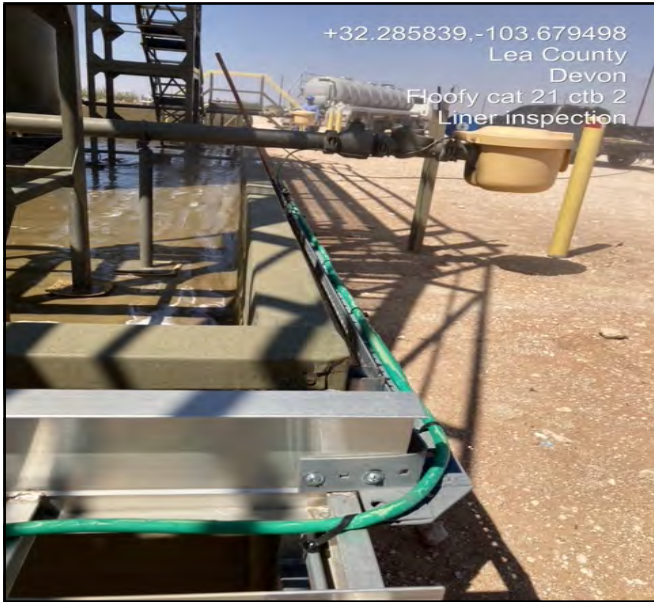
+32.285839,-103.679498  
Lea County  
Devon  
Floofy cat 21 ctb 2  
Liner inspection

Photograph capturing the power washing of a liner,  
with fluid runoff visible from the cleaning process.

On September 9, 2024, Pima personnel mobilized equipment to the site to perform power washing of the liner and containment. A vacuum truck accompanied the crew to recover the power washing fluids. During this process, the remaining fluid missed during the initial recovery effort was recovered.

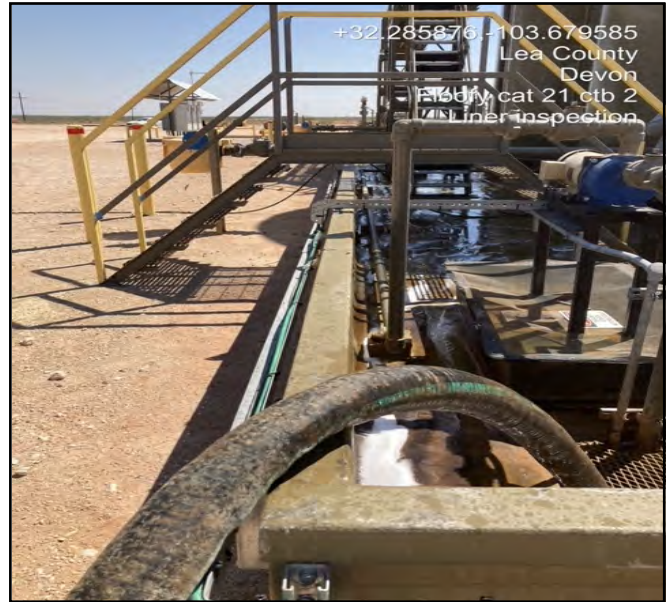
+32.285876,-103.679585  
Lea County  
Devon  
Floofy cat 21 ctb 2  
Liner inspection

Photograph capturing the power washing of a liner,  
with fluid runoff visible from the cleaning process.

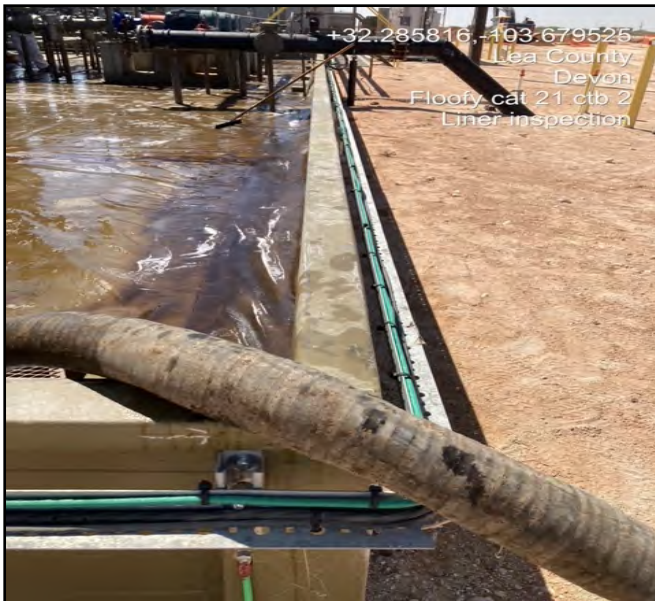
+32.285816,-103.679525  
Lea County  
Devon  
Floofy cat 21 ctb 2  
Liner inspection

Photograph capturing the power washing of a liner,  
with fluid runoff visible from the cleaning process.

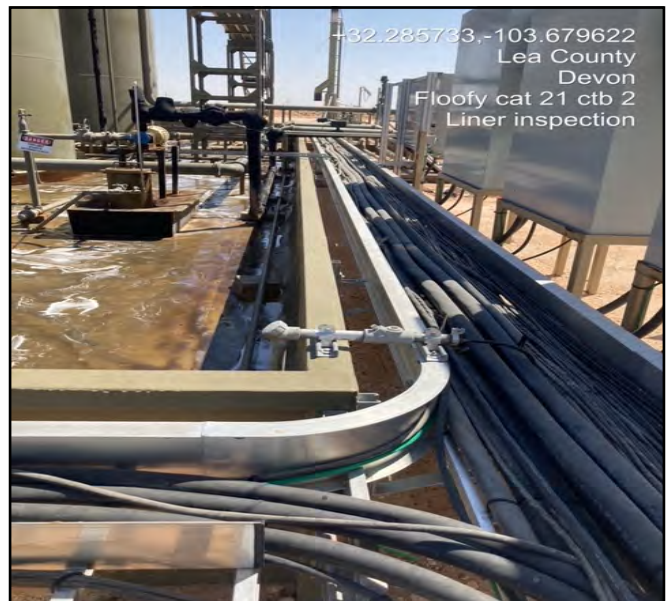
+32.285733,-103.679622  
Lea County  
Devon  
Floofy cat 21 ctb 2  
Liner inspection

Photograph capturing the power washing of a liner,  
with fluid runoff visible from the cleaning process.

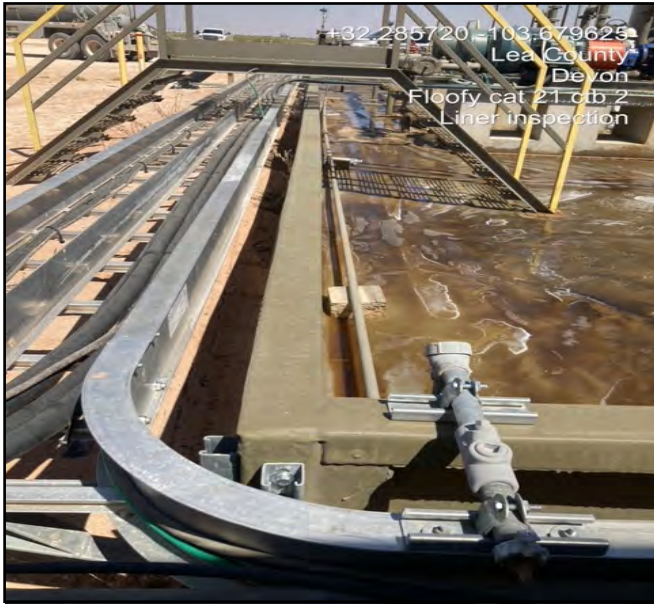
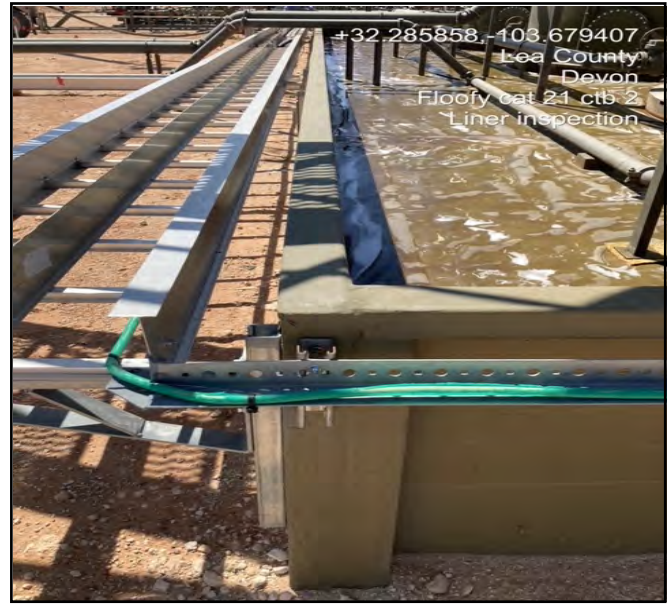
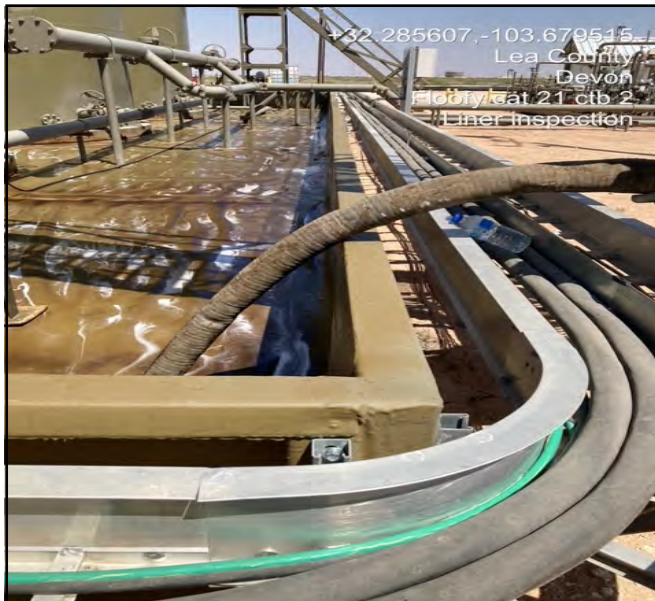
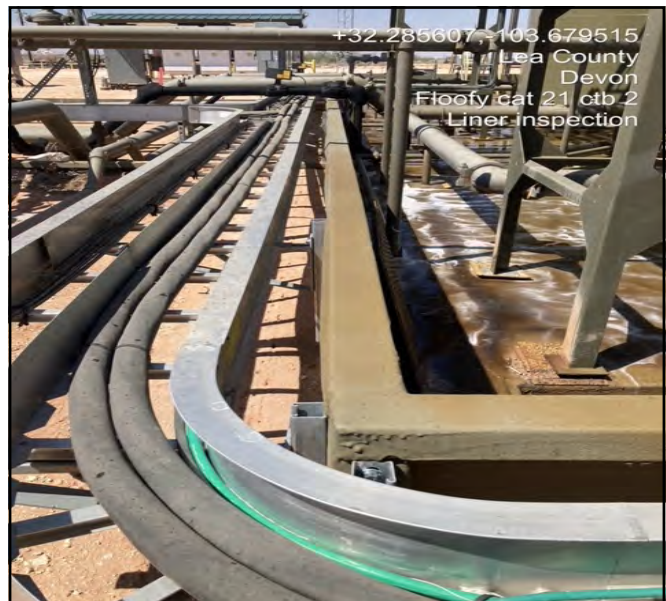
Photograph capturing the power washing of a liner, with fluid runoff visible from the cleaning process.

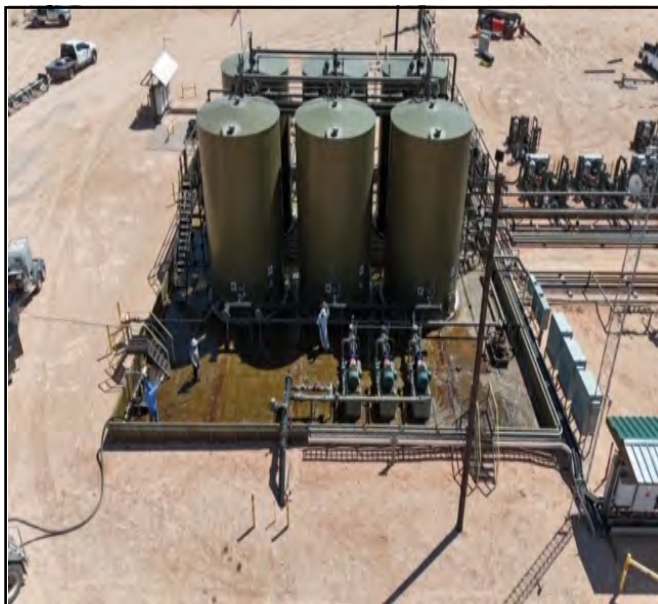
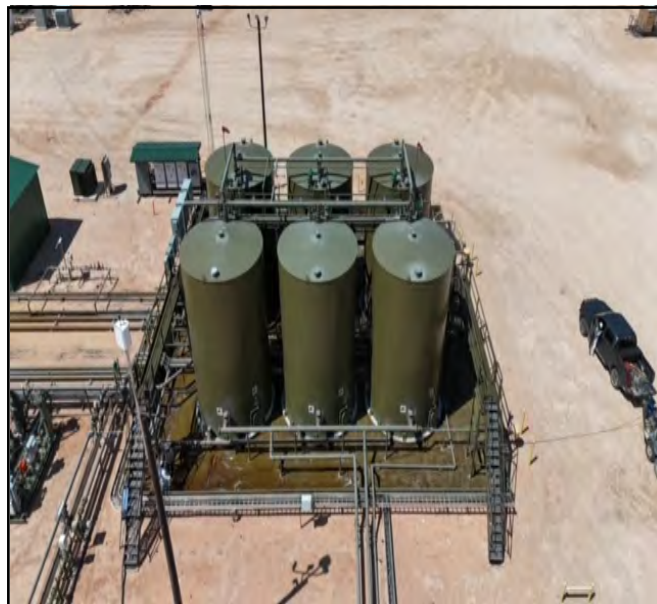
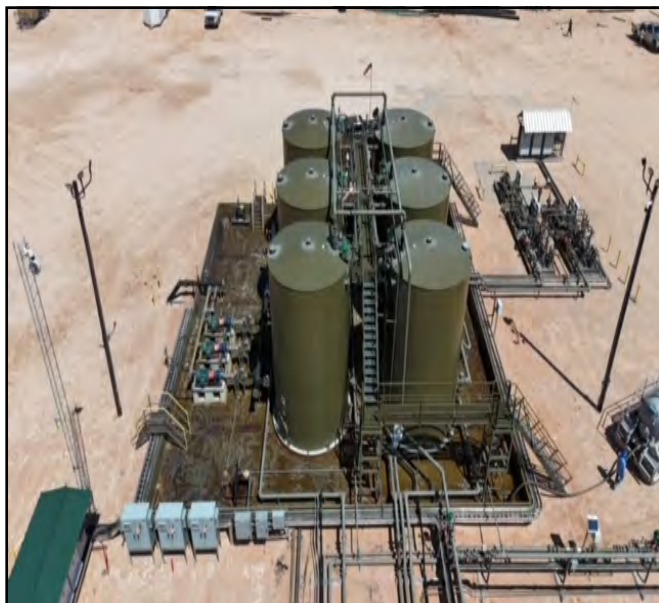
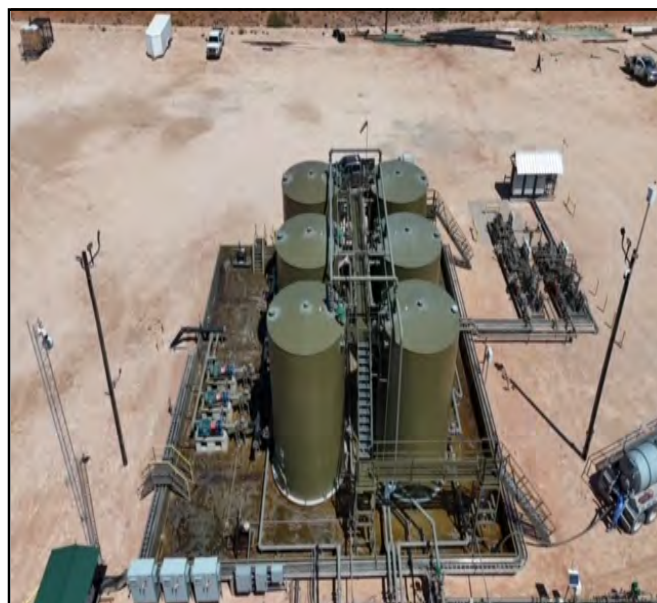
Photograph depicting the condition after power washing the liner taken from a drone.
