PHASE II ENVIRONMENTAL SAMPLING ASSESSMENT

Chalupa #4 SWD

Produced Water Flow Line Leak/Spill

March 5th, 2009

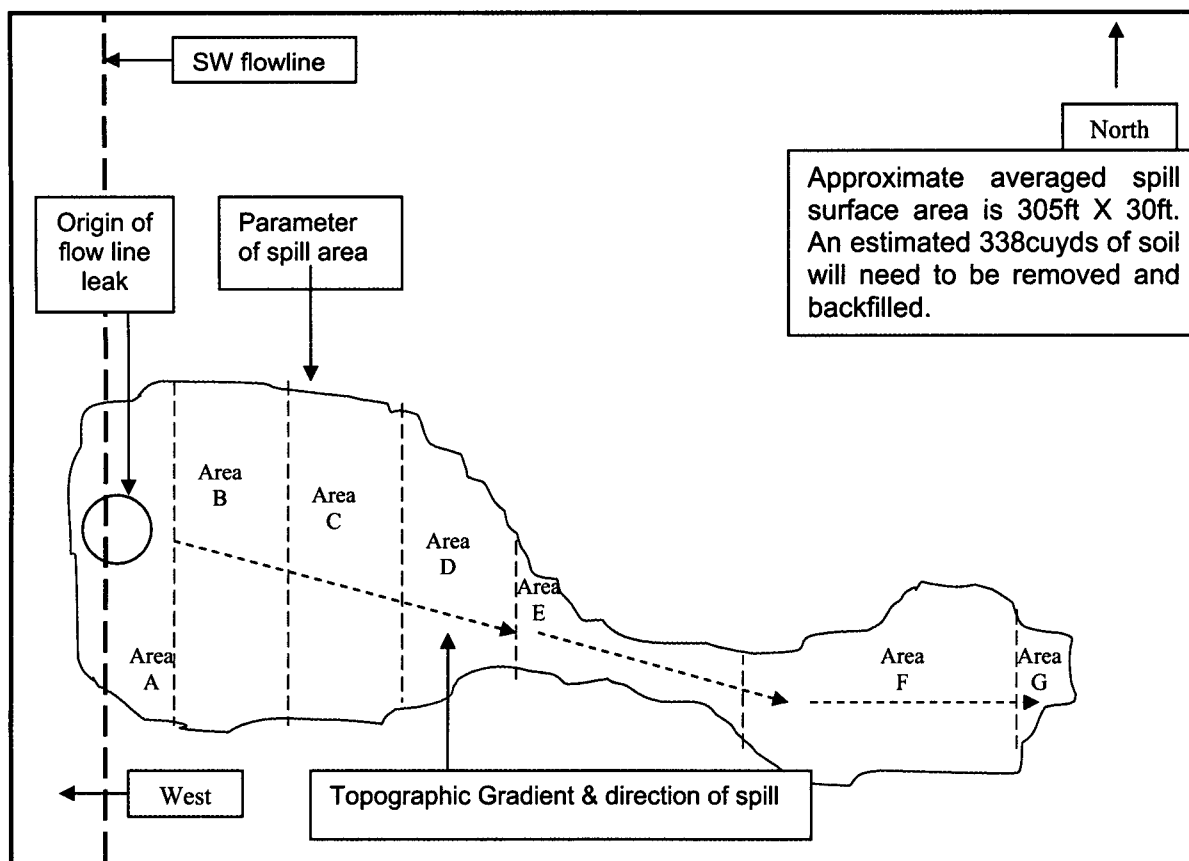
- **Chlorides:** Highest chloride levels were **28600ppm** at surface level in grid area "A". This was the source point where the actual leak occurred. Acceptable levels for chlorides were reached at a 3ft depth for grid area A. Grid areas D & E had acceptable levels at a 1ft to 2ft depths. Areas B, C, F, & G were at an acceptable level at a 1ft depth.

- **TPH:** Highest TPH levels were **1200ppm** at surface level in area A.
- Lab Samples: Samples were taken from grid areas A, B, C, D, E, F, & G.
- Decontamination procedures were maintained
