SECREST ET AL #1 SWD

Incident ID nAPP2507027904

Liner Inspection and Closure Report

March 31, 2025

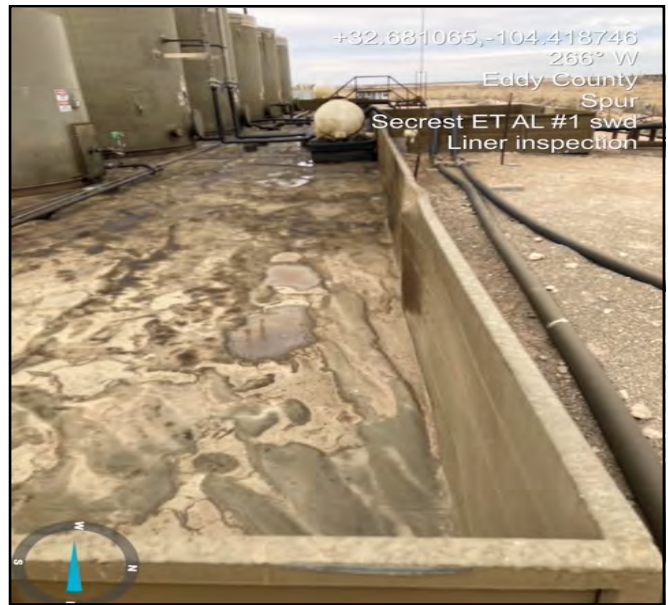
Photo of liner taken prior to power washing facing west.

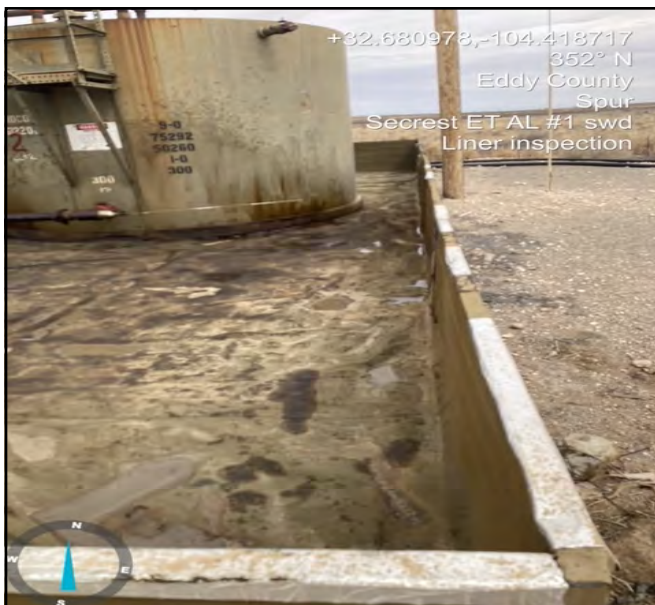
Photo of liner taken prior to power washing facing north.

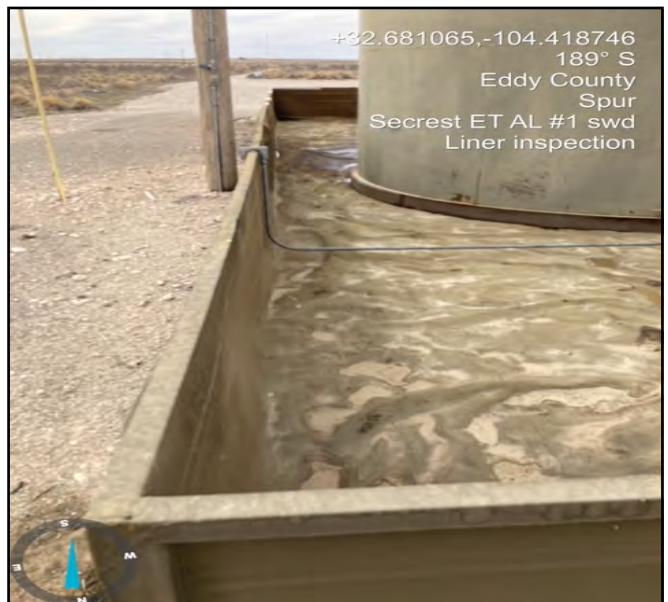
Photo of liner taken prior to power washing facing south.

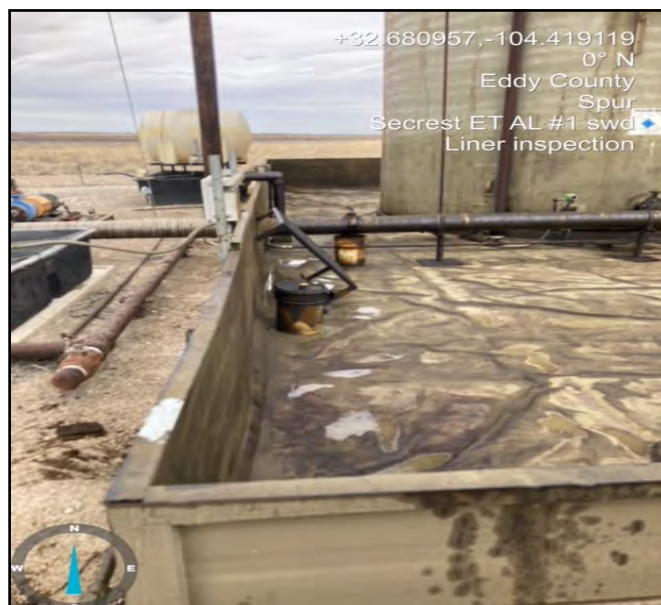
Photo of liner taken prior to power washing facing north.

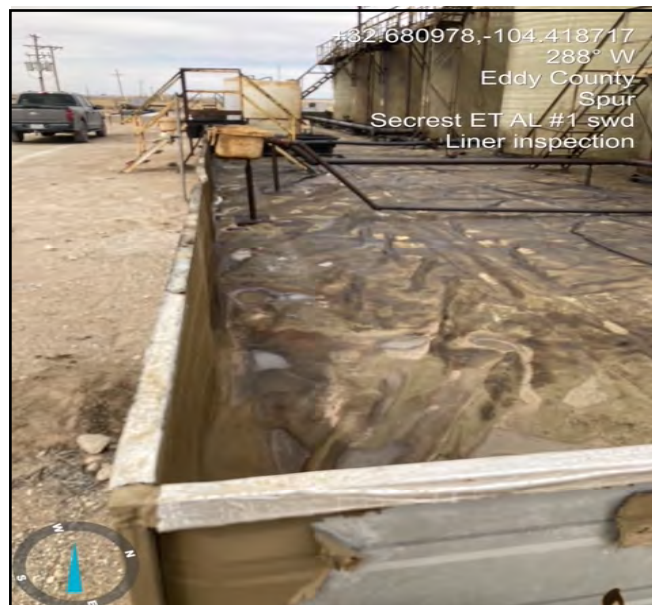
Photo of liner taken prior to power washing facing west.

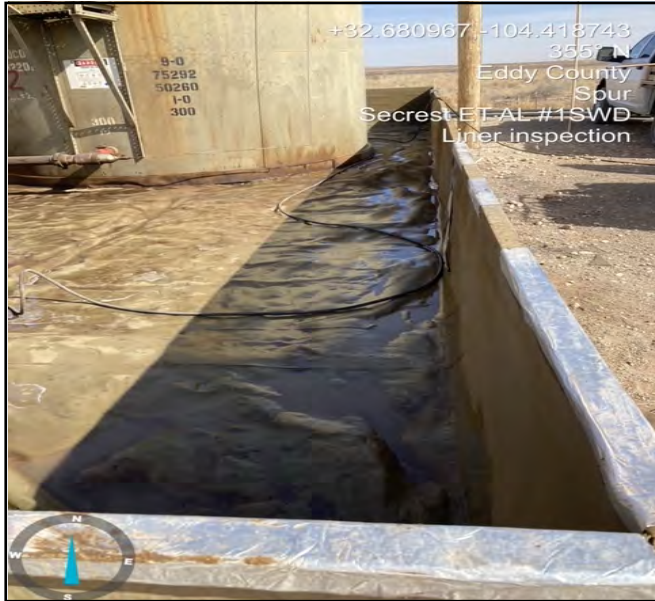
Photo taken pursuant to power washing facing north.

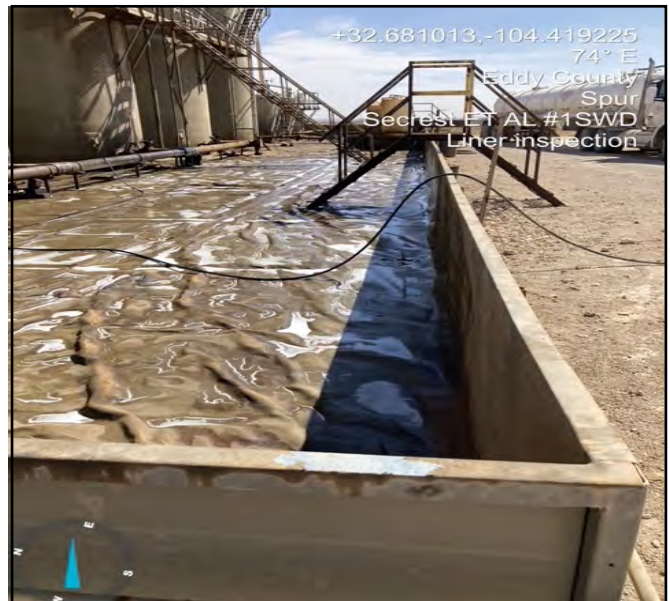
Photo taken pursuant to power washing facing east.

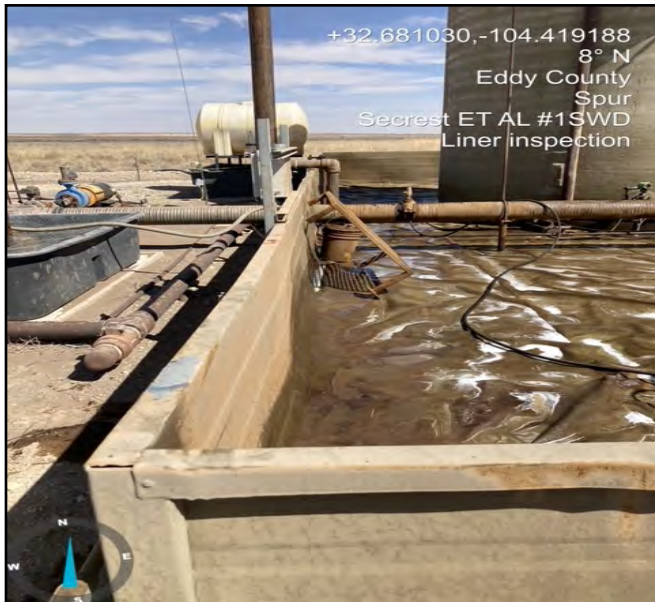
Photo taken pursuant to power washing facing north.

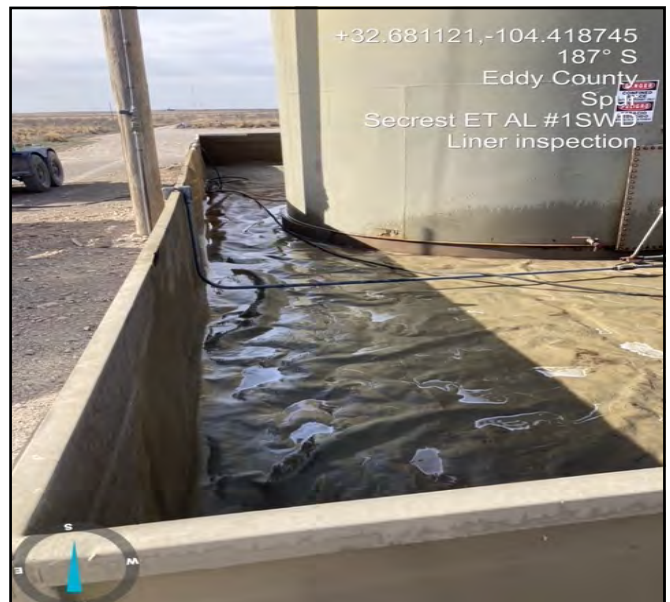
Photo taken pursuant to power washing facing south.

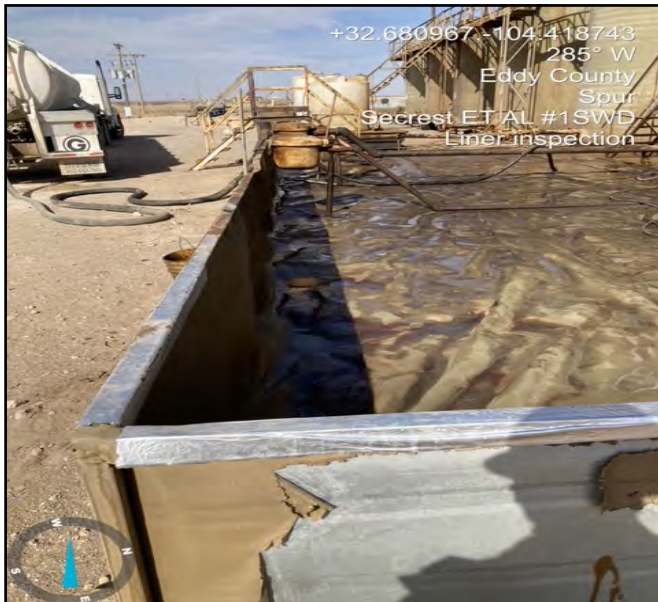
Photo taken pursuant to power washing facing west.

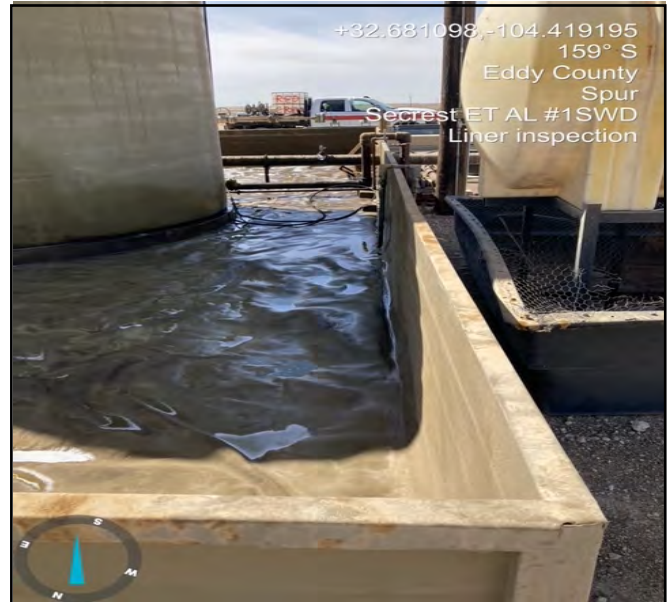
Photo taken pursuant to power washing facing south.
