Our Ref.: 12670291-NMOCD-1

June 06, 2025

Closure Report
Devon Energy Production Company, LP
Mule 23 CTB 2
Unit Letter B, Section 23, T25S, R31E
GPS: 32.1218234, -103.7471688
Eddy County, New Mexico

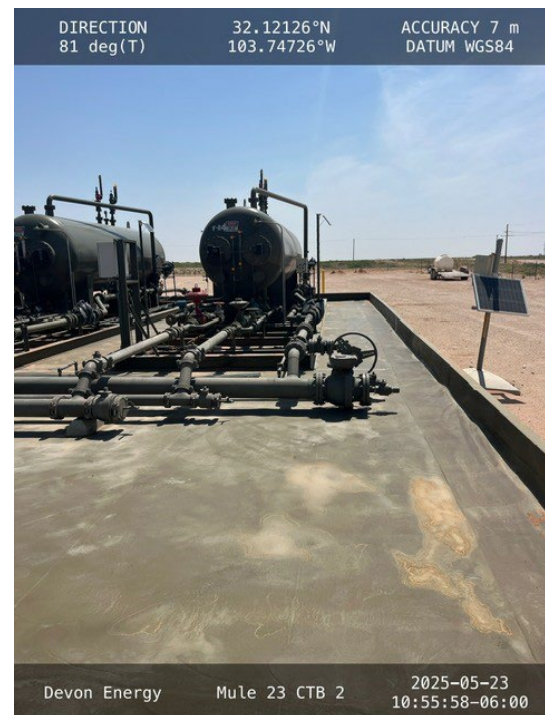
Photo 2 View of south side containment area towards east.

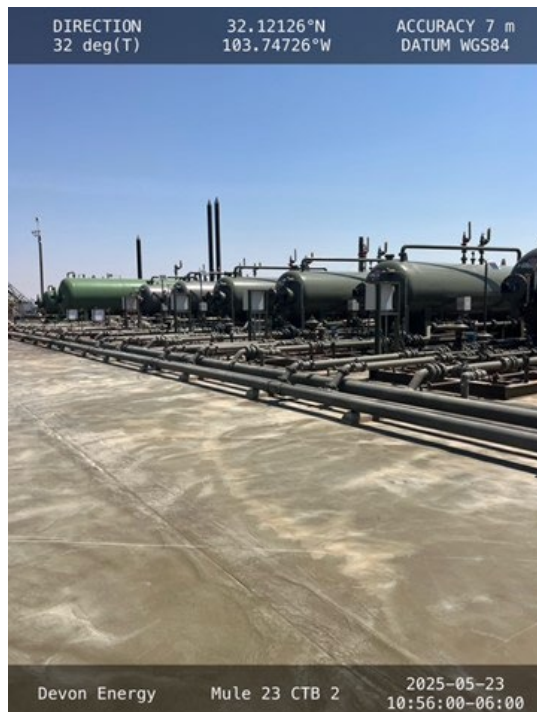
Photo 3 View of central portion of containment area towards northeast.

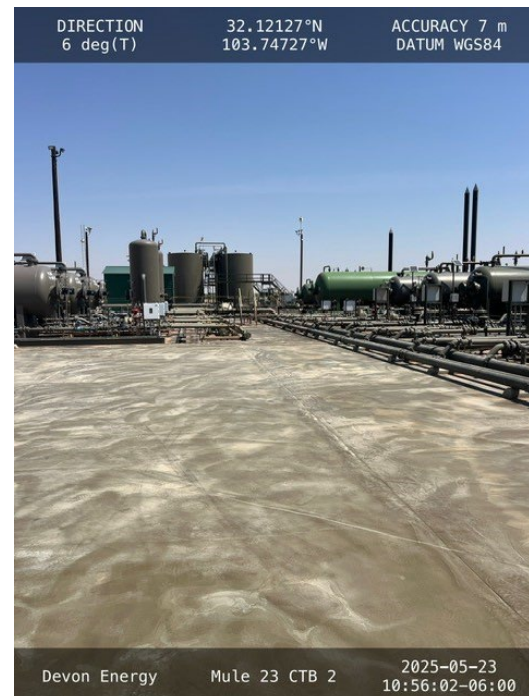
Photo 4 View of central portion of containment area towards north.

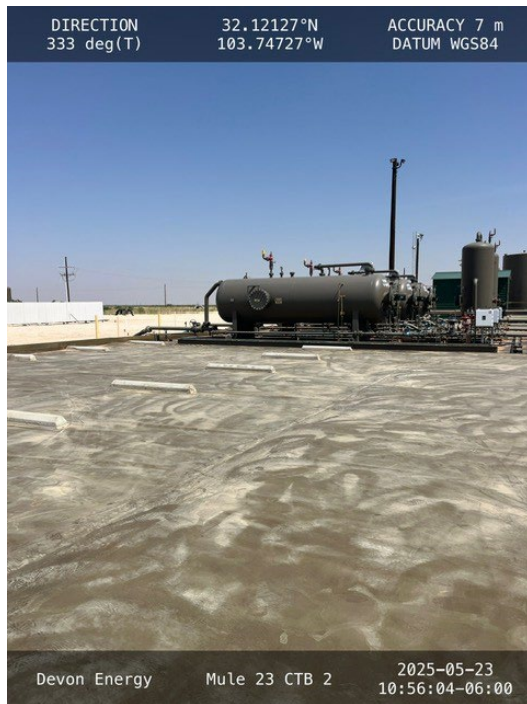
Photo 5 View of south side of containment area towards northwest.

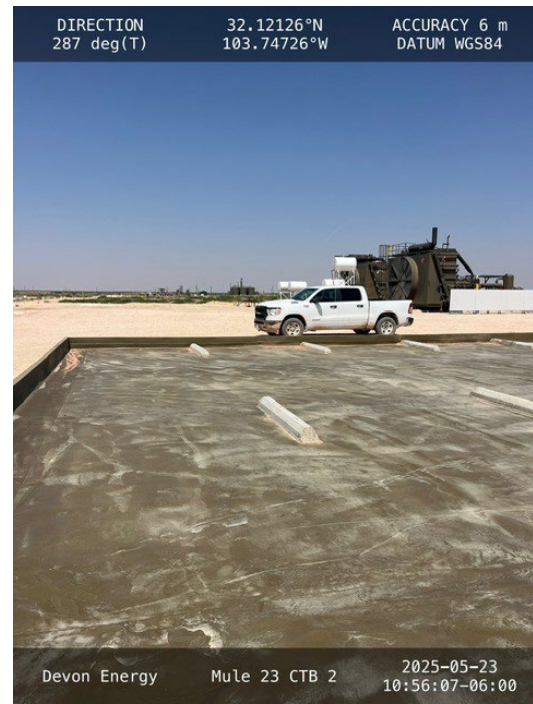
Photo 6 View of south side of containment area facing west.

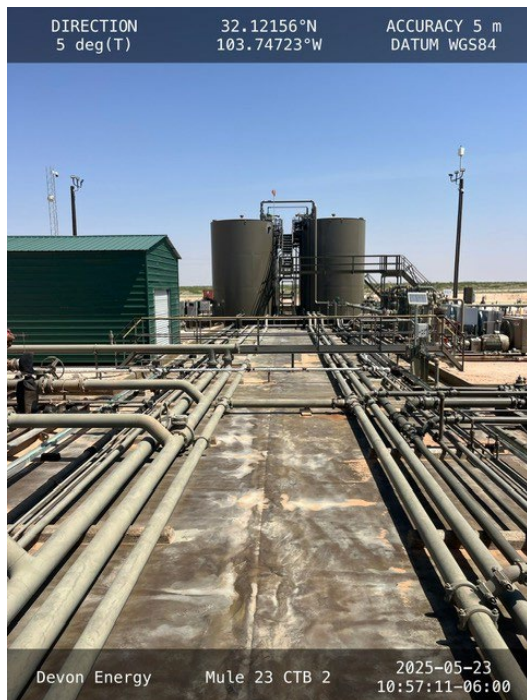
Photo 7 View of central portion of containment area facing north.

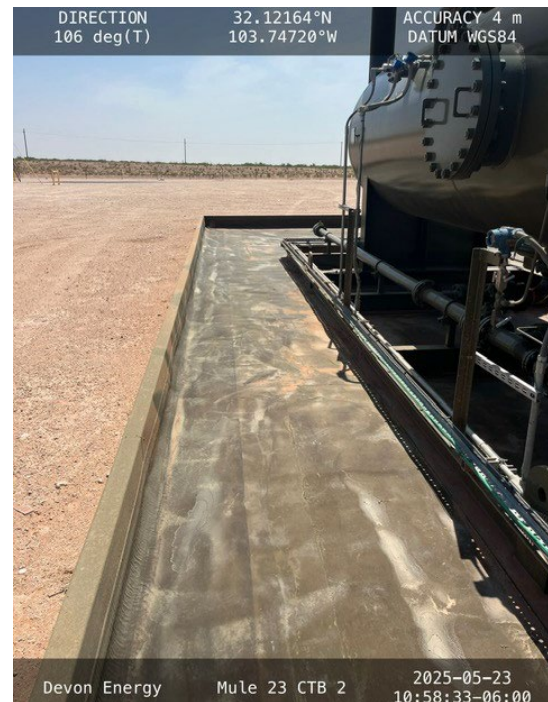
Photo 8 View of south side of containment area towards east.

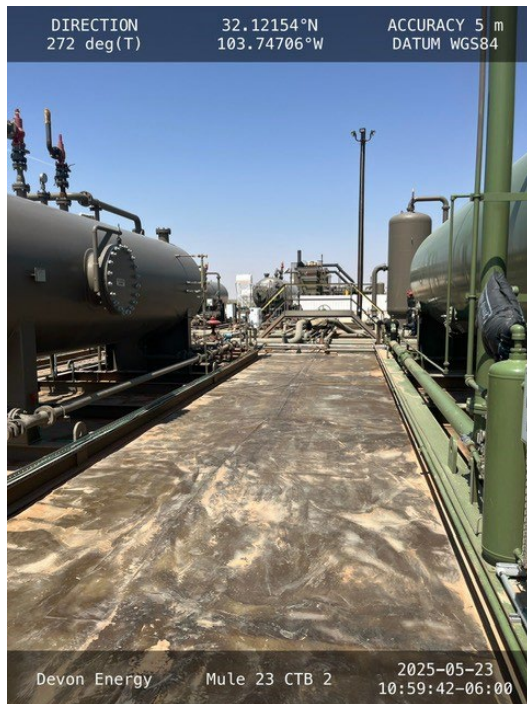
Photo 9 View of central portion of secondary containment towards west.

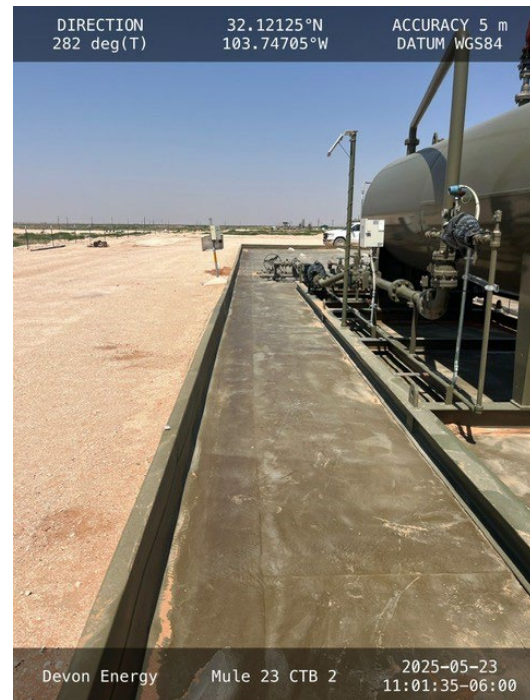
Photo 10 View of south side secondary containment towards west.
