GJ West Coop Unit 210 TB

Incident ID NAPP2512027179

## Liner Inspection and Closure Report

July 13, 2025

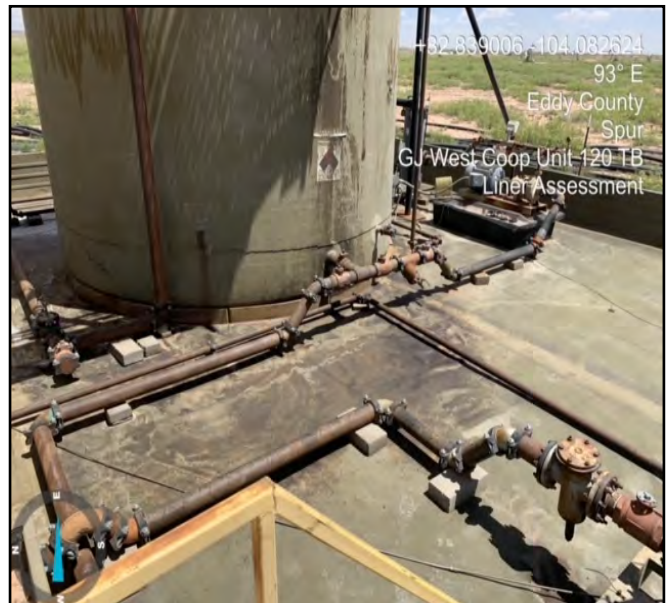
Photo of liner taken prior to power washing facing east.

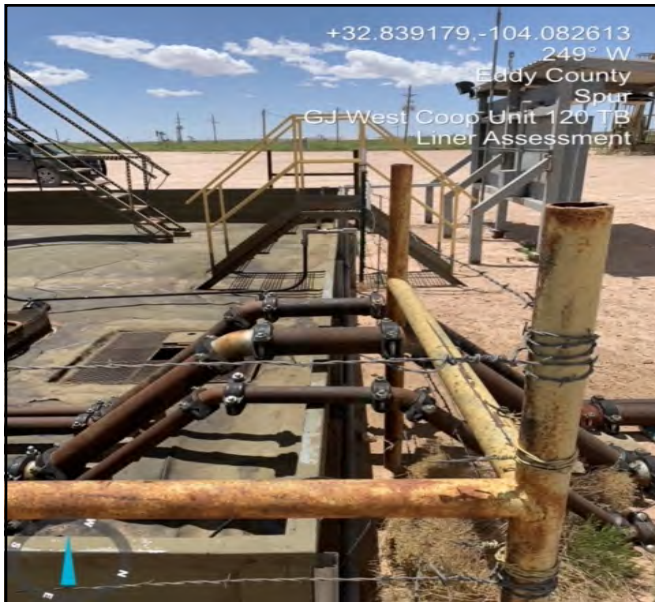
Photo of liner taken prior to power washing facing west.

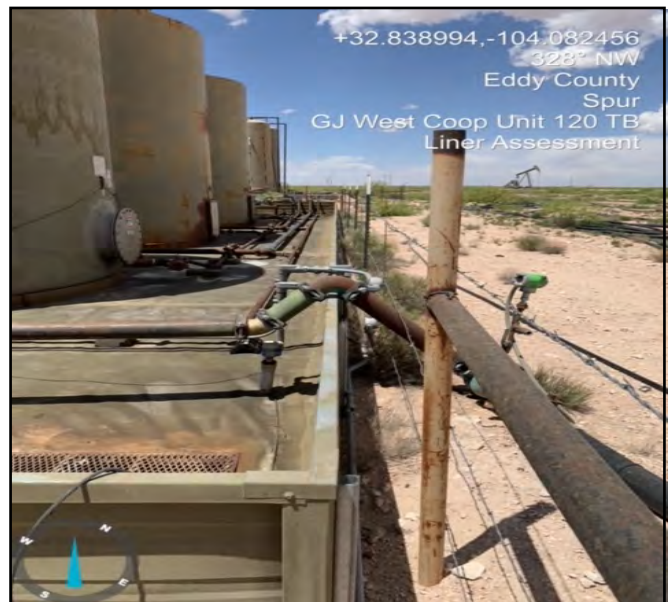
Photo of liner taken prior to power washing facing northwest.

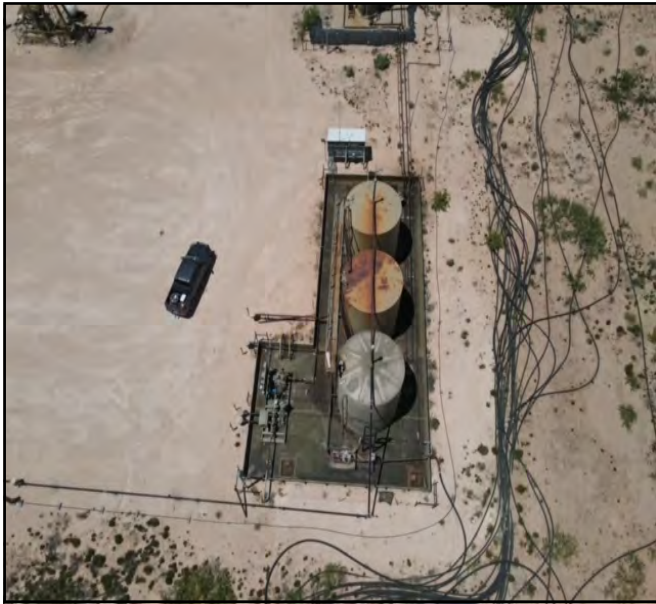
Photo of liner taken after power washing.

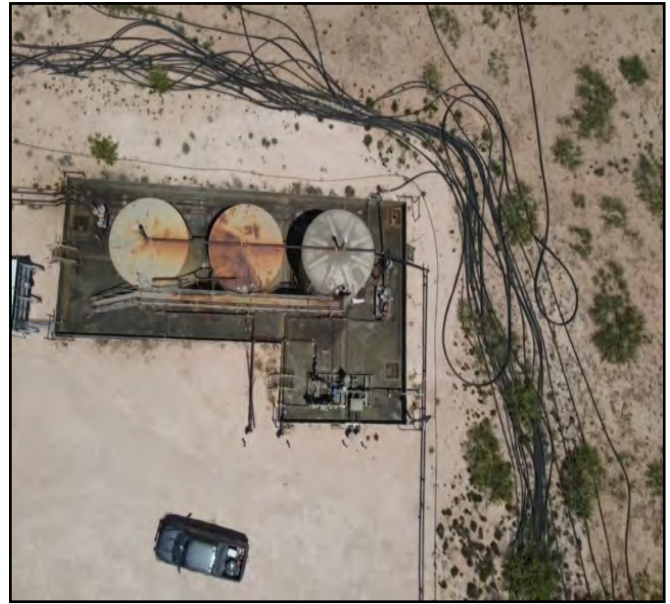
Photo of liner taken after power washing.

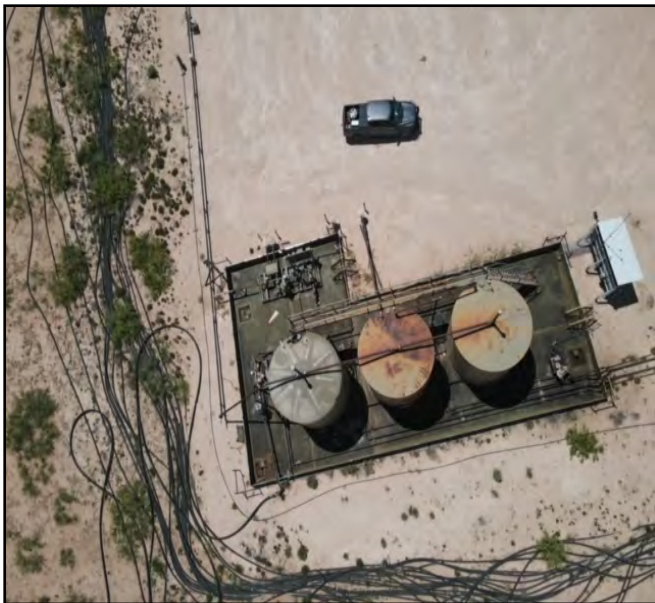
Photo of liner taken after power washing.

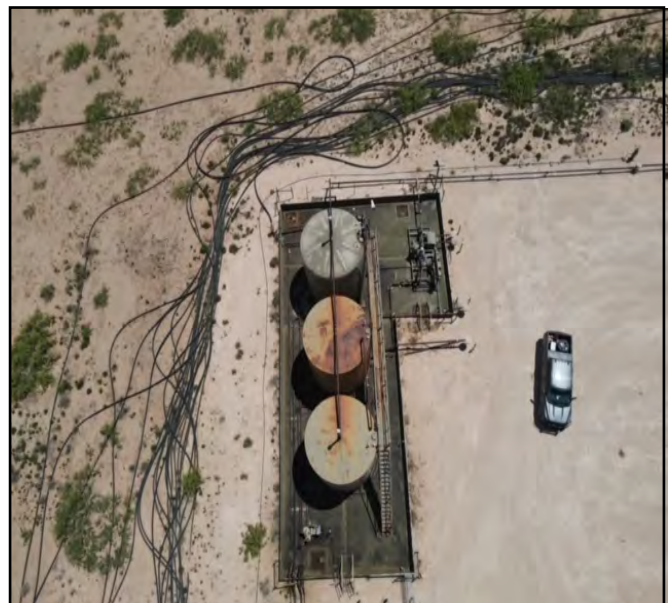
Photo of liner taken after power washing.
