Our Ref: 12670742–NMOCD–1

August 25, 2025

Closure Report  
Devon Energy Production Company, LP  
Serpentine 2 Facility 1  
Unit Letter O, Section 2, T23S, R33E  
GPS: 32.329689, -103.53964  
Lea County, New Mexico

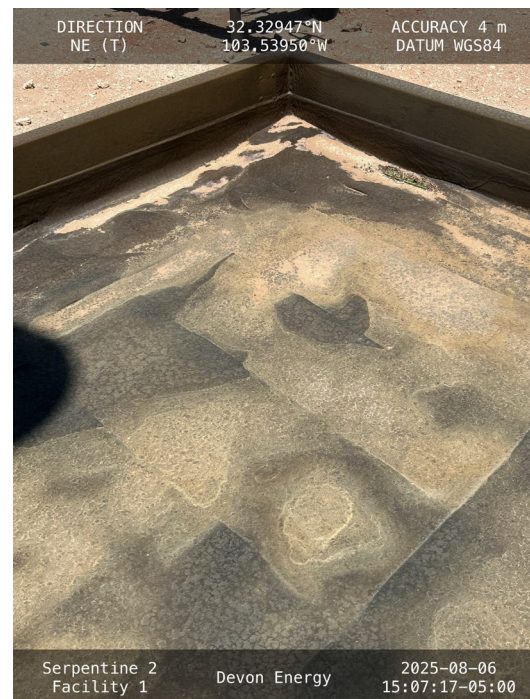
On August 1, 2025, the liner inspection notice was provided to NMOCD and NMSLO ECO. A liner integrity inspection was performed on August 6, 2025, after the secondary containment was cleaned for a visual inspection. The liner was visually inspected and no rips, tears, holes, or damage in the liner was observed. The

liner was determined to be intact with no integrity issues. Photographic documentation of the liner inspection is presented in **Attachment C**.

**Photo 2** View of northeast corner of secondary containment

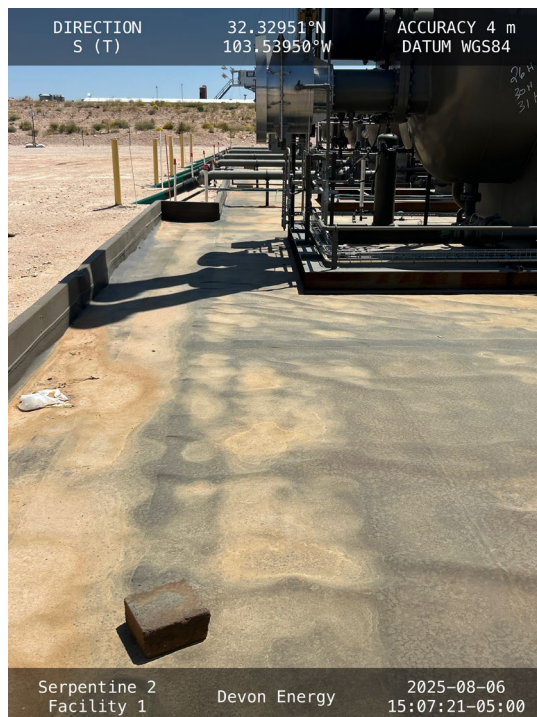
**Photo 3** View of eastern portion of containment facing south.

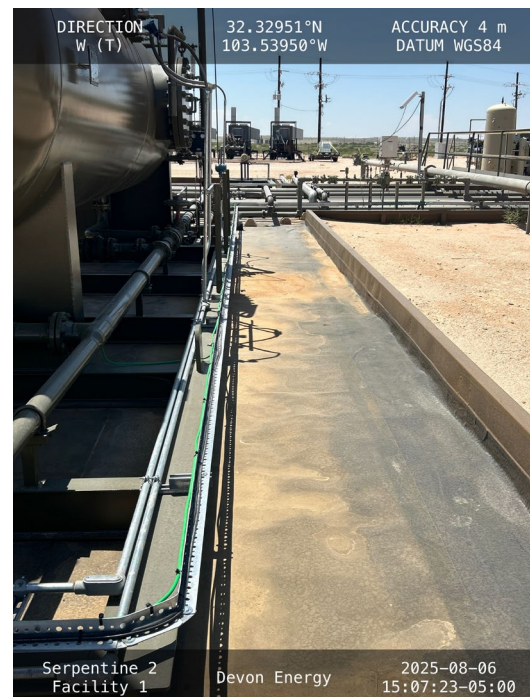
**Photo 4** View of northern portion of containment facing west.

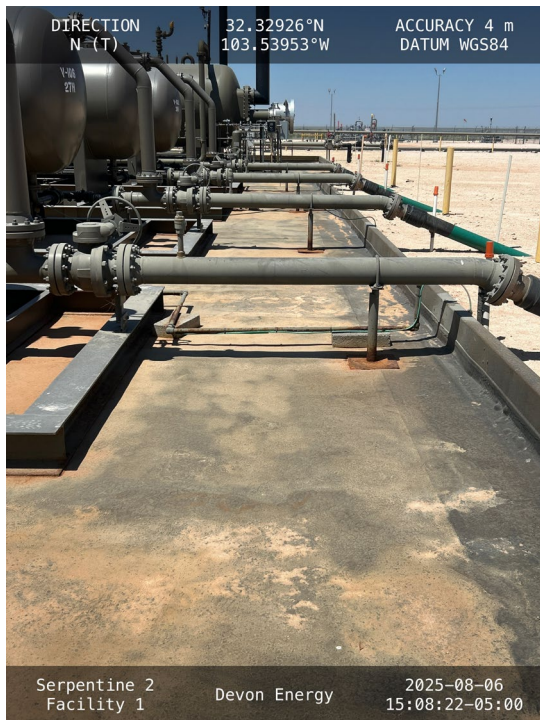
**Photo 5** View of eastern portion of containment facing north.

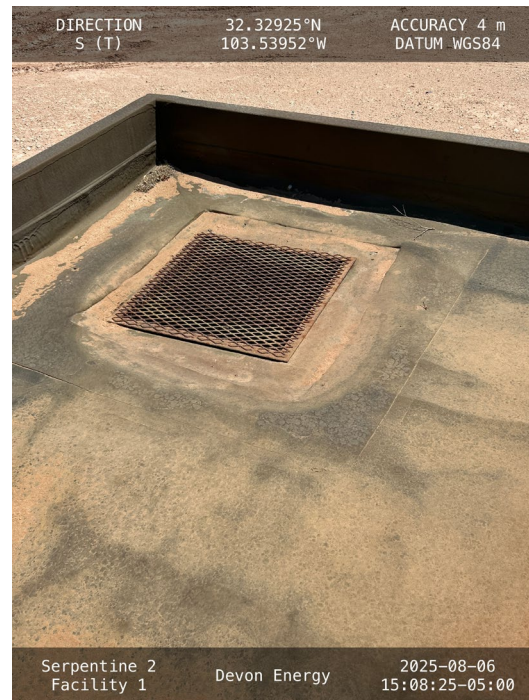
**Photo 6** View of southeast corner of secondary containment.

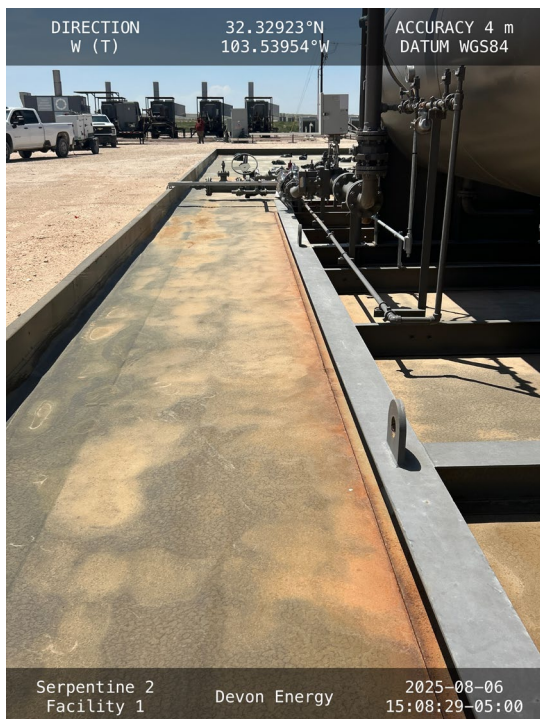
**Photo 7** View of southern portion of secondary containment facing west.

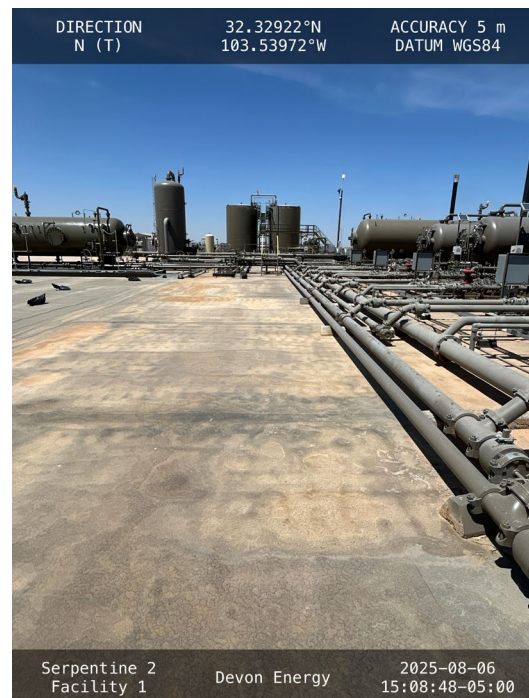
**Photo 8** View of central portion of containment facing north.

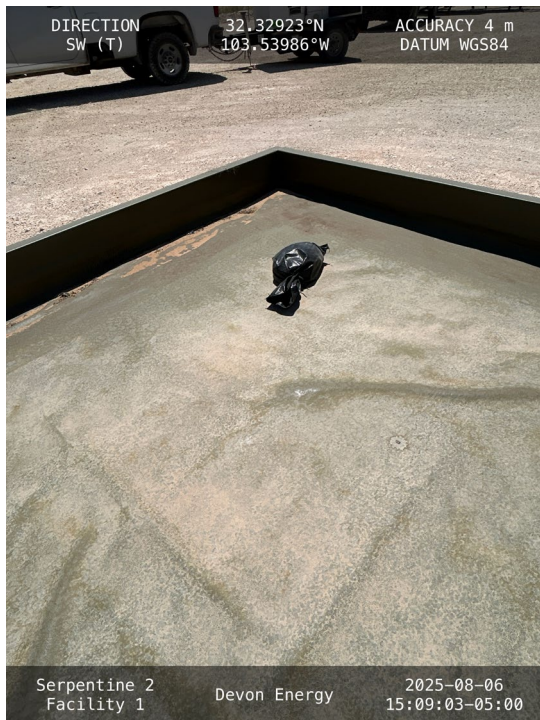
**Photo 9** View of southwest corner of secondary containment.

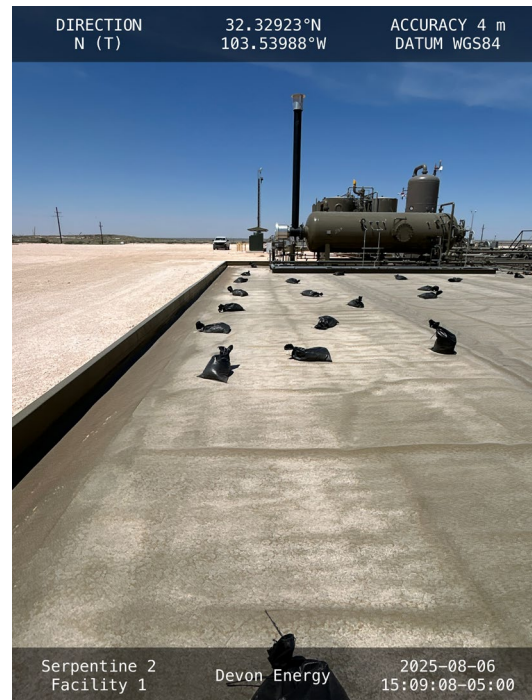
**Photo 10** View of western portion of containment facing north.

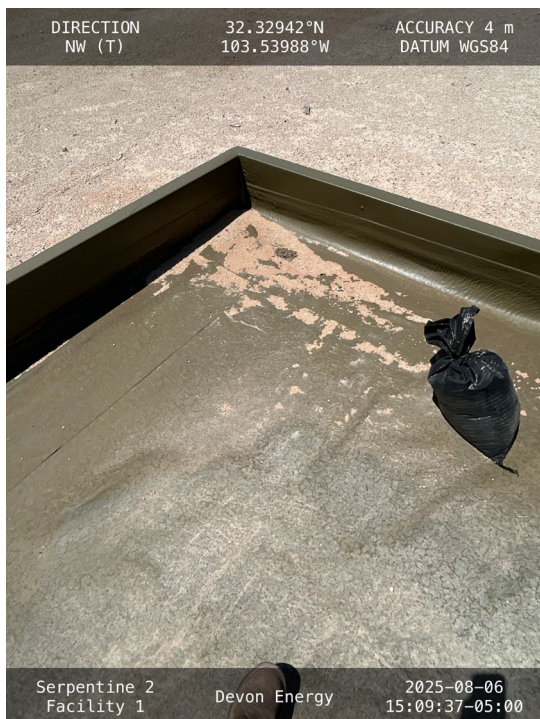
**Photo 11** View of northwest corner of containment.

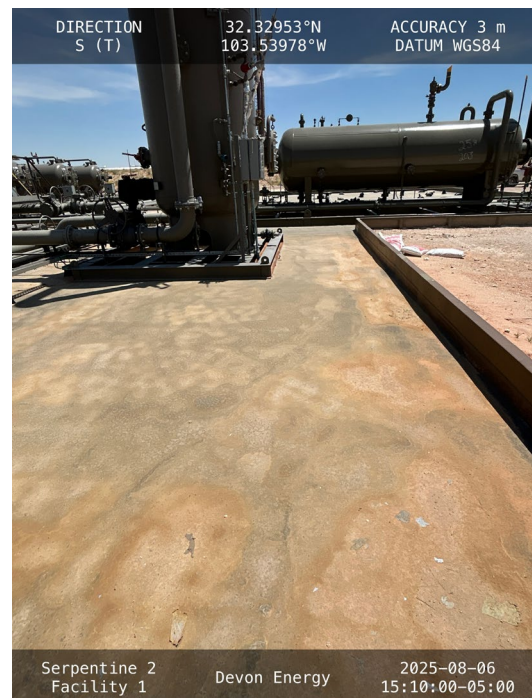
**Photo 12** View of western portion of containment facing south.

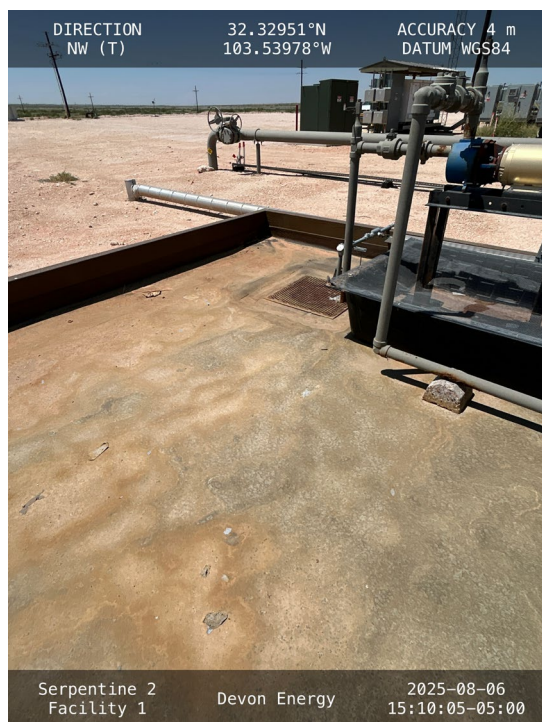
**Photo 13** View of northwest corner of containment.

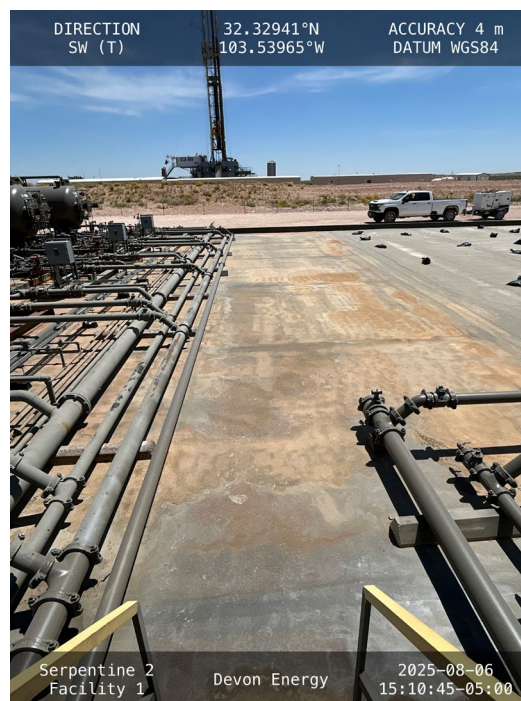
**Photo 14** View of central portion of containment facing southwest.

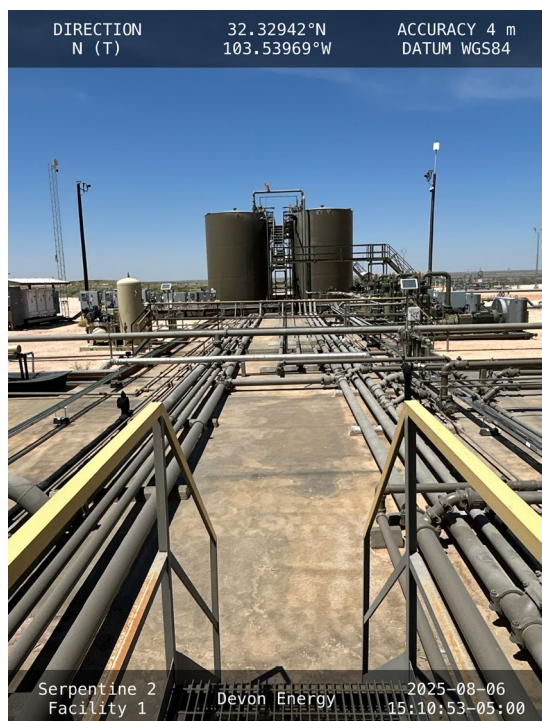
**Photo 15** View of central portion of containment facing north.
