CLOSURE REQUEST REPORT

Flagler 8 CTB 1

Incident Number nAPP2517871293

Closure Request Report
Incident Number nAPP2517871293
Flagler 8 CTB 1

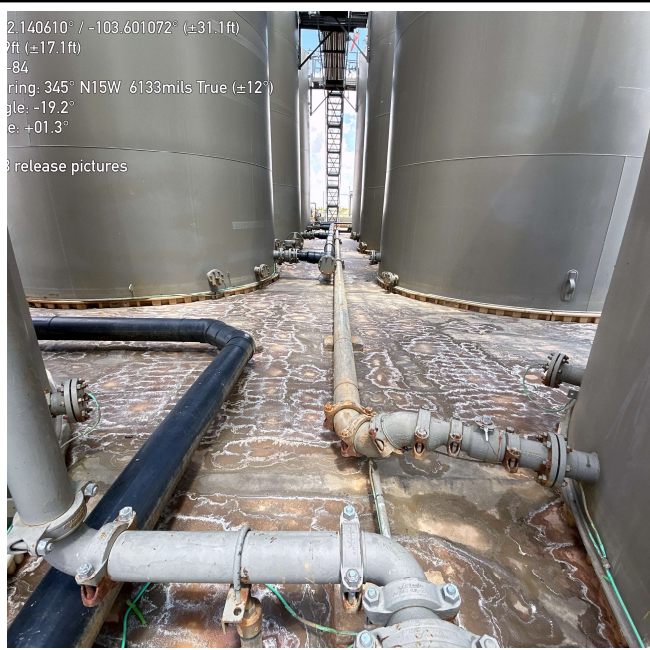
Photograph 1

Description: Northern view of tank battery liner.

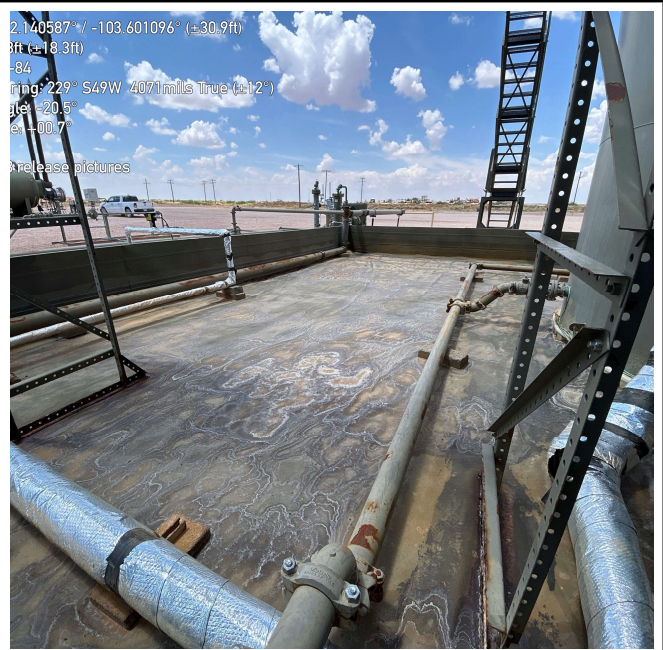
Photograph 2

Description: Southwestern view of tank battery liner.

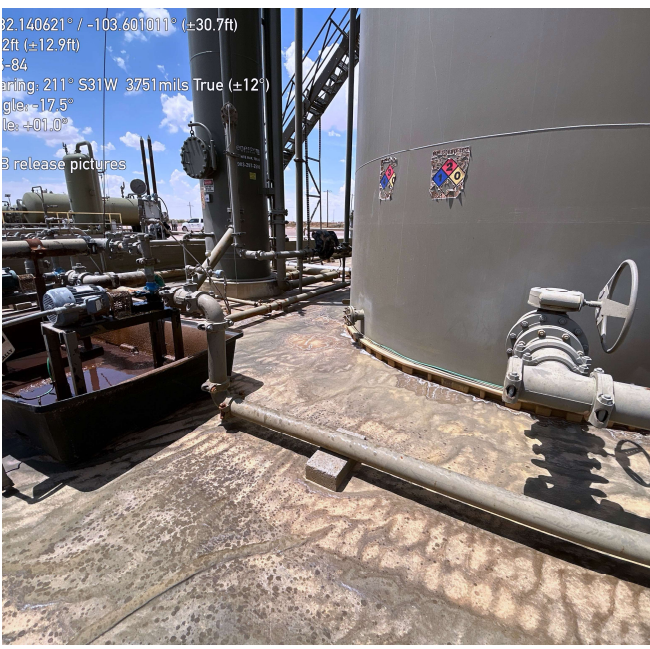
Photograph 3

Description: Southwestern view of liner during inspection.

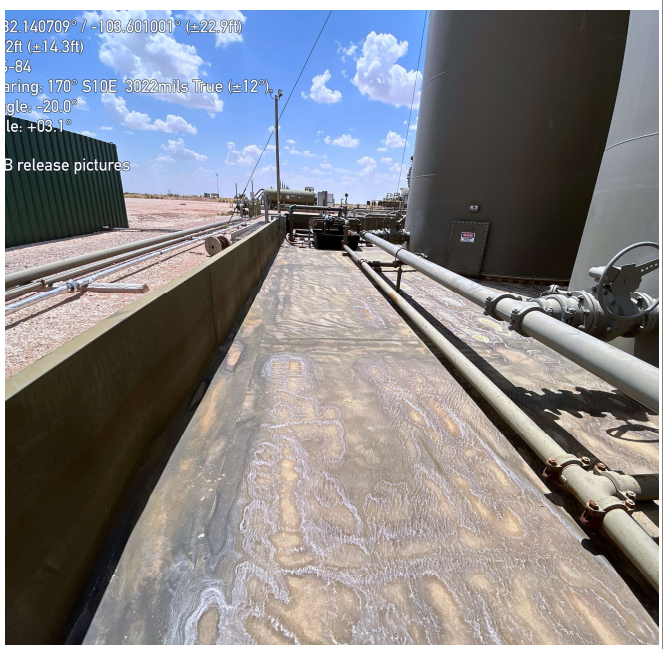
Photograph 4

Description: Southern view of liner during inspection.
