SUBJECT: Liner Inspection and Closure Report for Purrito 18 CTB 1 – August 26, 2025 Site Visit

Incident ID: nAPP2520230747
Facility ID (Name): fAPP2408639251 (PURRITO 18 CTB 1)
Facility Location: Unit A of Section 18, Township 23 South, Range 32 East, New Mexico
Facility GPS Coordinates: 32.308038, -103.7206141
Lea County, New Mexico

Environmental Liner Inspection Field Notes & Photolog Report

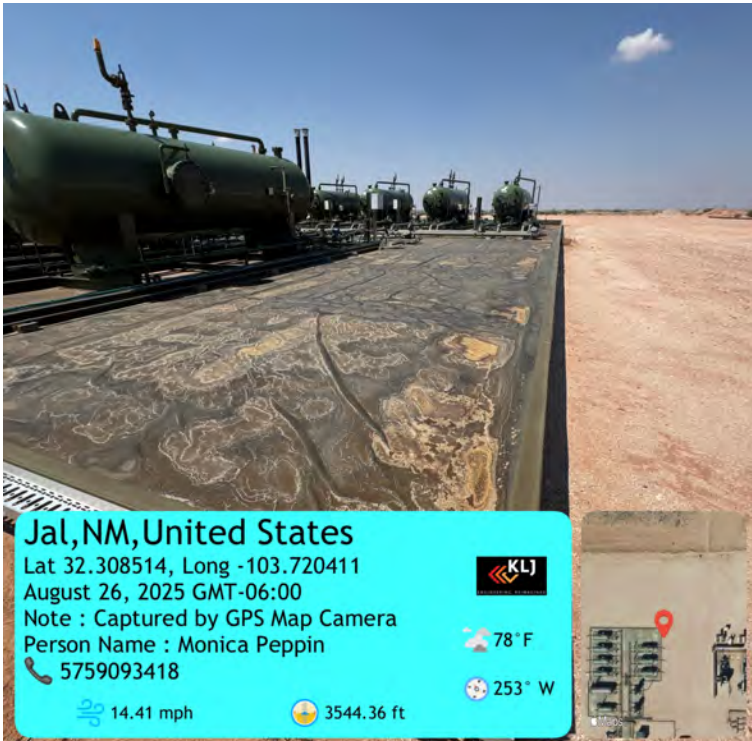
Northeast corner view facing west.

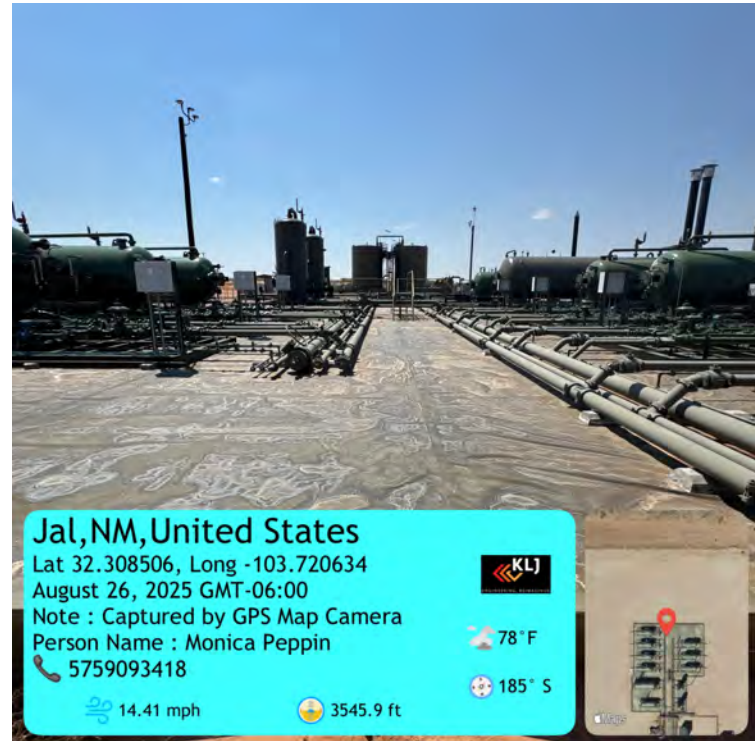
Facing south from north viewing liner in middle area.

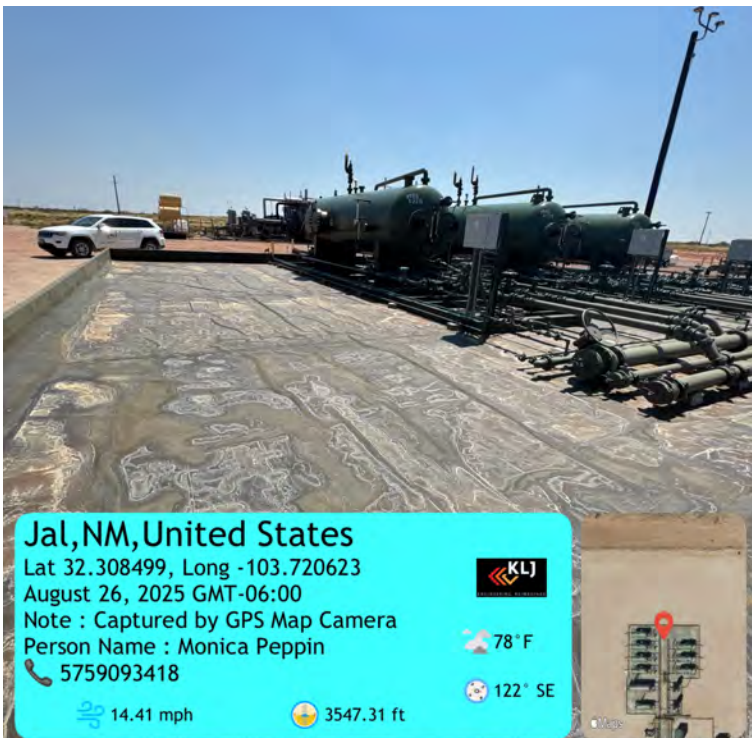
Northeast corner facing east towards separators.

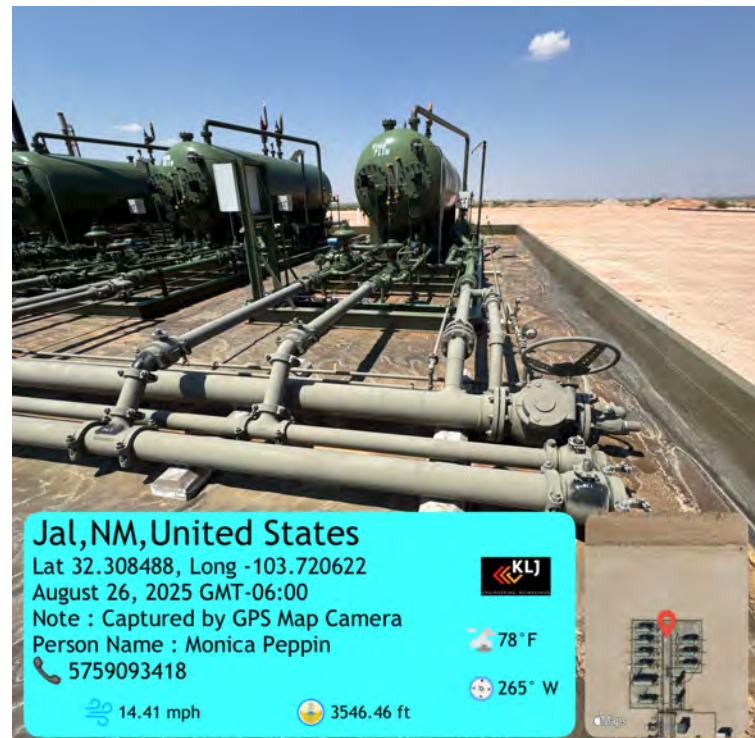
Liner under separators and piping.

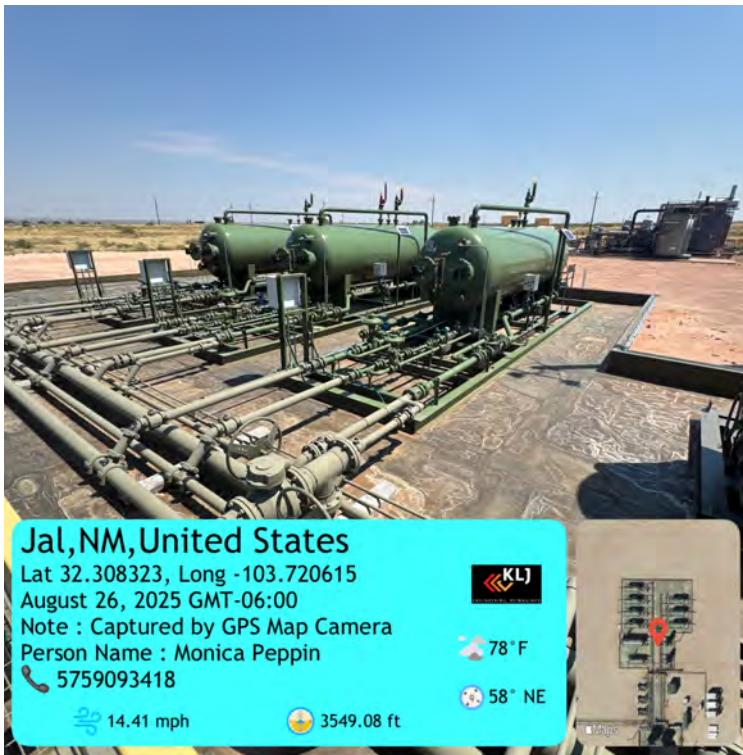
Liner under equipment from middle area of containment.

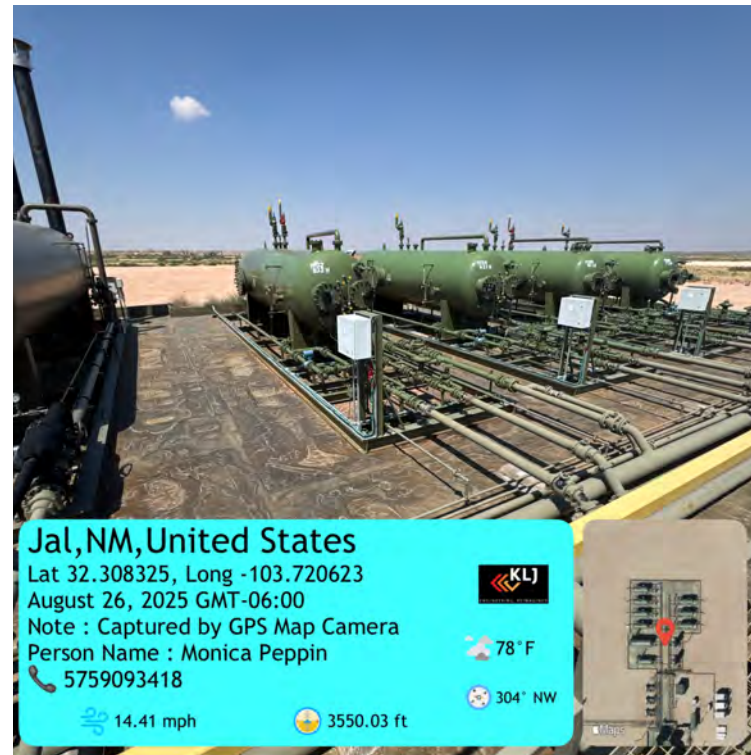
Liner under equipment facing northwest.

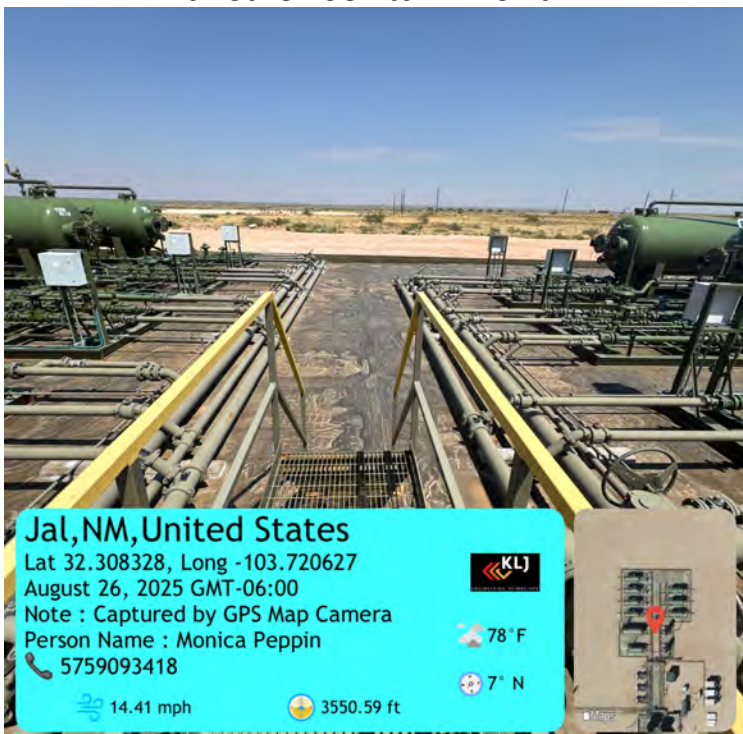
Facing north viewing liner from middle area.

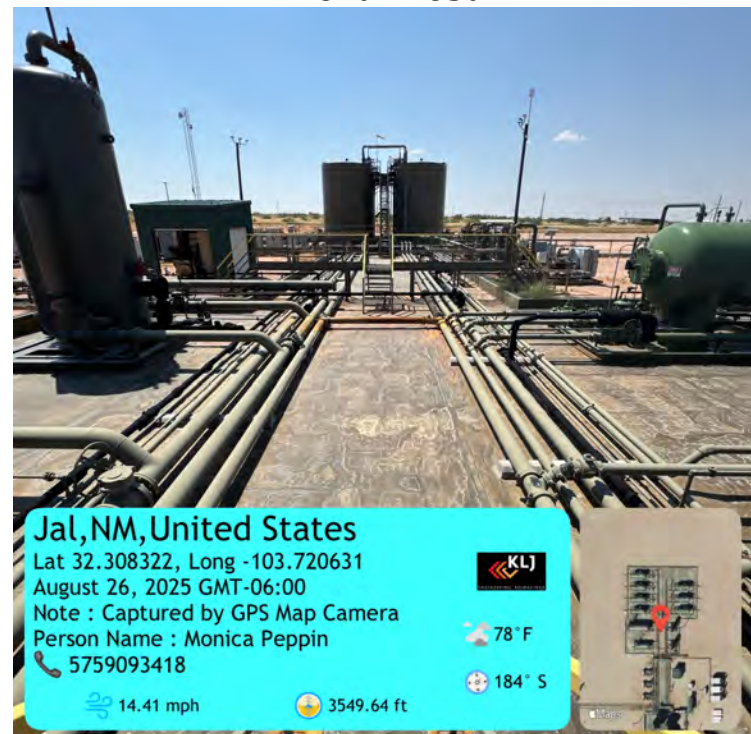
Liner between piping facing south.

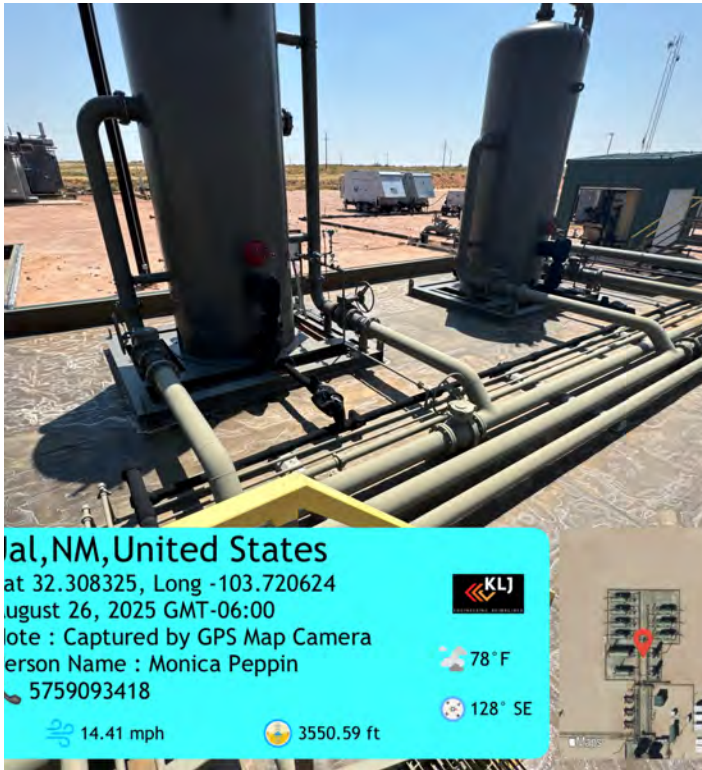
Liner under piping and vertical separators.

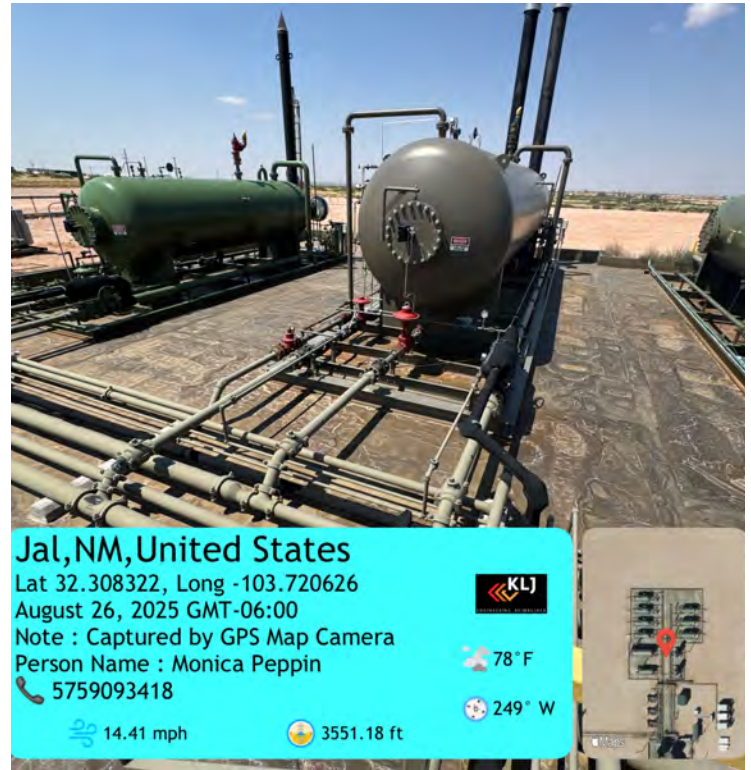
Liner under piping and heaters facing west.

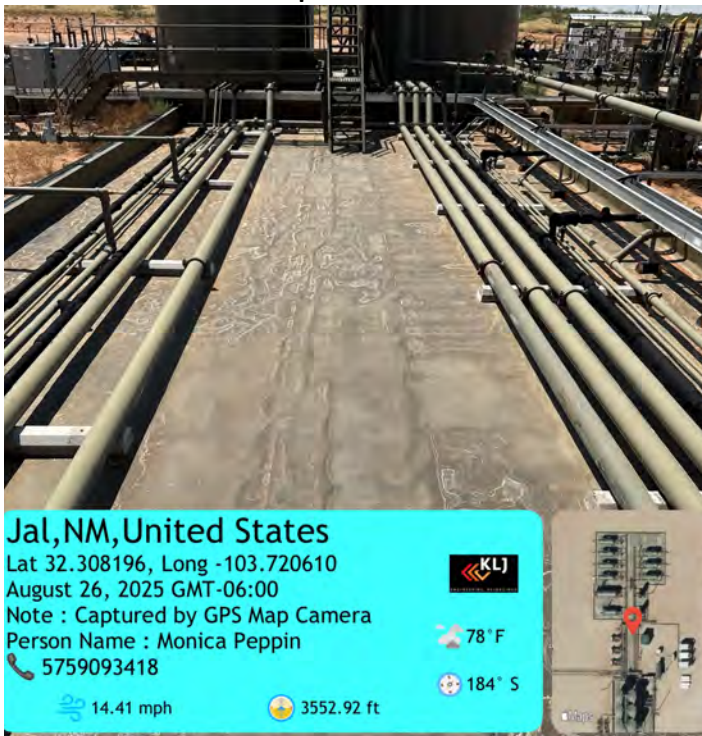
Liner near tank battery containment facing south.

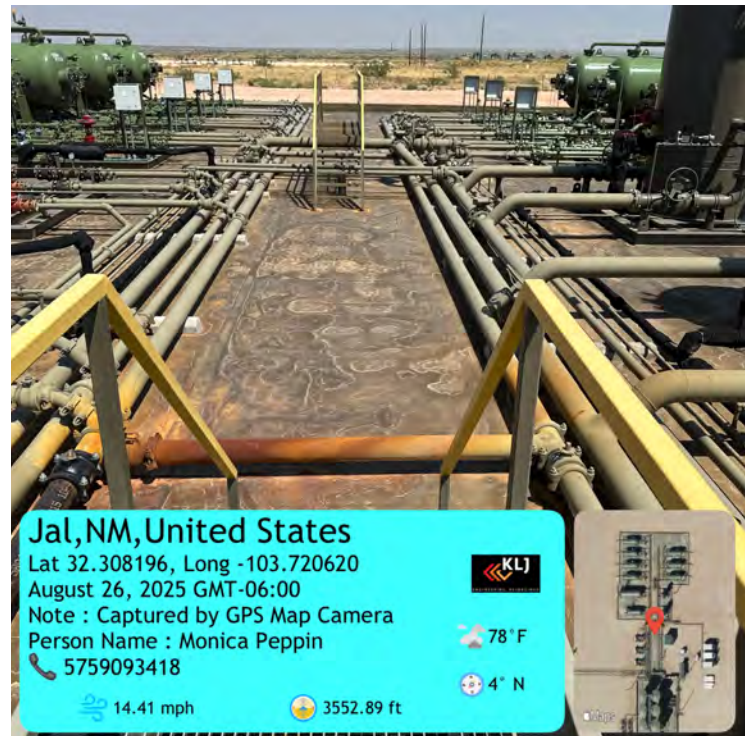
Viewing liner from tank battery facing north.

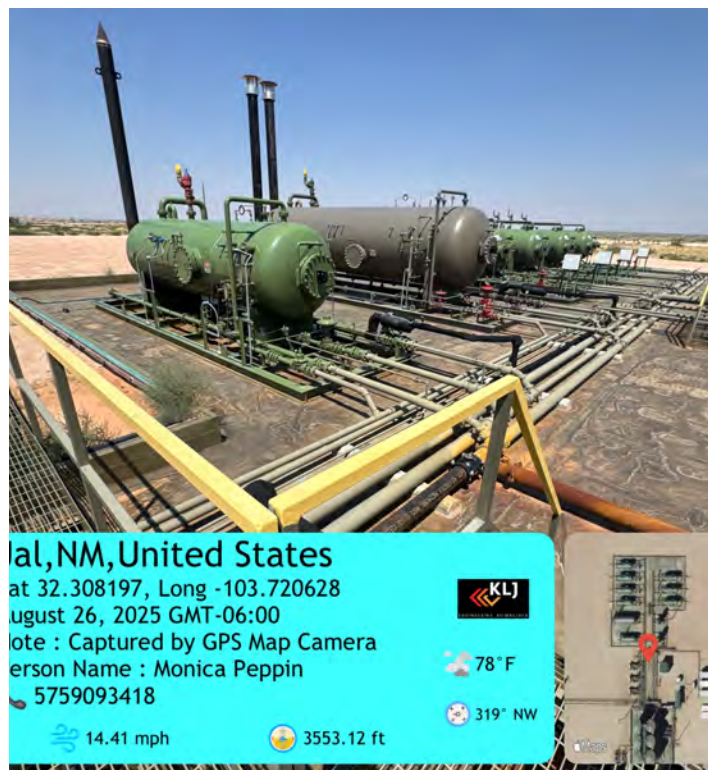
Facing west from east side viewing liner on north end.

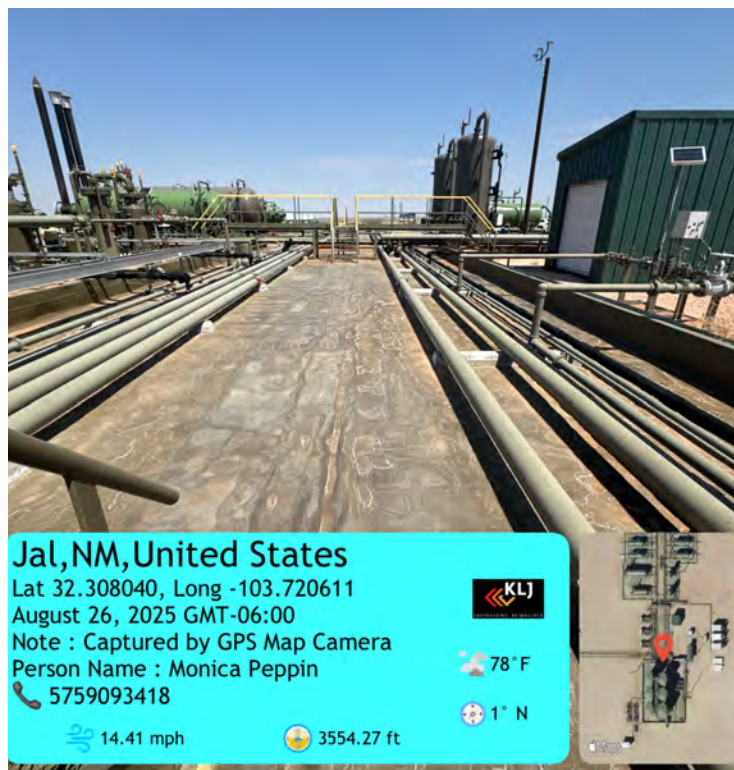
Facing north viewing liner from tank battery.

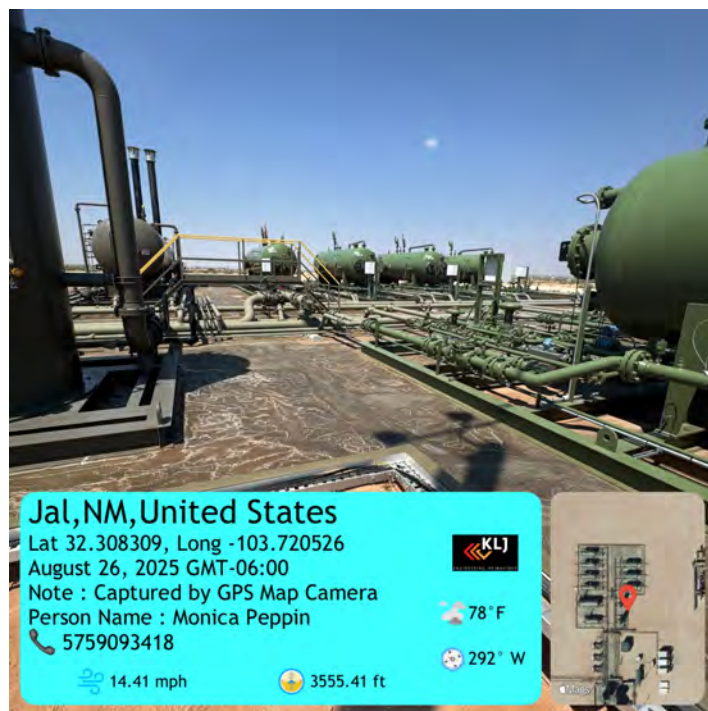
West side view facing south from north end.
