LINER INSPECTION AND CLOSURE REPORT

PREPARED FOR:
DEVON ENERGY PRODUCTION, LP.

LOCATION: Spud Muffin 31 CTB 2

NMOCD REF. NO. NAPP2520228286

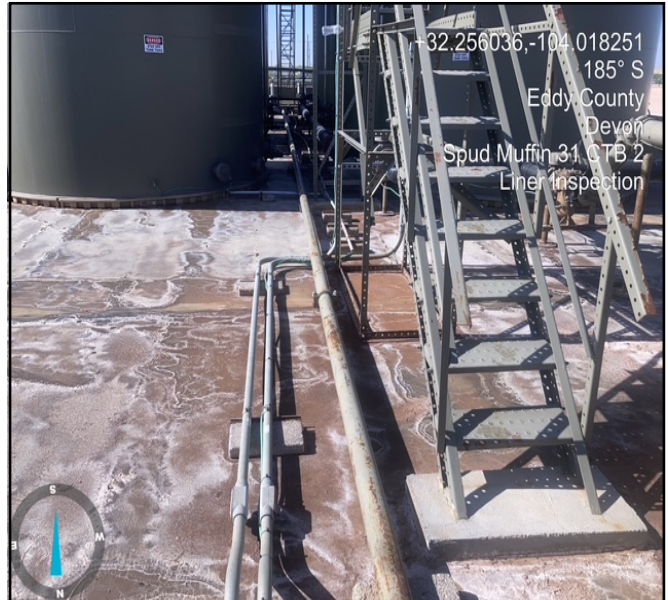
Photo of liner taken during initial liner inspection facing south.

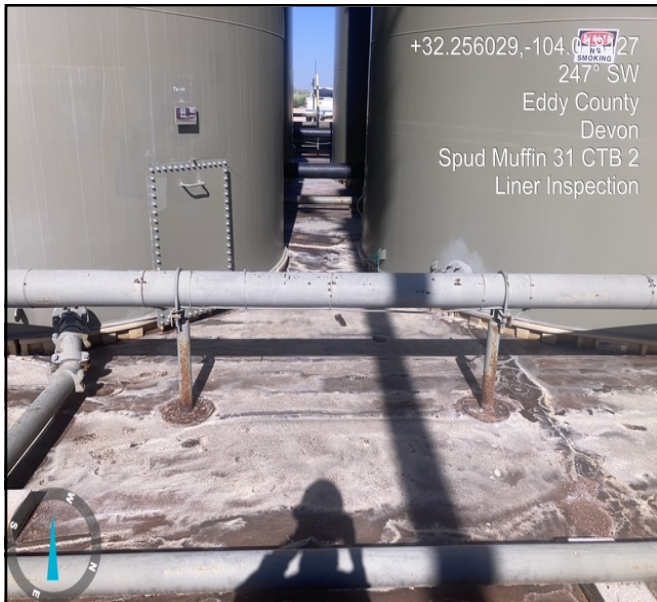
Photo of liner taken during initial liner inspection facing southwest.

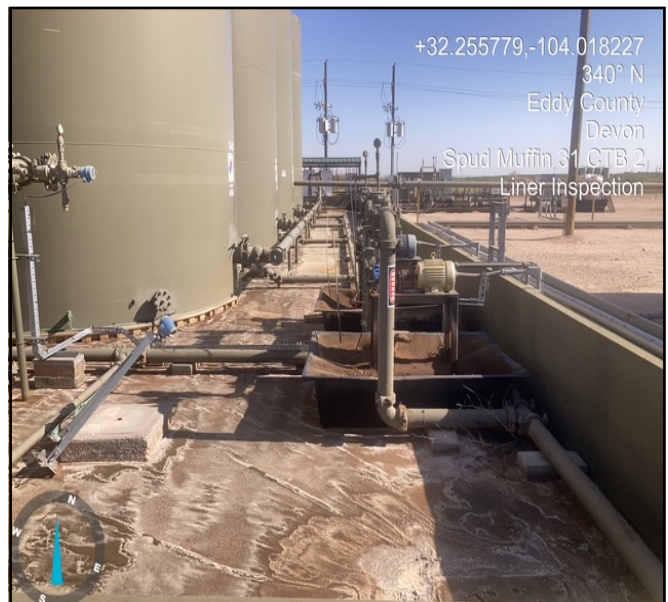
Photo of liner taken during initial liner inspection facing north.

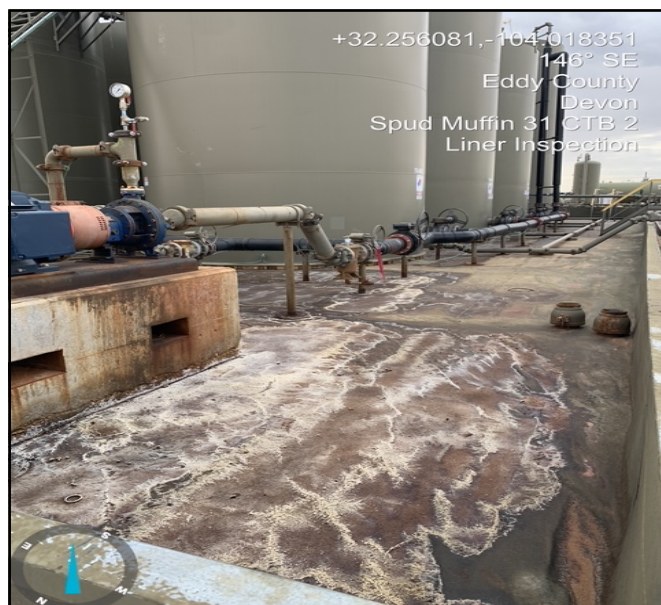
Photo of liner taken during initial liner inspection facing southeast.

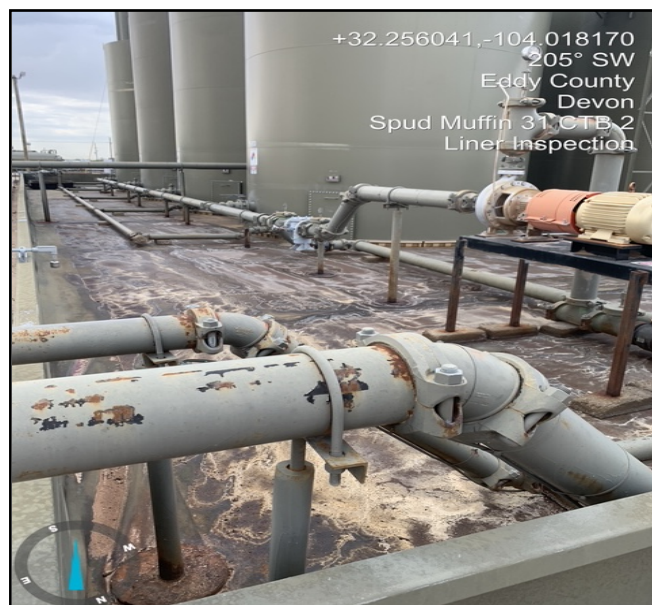
Photo of liner taken during initial liner inspection facing southwest.

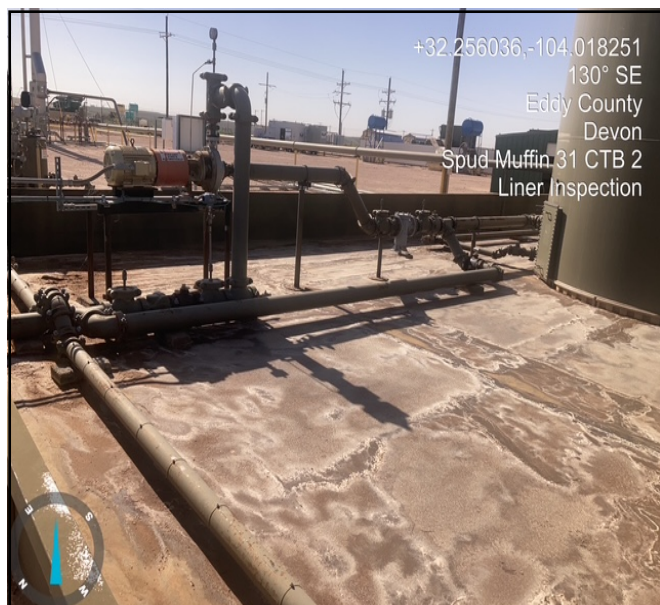
Photo of liner taken during initial liner inspection facing southeast.

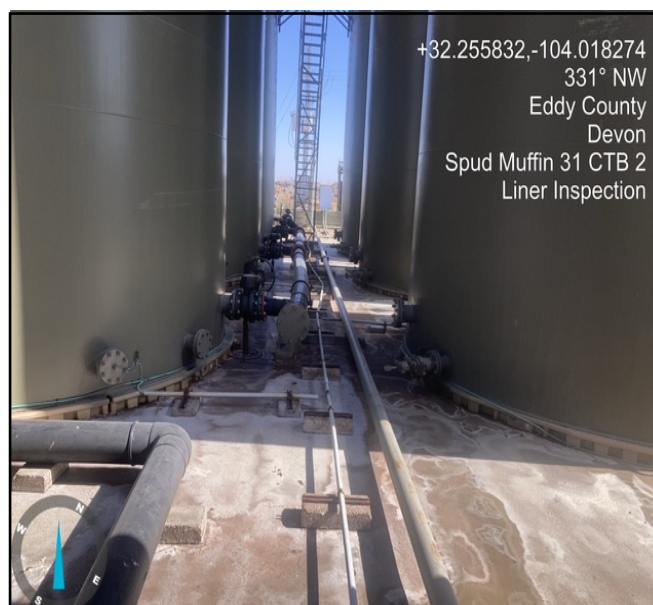
Photo of liner taken during initial liner inspection facing northwest.

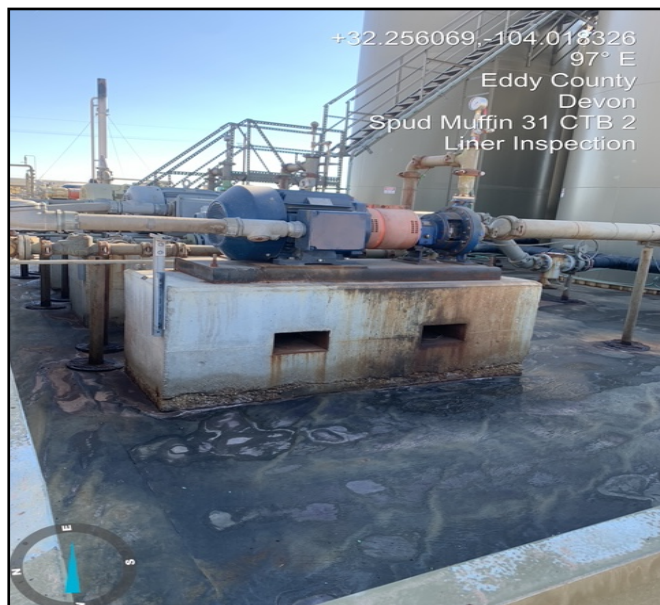
Photo taken pursuant to power washing.
Facing east.

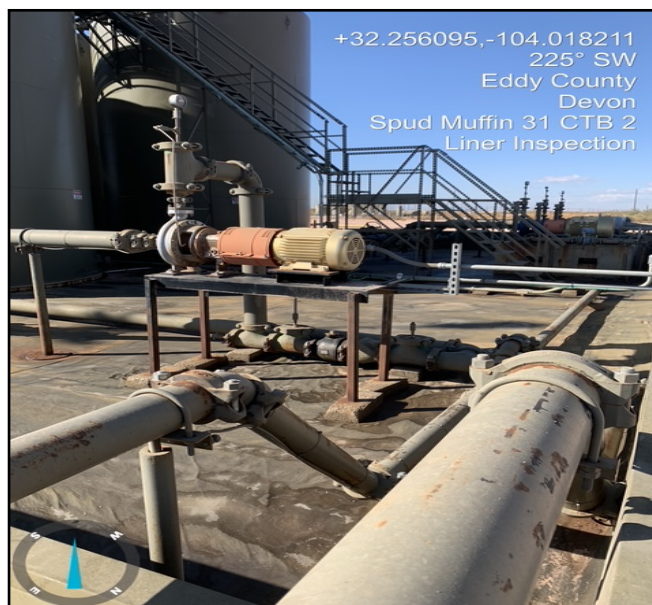
Photo taken pursuant to power washing. Facing
southwest.

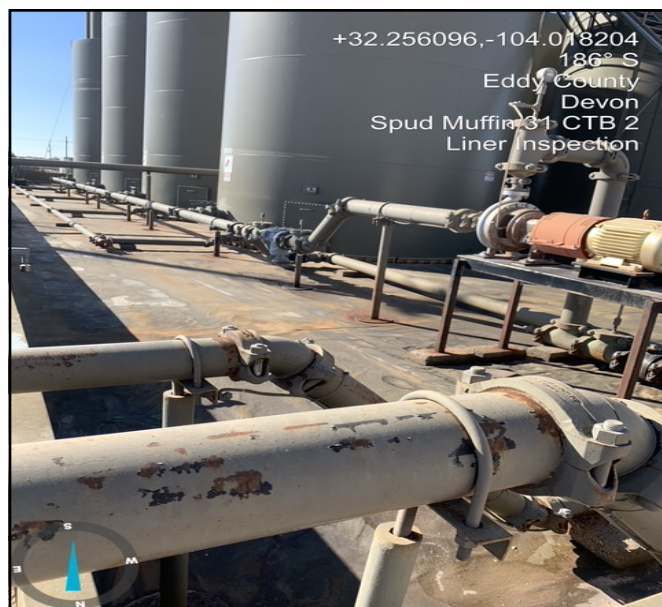
Photo taken pursuant to power washing.
Facing south.

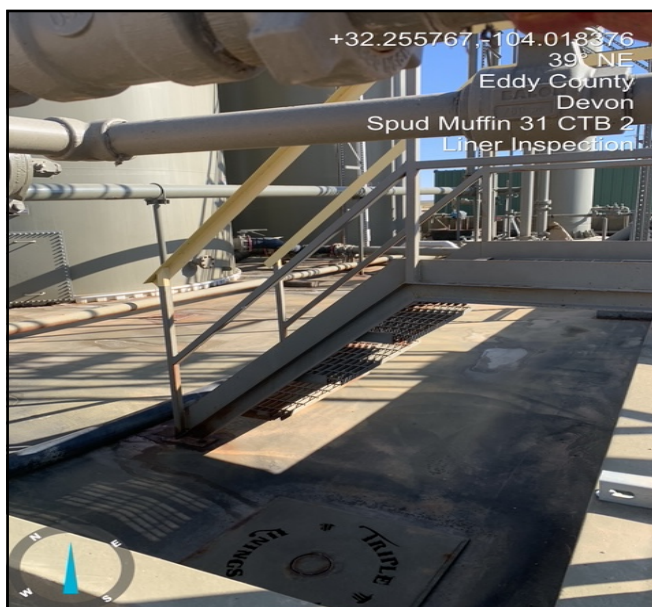
Photo taken pursuant to power washing.
Facing northeast.

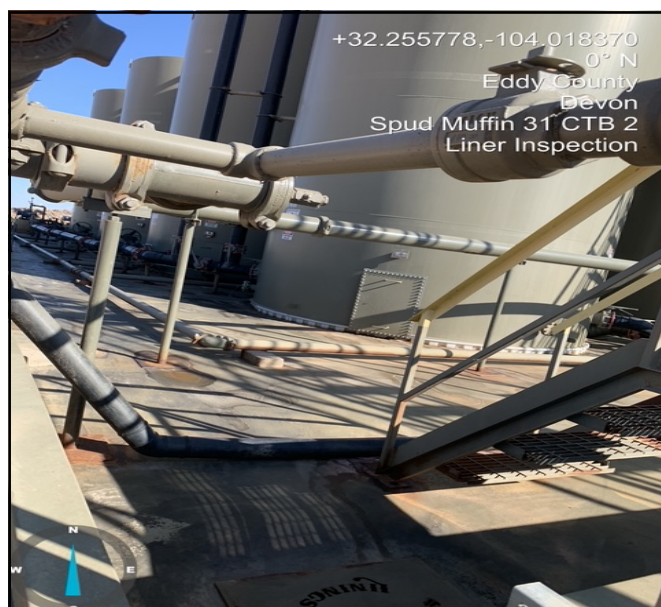
Photo taken pursuant to power washing.
Facing north.

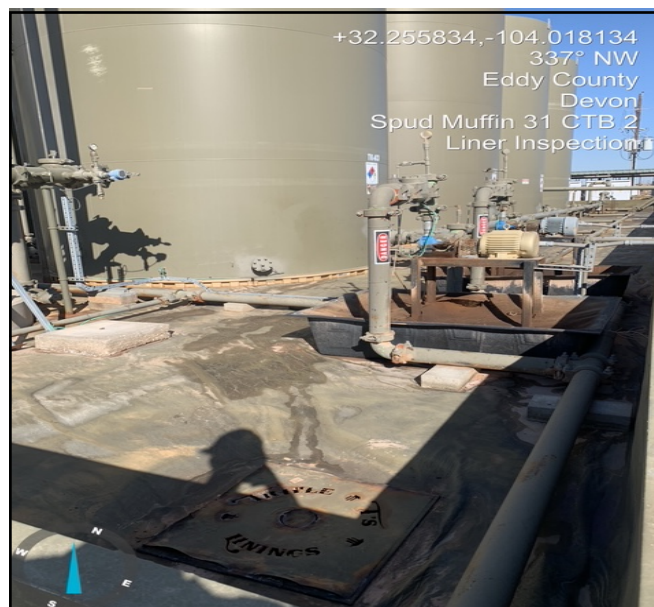
Photo taken pursuant to power washing.
Facing northwest.

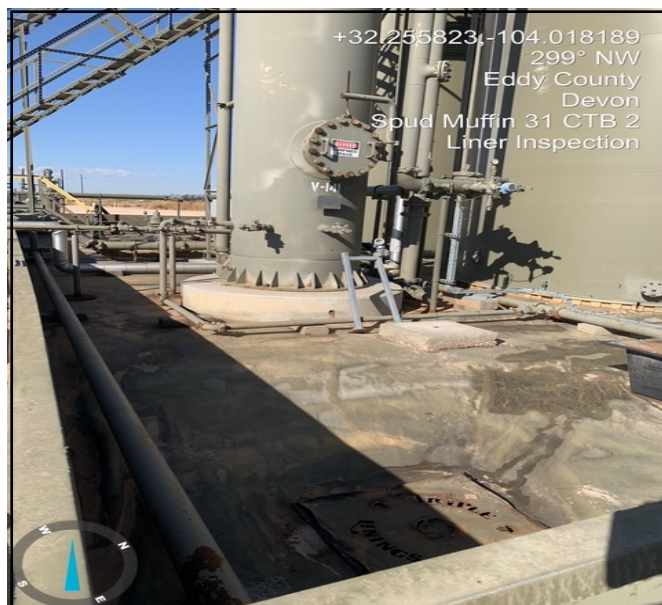
Photo taken pursuant to power washing.
Facing northwest.
