**LAKWOOD SOUTH TB**

Incident ID nAPP2604948372

**Liner Inspection and Closure Report**

**RE: Liner Inspection and Closure Report**  
**LAKEWOOD SOUTH TB**  
**Facility ID: fAPP2122833205**  
**GPS: Latitude 32.60865 Longitude -104.47923**  
**UL- D, Section 3, Township 20S, Range 25E**  
**NMOCD Reference No. NAPP2604948372**

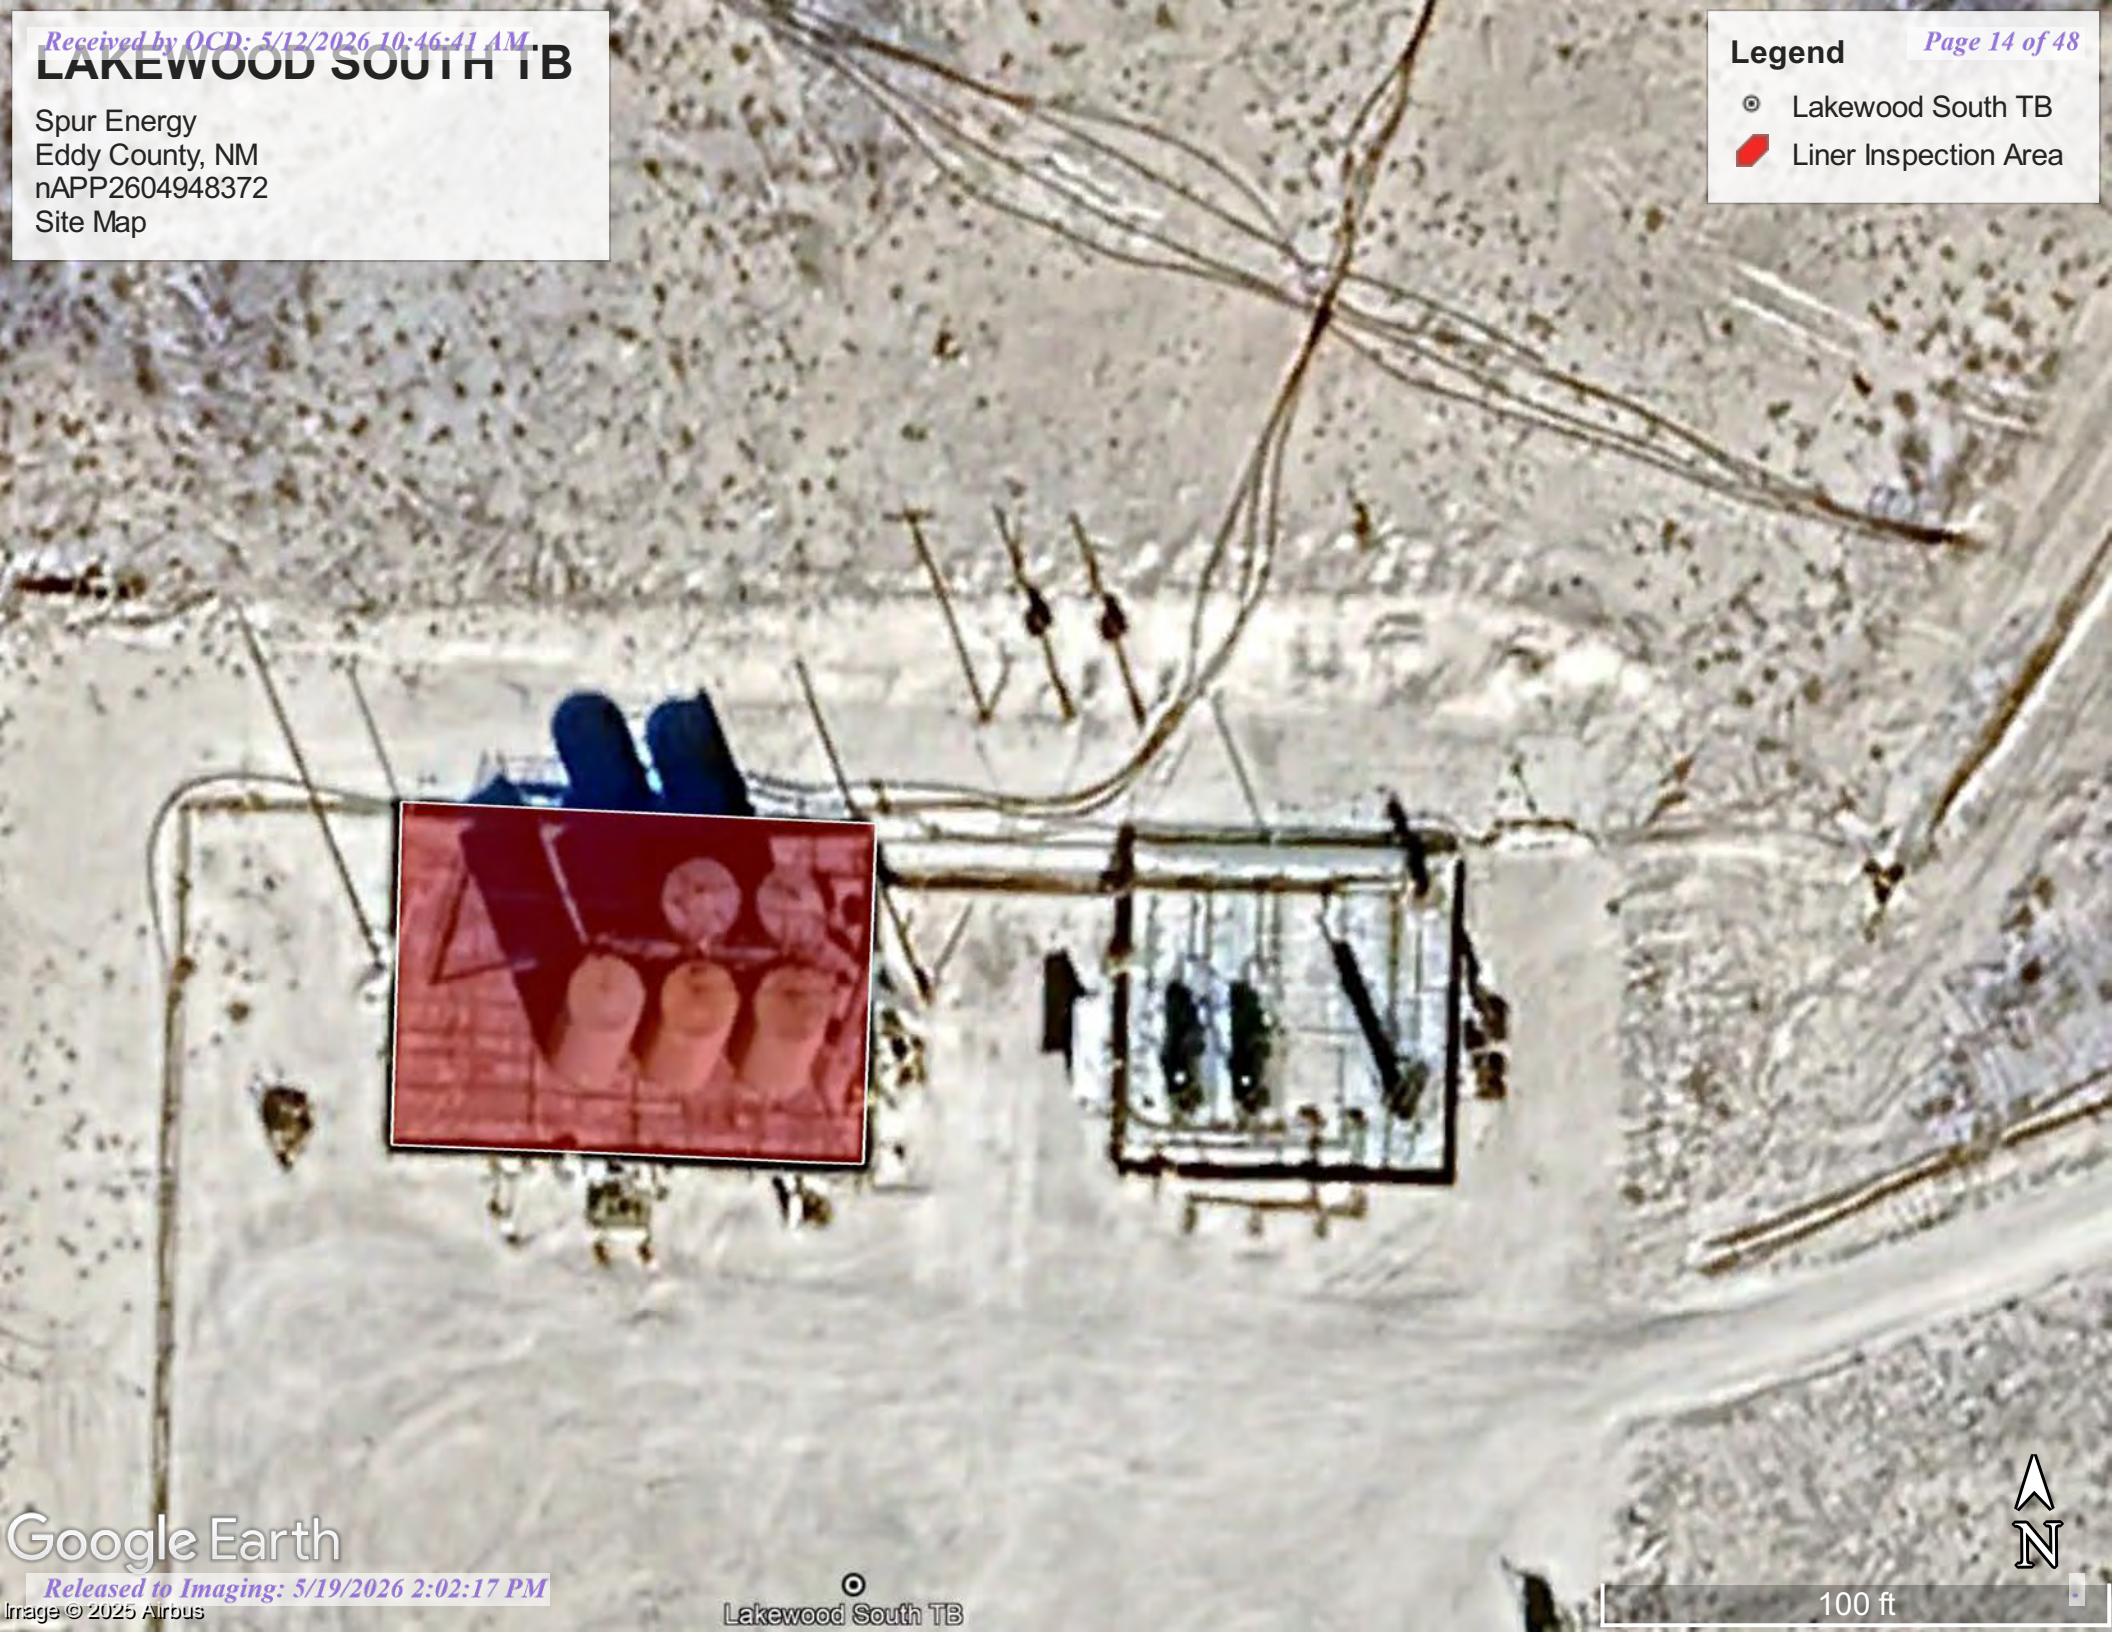
Figure 4- Site Map

**NAPP2604948372:** On February 18, 2026, a release of produced water and crude oil occurred due to corrosion of a nipple, resulting in the discharge of fluids into the lined containment. Approximately 42 barrels of produced water and 5 barrels of crude oil were released. Spur personnel immediately initiated response actions and successfully recovered all fluids using a vacuum truck. No impacts occurred outside of the lined containment. A site map is provided in Figure 4.

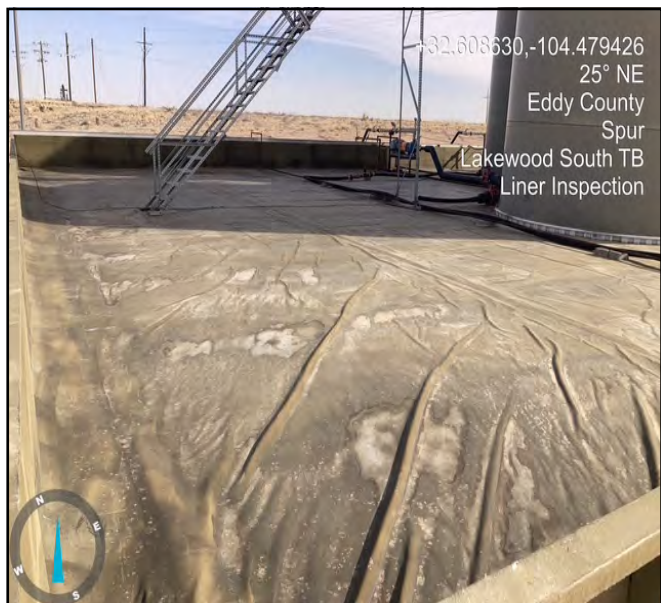
Photograph taken during initial assessment facing northeast.

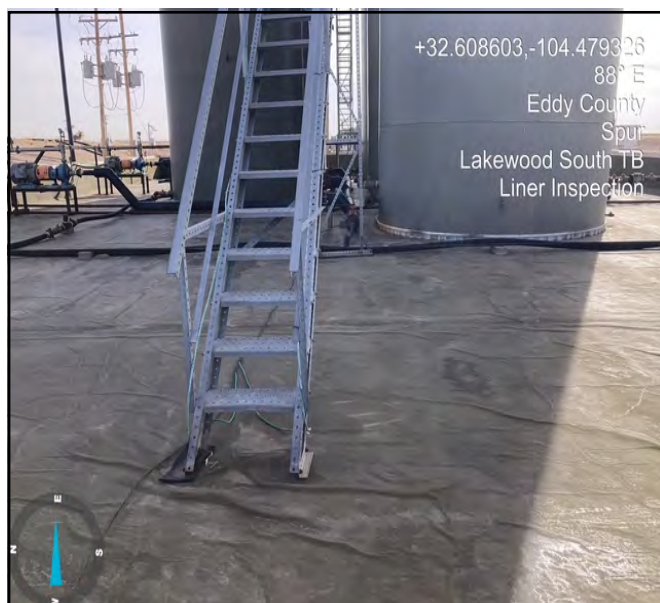
Photograph taken during initial assessment facing east.

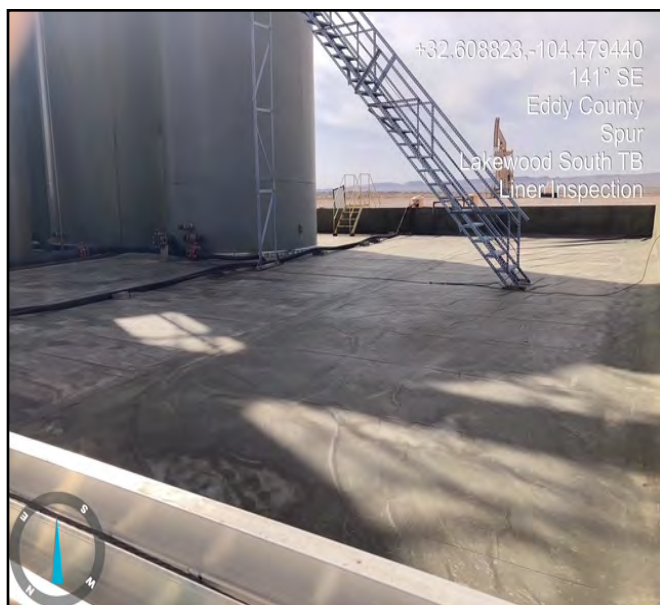
Photograph taken during initial assessment facing southeast.

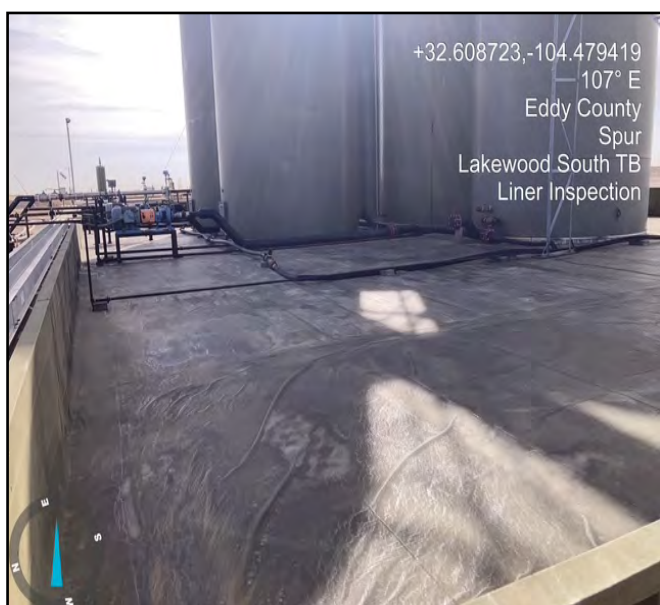
Photograph taken during initial assessment facing east.

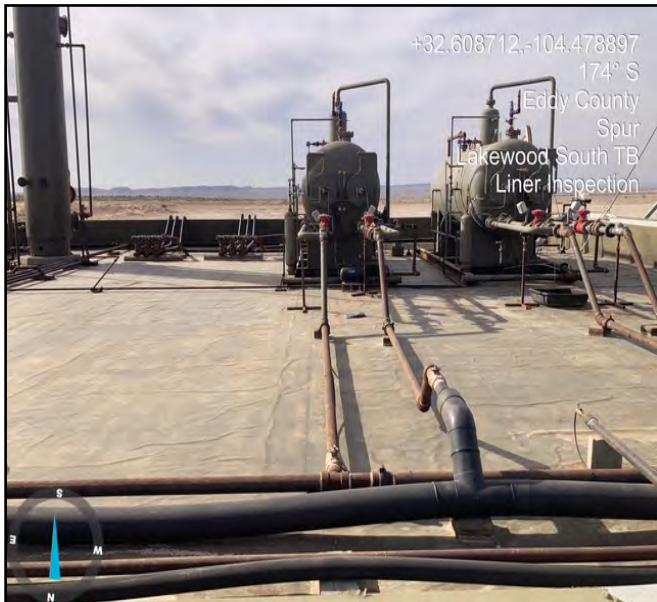
Photograph taken during initial assessment facing south.

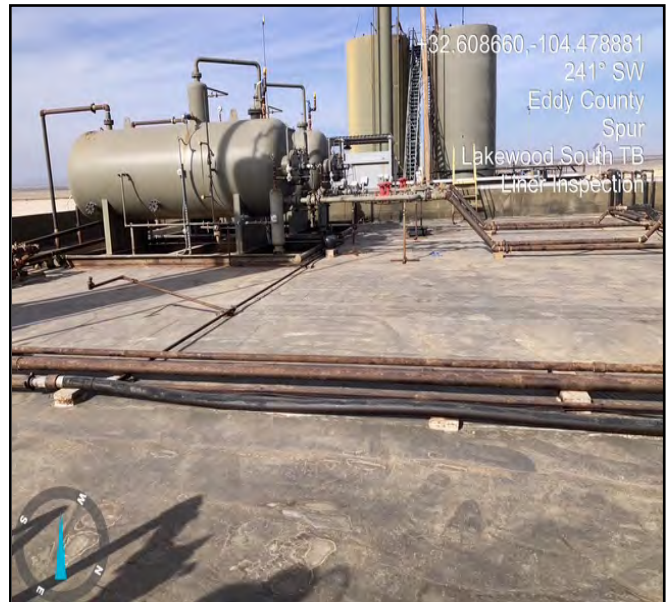
Photograph taken during initial assessment facing southwest.

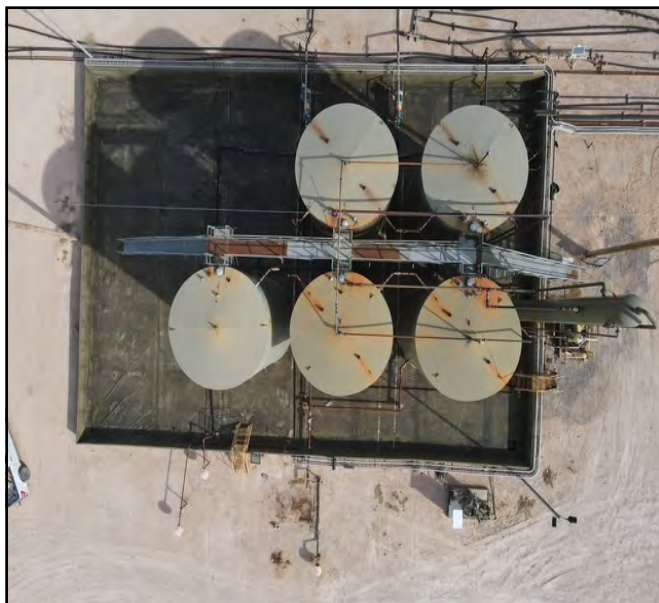
Aerial photo of initial assessment.

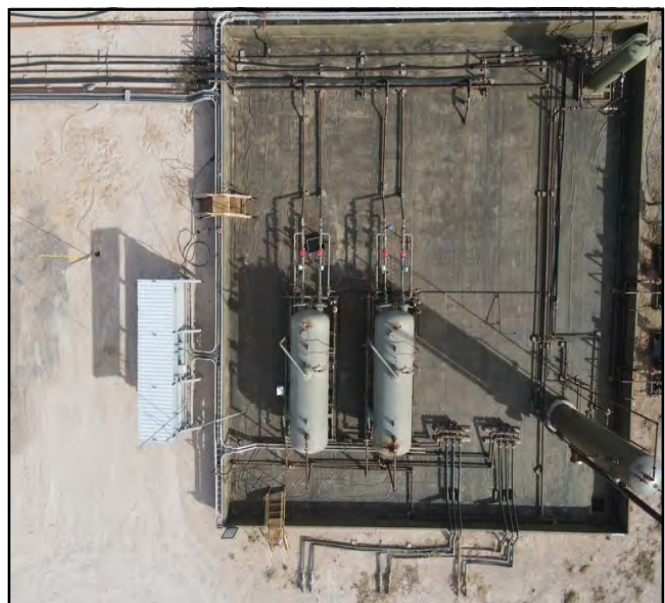
Aerial photo of initial assessment.
