GJ WEST COOP UNIT 92 TB

Incident ID nAPP2606927793

## Liner Inspection and Closure Report

April 27, 2026

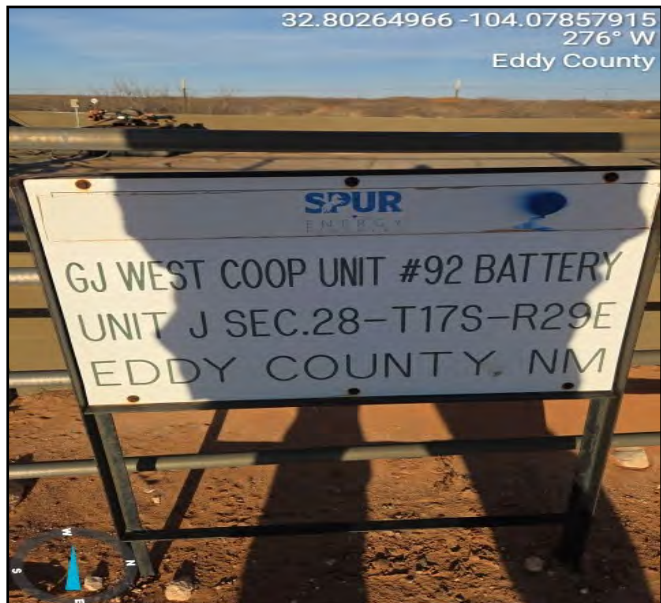
Site Information Sign.

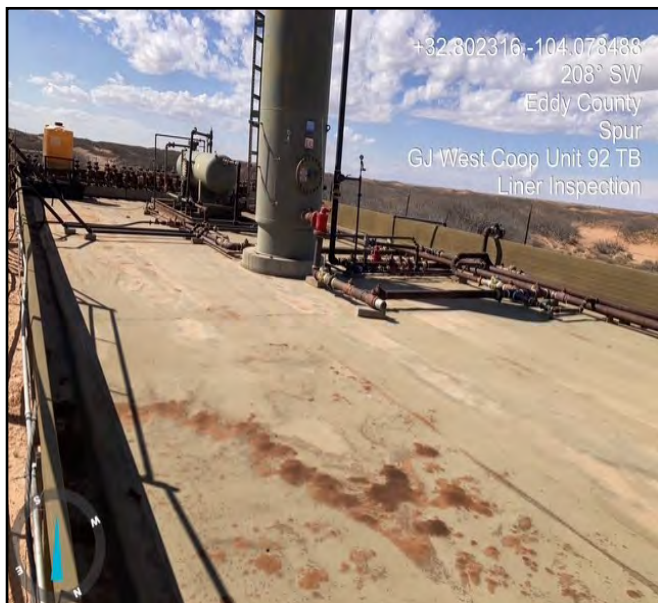
Photograph taken during initial spill release facing southwest.

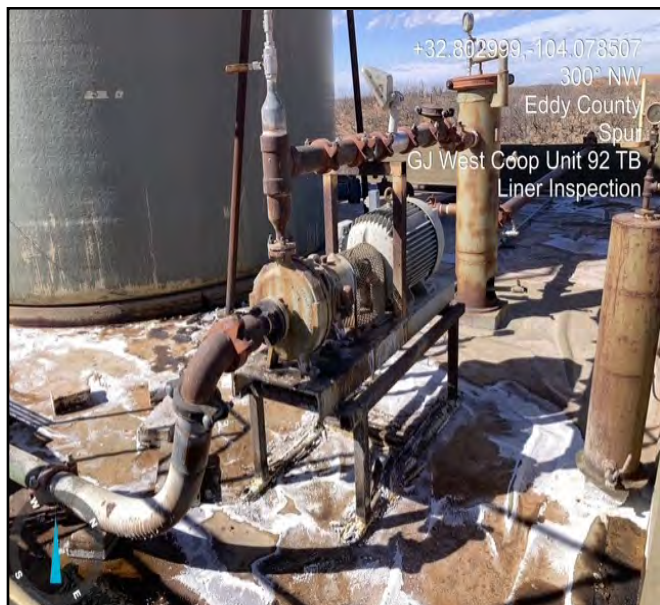
Photograph taken during initial spill release facing northwest.

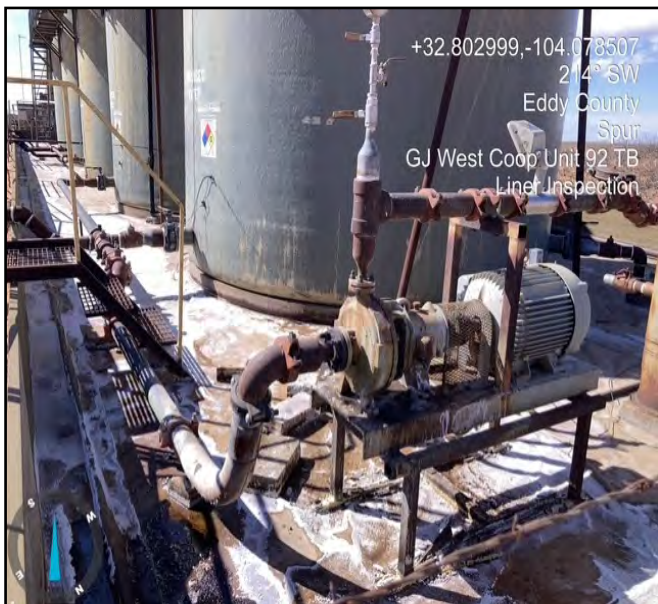
Photograph taken during initial spill release facing southwest.

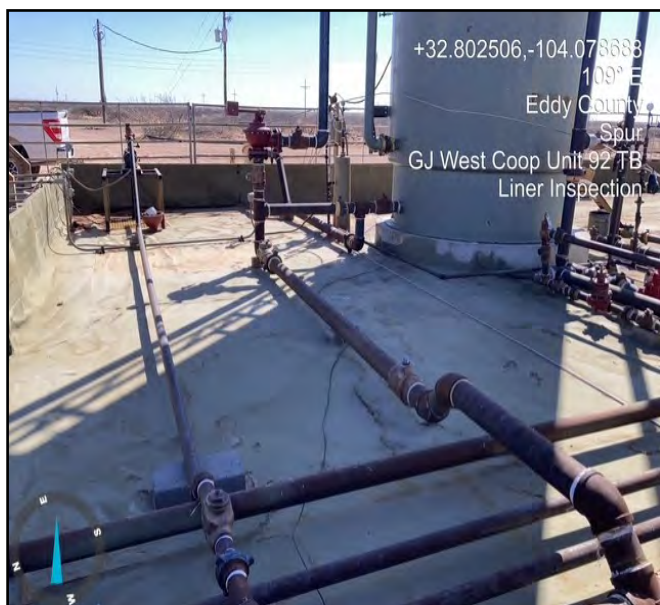
Photograph taken during initial spill release facing east.

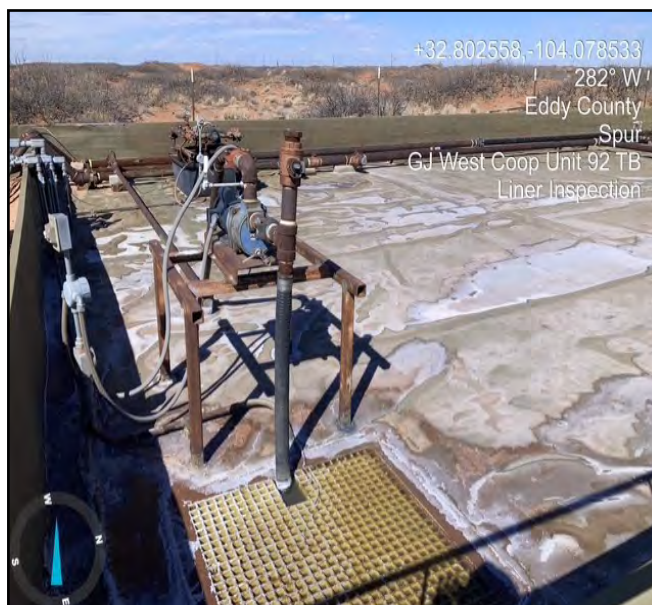
Photograph taken during initial spill release facing west.

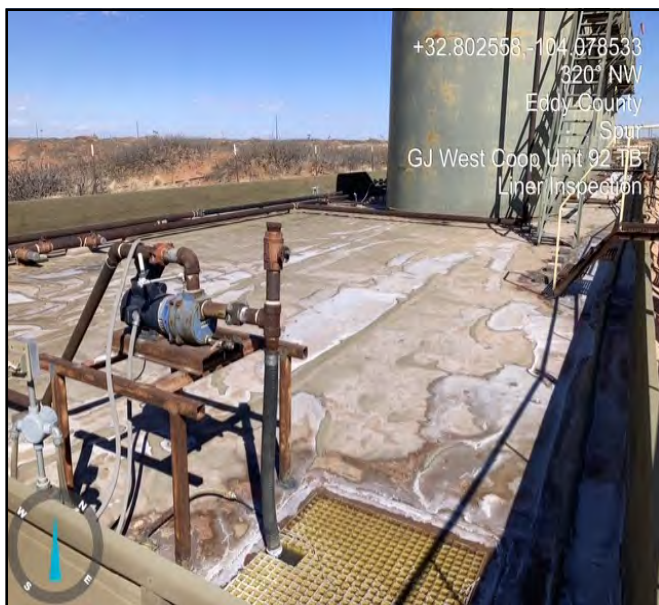
Photograph taken during initial spill release facing northwest.

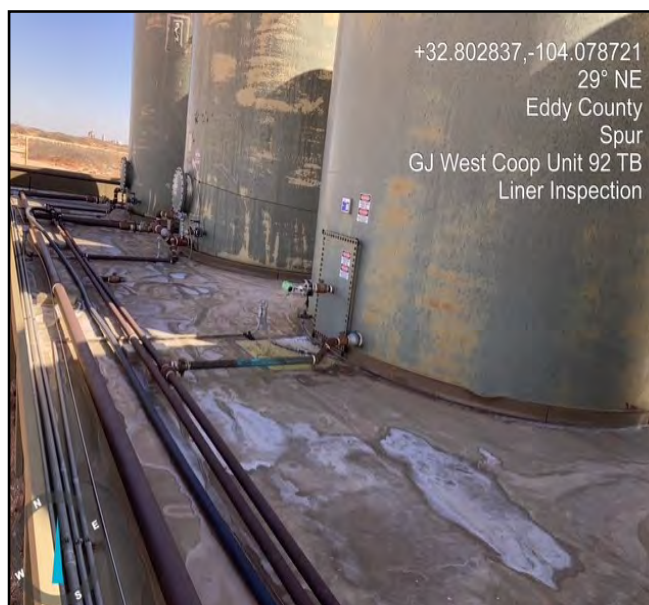
Photograph taken during initial spill release facing northeast.

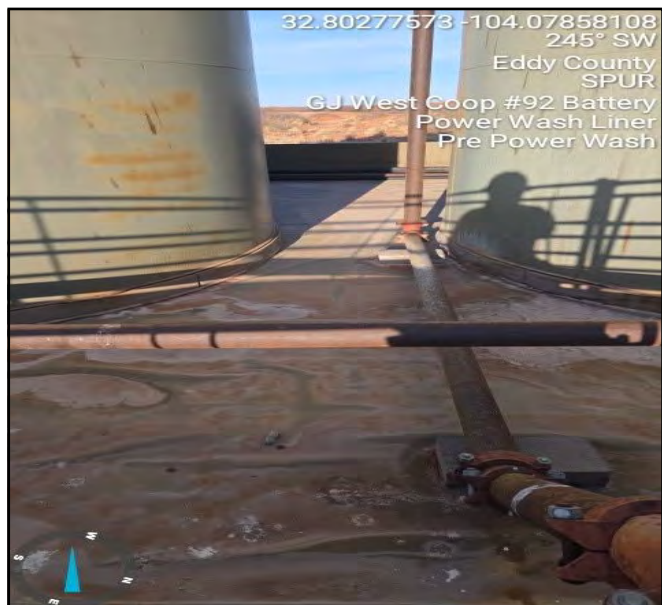
Photograph taken pre powerwash facing southwest.

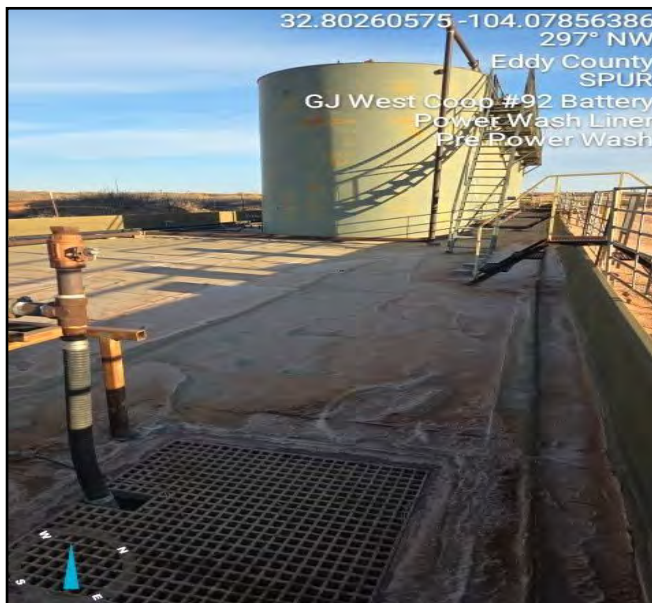
Photograph taken pre powerwash facing northwest.

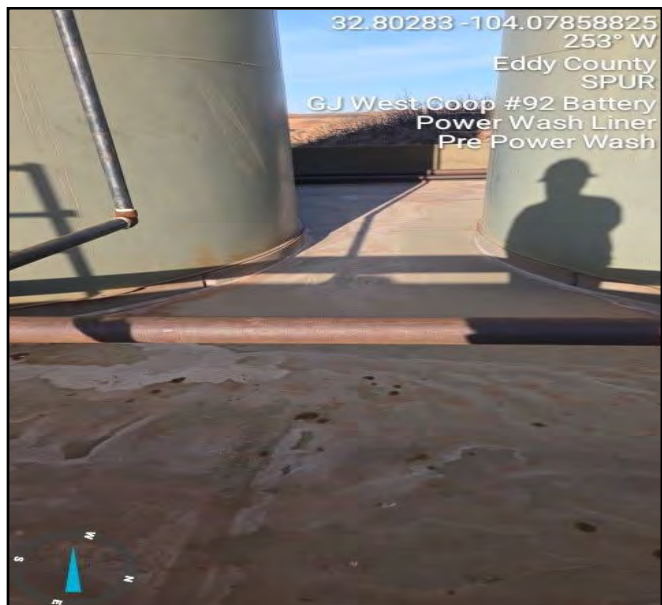
Photograph taken pre powerwash facing west.

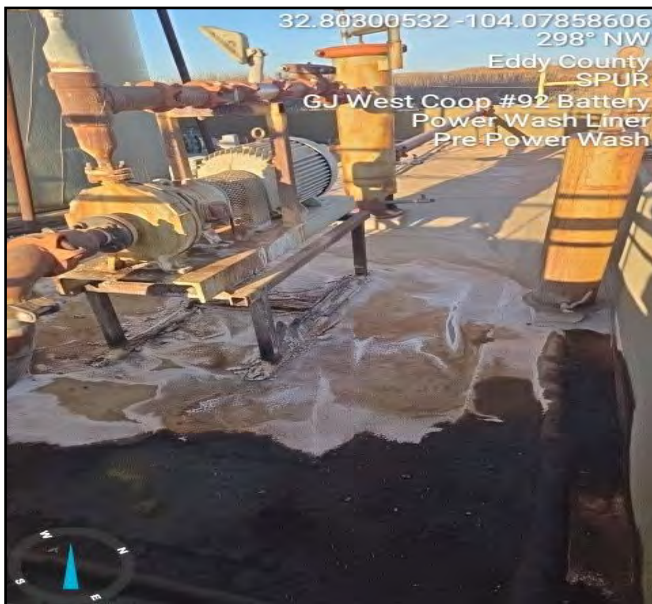
Photograph taken pre powerwash facing northwest.

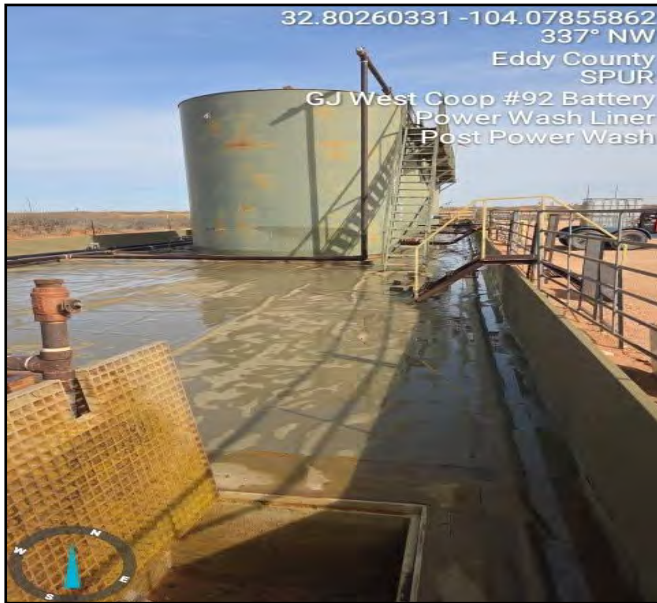
Photograph taken post powerwash facing northwest.

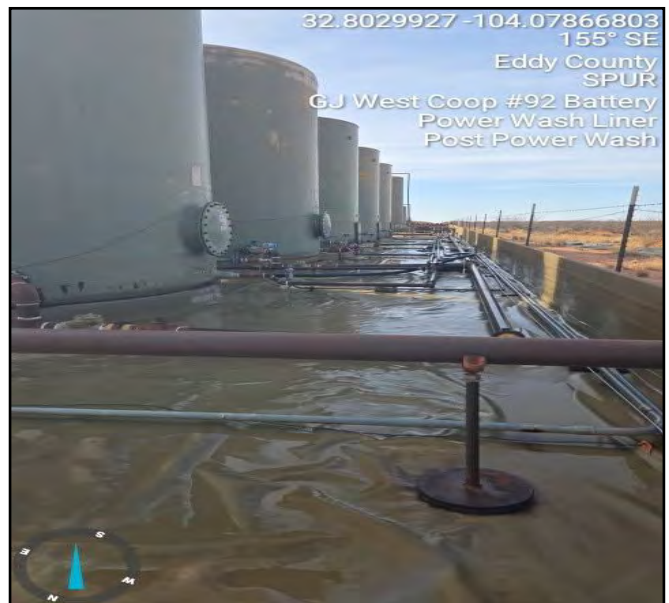
Photograph taken post powerwash facing southeast.

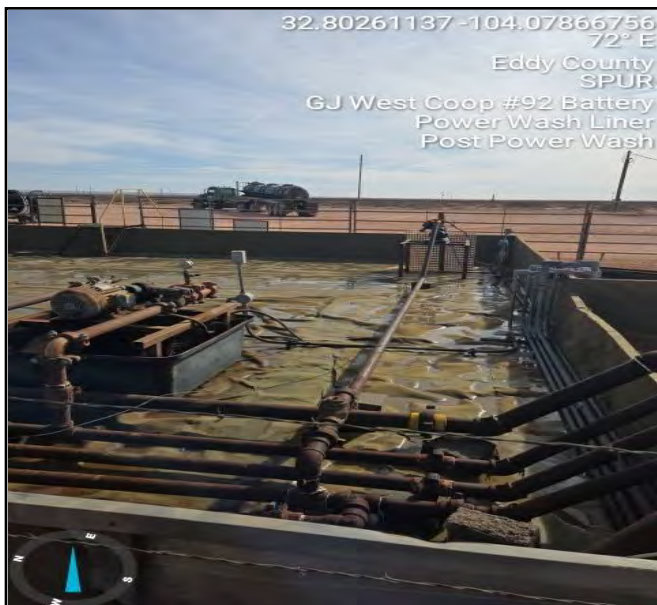
Photograph taken post powerwash facing east.

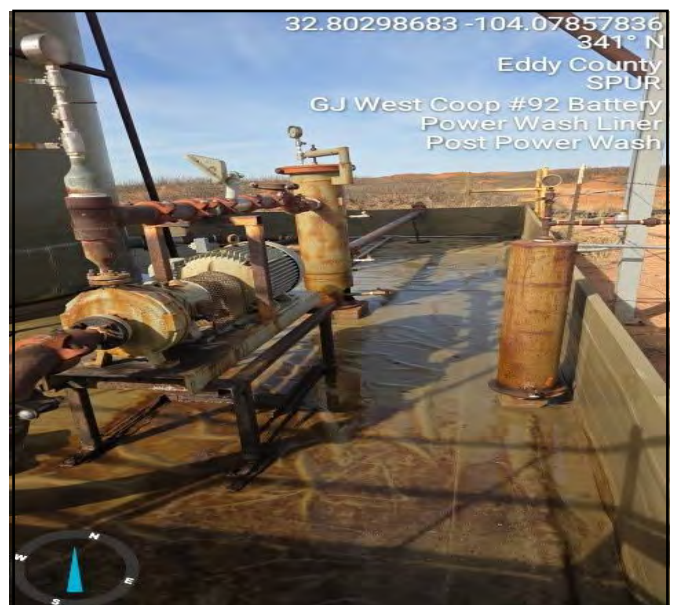
Photograph taken post powerwash facing north.

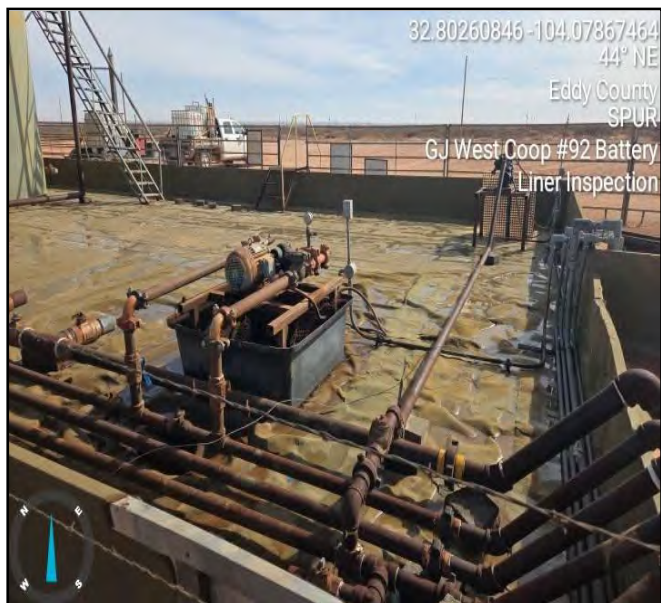
On March 18, 2026, Pima Environmental conducted a thorough inspection of the lined containment area. The evaluation process included cleaning the liner with a power washer and using a vacuum truck to ensure the complete removal of any residual fluids. The inspection confirmed that the system remained intact and successfully retained all fluids. As a result, the liner was deemed functional, preventing any further environmental impact. A detailed report, including photographic evidence, is provided in Appendices C and D.

Photograph taken during Liner Inspection facing northeast.

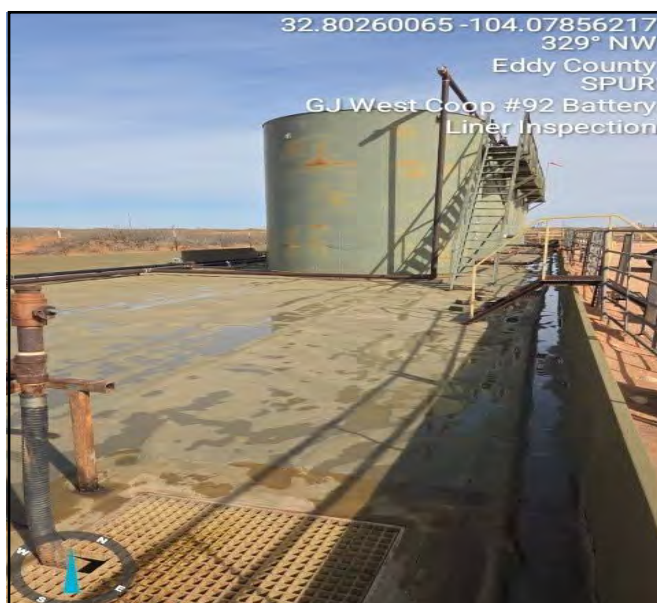
Photograph taken during Liner Inspection facing northwest.

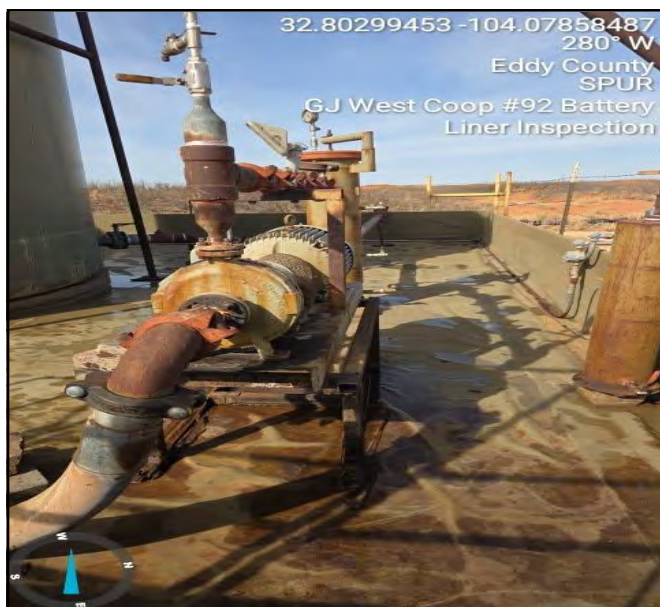
Photograph taken during Liner Inspection facing west.

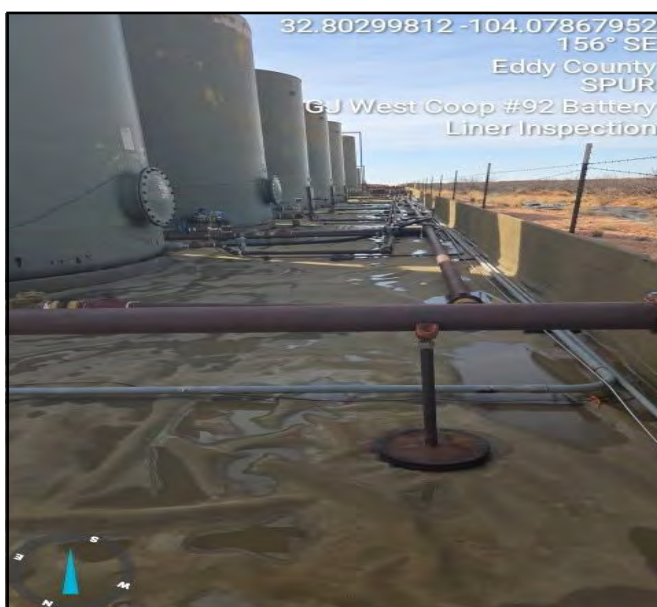
Photograph taken during Liner Inspection facing southeast.
