Our Ref.: 12670741 – NMOCD – 1

May 18, 2026

Closure Report  
Devon Energy Production Company, LP  
Stray Cat 8 CTB 5  
Unit Letter P, Section 08, T23S, R32E  
GPS: 32.31449095, -103.6916407  
Lea County, New Mexico

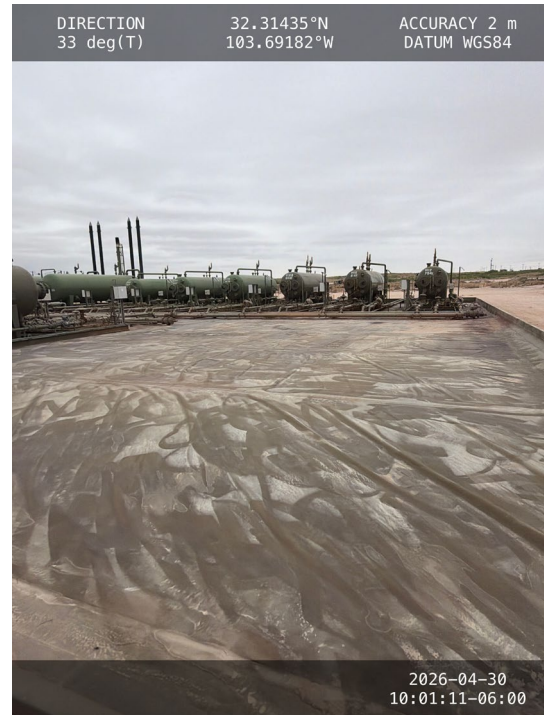
Photo 2 View of north-northeast side of containment.

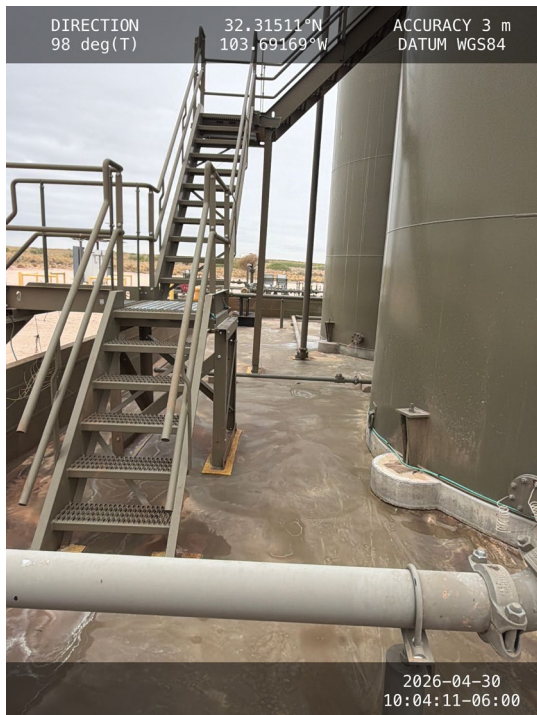
Photo 3 View of containment towards east.

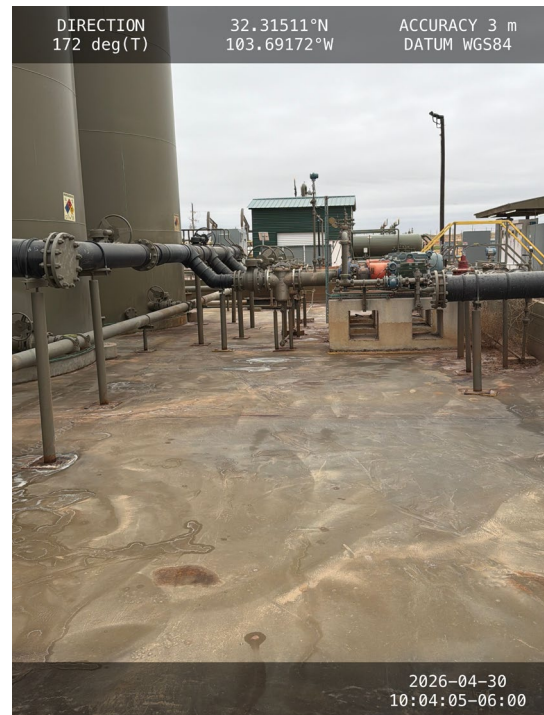
Photo 4 View of containment towards south.

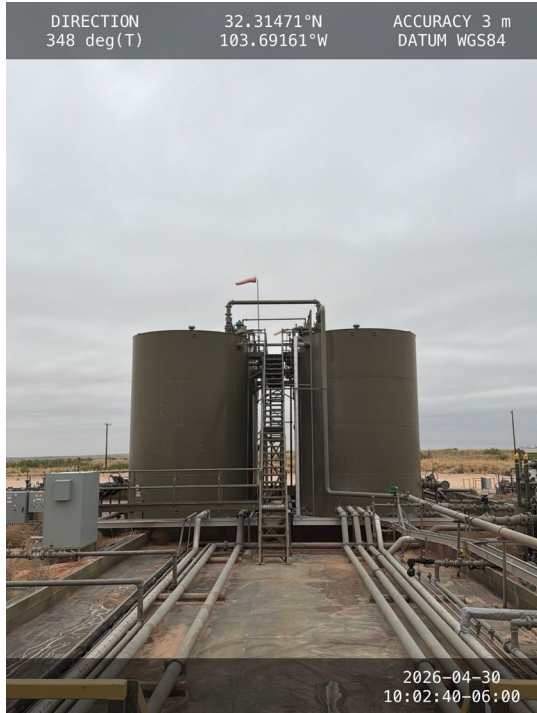
Photo 5 View of central containment towards north-northwest.

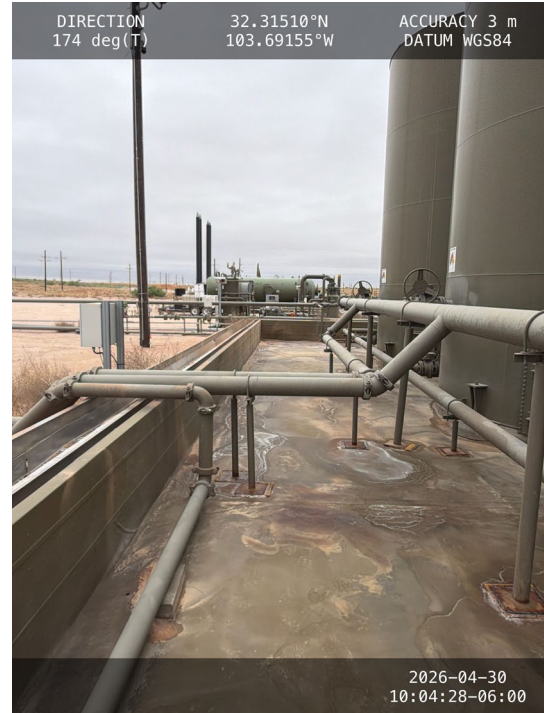
Photo 6 View of east side of containment towards south.

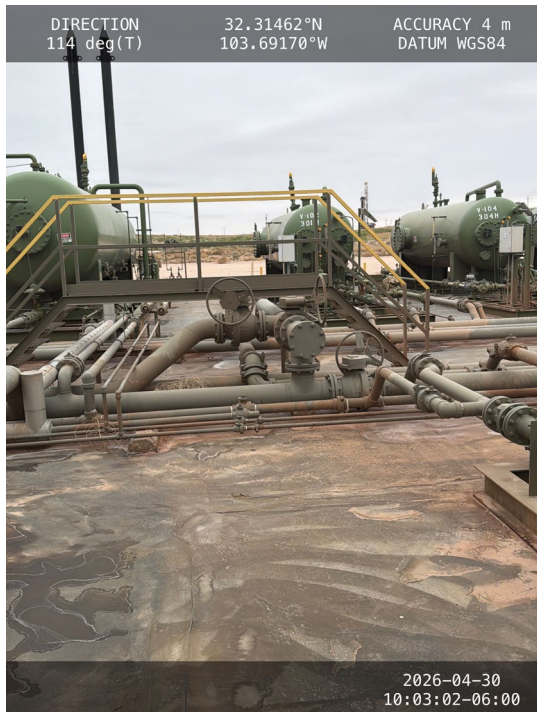
Photo 7 View of containment towards east-southeast.

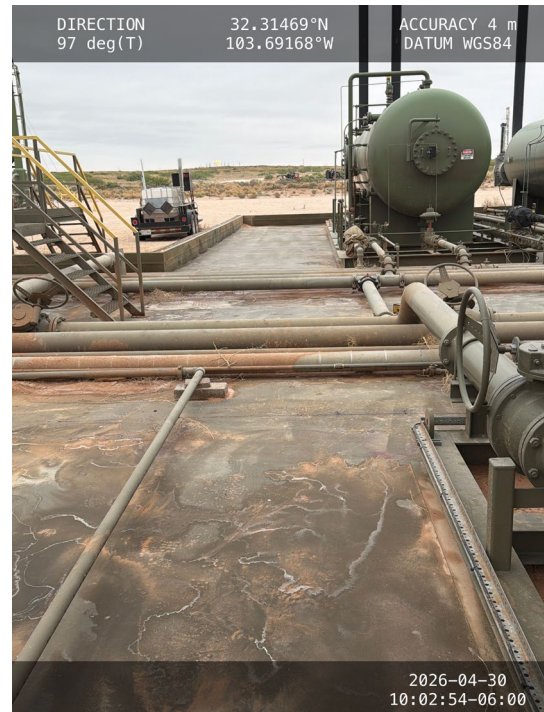
Photo 8 View of containment towards east.

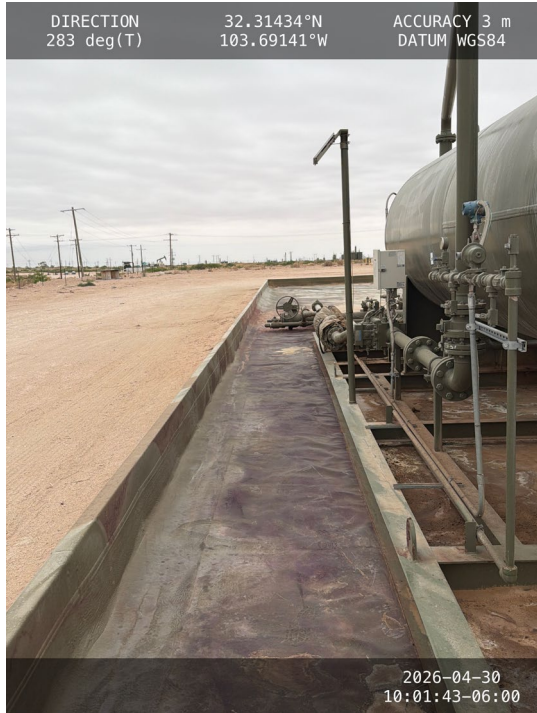
Photo 9 View of northwest corner of containment.

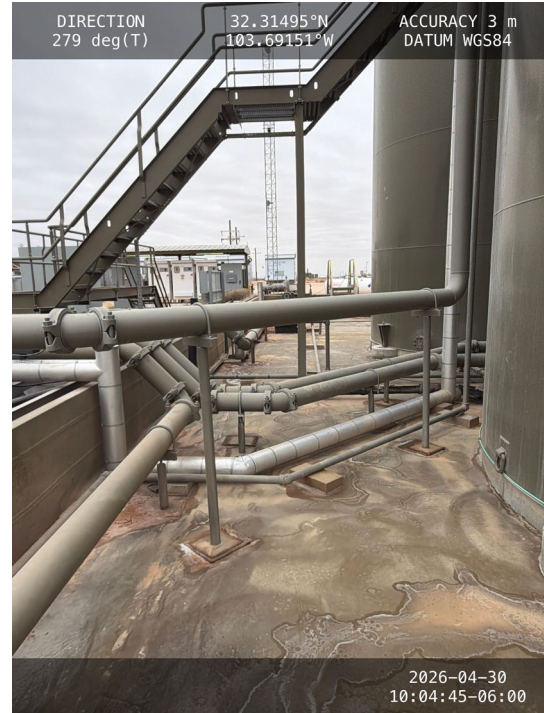
Photo 10 View of containment towards west.

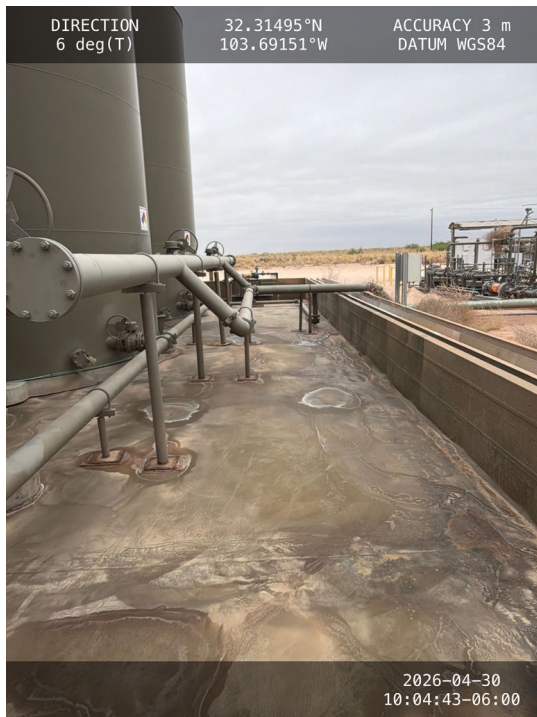
Photo 11 View of containment towards north.

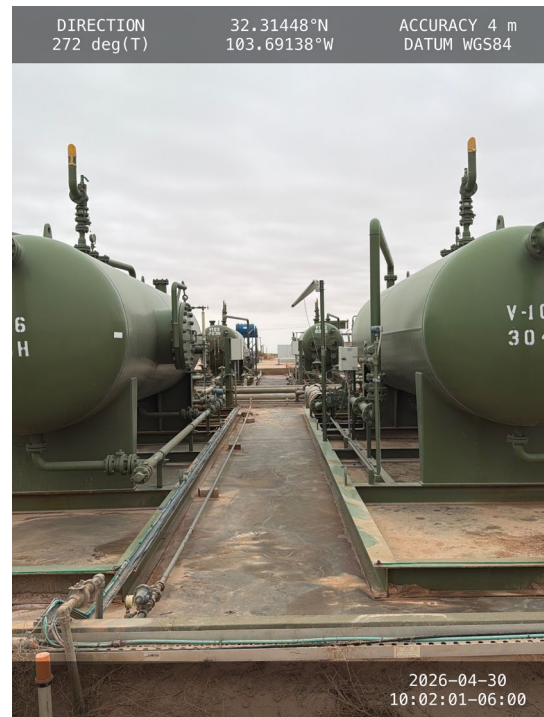
Photo 12 View of the central area of the secondary containment towards west.

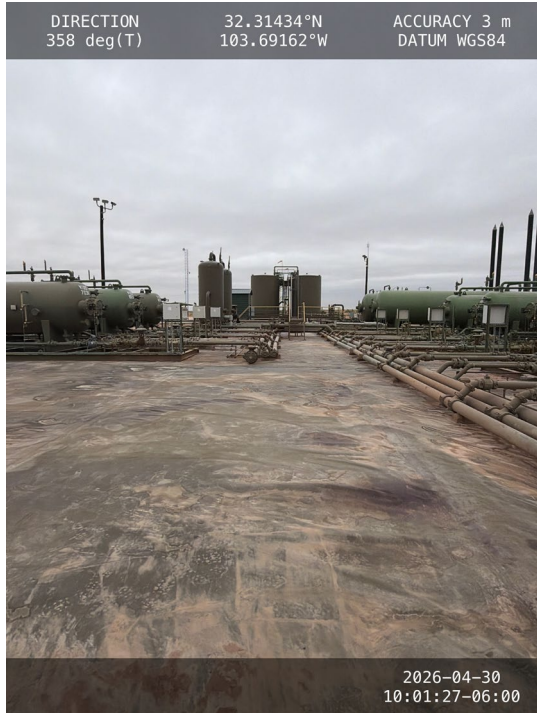
Photo 13 View of central containment towards north.

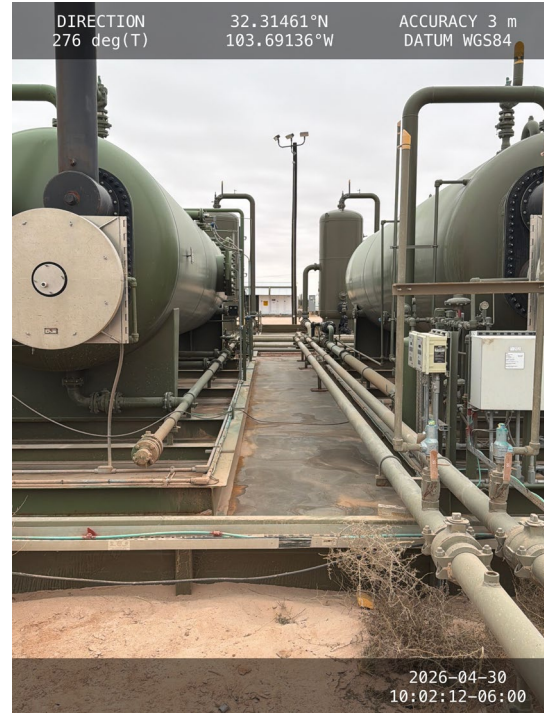
Photo 13 View of the secondary containment towards west.

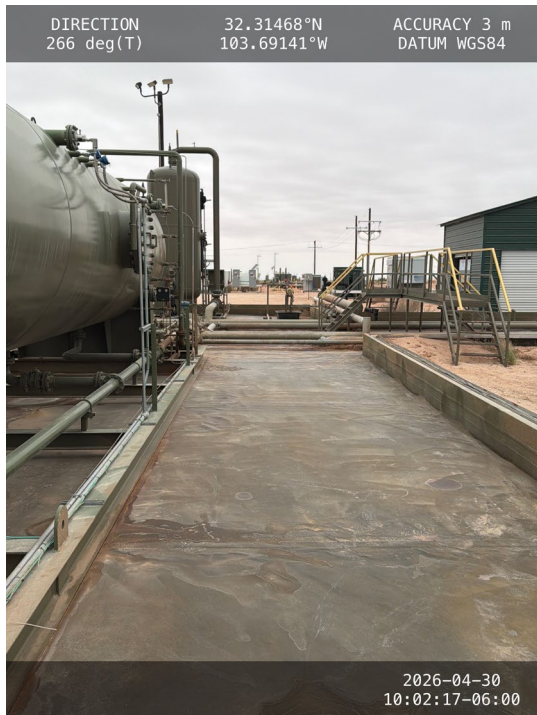
Photo 15 View of containment towards west.

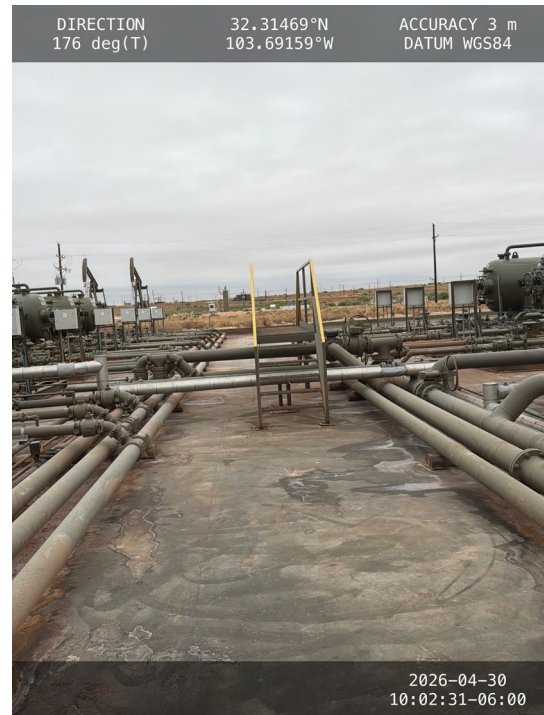
Photo 16 View of the central area towards south.
