Our Ref.: 12670741 – NMOCD – 1

May 18, 2026

Closure Report
Devon Energy Production Company, LP
Stray Cat 8 CTB 5
Unit Letter P, Section 08, T23S, R32E
GPS: 32.31449095, -103.6916407
Lea County, New Mexico

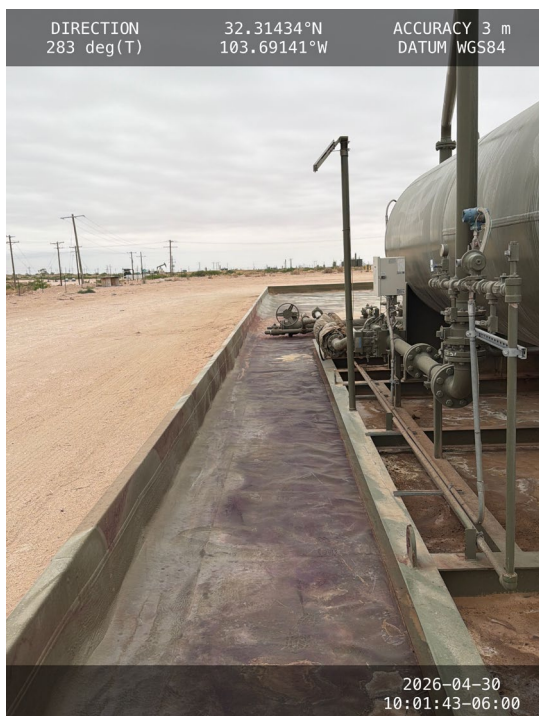
Photo 9 View of northwest corner of containment.

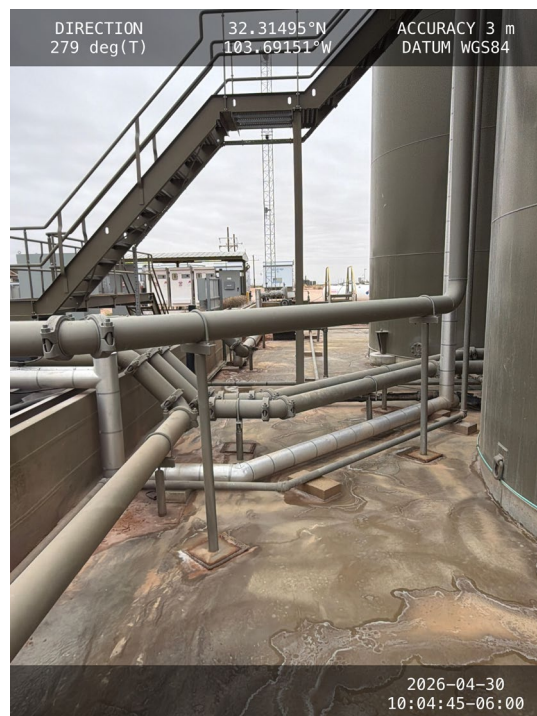
Photo 10 View of containment towards west.

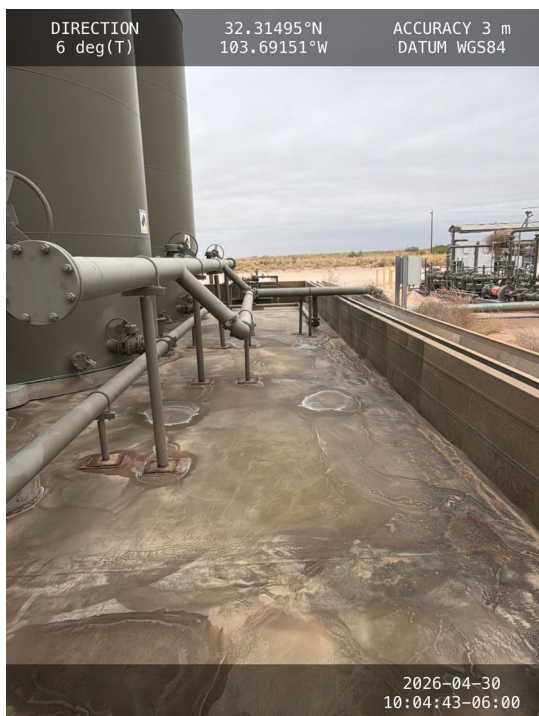
Photo 11 View of containment towards north.

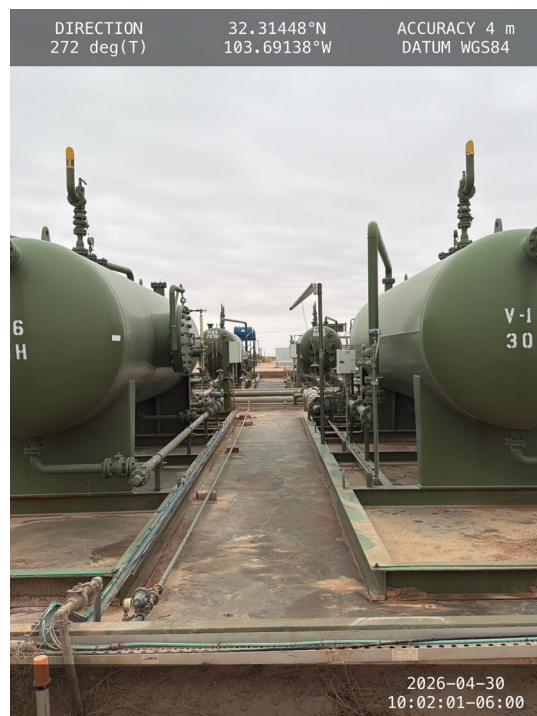
Photo 12 View of the central area of the secondary containment towards west.
