Our Ref.: 12670741 – NMOCD – 1

May 18, 2026

Closure Report
Devon Energy Production Company, LP
Stray Cat 8 CTB 5
Unit Letter P, Section 08, T23S, R32E
GPS: 32.31449095, -103.6916407
Lea County, New Mexico

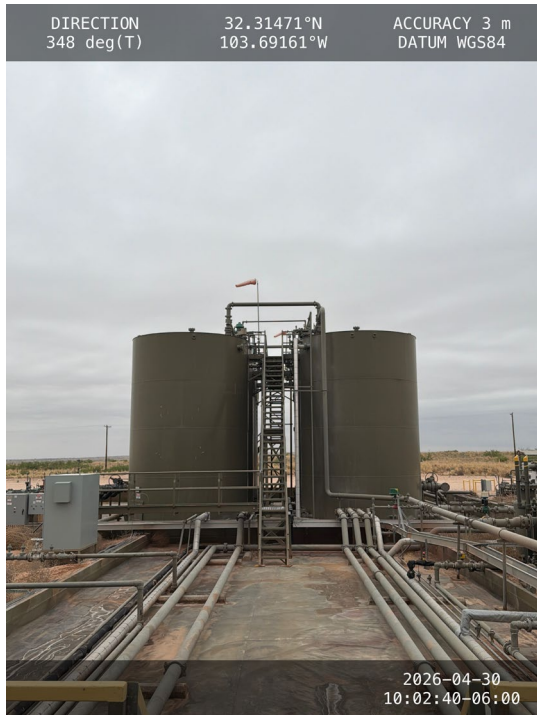
Photo 5 View of central containment towards north-northwest.

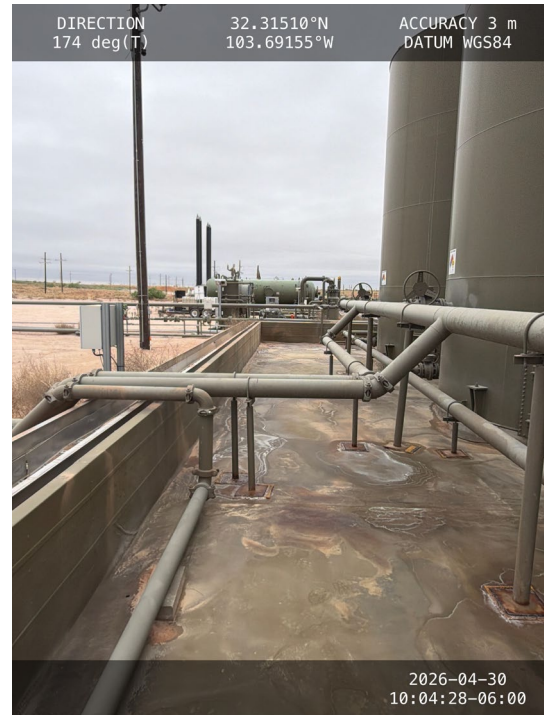
Photo 6 View of east side of containment towards south.

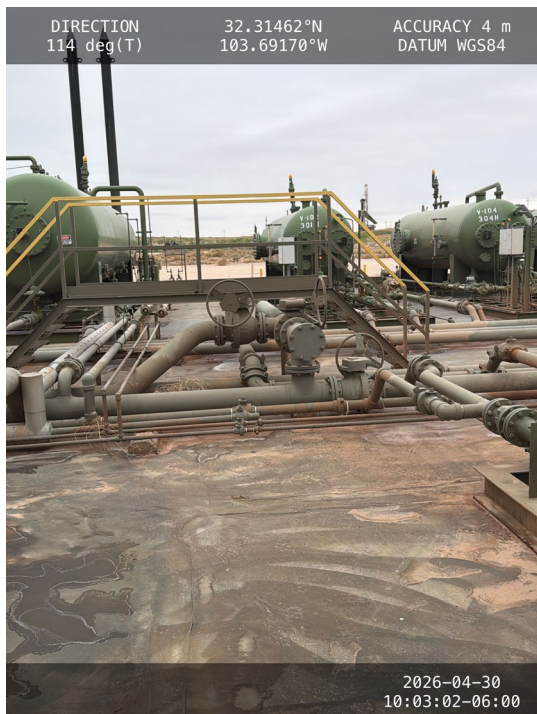
Photo 7 View of containment towards east-southeast.

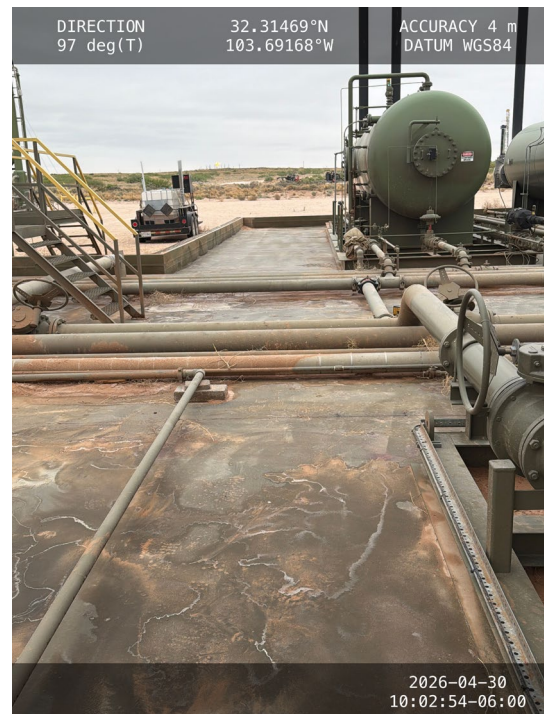
Photo 8 View of containment towards east.

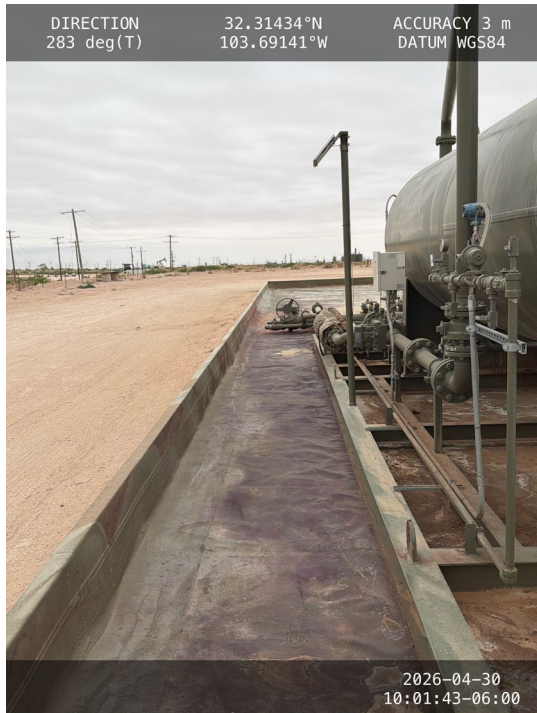
Photo 9 View of northwest corner of containment.

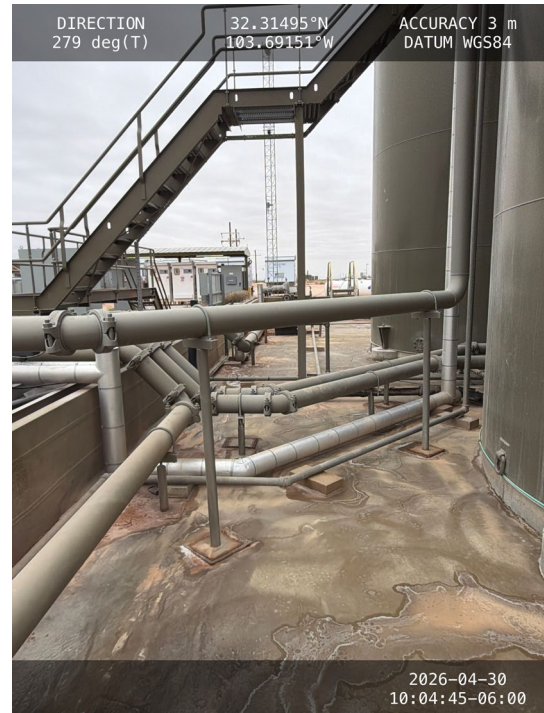
Photo 10 View of containment towards west.

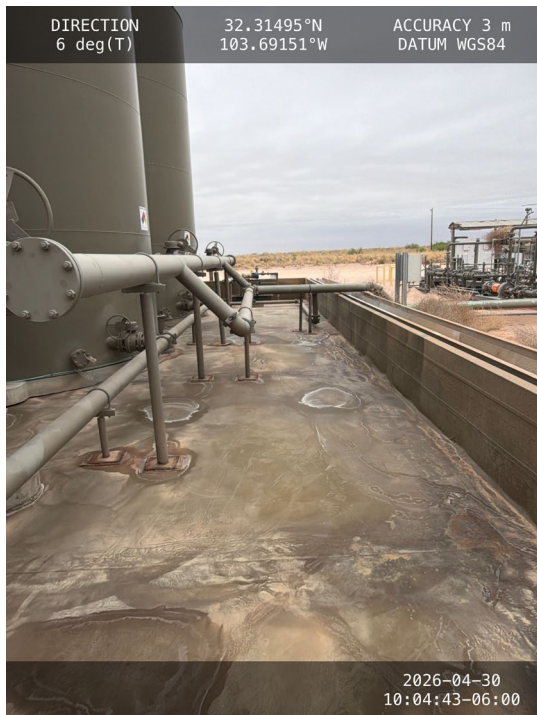
Photo 11 View of containment towards north.

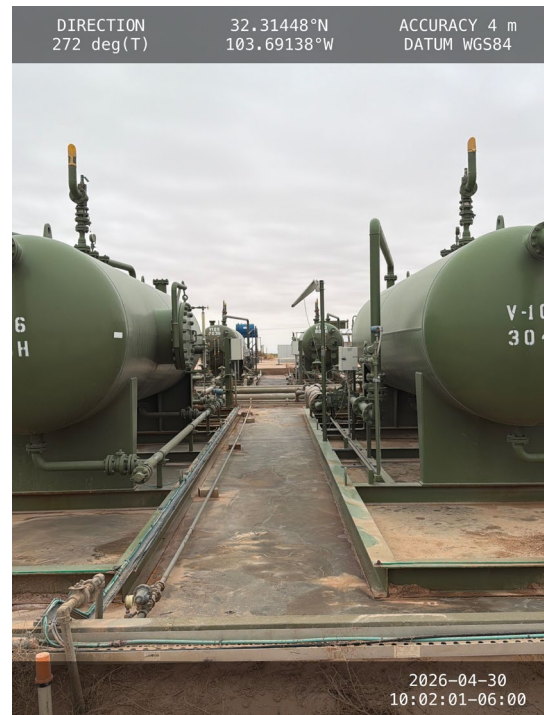
Photo 12 View of the central area of the secondary containment towards west.

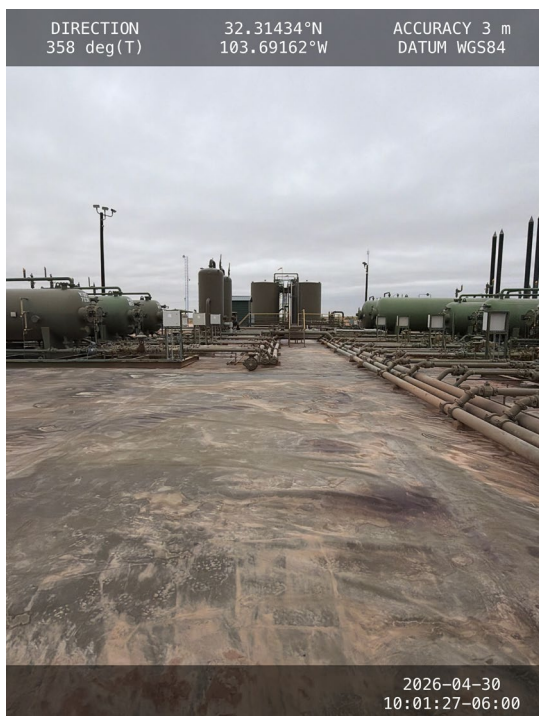
Photo 13 View of central containment towards north.

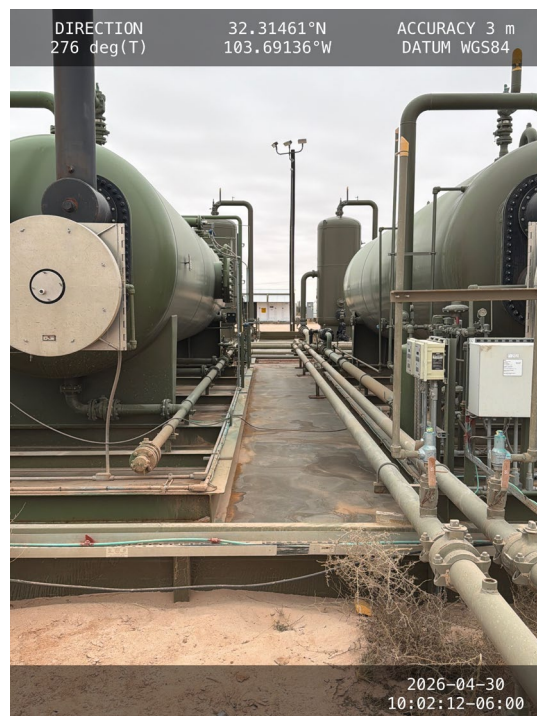
Photo 13 View of the secondary containment towards west.

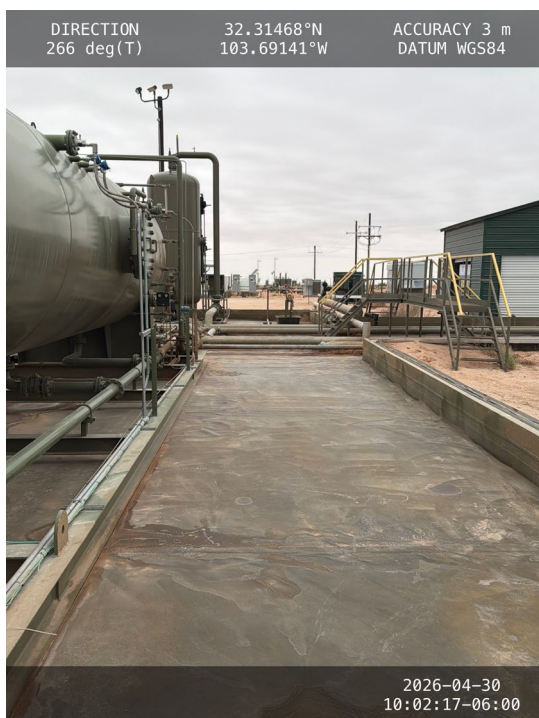
Photo 15 View of containment towards west.

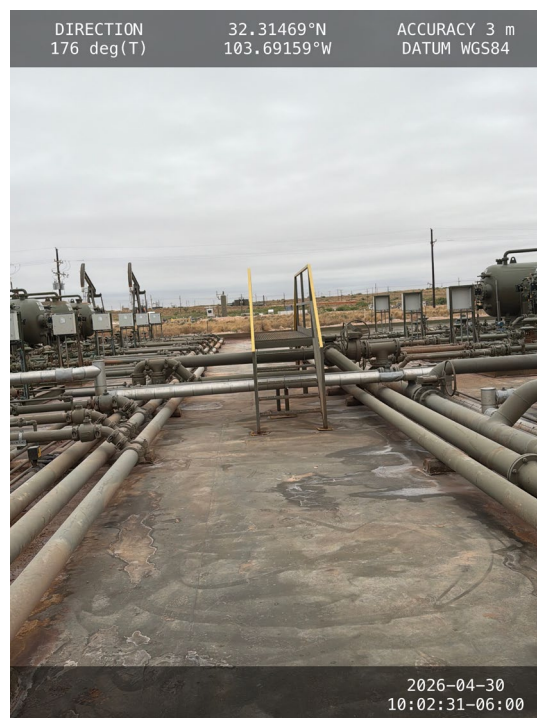
Photo 16 View of the central area towards south.
