Our Ref.: 12670741 – NMOCD – 1

May 18, 2026

Closure Report
Devon Energy Production Company, LP
Stray Cat 8 CTB 5
Unit Letter P, Section 08, T23S, R32E
GPS: 32.31449095, -103.6916407
Lea County, New Mexico

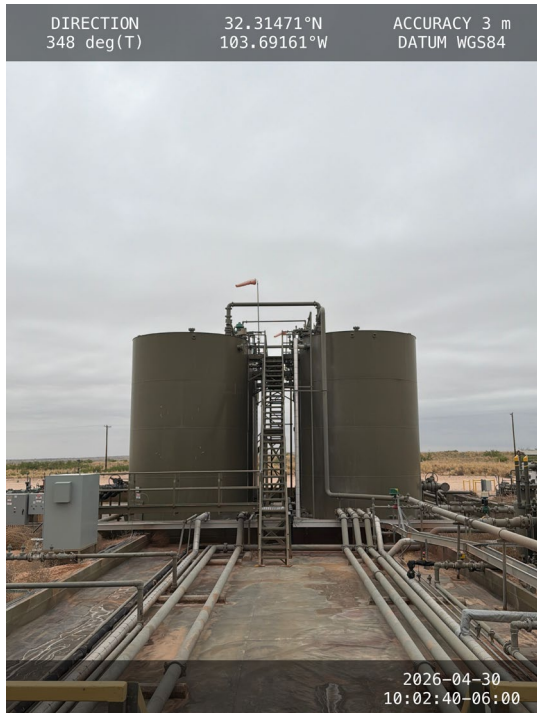
Photo 5 View of central containment towards north-northwest.

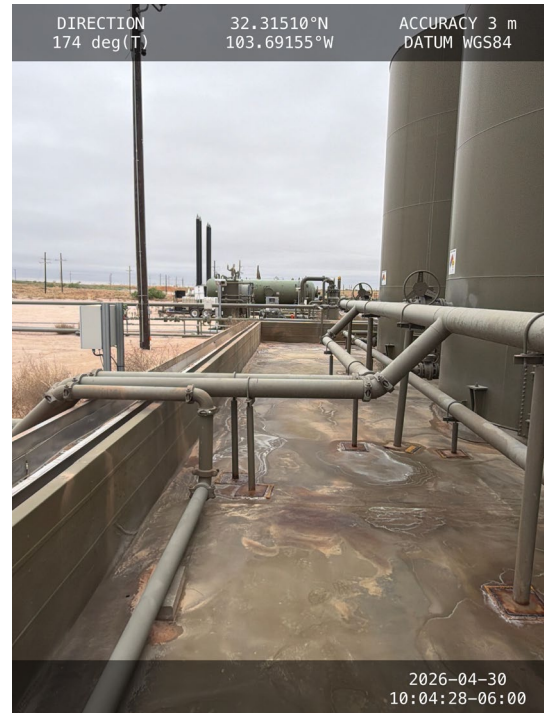
Photo 6 View of east side of containment towards south.

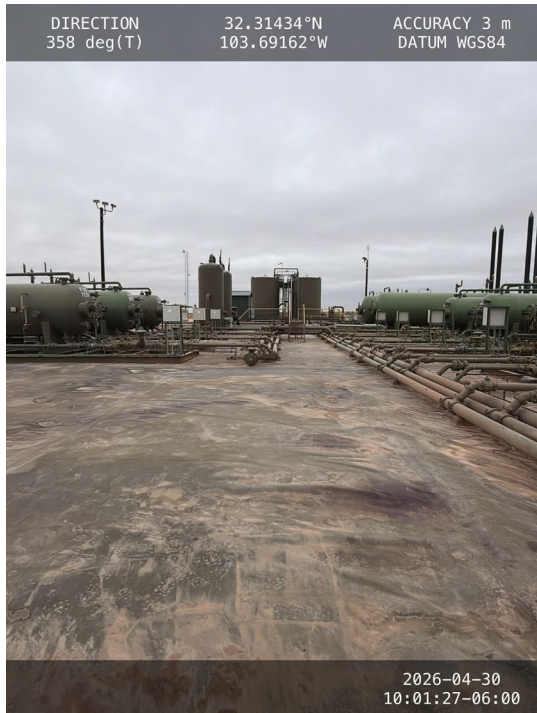
Photo 13 View of central containment towards north.

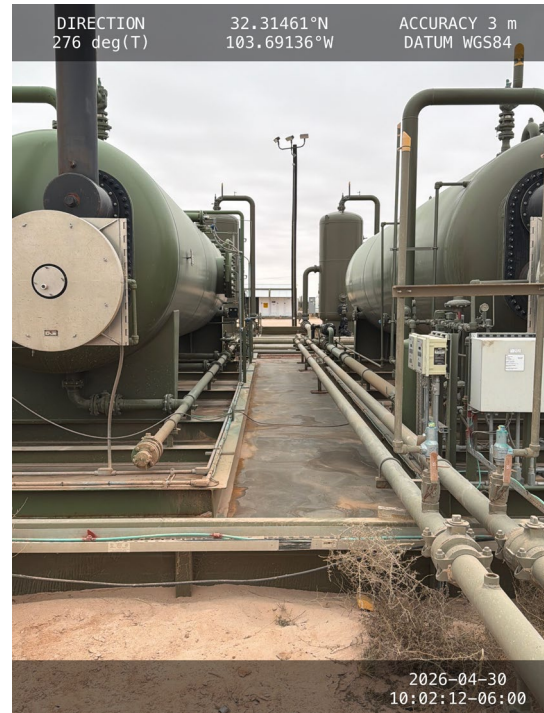
Photo 13 View of the secondary containment towards west.

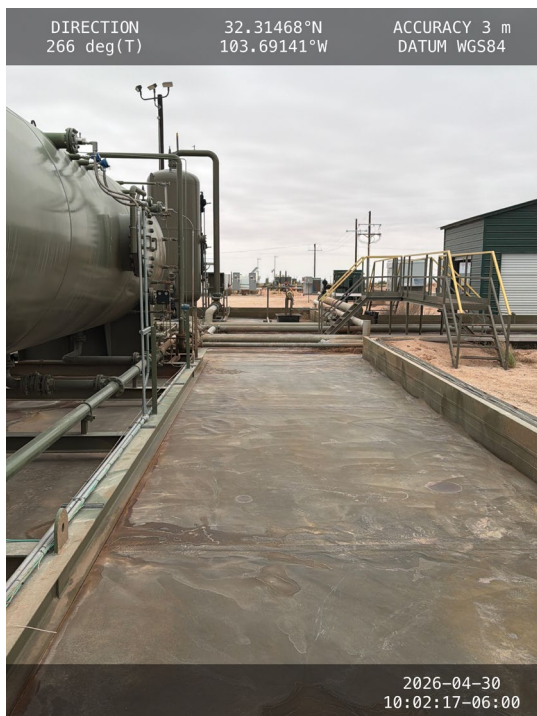
Photo 15 View of containment towards west.

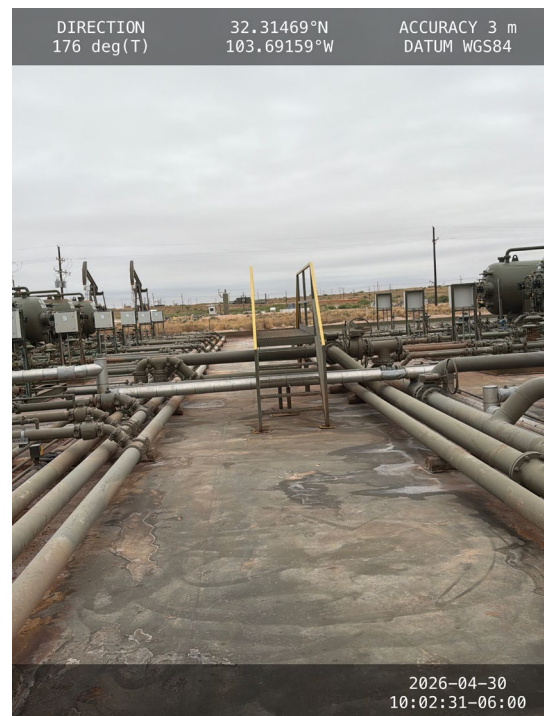
Photo 16 View of the central area towards south.
