Closure Report
Ragin Cajun 12 CTB 2 (04.13.2026)
Incident ID: nAPP2610324829
Lea County, New Mexico
Unit D, S12, T26S, R34E
32.06154708°, -103.4296151°

Produced Water Release
Point of Release: Pinhole leak on Dump Line
Release Date: 04.13.2026
Volume Released: 12 Barrels of Produced Water
Volume Recovered: 12 Barrels of Produced Water

Re: **Closure Report**
Ragin Cajun 12 CTB 2 (04.13.2026)
Incident ID: nAPP2610324829
Devon Energy Production Company
Site Location: Unit D, S12, T26S, R34E
32.06154708°, -103.4296151°
Lea County, New Mexico

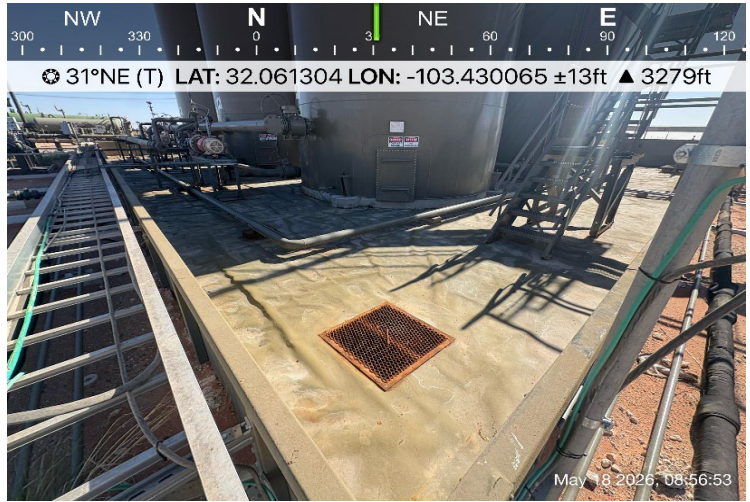
Photograph No. 1

Description:
View Northeast of exposed liner.

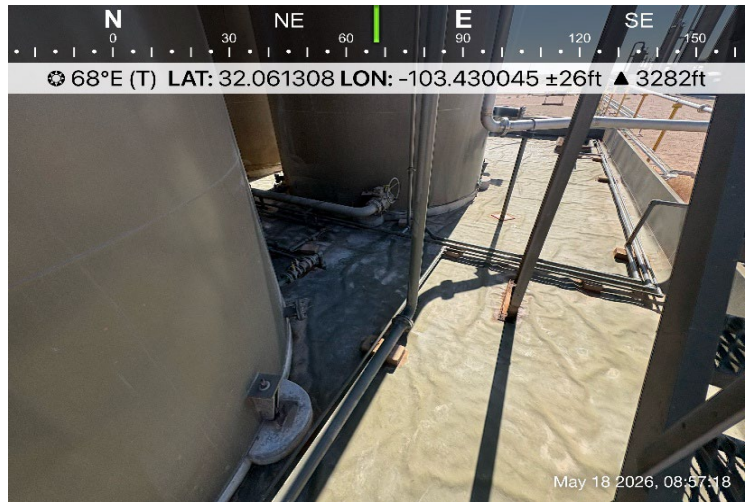
Photograph No. 2

Description:
View East of exposed liner.

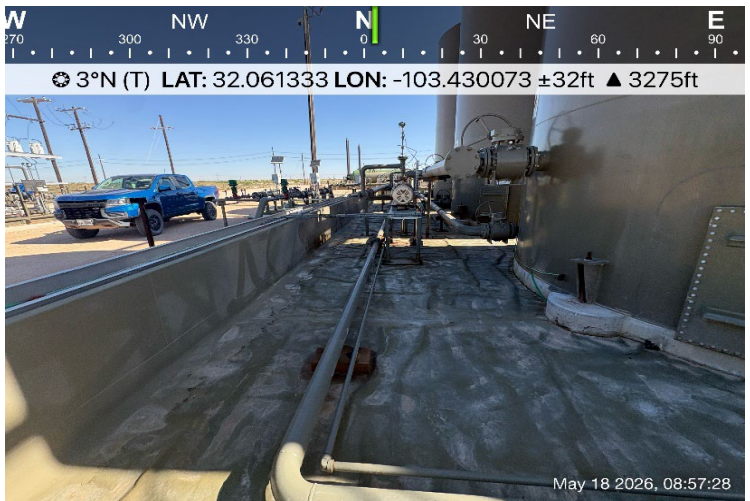
Photograph No. 3

Description:
View North of exposed liner.

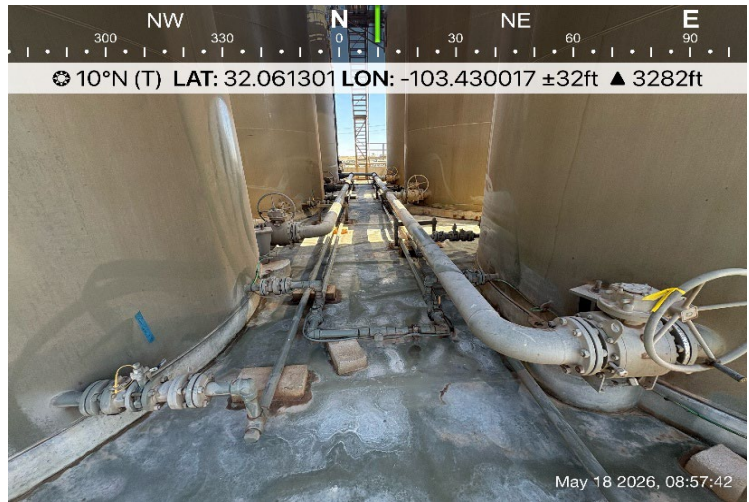
Photograph No. 4

Description:
View North of exposed liner.

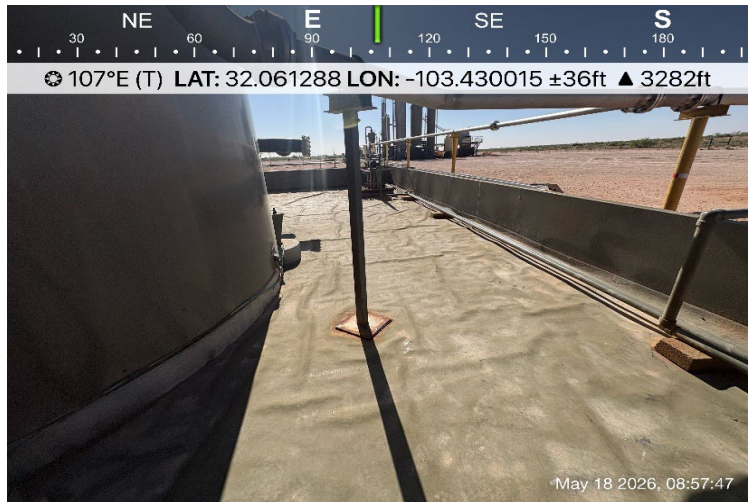
Photograph No. 5

Description:
View East of exposed liner.

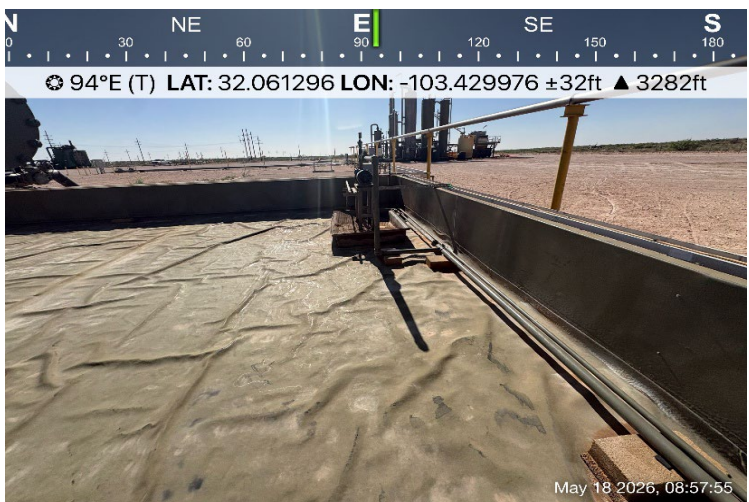
Photograph No. 6

Description:
View East of exposed liner.

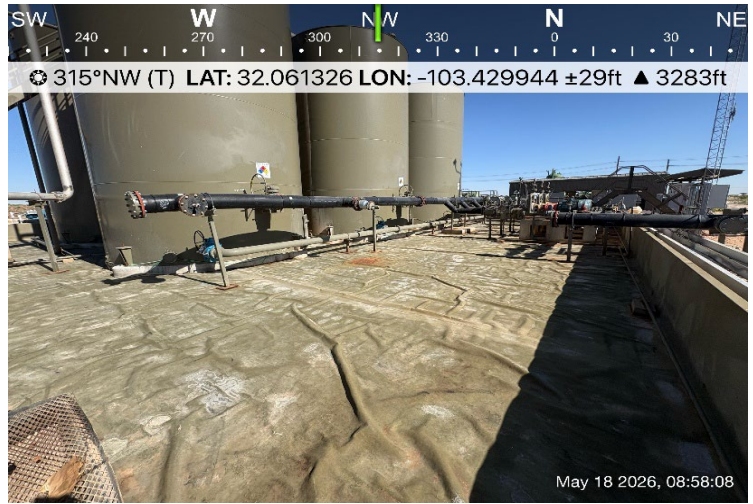
Photograph No. 7

Description:
View Northwest of exposed liner.

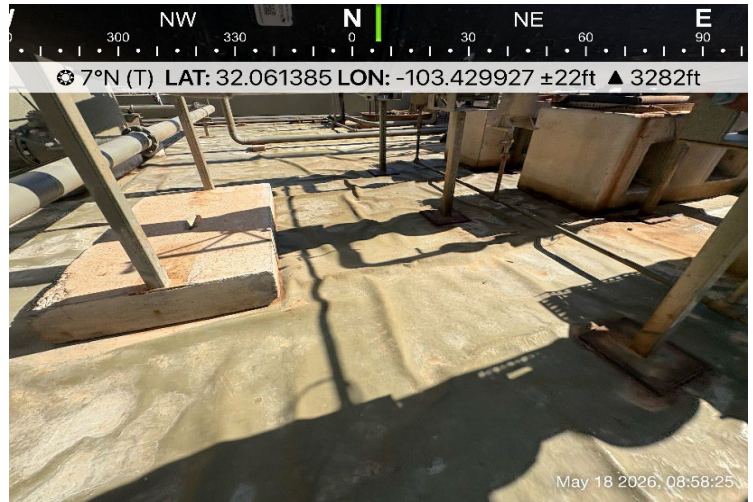
Photograph No. 8

Description:
View North of exposed liner.

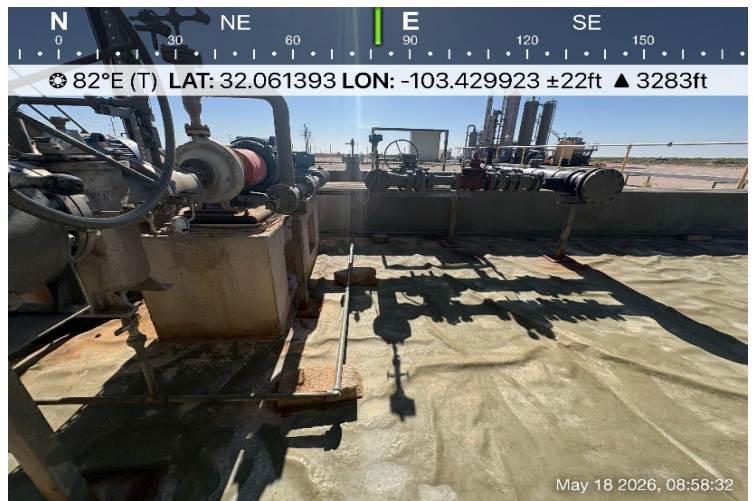
Photograph No. 9

Description:
View East of exposed liner.

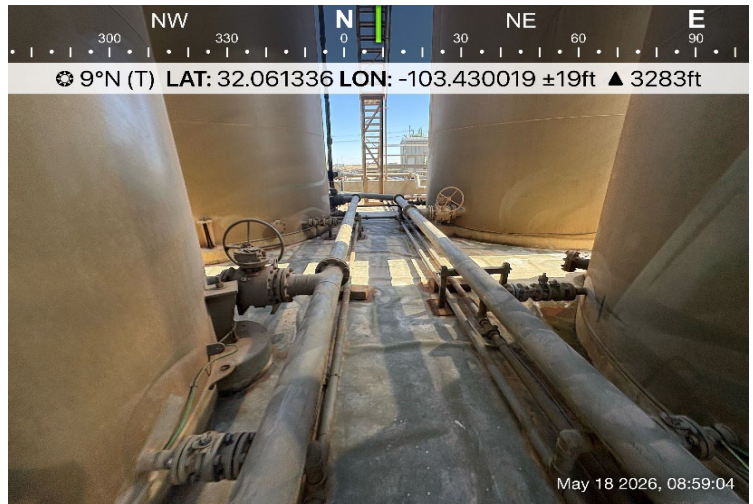
Photograph No. 10

Description:
View North of exposed liner.

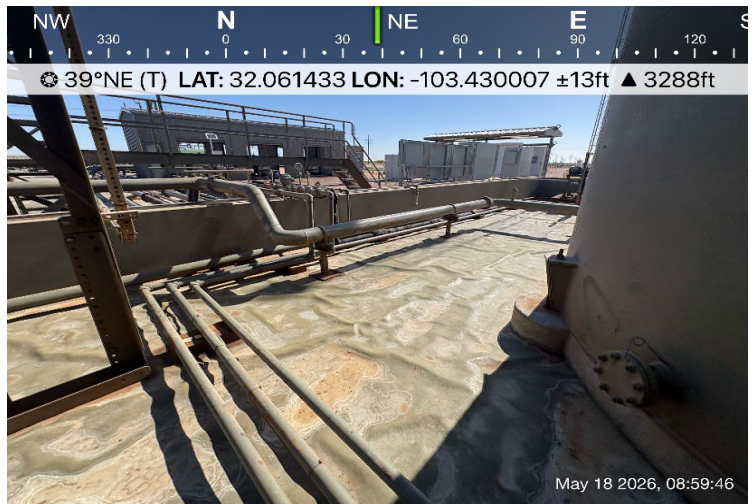
Photograph No. 11

Description:
View Northeast of exposed liner.

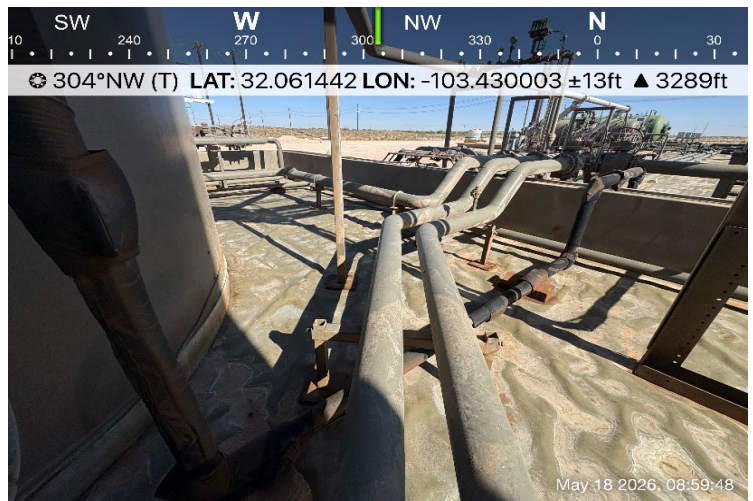
Photograph No. 12

Description:
View Northwest of exposed liner.

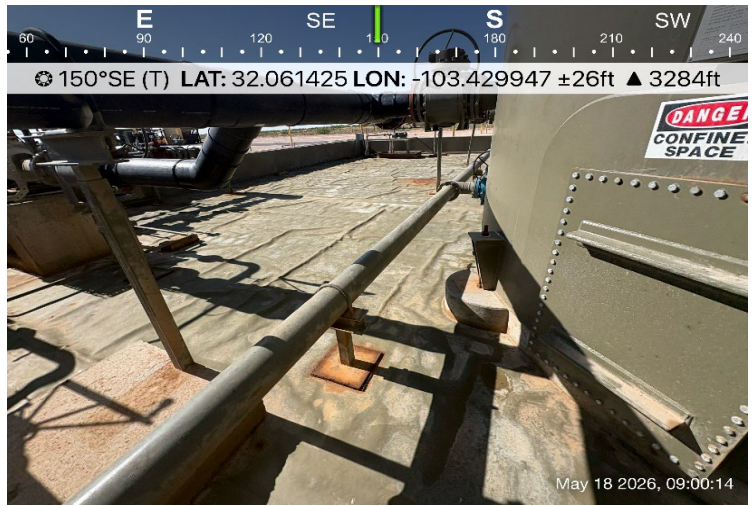
Photograph No. 13

Description:
View Southeast of exposed liner.

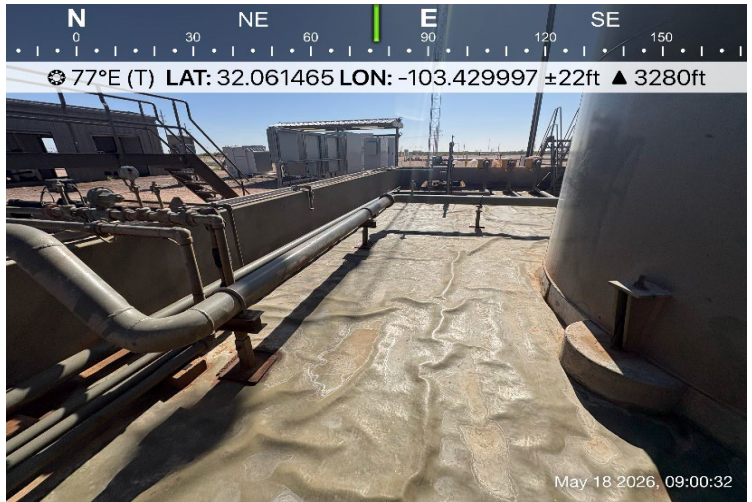
Photograph No. 14

Description:
View East of exposed liner.

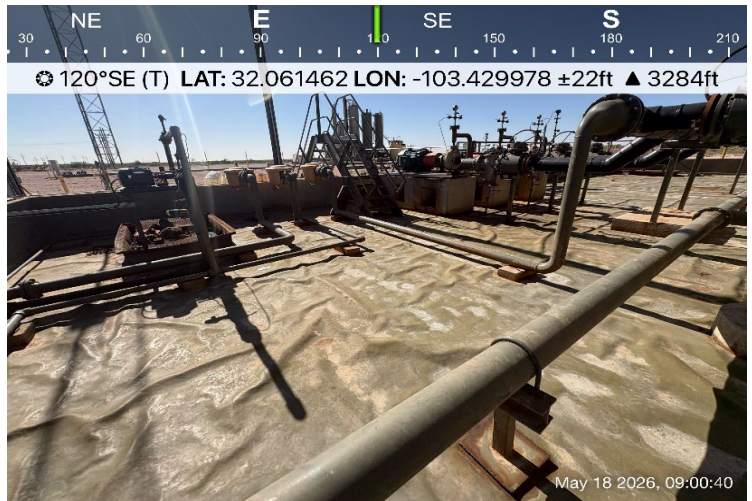
Photograph No. 15

Description:
View Southeast of exposed liner.

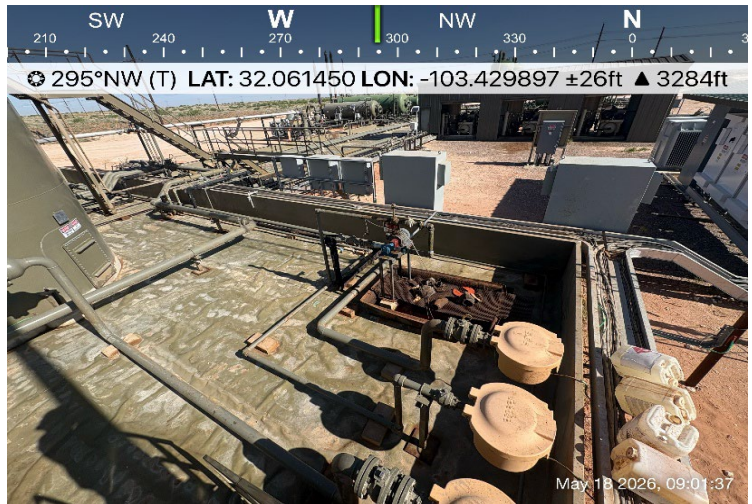
Photograph No. 16

Description:
View Northwest of exposed liner.

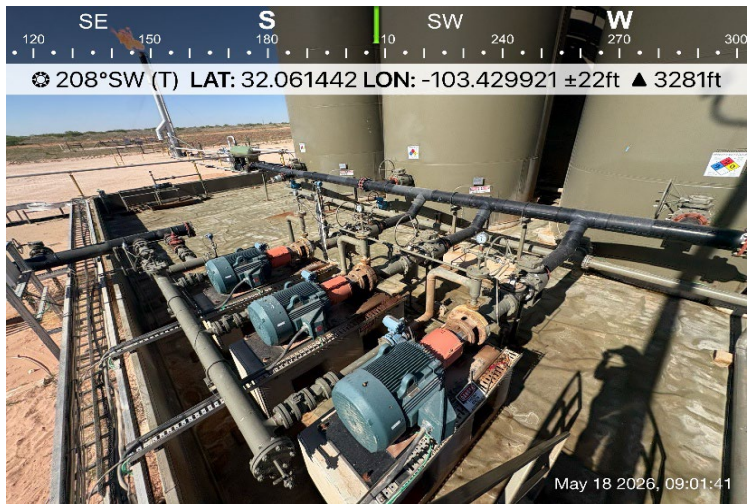
Photograph No. 17

Description:
View Southwest of exposed liner.

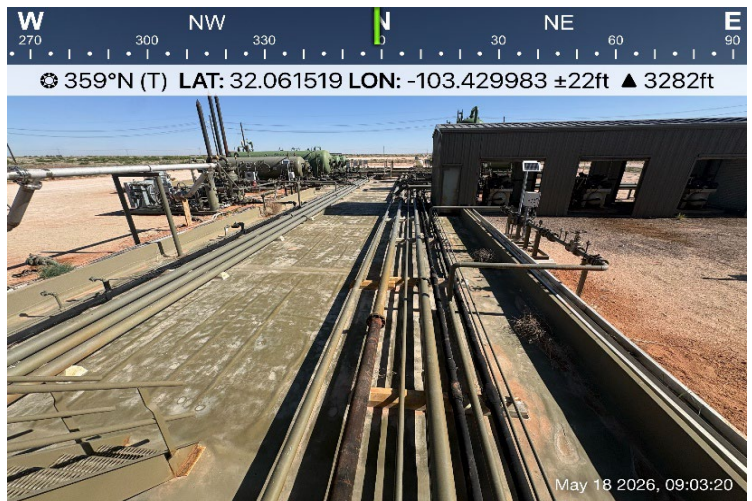
Photograph No. 18

Description:
View North of exposed liner.

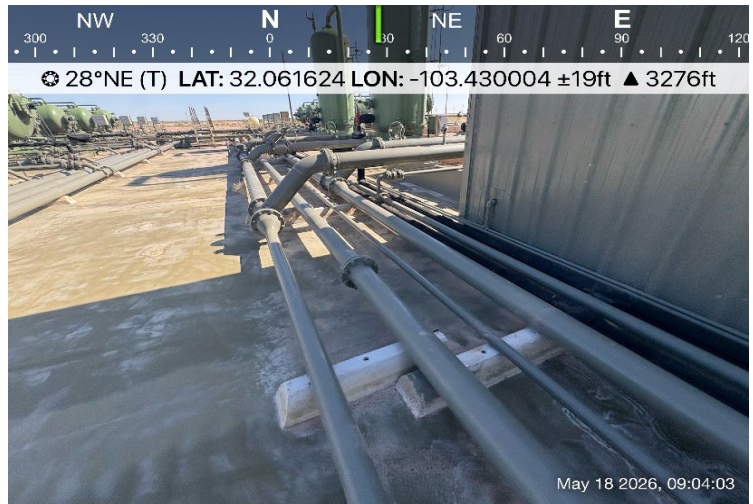
Photograph No. 19

Description:
View Northeast of exposed liner.

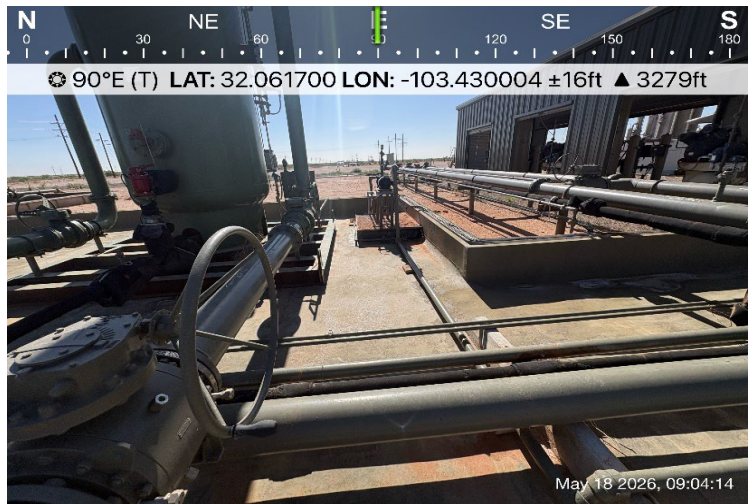
Photograph No. 20

Description:
View East of exposed liner.

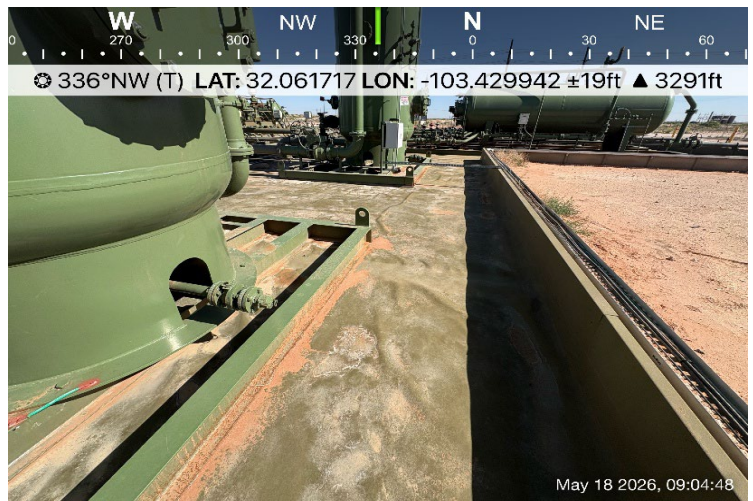
Photograph No. 21

Description:
View Northwest of exposed liner.

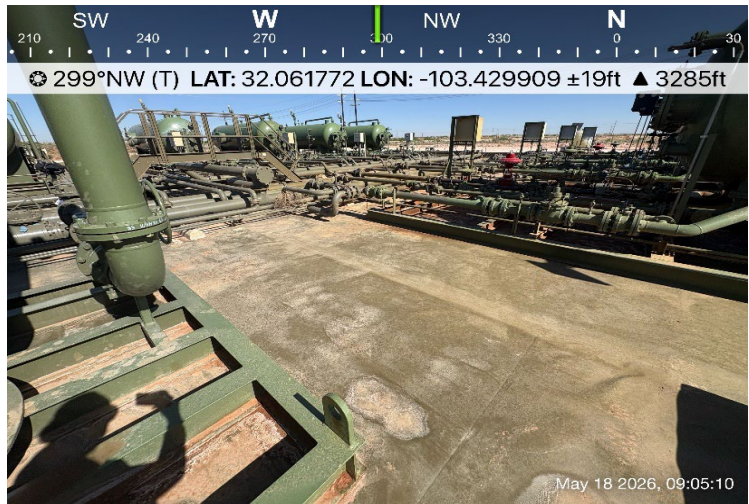
Photograph No. 22

Description:
View Northwest of exposed liner.

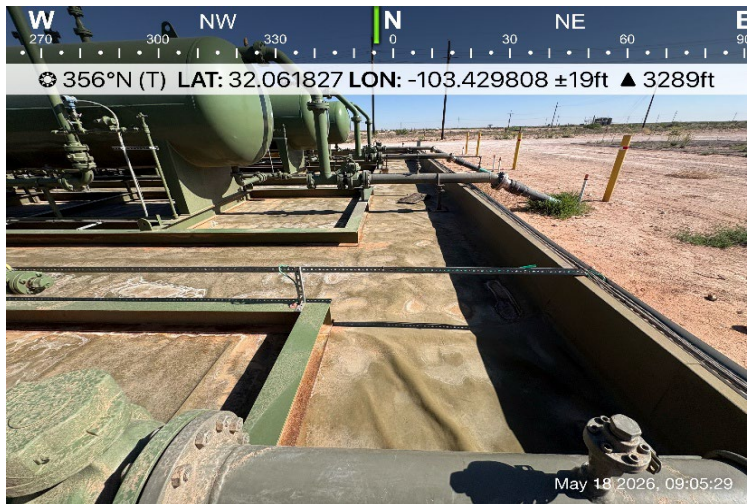
Photograph No. 23

Description:
View North of exposed liner.

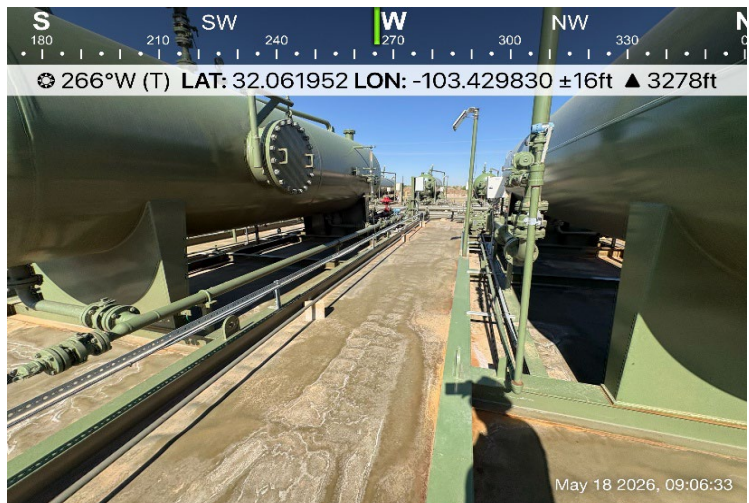
Photograph No. 24

Description:
View West of exposed liner.

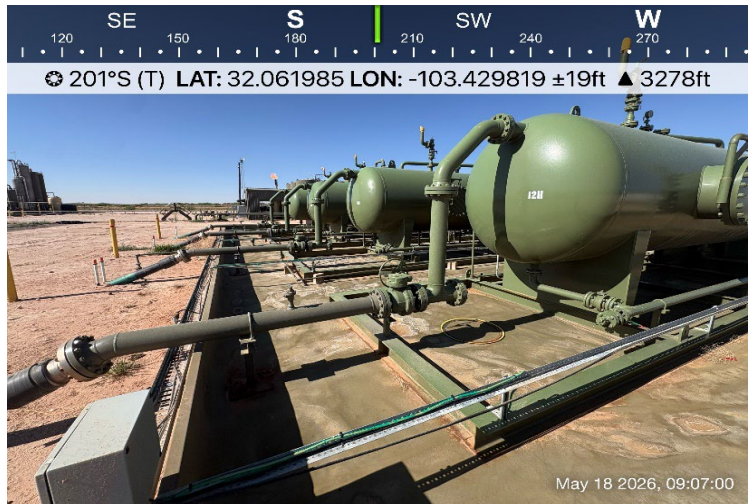
Photograph No. 25

Description:
View South of exposed liner.

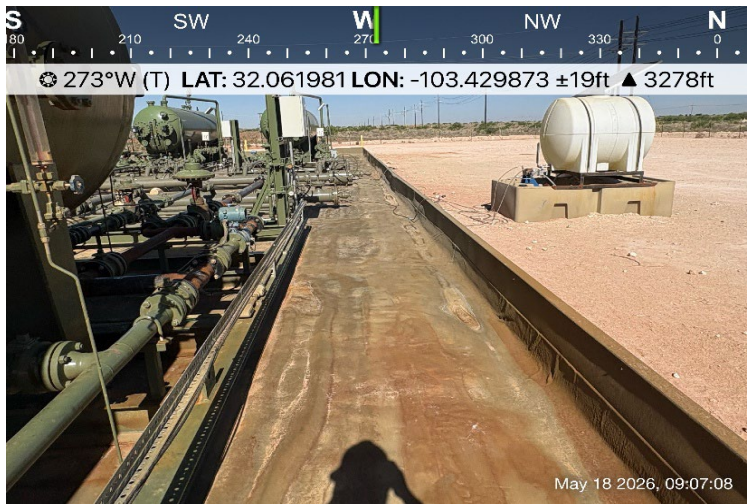
Photograph No. 26

Description:
View West of exposed liner.

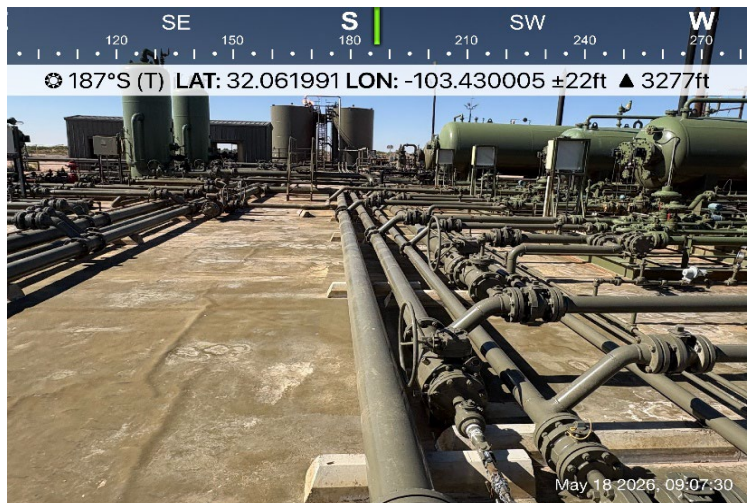
Photograph No. 27

Description:
View South of exposed liner.

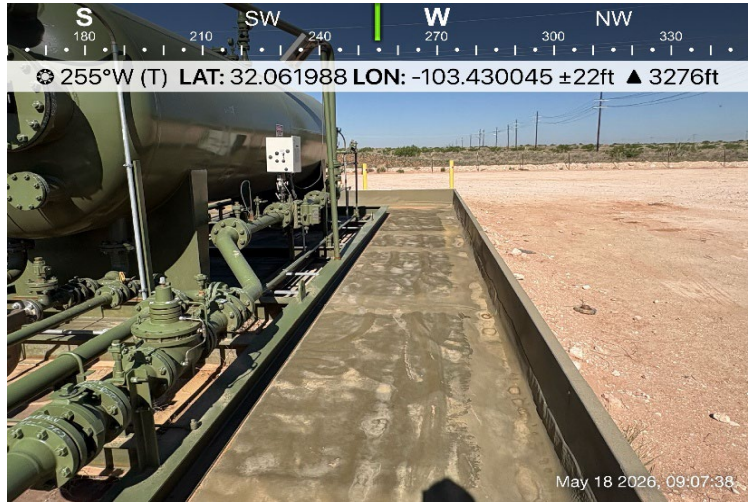
Photograph No. 28

Description:
View West of exposed liner.

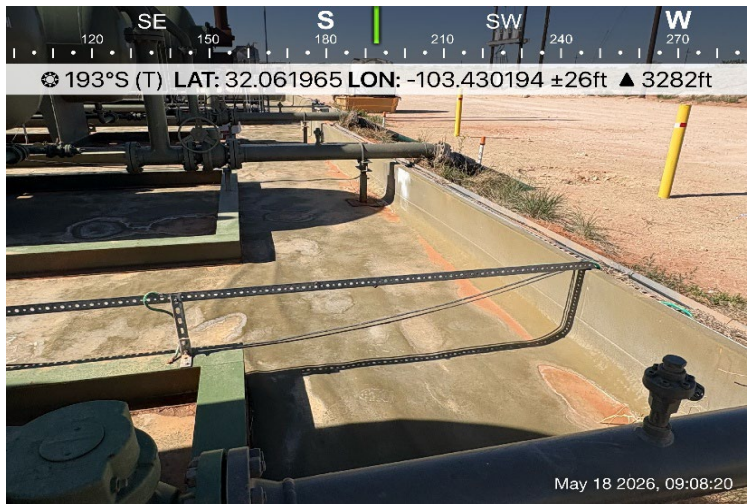
Photograph No. 29

Description:
View South of exposed liner.

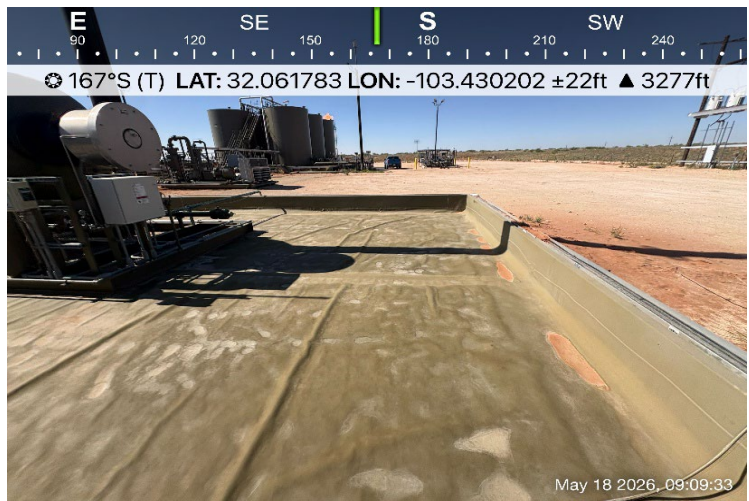
Photograph No. 30

Description:
View South of exposed liner.

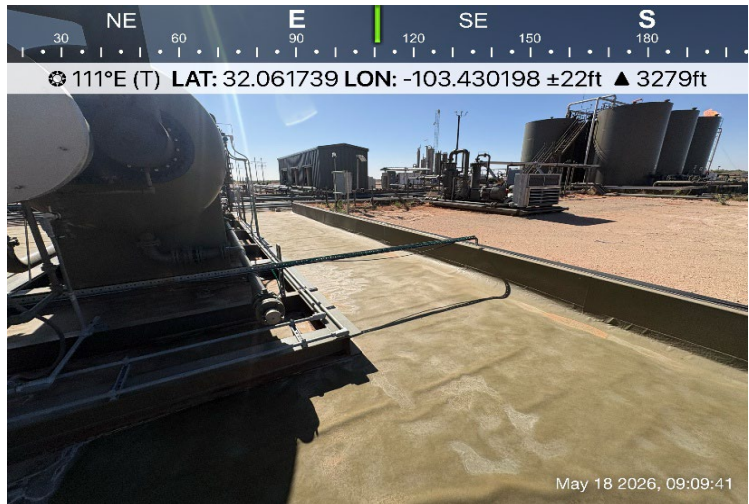
Photograph No. 31

Description:
View East of exposed liner.

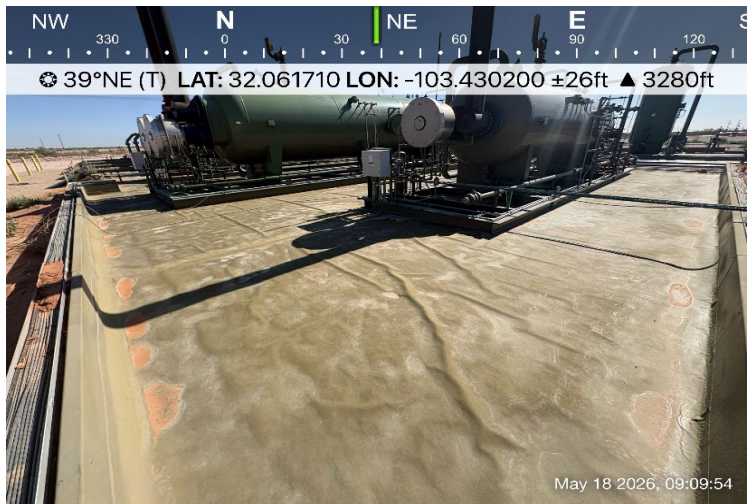
Photograph No. 32

Description:
View Northeast of exposed liner.

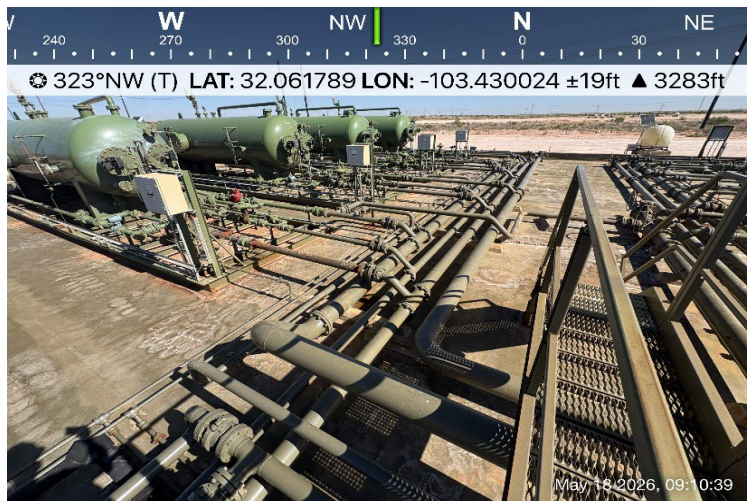
Photograph No. 33

Description:
View Northwest of exposed liner.
