INITIAL C-141 AND SUPPORTING ITEMS

Release Notification and Corrective Action

Name of Company: Linn Energy	Contact: Joe Hernandez
Address: 2130 W Bender Blvd. - Hobbs, NM	Telephone No.: 575-942-8675
Facility Name: CMU Battery A	Facility Type: Oil and Produced Water Tank Battery

Project Name: CMU Battery A Release 09/05/11
Project No: 259-2970-000

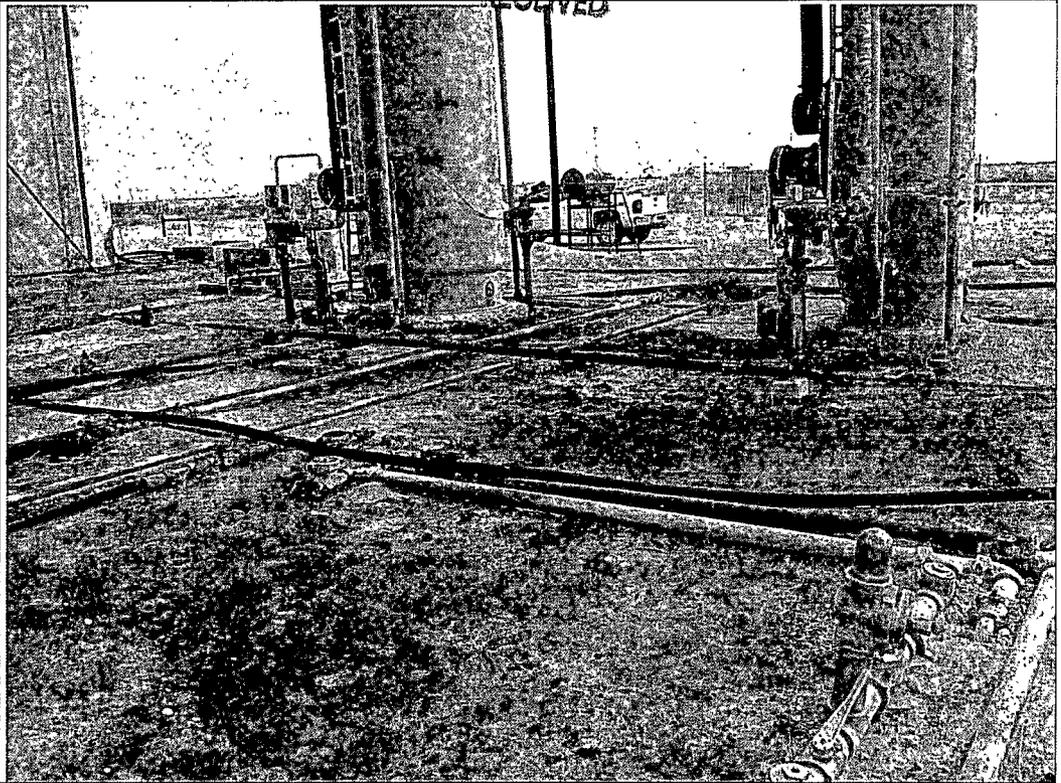
Photo No:
7.

Direction Taken:
Southeast

Description:
View from the NW corner of the containment looking across the impacted area inside the containment.
