COG Operating  
GJ West COOP # 135 Flow line Leak  
Section 22, T17S, R29E  
Eddy County, New Mexico

**Report Type: Work Plan**

**Re: Work Plan for the COG Operating LLC., GJ West COOP #135 Flow Line, Unit B, Section 22, Township 17 South, Range 29 East, Eddy County, New Mexico.**

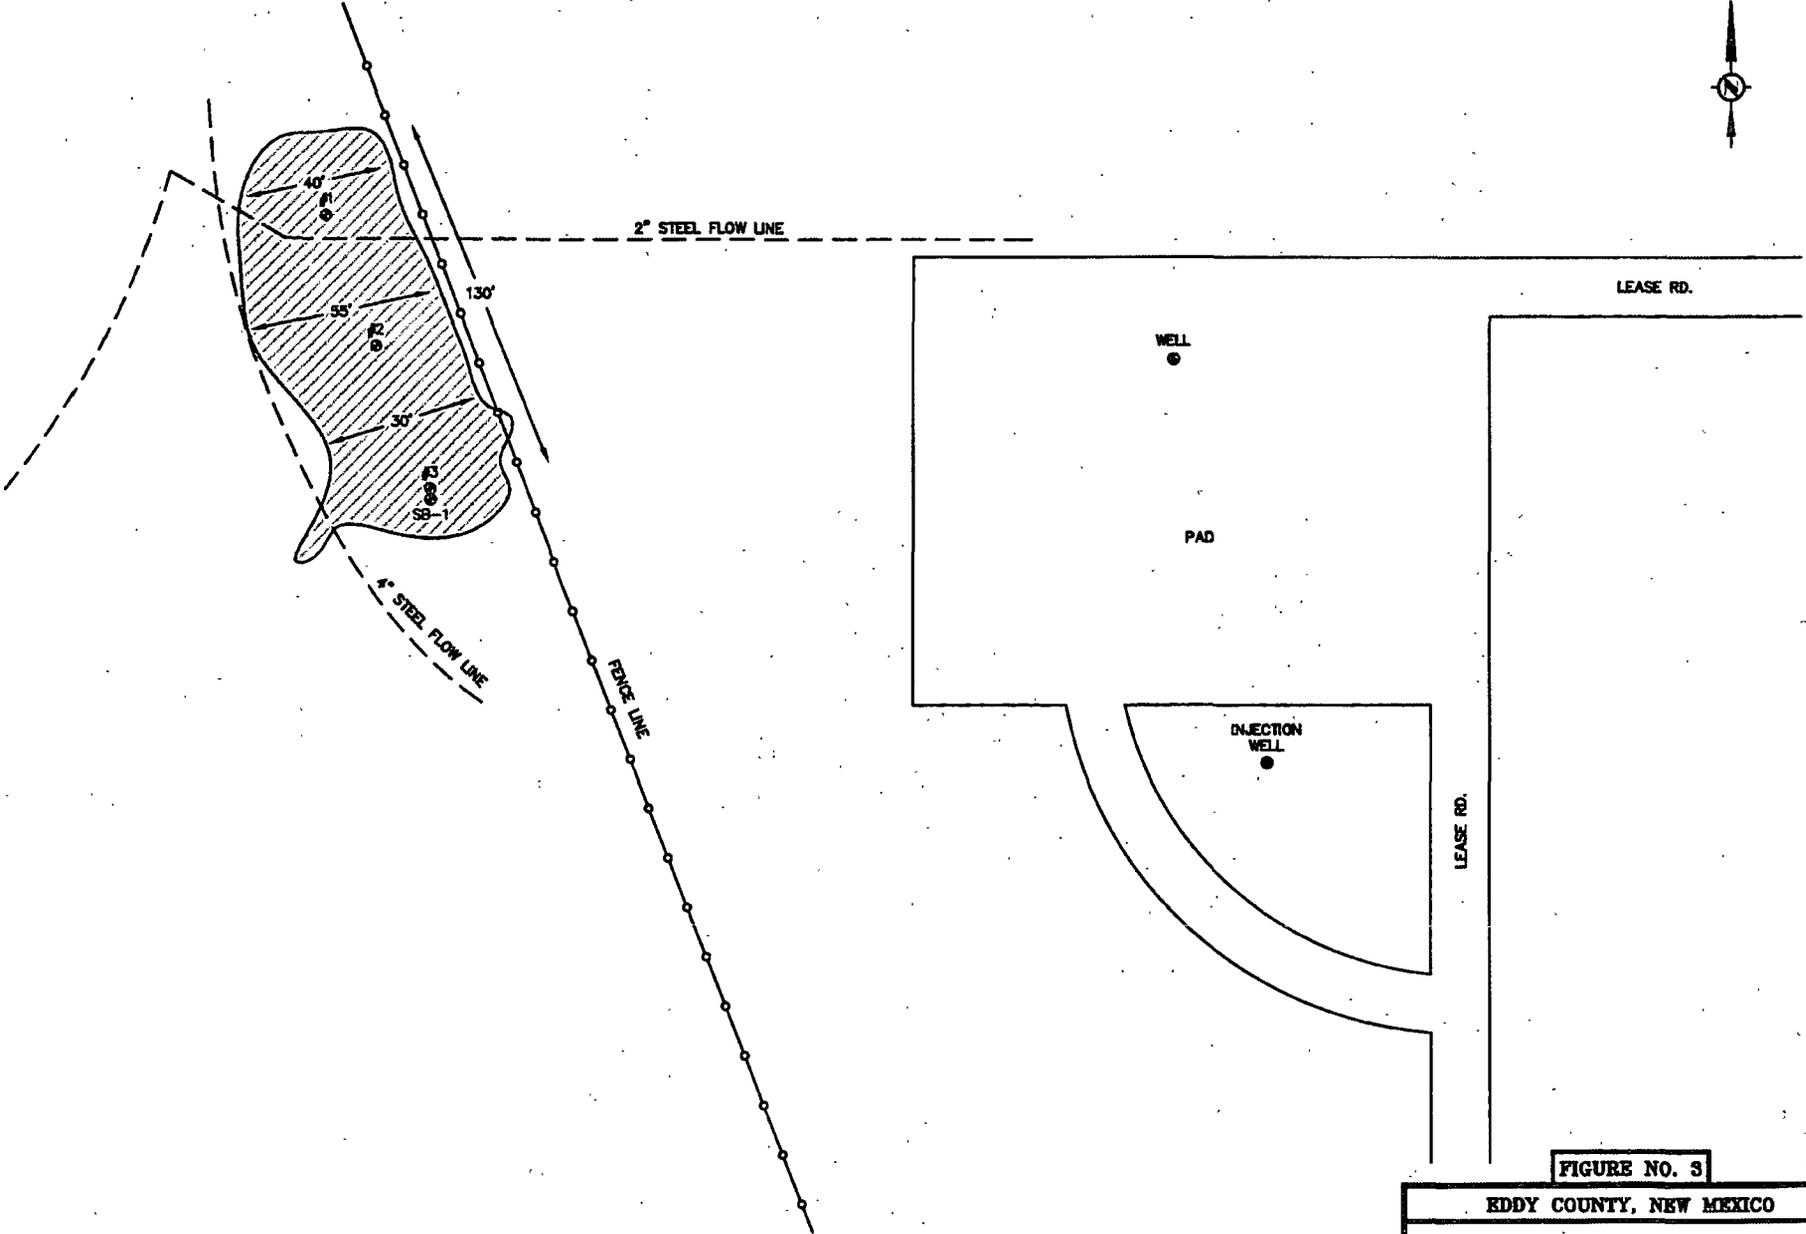
FIGURE NO. 3
EDDY COUNTY, NEW MEXICO
COG OPERATING LLC
GJ WEST #135
TETRA TECH, INC. MIDLAND, TEXAS

On February 22, 2009, Tetra Tech personnel inspected and sampled the spill area. A total of three (3) auger holes (AH-1 through AH-3) were installed using a stainless steel hand auger to assess the impacted soils. Select samples were analyzed for TPH analysis by EPA method 8015 modified, BTEX by EPA Method 8021B and chloride by EPA method 300.0. Copies of laboratory analysis and chain-of-custody documentation are included in Appendix B. The sampling results are summarized in Table 1. The spill area and auger hole locations are shown on Figure 3.

Referring to Table 1, AH-1, AH-2, and AH-3 samples exceeded the RRAL for TPH and BTEX at surface down to 3-3.5' below surface. Concentrations decreased to below the RRAL for TPH and BTEX at 4-4.5' below surface at each of the three auger holes. Chloride impact was defined in AH-1 and AH-2 but not at AH-3. Chloride concentration for AH-3 at 7-7.5' below surface was 6,410 mg/kg.
