Texerra LLC

February 2nd, 2012

RE: **Corrective Action Plan (CAP) Progress Report and Soil Closure Request**
Rice Operating Company – BD SWD System
BD O-23 Vent UL O, Sect 23, Township 21S, Range 37E
NMOCD Case Number 1R426-99

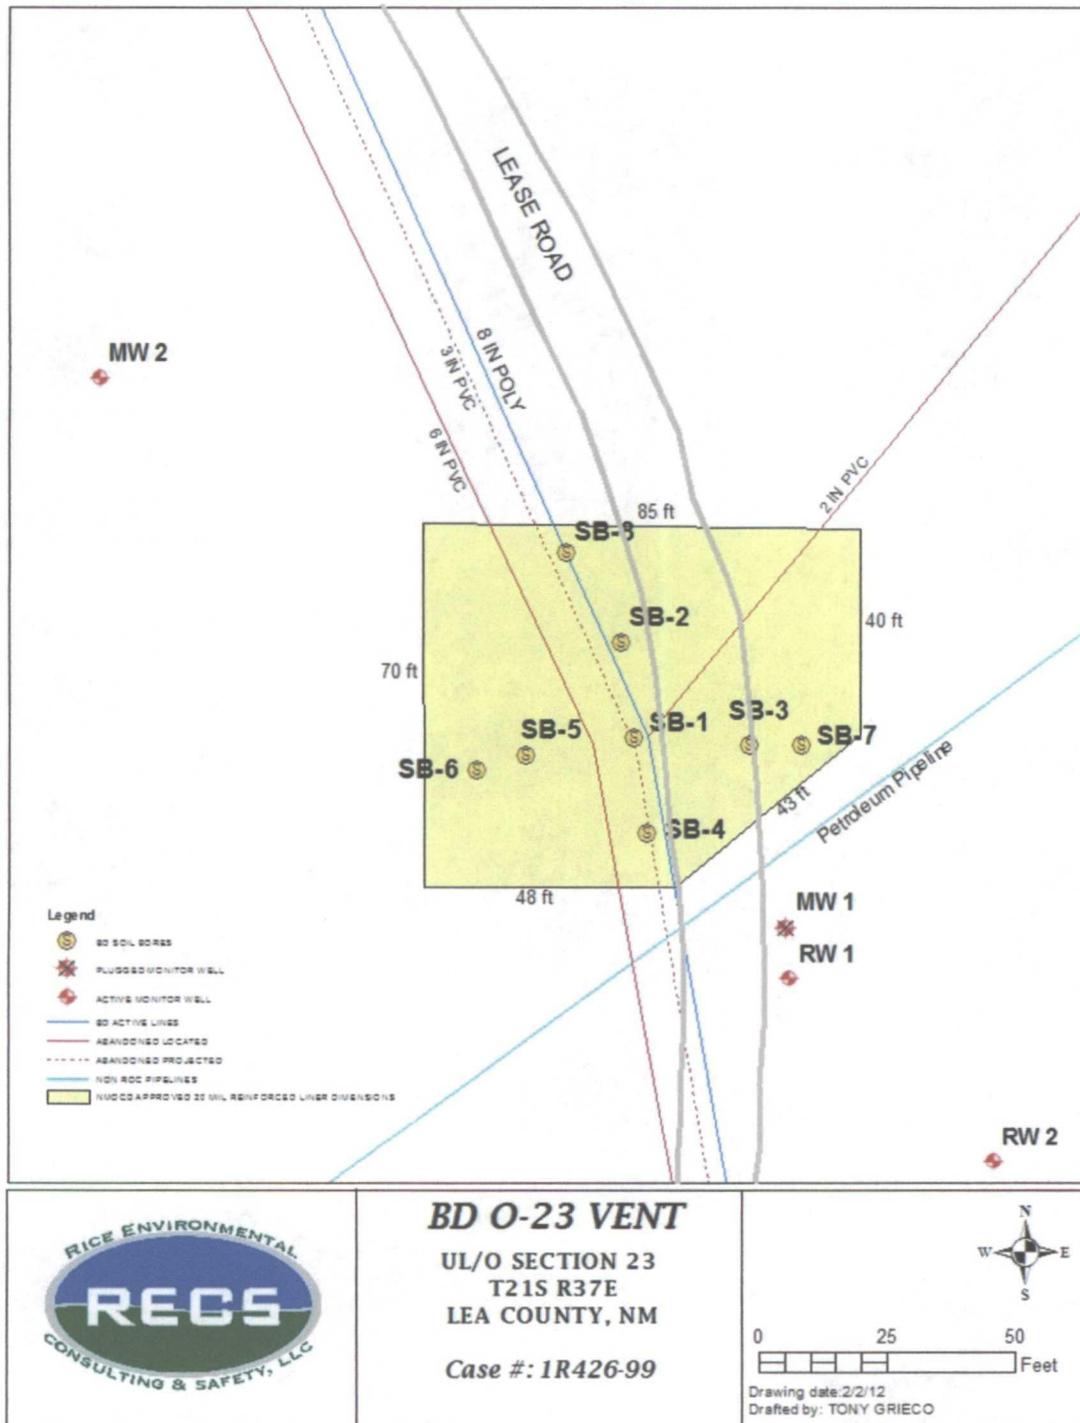
Figure 2– NMOC approved liner dimensions and monitor well/ recovery well locations at BD O-23 Vent.

During March and April 2011, chloride impacted soils were removed across the affected area, approximately 70 x 90 ft, to a depth of 5 ft below ground surface (bgs, Figures 2 & 3). Six inches of clean blow sand (padding) were added to the bottom of the excavation and a 20 mil synthetic, impermeable liner was carefully installed. An additional 6 inches of clean blow sand was padded on top of the liner before blended, excavated soil material was placed above it. Eight-point composite samples were taken of blended backfill material on March 15th and March 25th. The March 15th sample tested 288 mg/kg for chlorides and 5.9 ppm for PID hydrocarbons. The March 25th sample tested 256 mg/kg for chlorides and 3.9 ppm for PID hydrocarbons. Laboratory chloride and field PID reports are given in Figures 4 through 7. Clean, imported topsoil was amended with peanut hay and spread over the work area and the lease road was repaired using imported base coarse. The site was seeded using 30 pounds (lbs) of Pecos District Mix, 15 lbs of BLM #2 and 20 lbs of Race Horse Oats (Figure 8) and silt fencing was installed to preclude wildlife during seedling growth.

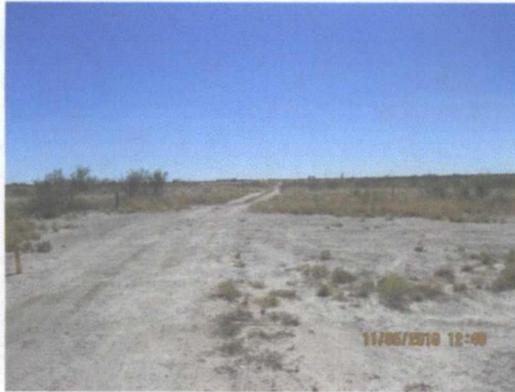
site prior to excavation, facing south

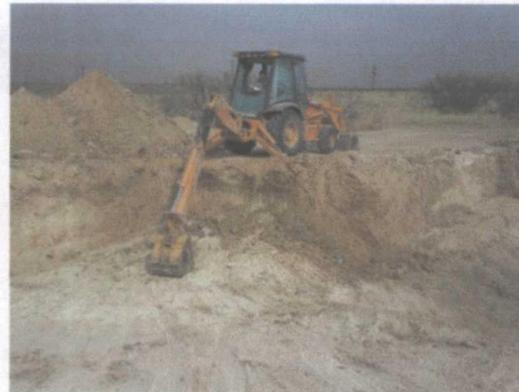
excavating the site, facing west

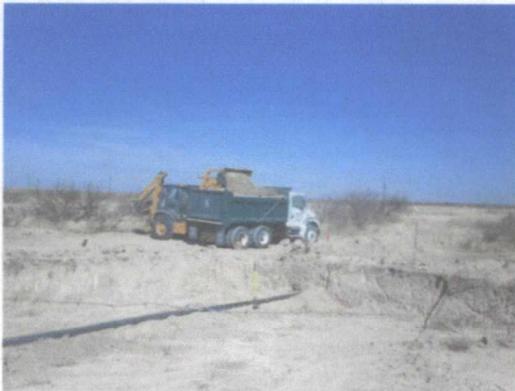
hauling off soil to Sundance

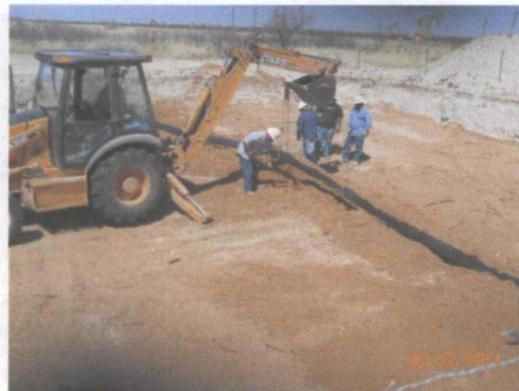
padding the base of the excavation with 6" of blow sand, facing northeast

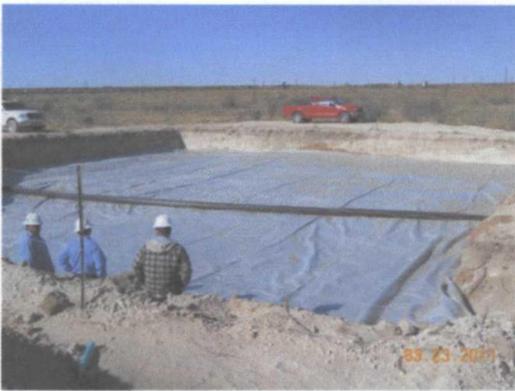
70x90 ft, 20-mil reinforced liner installed at 4.5 ft bgs, facing southwest

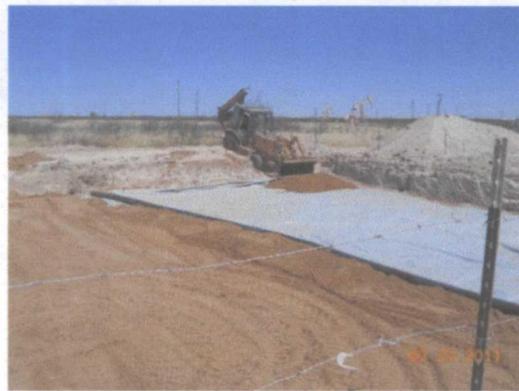
padding above the liner with 6" of blow sand, facing northeast

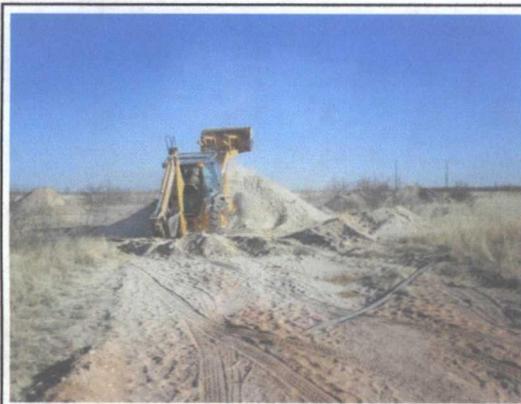
blending excavated soil

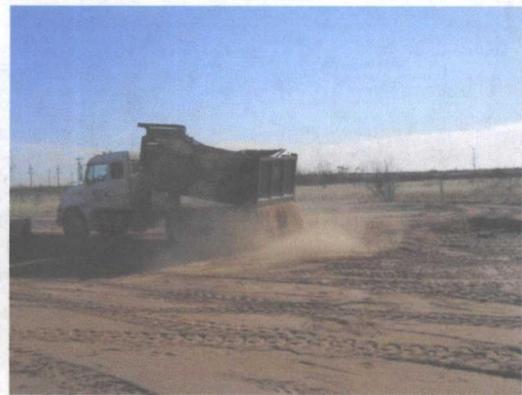
importing clean soil to contour the site,
facing east

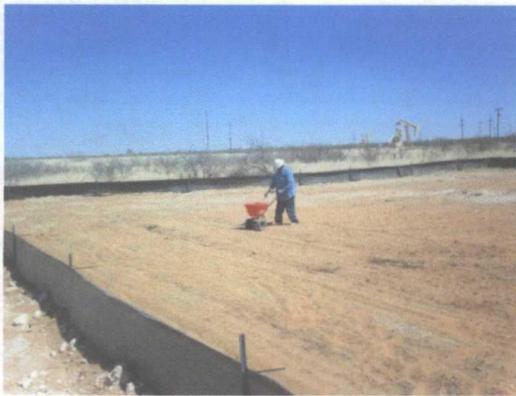
seeding the backfilled site, facing north

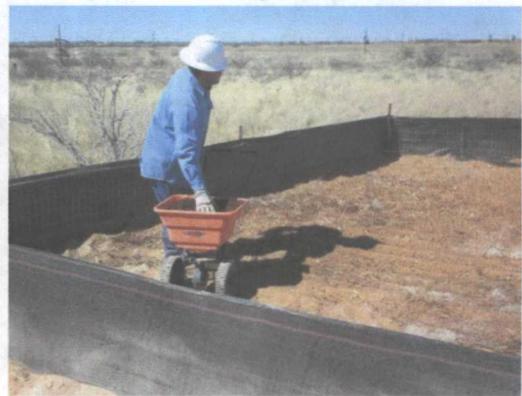
spreading restorNhance on the backfilled site,
facing northwest

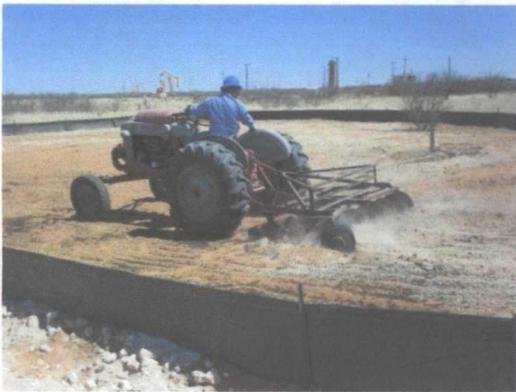
tilling in seed and bioNhance, facing northeast

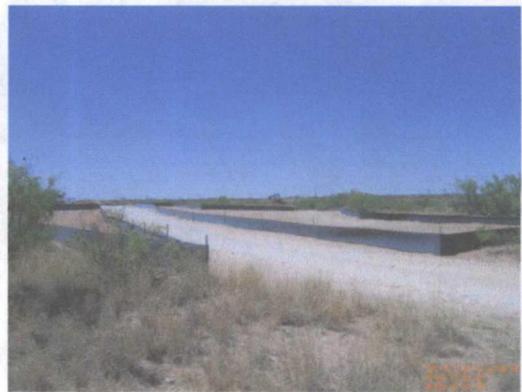
site completed, facing south-southwest
