RECR - 12

**WORK PLAN AND
PURCHASING ORDER**

Re: Work Plan for Remedial Action at the Ramapo #1 Site in Southeastern New Mexico

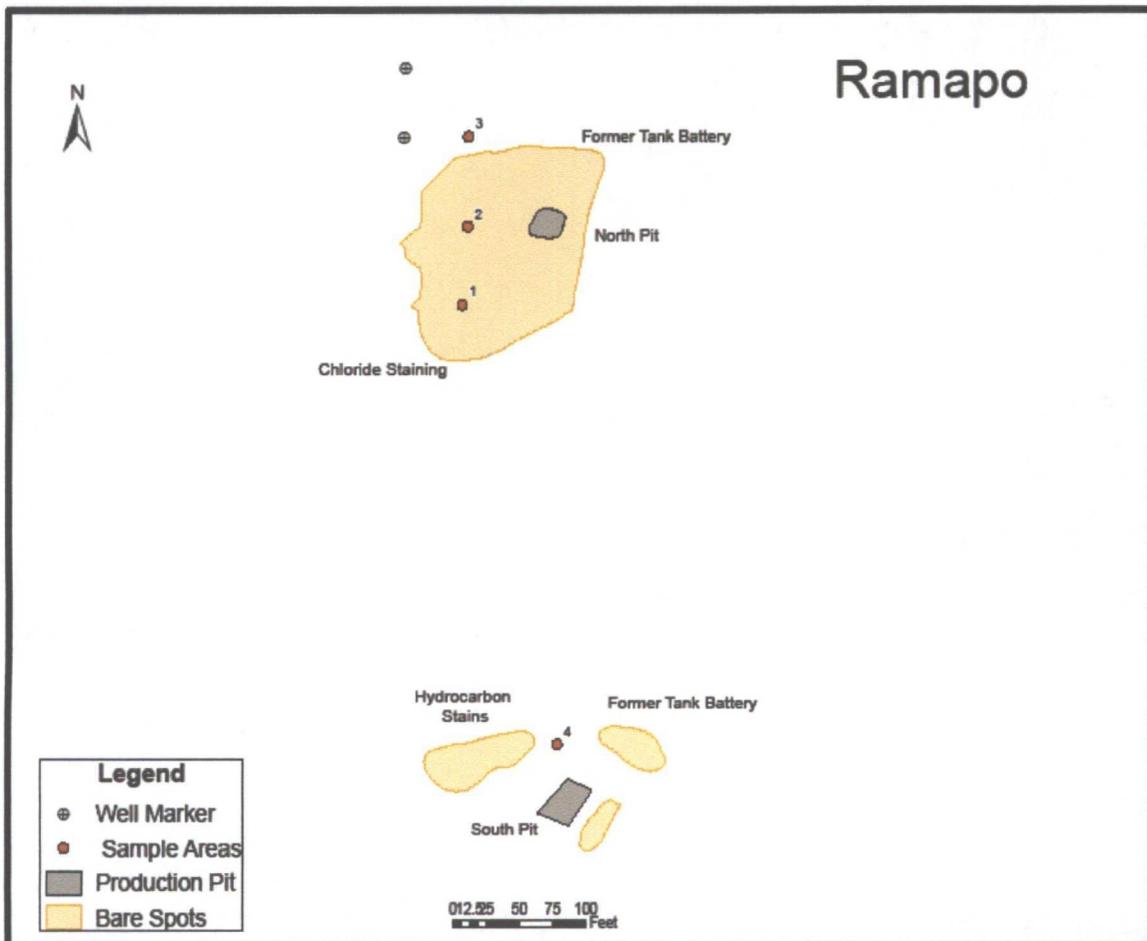
The assessment involved the mapping of soil staining, pits, and well markers with a Trimble GPS unit and potholing the site with a rubber-tired backhoe to delineate yardage for remediating the site. Four test pits, marked in red and numbered in the site diagram below, were dug to a depth of 2 feet, and several areas of hydrocarbon staining were excavated to a depth of 3 feet to reveal the extent of contamination.

As shown in the site diagram, an approximately 15,000-square-foot area surrounding the north production pit is denuded of vegetation. During the site investigation, RESPEC observed evidence of recent 18 wheeler activity in this area. The southern part of this area had a white crystalline crust on the surface soil. West of the north production pit, in the strongest concentration of visible chloride contamination, three potholes in a north-south line were excavated so that RESPEC personnel could collect soil samples and perform a field chloride test in accordance with the suggested method outlined in the David G. Boyer report provided by OCD.

The test results indicated very high chloride contamination at the surface in Test Pit #1 and Test Pit # 2 (18,576 parts per million (ppm) and more than 26,000 ppm, respectively). However, surface contamination in Test Pit # 3 was much lower—2,212 ppm. Samples from 2 feet below the surface in the same three pits showed a dramatic lowering of chloride levels (from approximately 7,320 ppm at the surface to 1,008 ppm at -2 ft). Overall, these results indicate that the approximately 15,000-square-foot area of bare soil surrounding the north production pit has high levels of chloride contamination at a shallow depth. The highest levels were recorded to the south and southwest of the north production pit.

A small area of surface chloride contamination was observed and potholed near Test Pit #4. Field test results indicated that soil at the surface had a chloride concentration of 8,680 ppm and at 2 feet of depth had chloride contamination of 5,697 ppm.

Other areas of interest were the locations of the former tank batteries to the north of both production pits. These approximately 900-square-foot areas contained surface hydrocarbon contamination mixed with pea gravel and were excavated with the rubber-tired backhoe. Indications of hydrocarbon contamination were observed at depths in excess of three feet.

Two minor hydrocarbon stains were observed near the south production pit. Field investigation revealed that the broad areas (1,834 square feet and 479 square feet) were relatively shallow and should be easily excavated for remediation.

Based on this site characterization, RESPEC recommends that the following amounts of contaminated soil be excavated and removed from the site for proper disposal:

- South production pit: 585 square feet to a depth of 10 feet = 5,850 cubic feet = 217 cubic yards
- North production pit: 372 square feet to a depth of 10 feet = 3,720 cubic feet = 138 cubic yards
- Two former tank batteries: 900 square feet **each** to a depth of 5 feet = 1,800 x 5 = 9,000 cubic feet = 333 cubic yards
- Larger hydrocarbon-stained area around south production pit: 1,834 square feet to a depth of 3 feet = 5,502 cubic feet = 204 cubic yards
- Smaller hydrocarbon-stained area around north production pit: 479 square feet to a depth of 3 feet = 1,437 cubic feet = 53 cubic yards

- Chloride-stained soil surrounding north production pit: 14,840 square feet to a depth of 1 foot = 14,840 cubic feet = 550 cubic yards

Total: 1,495 cubic yards (in place) + 55 cubic yards for chasing contamination and for landscaping = **Grand Total: 1,550 cubic yards (in place).**

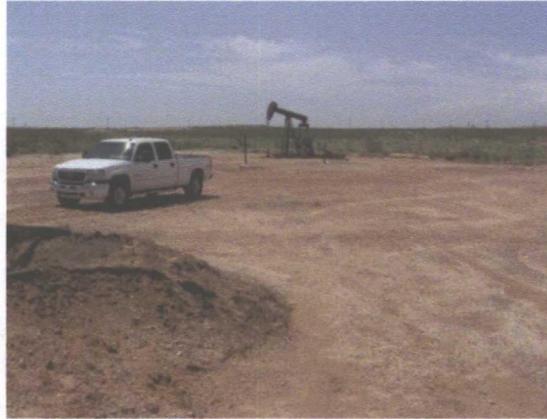
Photograph 3. Area Around South Production Pit.

The soil in the area around the south production pit (see Photograph 3 on the next page) is contaminated with chloride and hydrocarbon patches. RESPEC will oversee the removal of these patches of contaminated soil to a depth of 3 to 5 feet. The contaminated soil will be removed from the site and taken to a waste facility approved by the OCD and will be replaced with soil free from contamination. The area will then

be regraded so as to divert water runoff, thereby preventing erosion of the downgradient road.

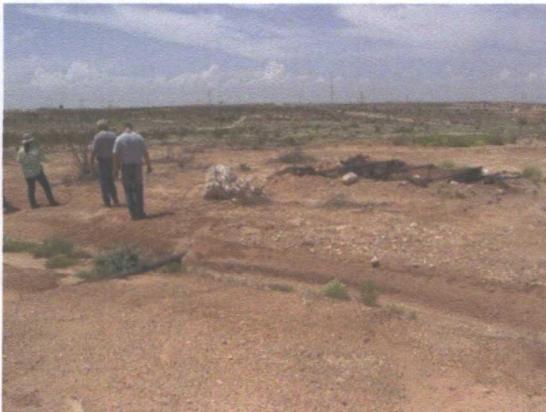
Photograph 4. Area of North Production Pit.

The soil in the area around the north production pit (see Photograph 4 below) is contaminated with chloride and hydrocarbons. RESPEC will oversee the removal of this contaminated soil to a depth of 1 to 5 feet. The contaminated soil will be removed from the site and taken to a waste facility approved by the OCD and will be replaced with soil free from contamination. The area will then be regraded so as to divert water runoff, thereby preventing erosion of the road and pad. In the process of soil removal and regrading, RESPEC will make sure that the two buried pipelines in this area (one possibly for fresh water) are not damaged or disturbed. Photograph 5 below shows an exposed pipeline. The area around the north production pit will be seeded with grass and watered.

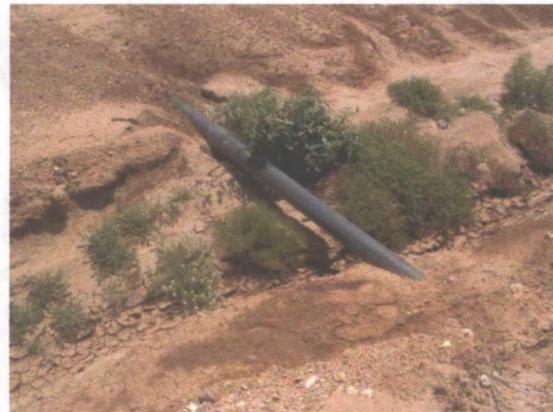
Photograph 5. One of Two Buried Pipelines.
