## Report Type: Work Plan

**Re: Assessment and Work Plan for the COG Operating LLC., Chicken Hawk State #1, Unit A, Section 15, Township 25 South, Range 28 East, Eddy County, New Mexico.**

COG Operating LLC  
Chicken Hawk State #1 Tank Battery  
Eddy County, New Mexico  
Site Assessment (drilling): August 17-18, 2011

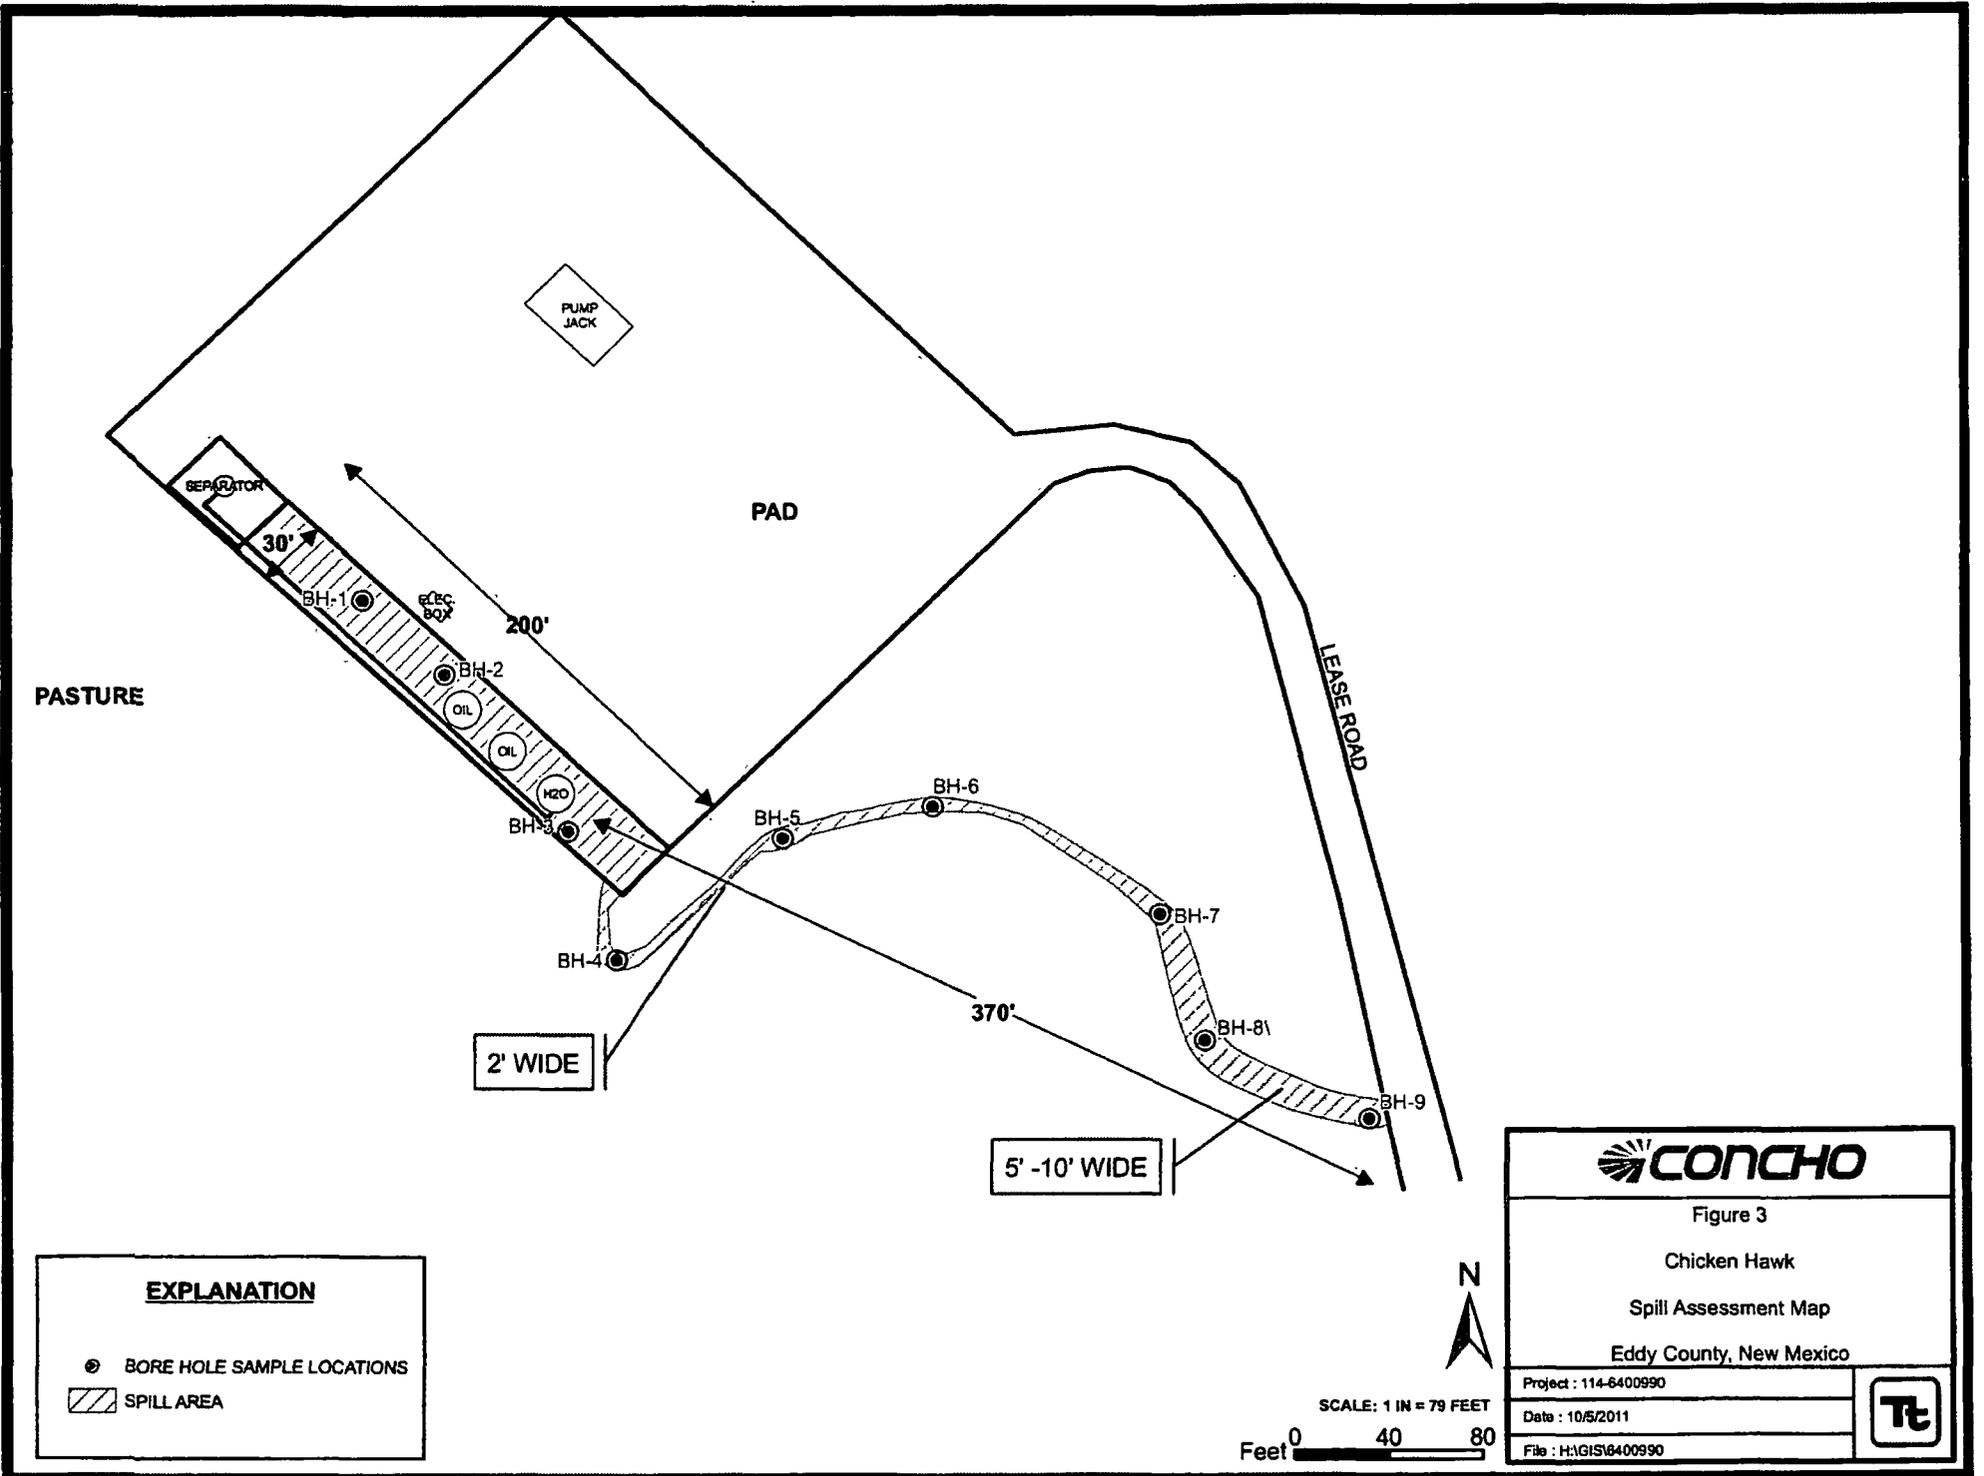
Figure 3	
Chicken Hawk	
Spill Assessment Map	
Eddy County, New Mexico	
Project : 114-6400990	
Date : 10/5/2011	
File : H:\GIS\6400990

On August 17-18, 2011, Tetra Tech supervised the installation of nine (9) boreholes (BH-1 through BH-9) utilizing an air rotary drilling rig. Samples were collected to approximate depths of 15' to 30' below surface. Samples were placed in laboratory provided containers and submitted for laboratory analysis. Copies of the laboratory analysis and chain-of-custody documentation are included in Appendix C. The sampling results are summarized in Table 1. The borehole locations are shown on Figure 4.

Referring to Table 1, the sample from BH-1 exceeded the RRAL for total BTEX at 0-1' of 116.7 mg/kg and was not defined. All the boreholes exceeded the RRAL for TPH of 100 mg/kg, with the exception of BH-8. Borehole (BH-7) showed a TPH of 1,305 mg/kg at 5.0' and was not vertically defined. Boreholes (BH-6 and BH-9) declined below the RRAL at

COG proposes to remove the impacted material as highlighted (green) in Table 1 and shown on Figure 4. In order to remove the hydrocarbon and elevated chloride concentrations, the proposed excavations will range from approximately 1.0' to 7.0' below surface. At the tank battery area, the deepest impact was encountered in the areas of BH-1, BH-2 and BH-3, with proposed excavation depths of 5.0' to 7.0' below surface, if accessible. Due to the proximity of the tanks, lines and equipment, the excavation depths may not be achieved at the tank battery. Based on the results, the hydrocarbon impact left in place would naturally attenuate and deferred the impact until abandonment.

The areas of BH-4, BH-5, BH-7 and BH-9 will be excavated approximately 5.0' to 7.0' below surface and (BH-6 and BH-8) will be to depths of approximately 1.0' to 3.0' below surface.

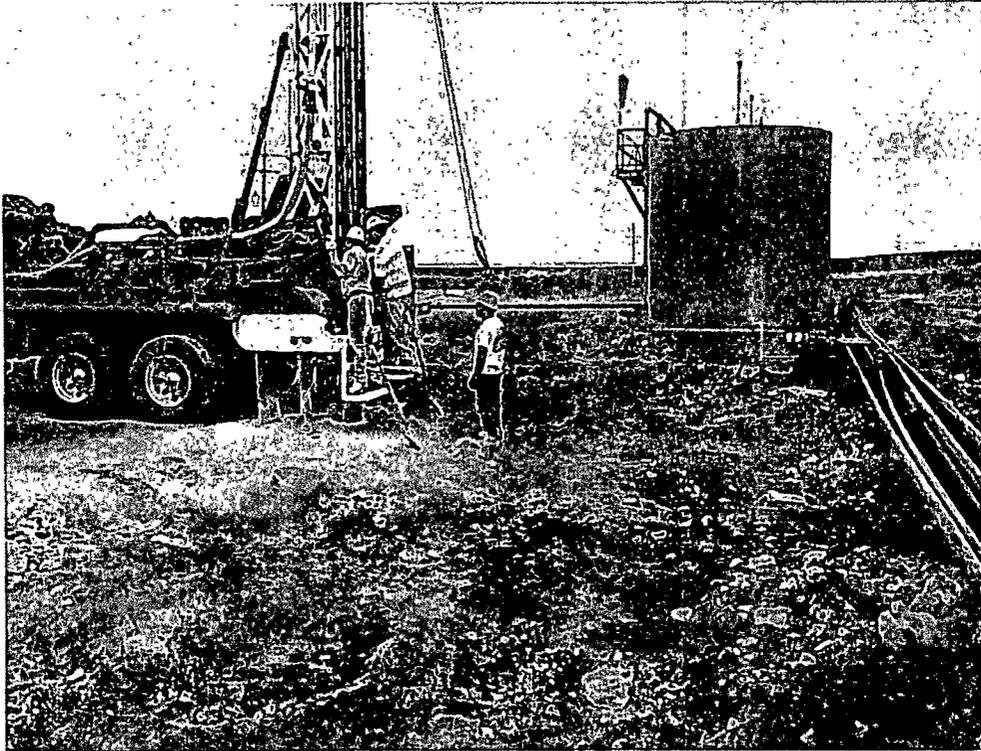
Installation of BH-1 inside tank battery

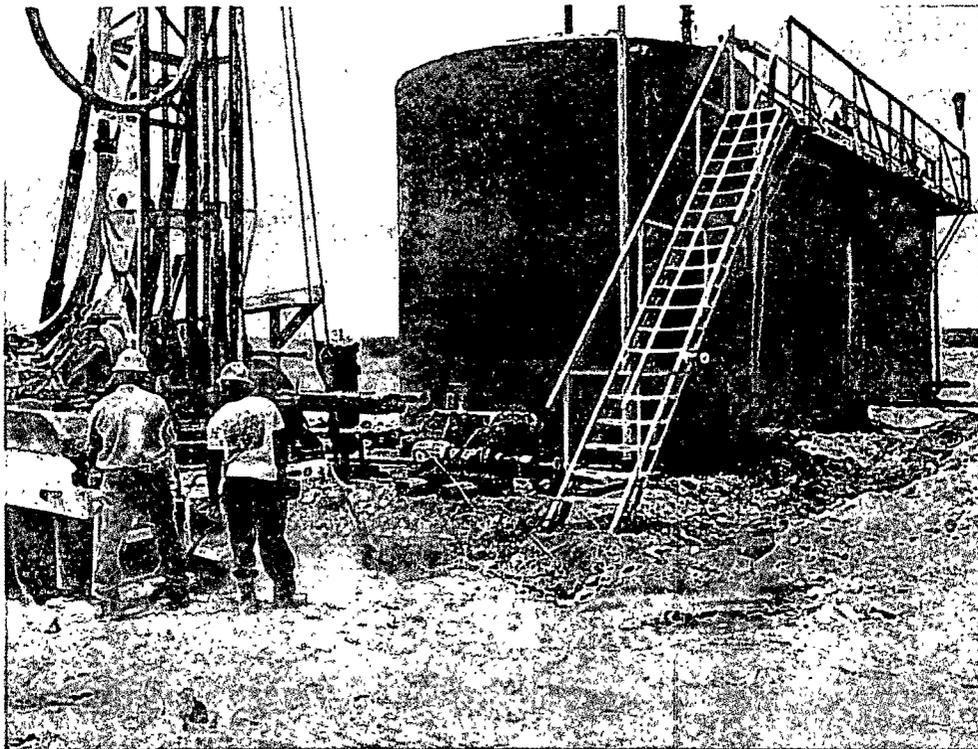
Installation of BH-3 near area spill breached berm

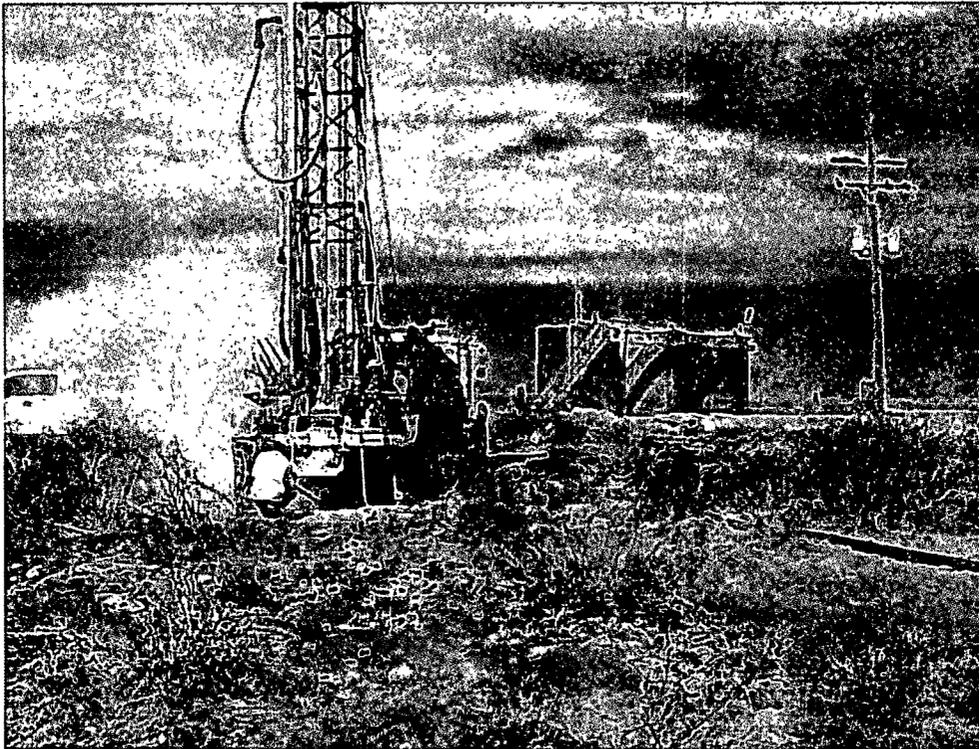
Installation of BH-6

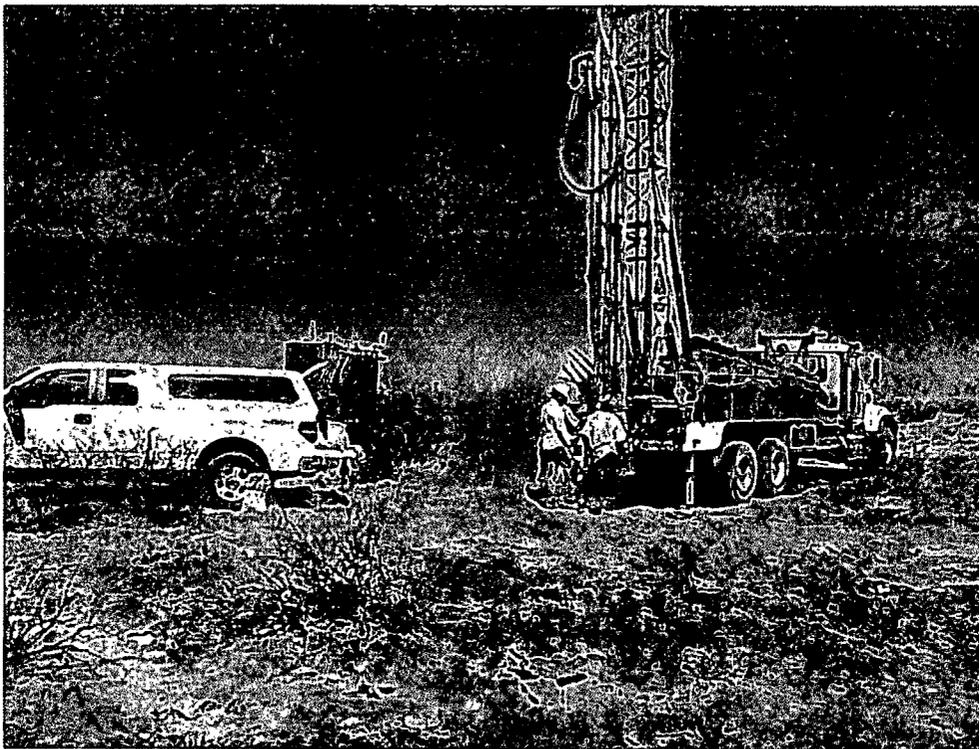
Installation of BH-8
